MARINE CASUALTY REPORT

CONTINENTAL OIL RIG 43-A
EXPLOSION AND FIRE WITH NO LOSS OF LIFE
GULF OF MEXICO, 24 OCTOBER 1967

U.S. COAST GUARD
MARINE BOARD of INVESTIGATION REPORT
and COMMANDANT'S ACTION

ACTION BY
NATIONAL TRANSPORTATION SAFETY BOARD

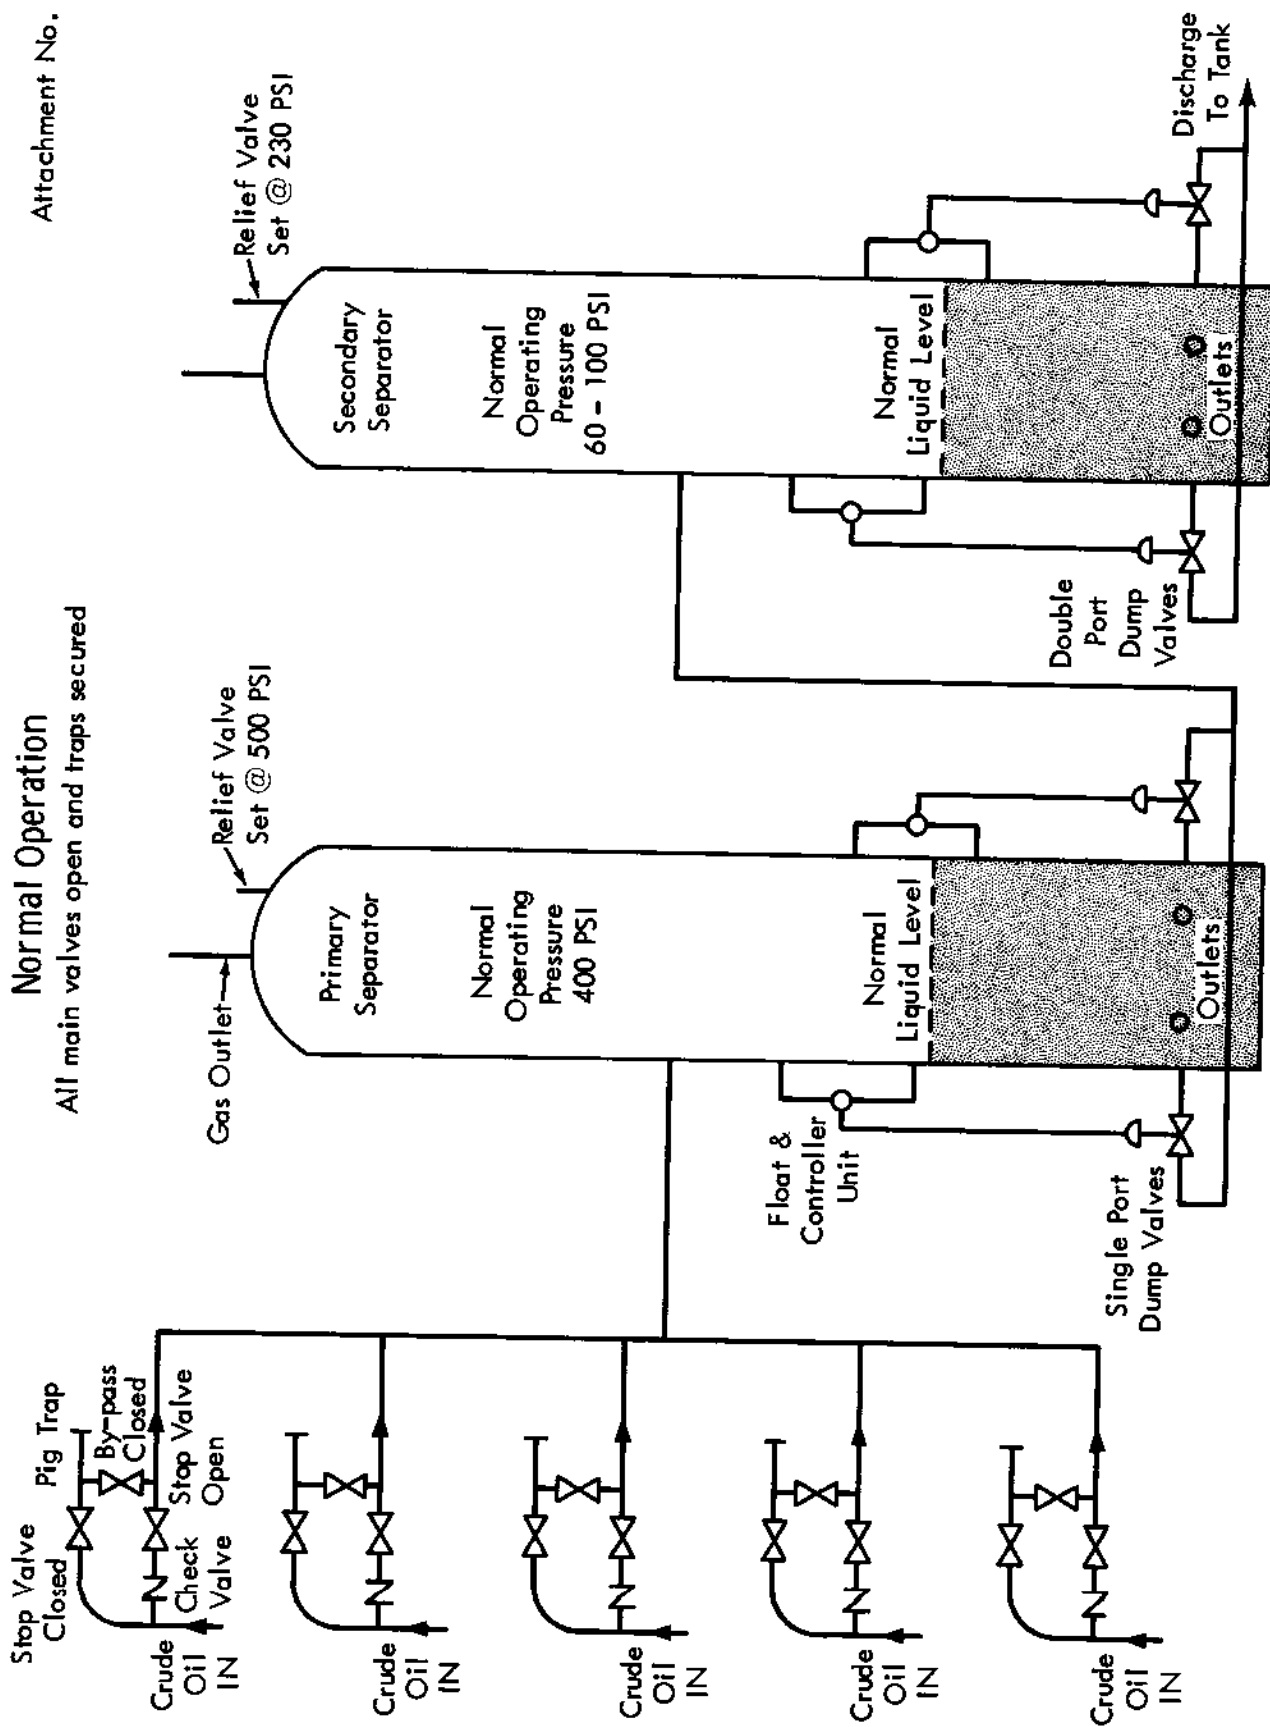
Normal Operation

The function of platform 43-A was to collect and process crude oil produced from nearby wells. The oil and extracted gas were then piped ashore. Attachment No. 1 is a scheme of the main flow components involved in the casualty. The main part of the processing in this type of operation took place in a primary and a secondary separator. The function of these was the separation of the gas from the crude oil, utilizing gravitational and centrifugal forces. Incoming crude oil, at a pressure of approximately 400 p.s.i., was piped directly to the primary separator which had a relief valve set to open at 500 p.s.i. Gas products were taken off at the top of the separator while the oil which collected in the lower part of the separator discharged, by means of level actuated dump valves, to the secondary separator where the process was continued. The normal operating pressure on the secondary separator was 60

All main valves open and traps secured

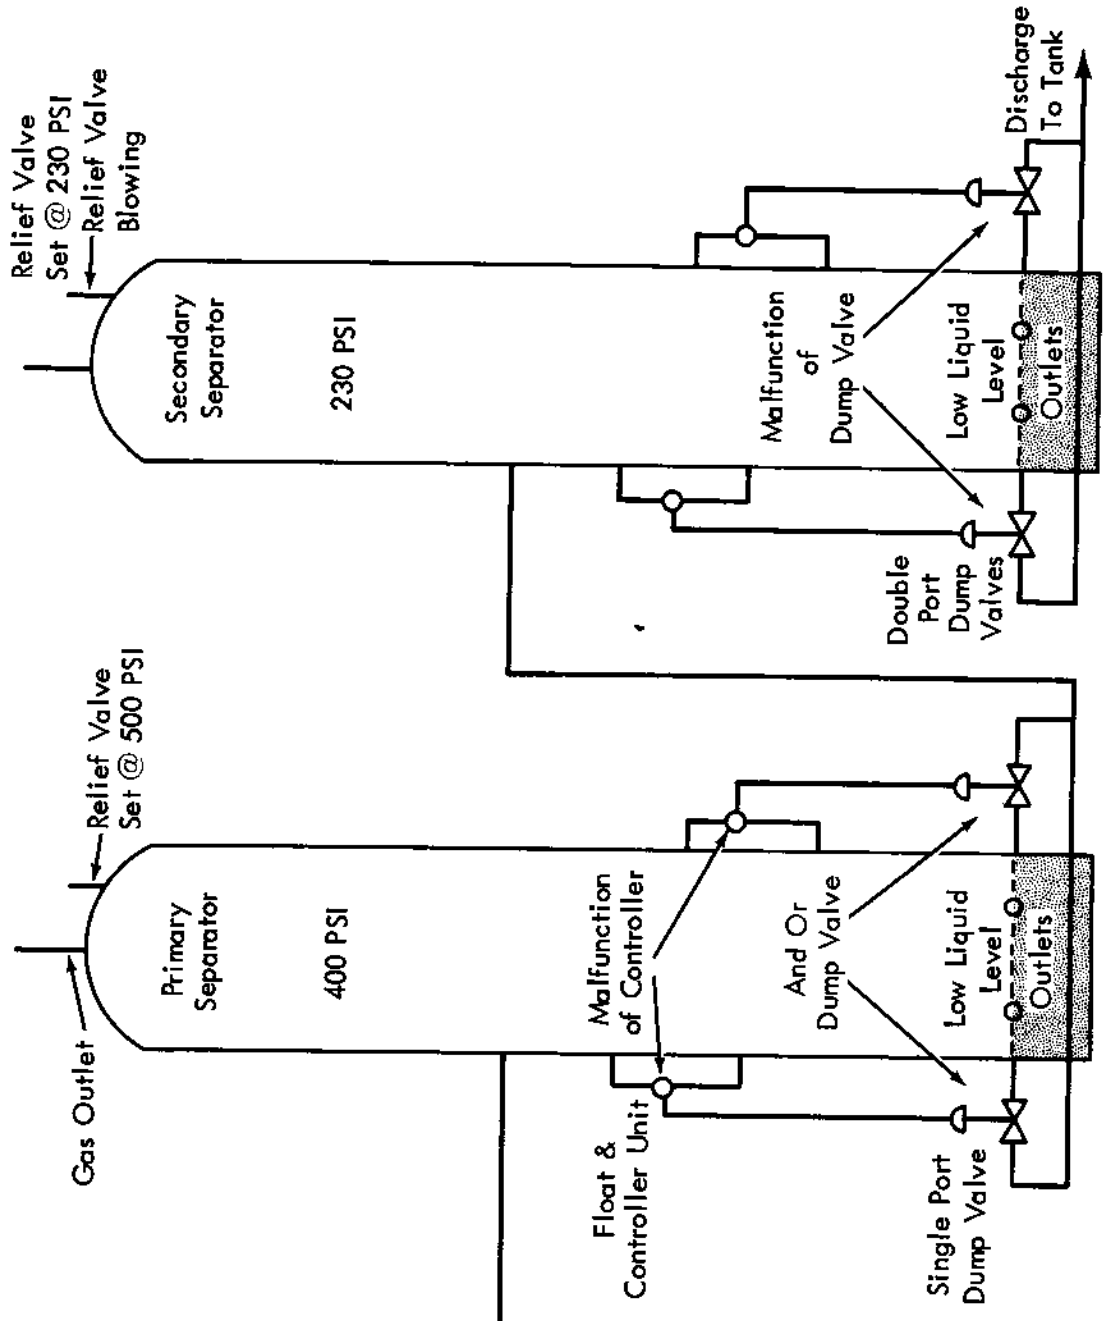
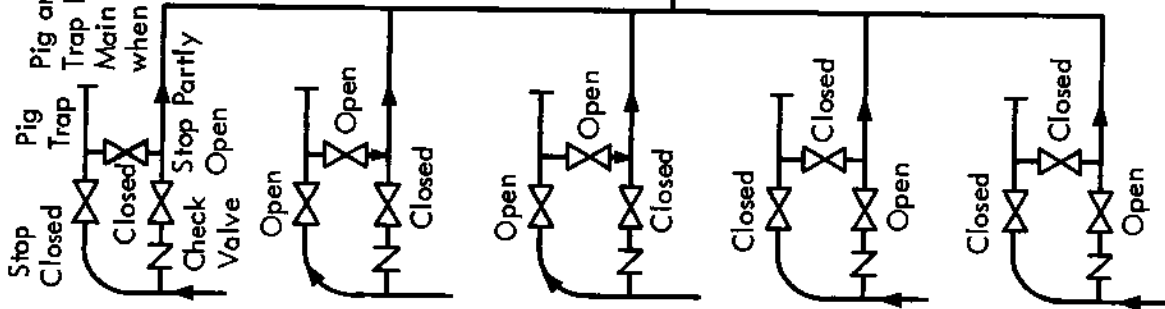
Situation at Time of Casualty

The first evidence of unusual conditions on the main deck was the operation of the relief valve on the secondary separator. This was followed in rapid sequence by a rumbling sound in the storage tank, the spraying of the oil from the tank vents, rupture of the tank, a loud explosion-like noise, and fire. Attachment No. 2 indicates the hypothesis of the plant situation at the time of the casualty.

7. The vents did not have the aggregate area to relieve this volume of gas at the high flow rate, and the tank was subjected to over-pressure.
8. The tank ruptured.

The Safety Board concludes that the investigative record in this case does not contain sufficient information to provide a determination of the cause of this casualty. However, based on the most likely hypothesis, the Board concludes that the most probable cause was faulty operation of two of the four dump valves of the separators in a chain of events combined with a malfunction of the primary dump valve controller during the pipe cleaning operation which allowed a large volume of high pressure gas to enter the storage tank, rupturing it.

Stop Pig arrived in trap.
Trap Inlet & By-pass were closed
Main flow valve was being opened
when Storage Tank ruptured.
