MARINE CASUALTY REPORT

SS EDGAR M. QUEENY - S/T CORINTHOS; COLLISION
AT MARCUS HOOK, PENNSYLVANIA ON 31 JANUARY 1975
WITH LOSS OF LIFE

U.S. COAST GUARD
MARINE BOARD OF INVESTIGATION REPORT
AND COMMANDANT'S ACTION

REPORT NO. USCG/NTSB MAR-77-2
RELEASED

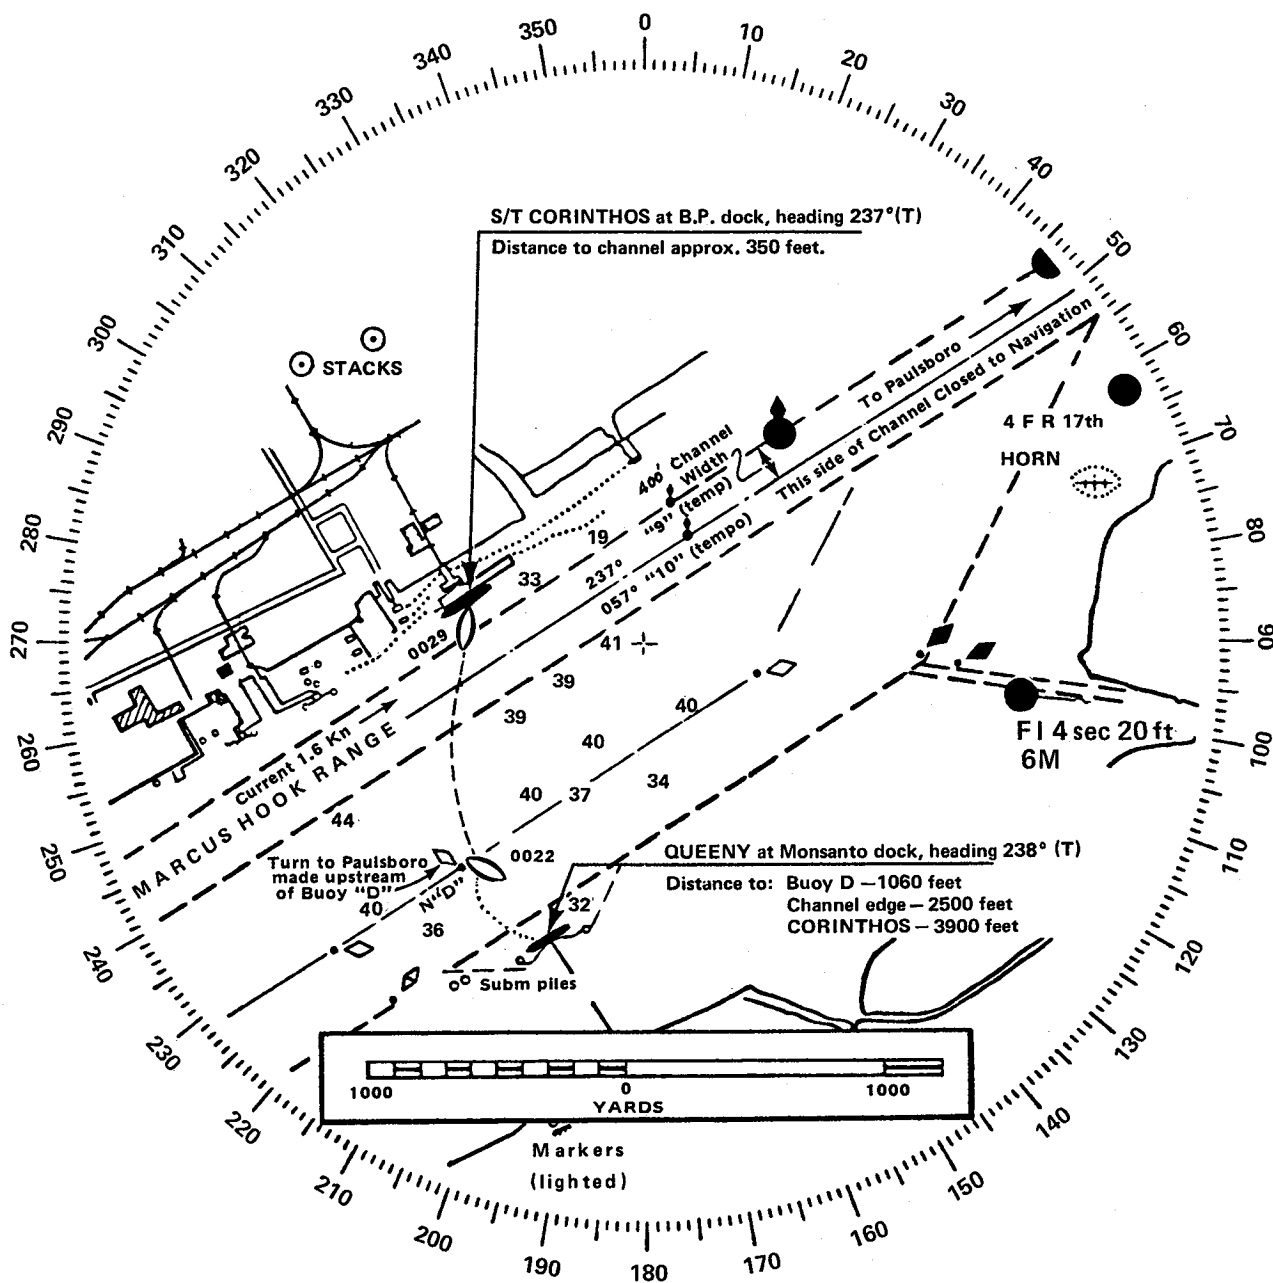
FIGURE 1

Plan of accident site

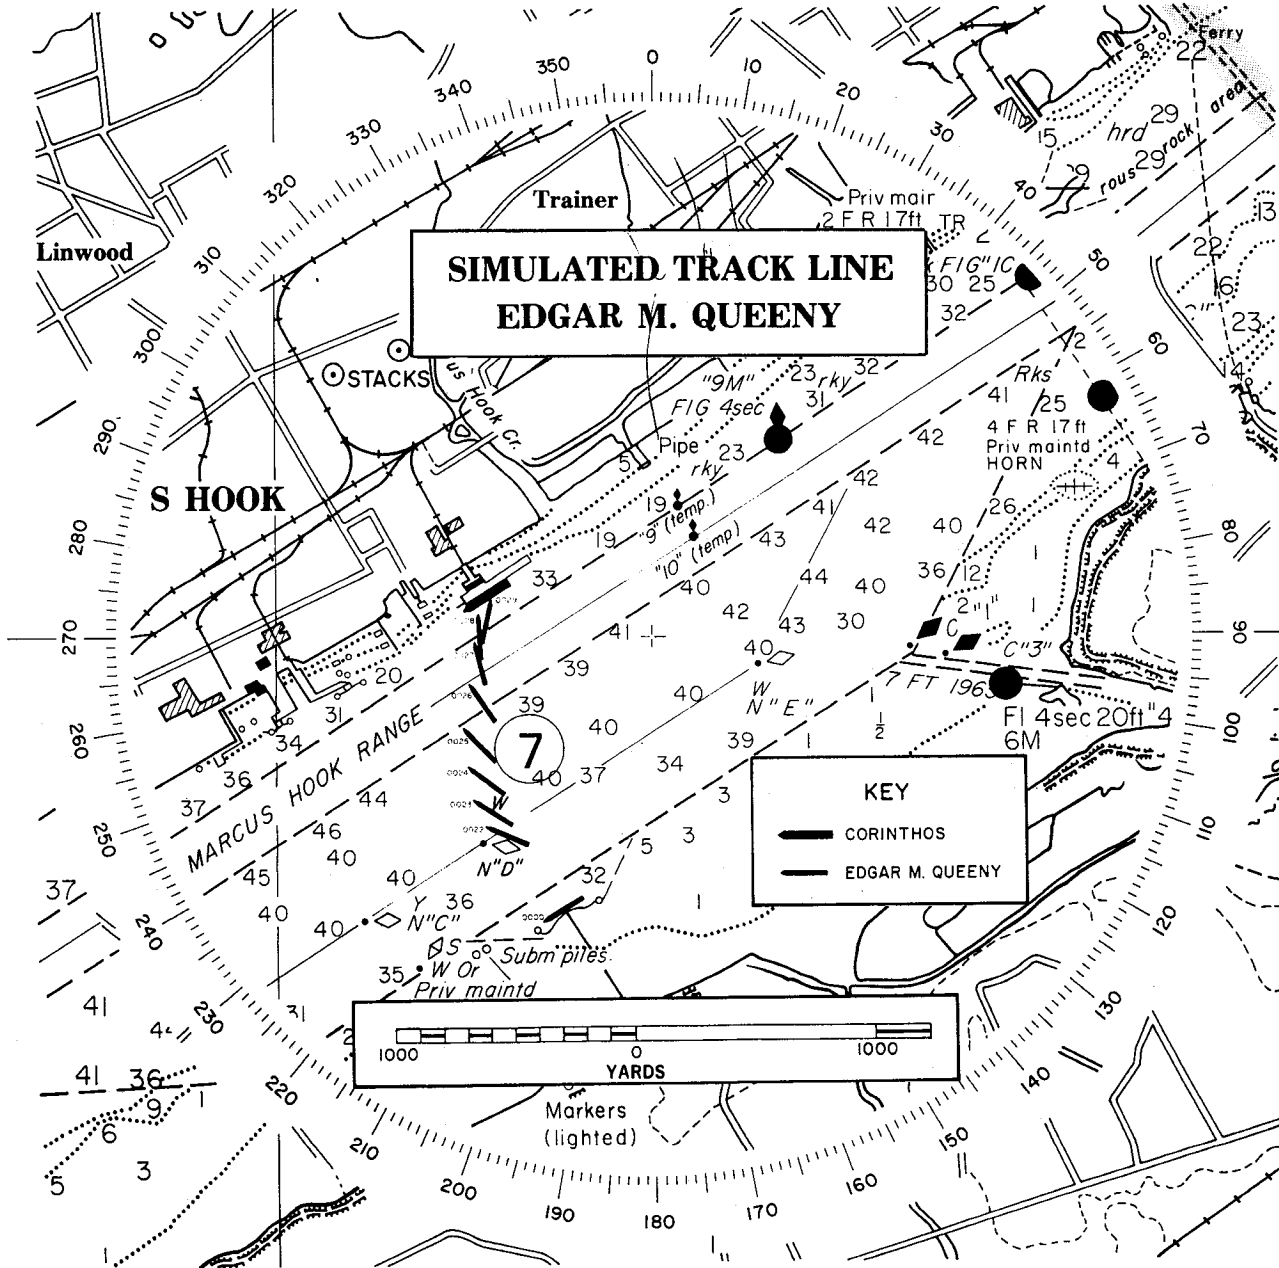
FIGURE 1

37. During the preparation of Figure 1 appended hereto, the Board determined that the EDGAR M. QUEENY rudder was hard right at the time that the vessel struck the CORINTHOS. The Board recognizes that this presumption conflicts to some degree with the testimony of the Helmsman Mr. Sutton. One part of Mr. Sutton's testimony alternately indicates that he observed the rudder amidships at or before the time of collision. Comparing the description of one of his observations with other events it is obvious that he was describing a condition that existed for several minutes before the collision. Repeated questioning by Board members, and others participating in the hearings, also elicited from Mr. Sutton an acknowledgement that the observation could have been made after the collision. The Board chose to discount his testimony regarding this point since it could not be corroborated and because of his tentative and contradictory accounts.
