MARINE CASUALTY REPORT

S/S EXXON HOUSTON

GROUNDING NEAR BARBERS POINT, HAWAII

REPORT NO. USCG 16732/01 HQS 92

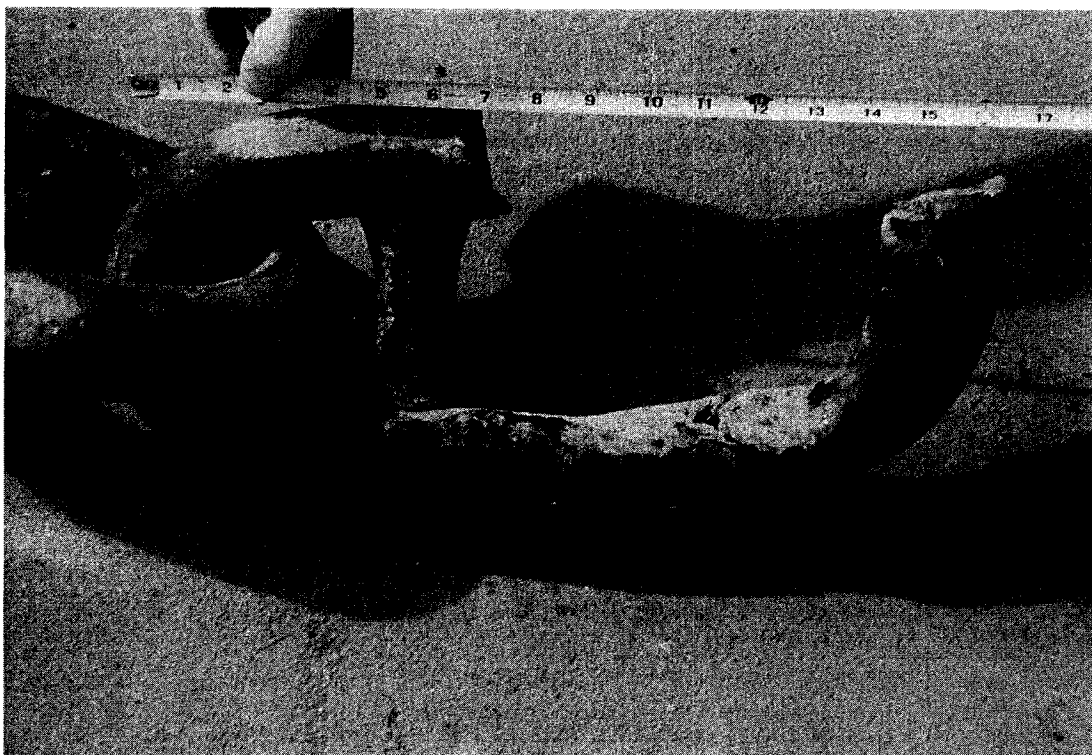
examination of the chain links revealed wear patterns at the end of some of the links which indicated that the chain had experienced a considerable load during service resulting in a mushrooming effect. The bullnose of the Exxon Houston also showed evidence of wear, such as would be produced by a chain link rubbing against the surface.

"It is concluded that the failure of link No. 10 in the mooring chain was due to the defects in the weld and to the poor properties exhibited by the base metal immediately adjacent to the weld. The poor properties of the base metal are attributed to the forging design which caused the material to be loaded, effectively, in the transverse direction. The transverse properties, ductility and strength of steels such as used here are undoubtedly lower than the longitudinal properties measured in the tensile test. The defects left in the weld are caused by inadequate ejection of molten metal during the welding process and suggest that a redesign of the weld cycle is warranted."

LINK NO. 10 OF FAILED CHAFE CHAIN. THIS LINK REMAINED ON BOARD EXXON HUSTON AFTER SEPARATION. PHOTO TAKEN BY LT ZUSTRA ON 5 MARCH 1989. EXHIBIT NO. 41

Action: I do not concur with this recommendation. As discussed in my comments on conclusion 13 above, the chafe chain which parted did not meet the ABS standard for offshore mooring chain. Chain meeting the ABS standard would be more suitable for use on the SPM.
