# MARINE CASUALTY REPORT

UNINSPECTED TOWING VESSEL  
FRANK PALLADINO JR  
O.N. 619166

COLLISION WITH A PLEASURE  
CRAFT (OH 0164 YU) IN THE  
SOUTH PASSAGE OF LAKE  
ERIE, ON 1 OCTOBER 1994,  
WITH AN INJURY AND  
MULTIPLE LOSS OF LIFE.

U.S. COAST GUARD  
ONE-MAN FORMAL INVESTIGATION REPORT  
REPORT NO. USCG 16732/24DET94/MC94020576

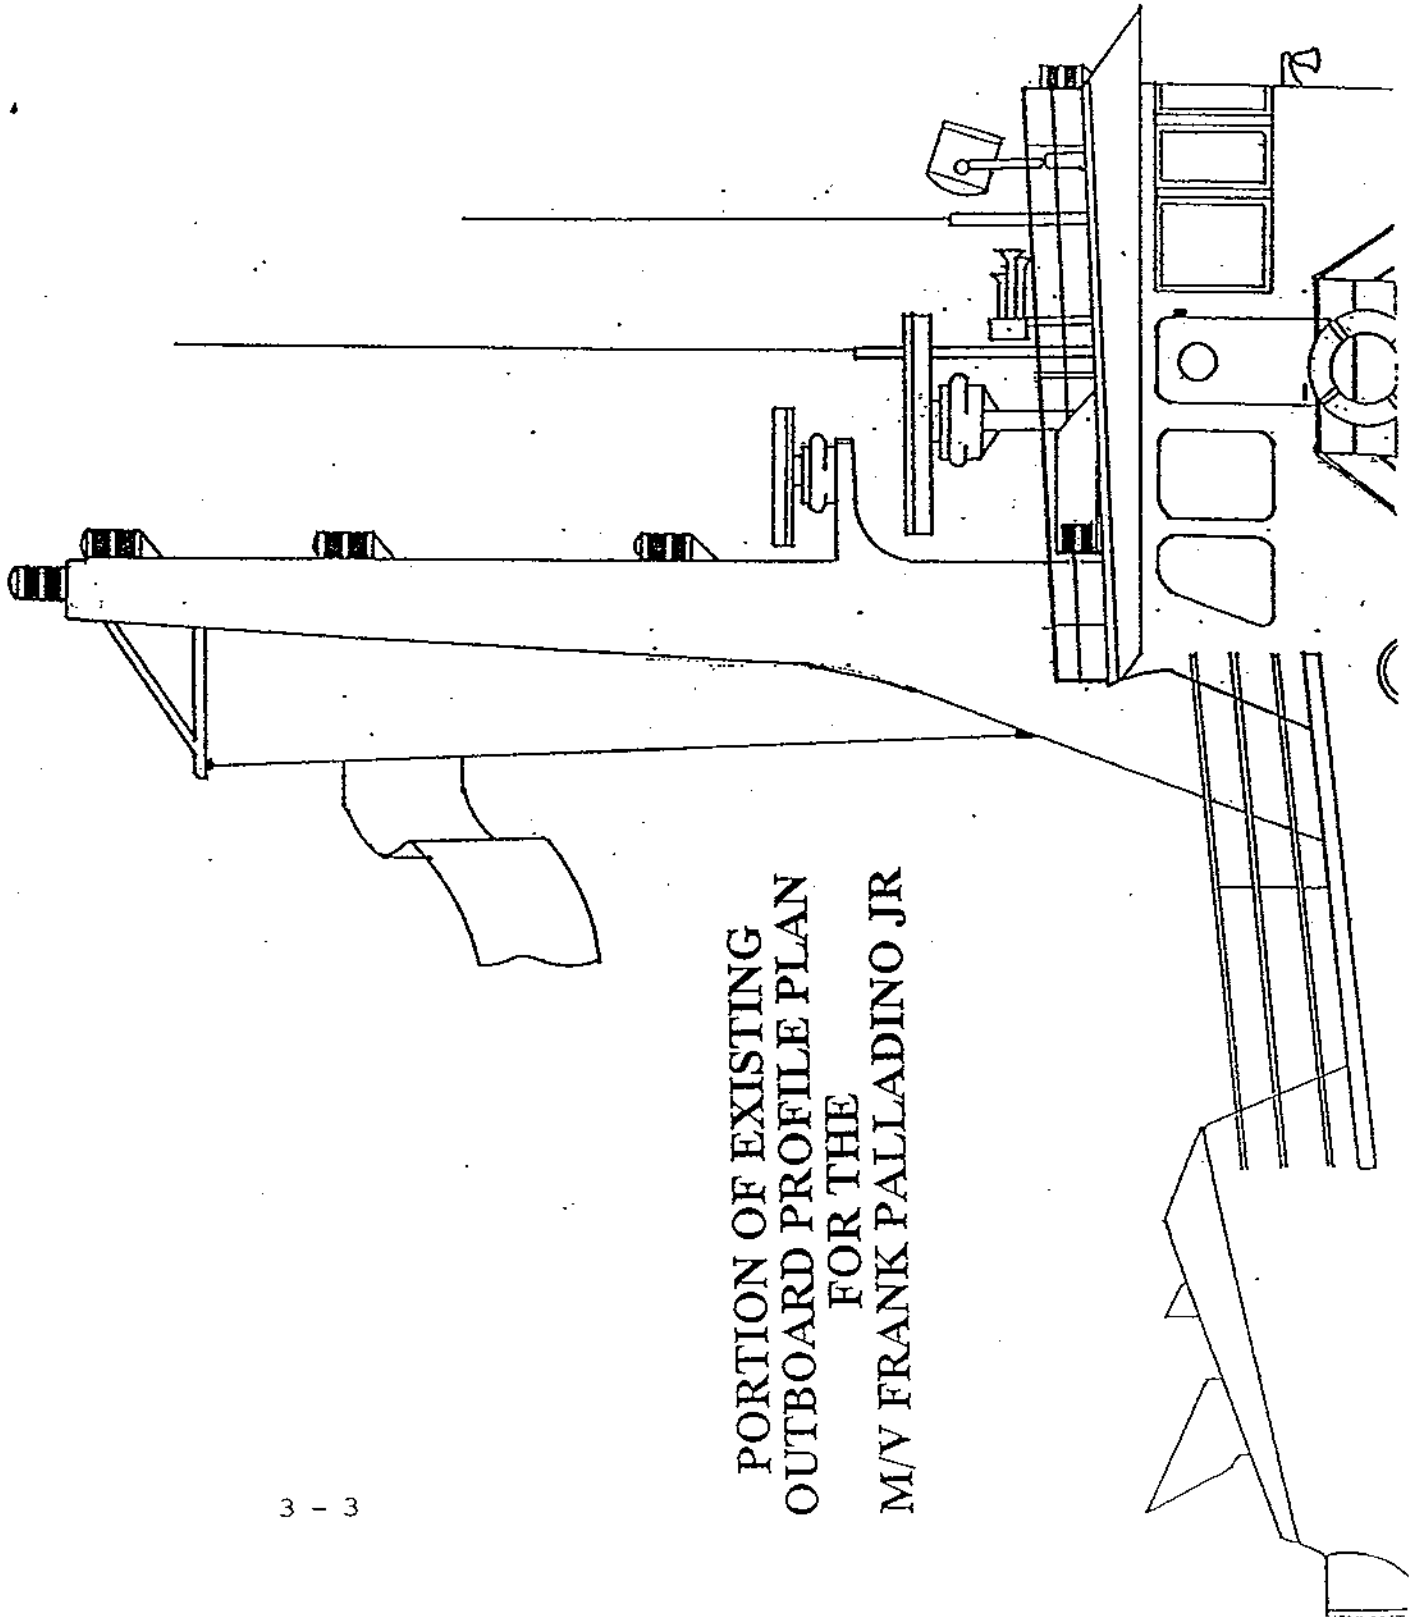
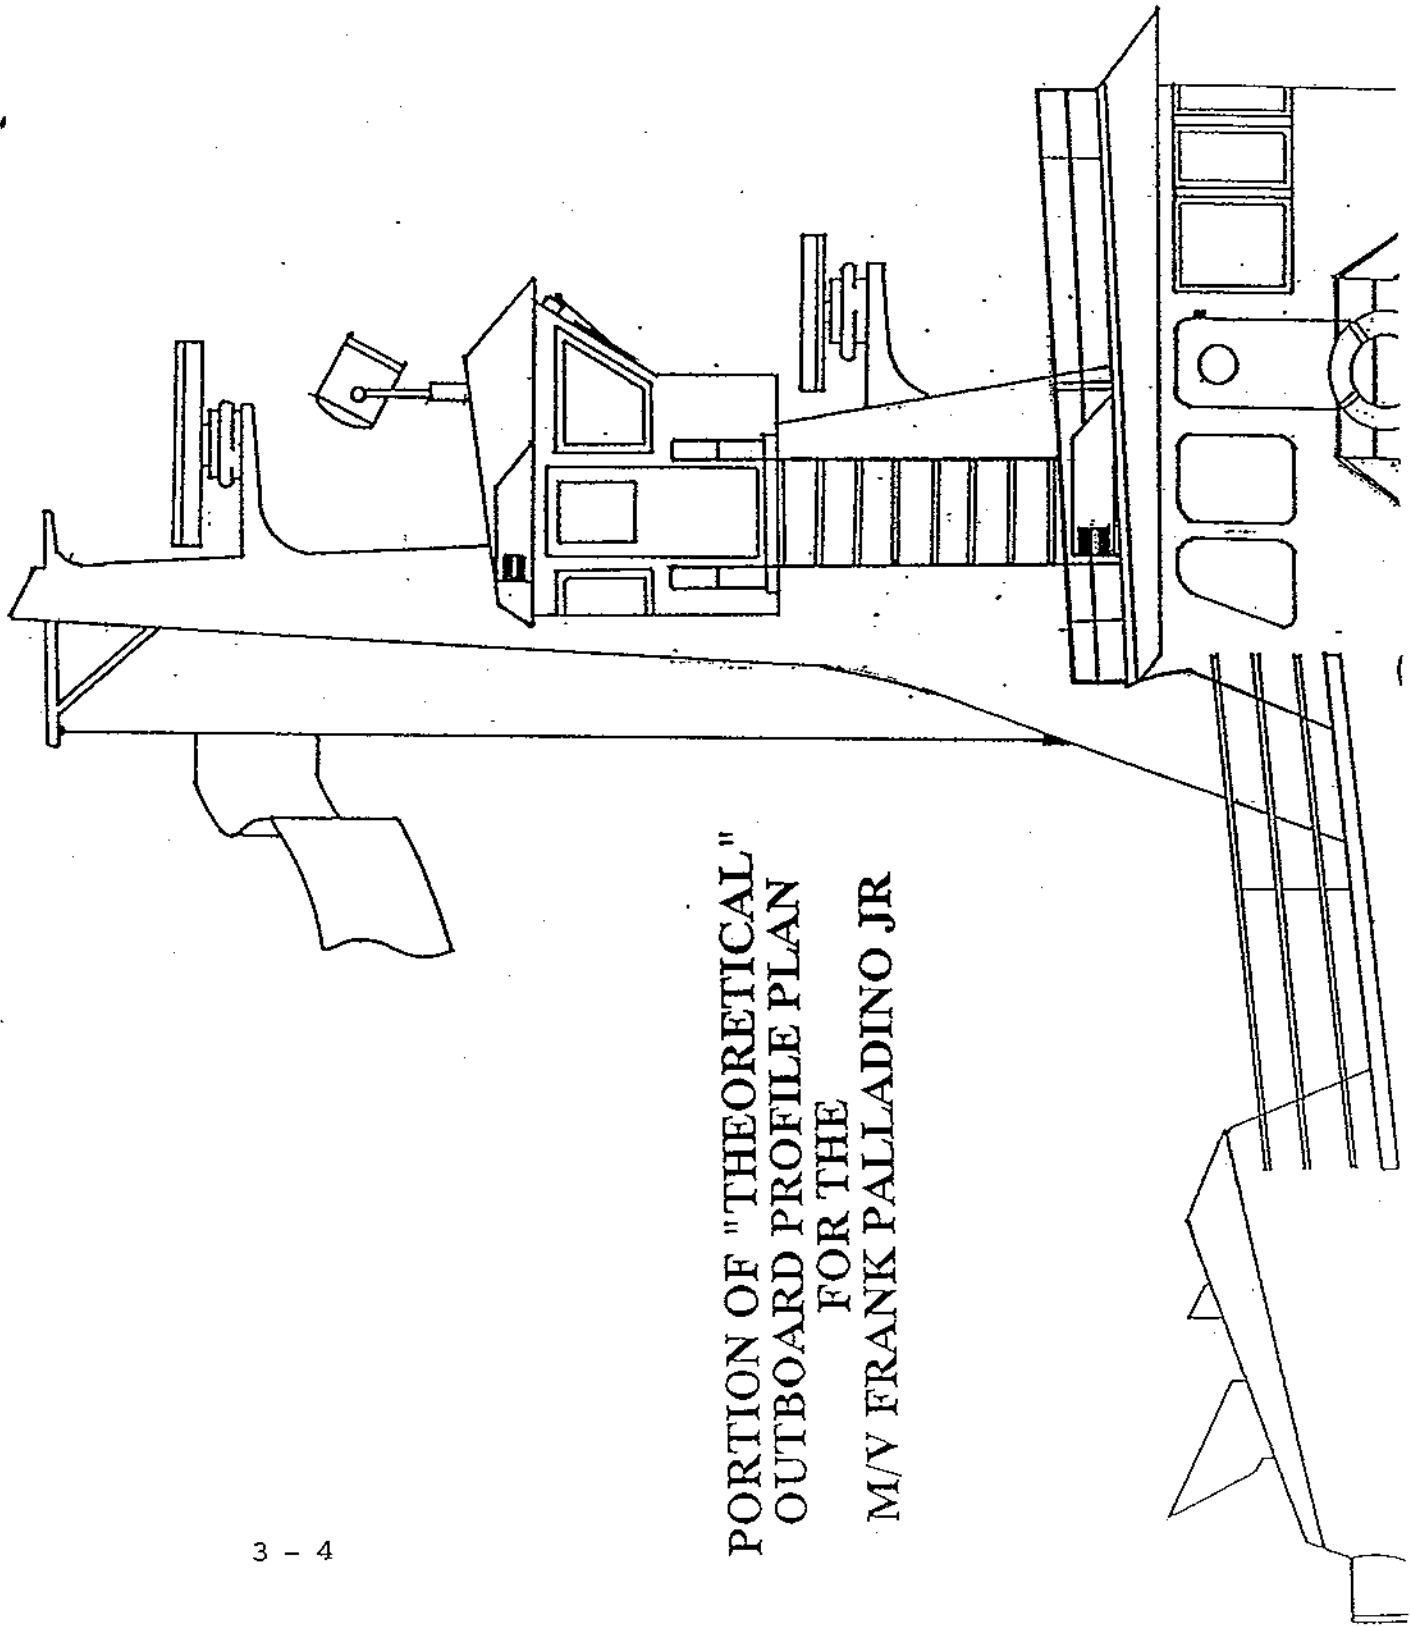
1. A cardboard tube of blueprints for the tug was given by Captain Verret to LTJG McDonald, while the latter was onboard the tug, on 2 October 1994. Captain Verret stated that he had them in his home on Kelly's Island. In this tube, was found a blueprint marked as "Outboard Profile Plan." A piece of tracing paper was taped over the superstructure of the tug with some drawing on it. The drawing depicted a theoretical modification to the tug which was studied in Cleveland, OH, in 1993. Consideration was given to add a raised pilot control station as an alternative to ballasting the barge. However, the company concluded that ballasting the barge was preferable to operating from an upper control station. [CG2, CG3, CG65A, p. 14; Figure 3 - 1; Figure 3 - 2]

TABLE 3 -1. Waterline distance forward of the bow obscured from the conning station for the towing vessel FRANK PALLADINO JR in the notch of the empty Great Lakes barge KELLSTONE I. The length over all (LOA) for the combination is 456 feet (138.99 m). Two tug/barge lengths is equal to 912 feet (277.98 m).

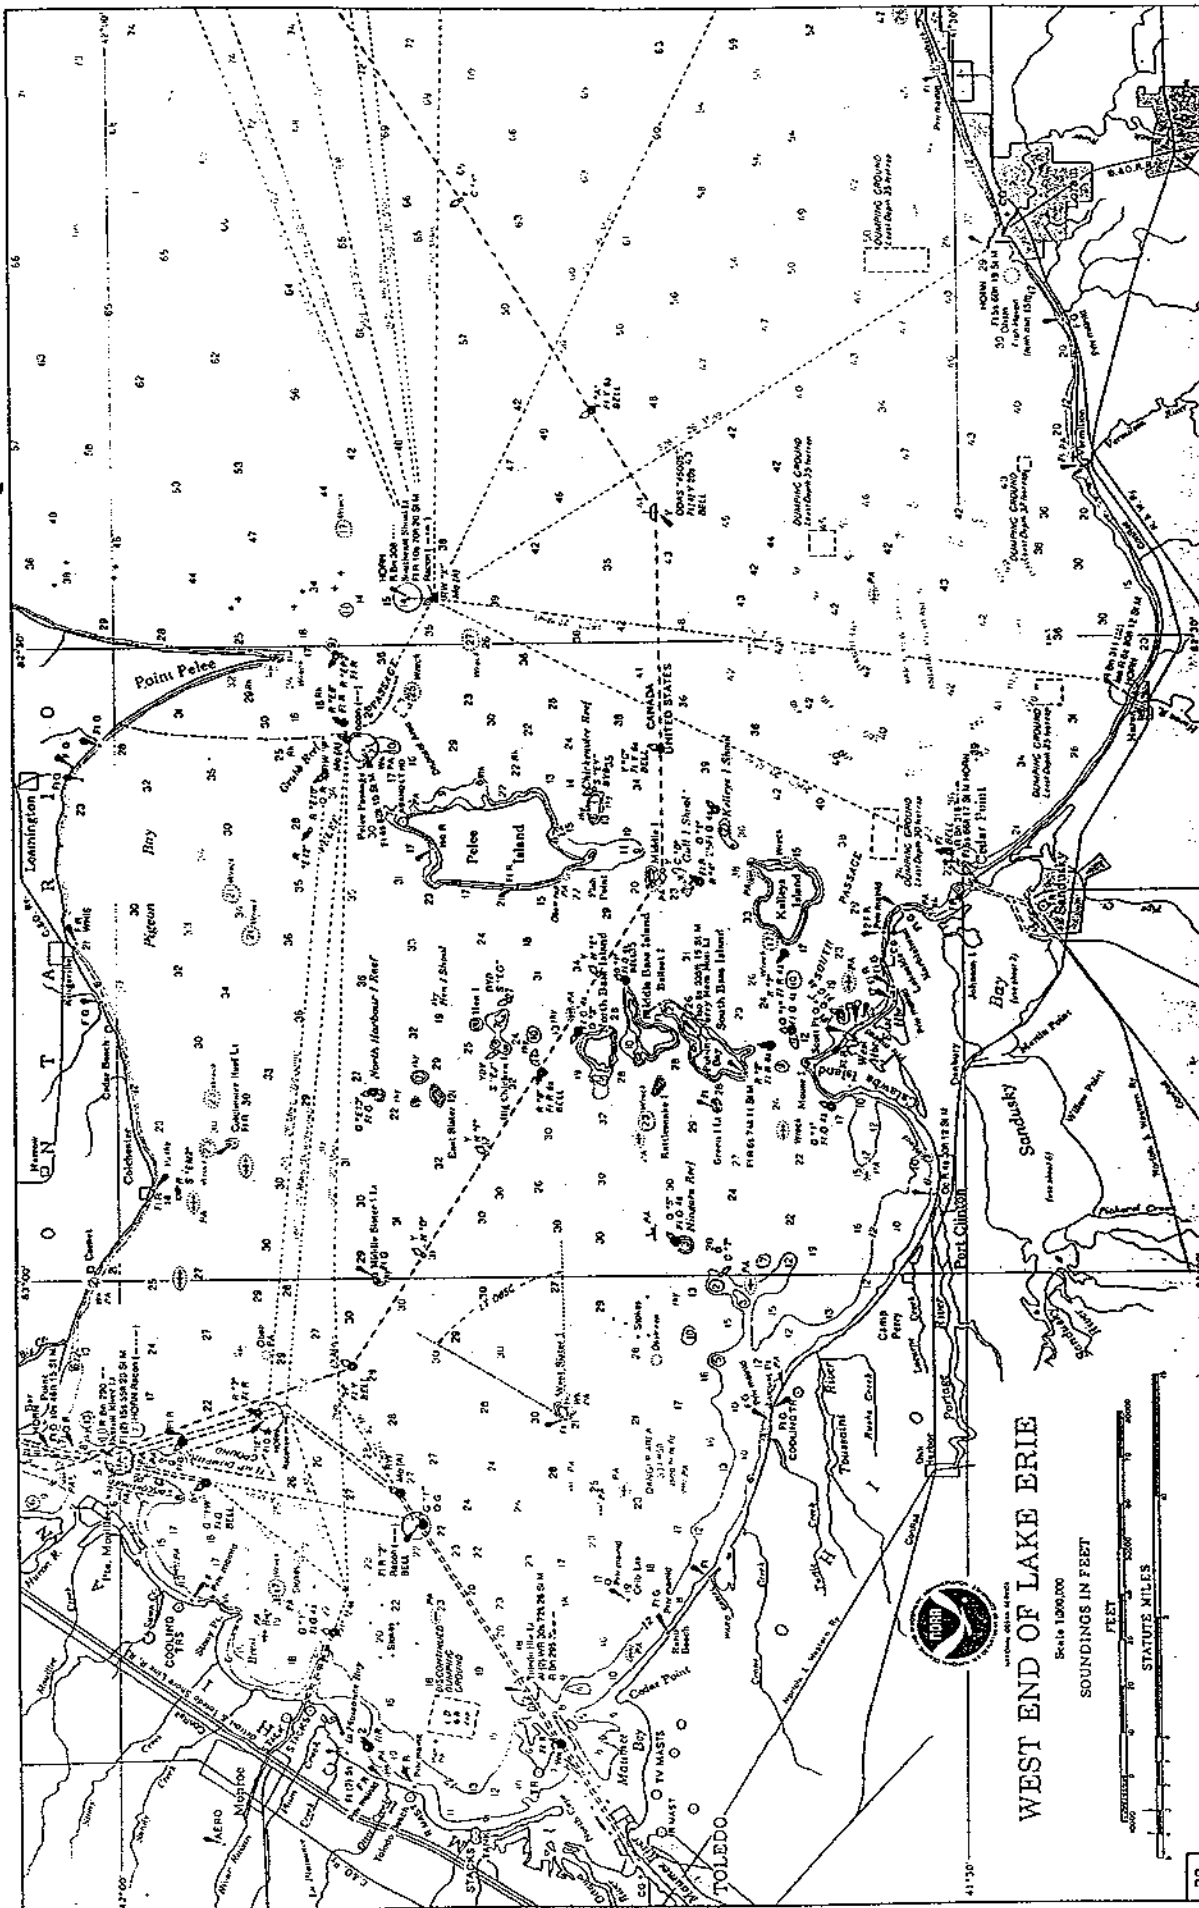
FIGURE 3 - 5

19. "The Lake Carriers' Association (LCA) and the Canadian Shipowners Association (CSA) have recommended, for vessels enrolled in the associations, separation of routes for upbound and downbound traffic in Lake Erie." [CG13; CG78; IBT22; IBT23M; USCP 6, 1994, p. 135; Figure 3 - 5]

20. The latest editions of Recreational Chart 14842 and Charts 14830 and 14844 have LCA/CSA recommended routes printed on them. These routes are marked as dashed black lines with courses and distances in magenta lettering above the lines. There are no LCA/CSA recommended routes through the South Passage. The *historic* LCA/CSA recommended route of 302° T through the South Passage was removed sometime between 1952 and 1974. Also on these charts, are ferry routes that cross the eastern and western entrances to the South Passage. These routes are marked as dashed magenta lines with the word "Ferry" in black lettering above each line. [CG5; CG6A; CG6C; CG13; CG78; IBT22; IBT23M; USCP 6, 1994, p. 135; Chart No. 1, p. 14; Figure 3 - 5]

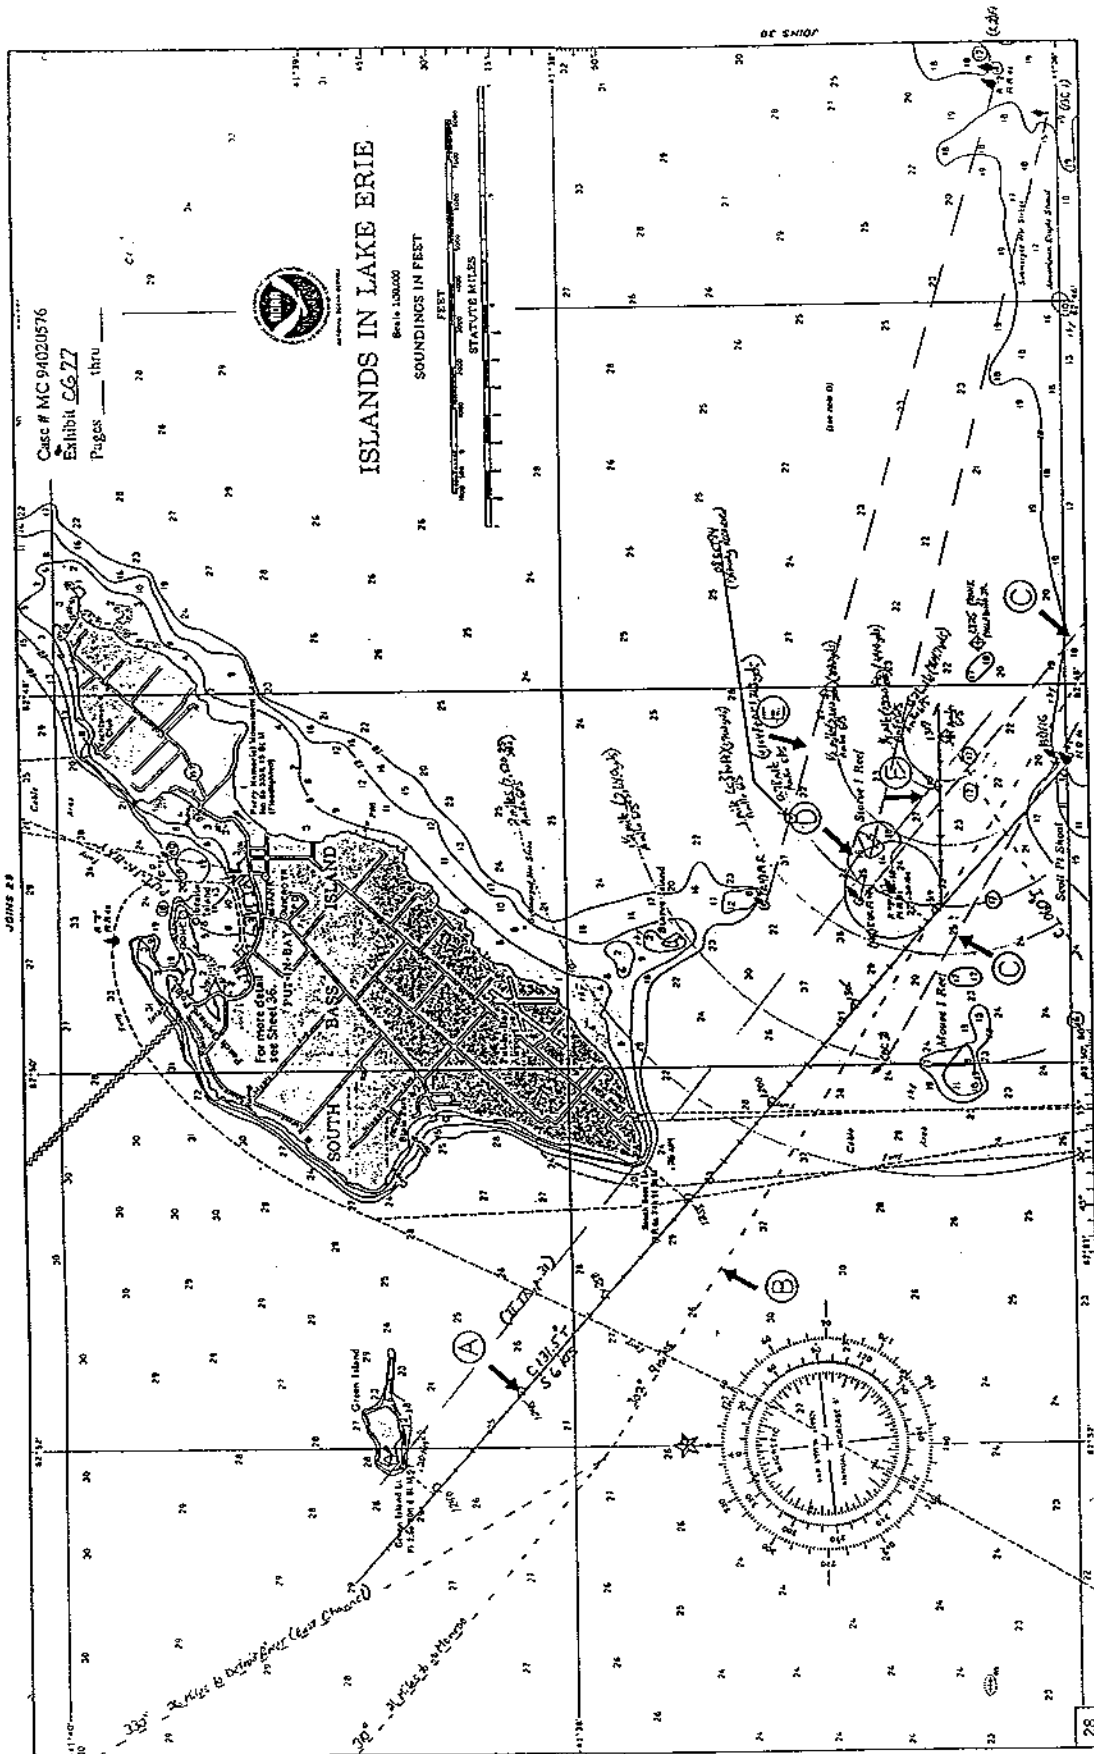
Figure 4 - 1

- A = Tug and barge trackline position as found on the original chart from the tug (CG6A), but without times and DR markings.
- B = LCA recommended routes as found on USACOE Chart Nos. 36(1952) & 364(1955).
- C = Dashed lines connecting historic aids to navigation on USACOE Charts (above)(Drawn by LTJG McDonald).
- D = Turn radius and bearing as found on original chart from tug (CG6A).
- E = (same as letter C above)
- F = Tangent bearing of Green Island & South Bass Island. The Mach 1 was located somewhere northeast of this bearing as evidenced by Fact 4.25.

APPROXIMATE PRE-COLLISION  
DR TRACK OF THE  
TUG AND BARGE IN  
THE SOUTH PASSAGE

30. David Marracino saw the Mach 1 at or about 1303 hours, at approximately 1-1/2 miles away. This was about 14 minutes before the accident. [CG38; CG77; Figure 4 - 1; Figure 4 - 2]

31. The tug and barge picked the less congested path as they approached vessels south of the Starve Island Reef Buoy. [CG38]
32. Virginia Ostrom first saw the "large black vessel" (i.e., tug and barge) at least 8 minutes before the accident or sometime before approximately 1309 hours. At that time, Mr. Crane and Ms. Ostrom could see down the port side of the barge and all of the bow. They could not see the tug. The second time Ms. Ostrom saw it, it had already turned towards her. Mr. Crane did not believe that the large black vessel represented any danger when he first observed it. [CG77; K18; Figure 4 - 1; Figure 4 - 2; II TR, pp. 55, 56, 130, 131, 149, 150, 160, 165]

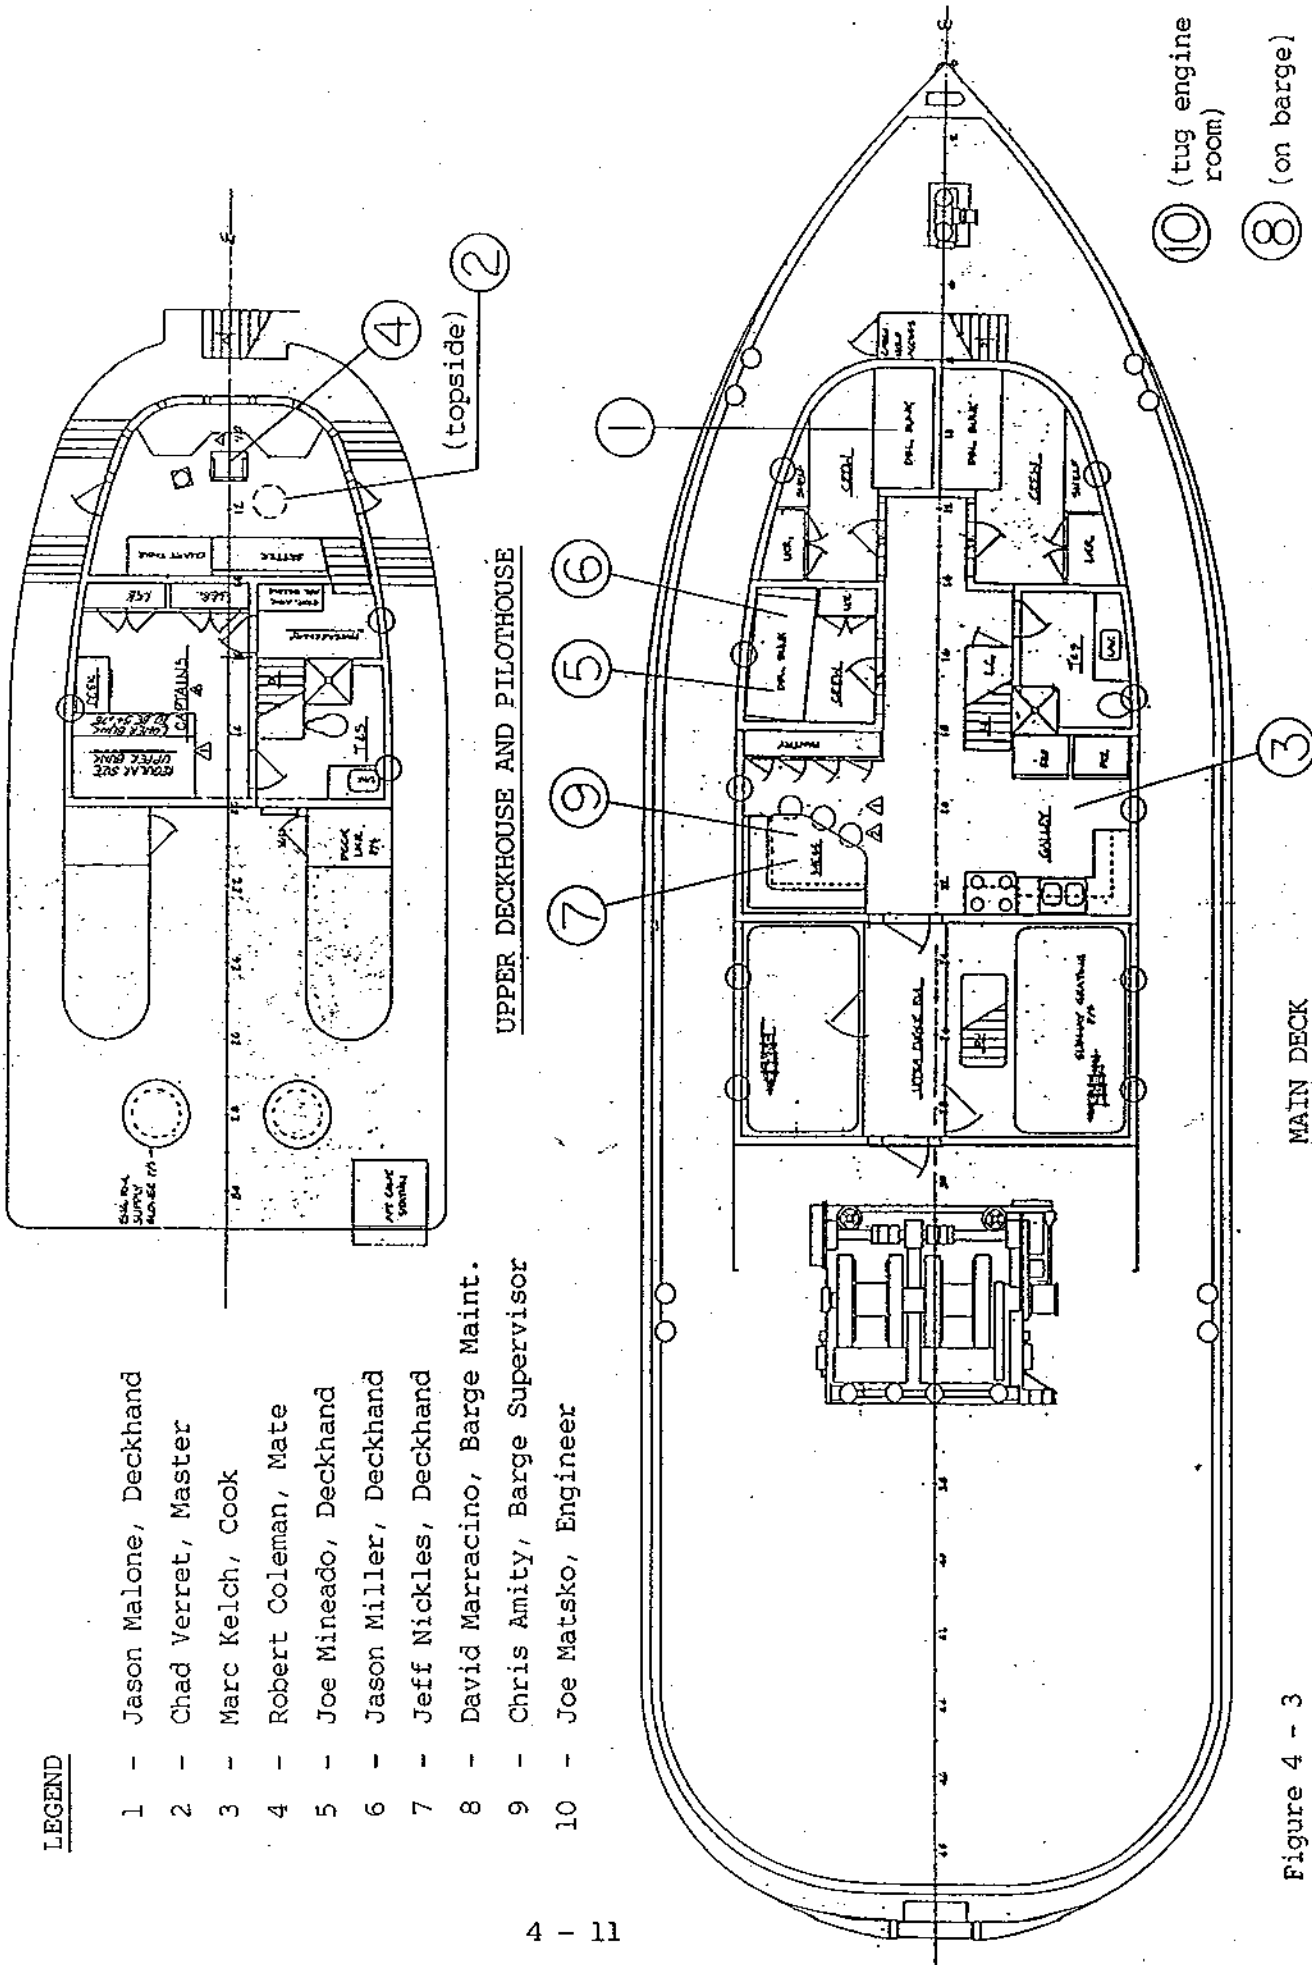
# TUG AND BARGE CREW LOCATIONS AT THE TIME OF THE ACCIDENT

62. Figure 4 - 3 depicts the location of the tug and barge crewmembers at the time of the accident. [CG52]
