**GROUNDING OF THE SS HILLYER BROWN
AT COLD BAY, ALASKA ON 7 MARCH 1973
WITHOUT LOSS OF LIFE**

**U.S. COAST GUARD
MARINE BOARD OF INVESTIGATION REPORT
AND COMMANDANT'S ACTION**

REPORT NO. USCG/NTSB - MAR-75-1

RELEASED 31 MAR 1975

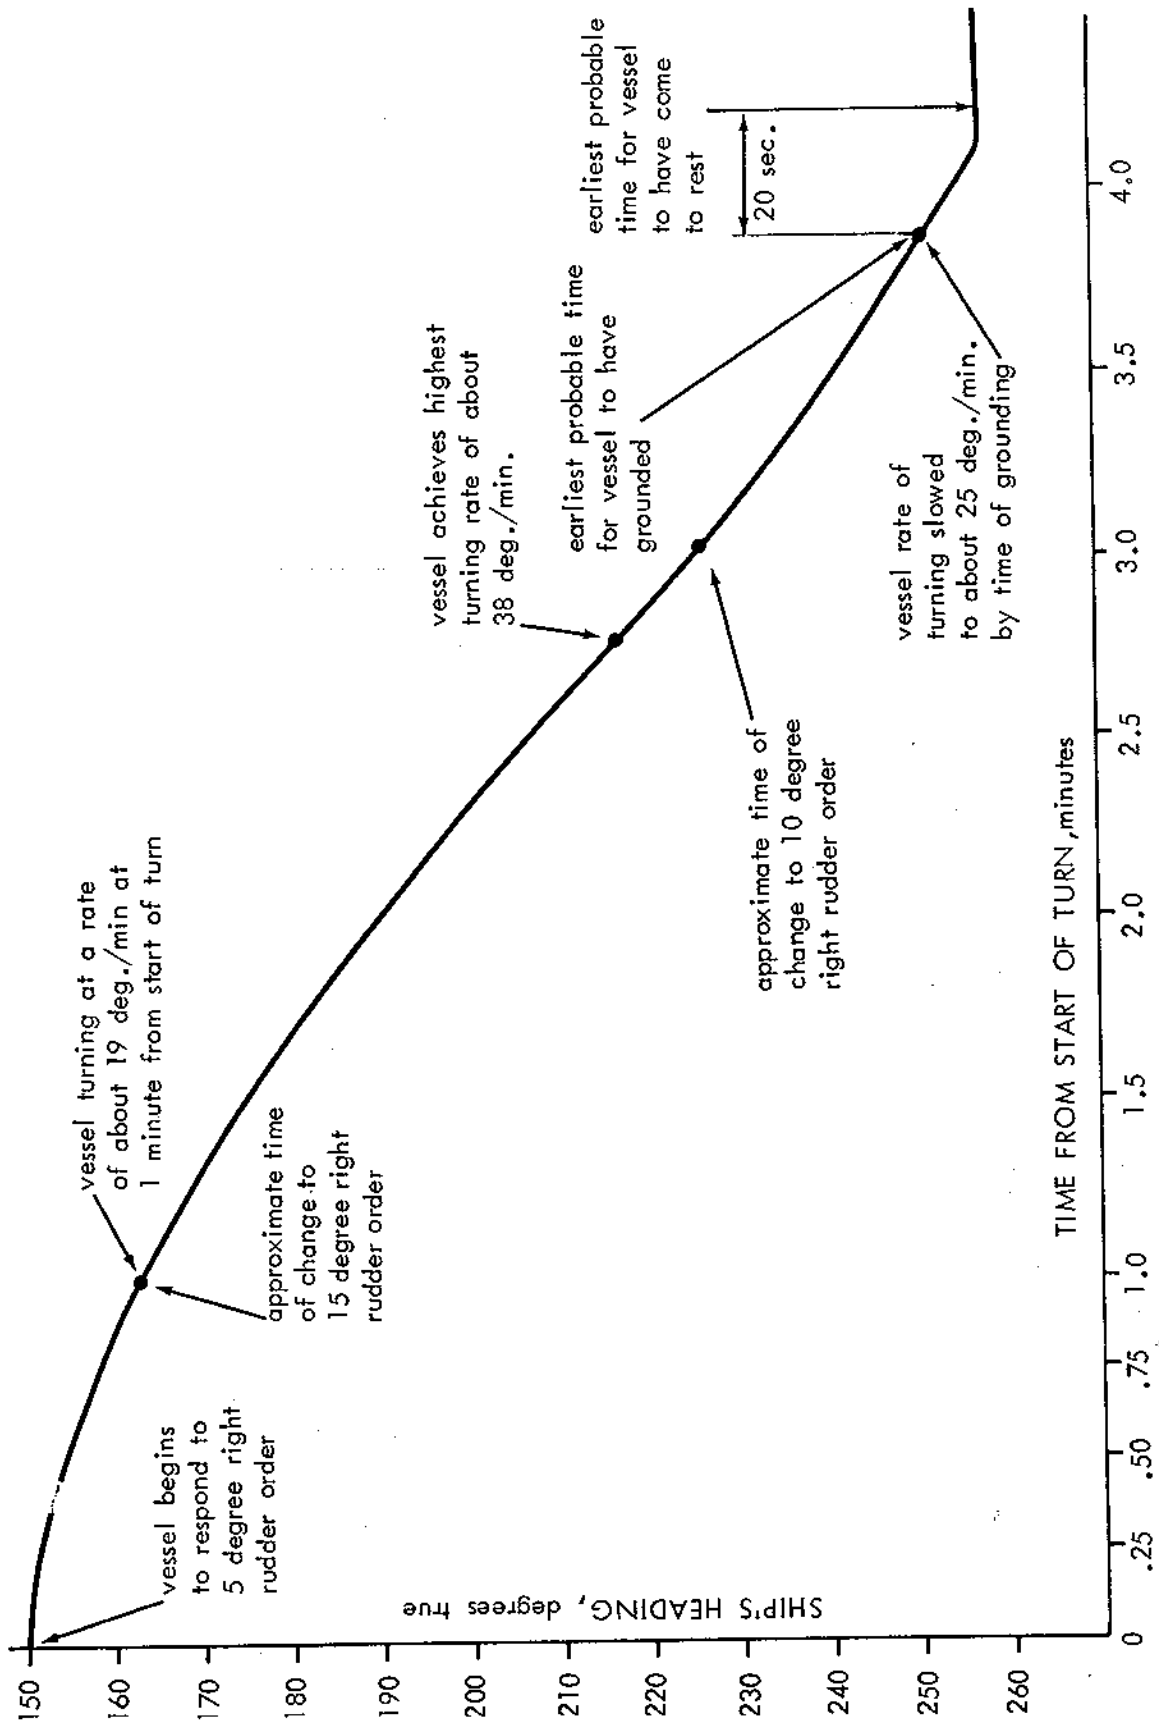
Figure 1. PLOT OF DATA FROM EXPANDED (30 Xs) READOUT OF HILLYER BROWN COURSE RECORDER.

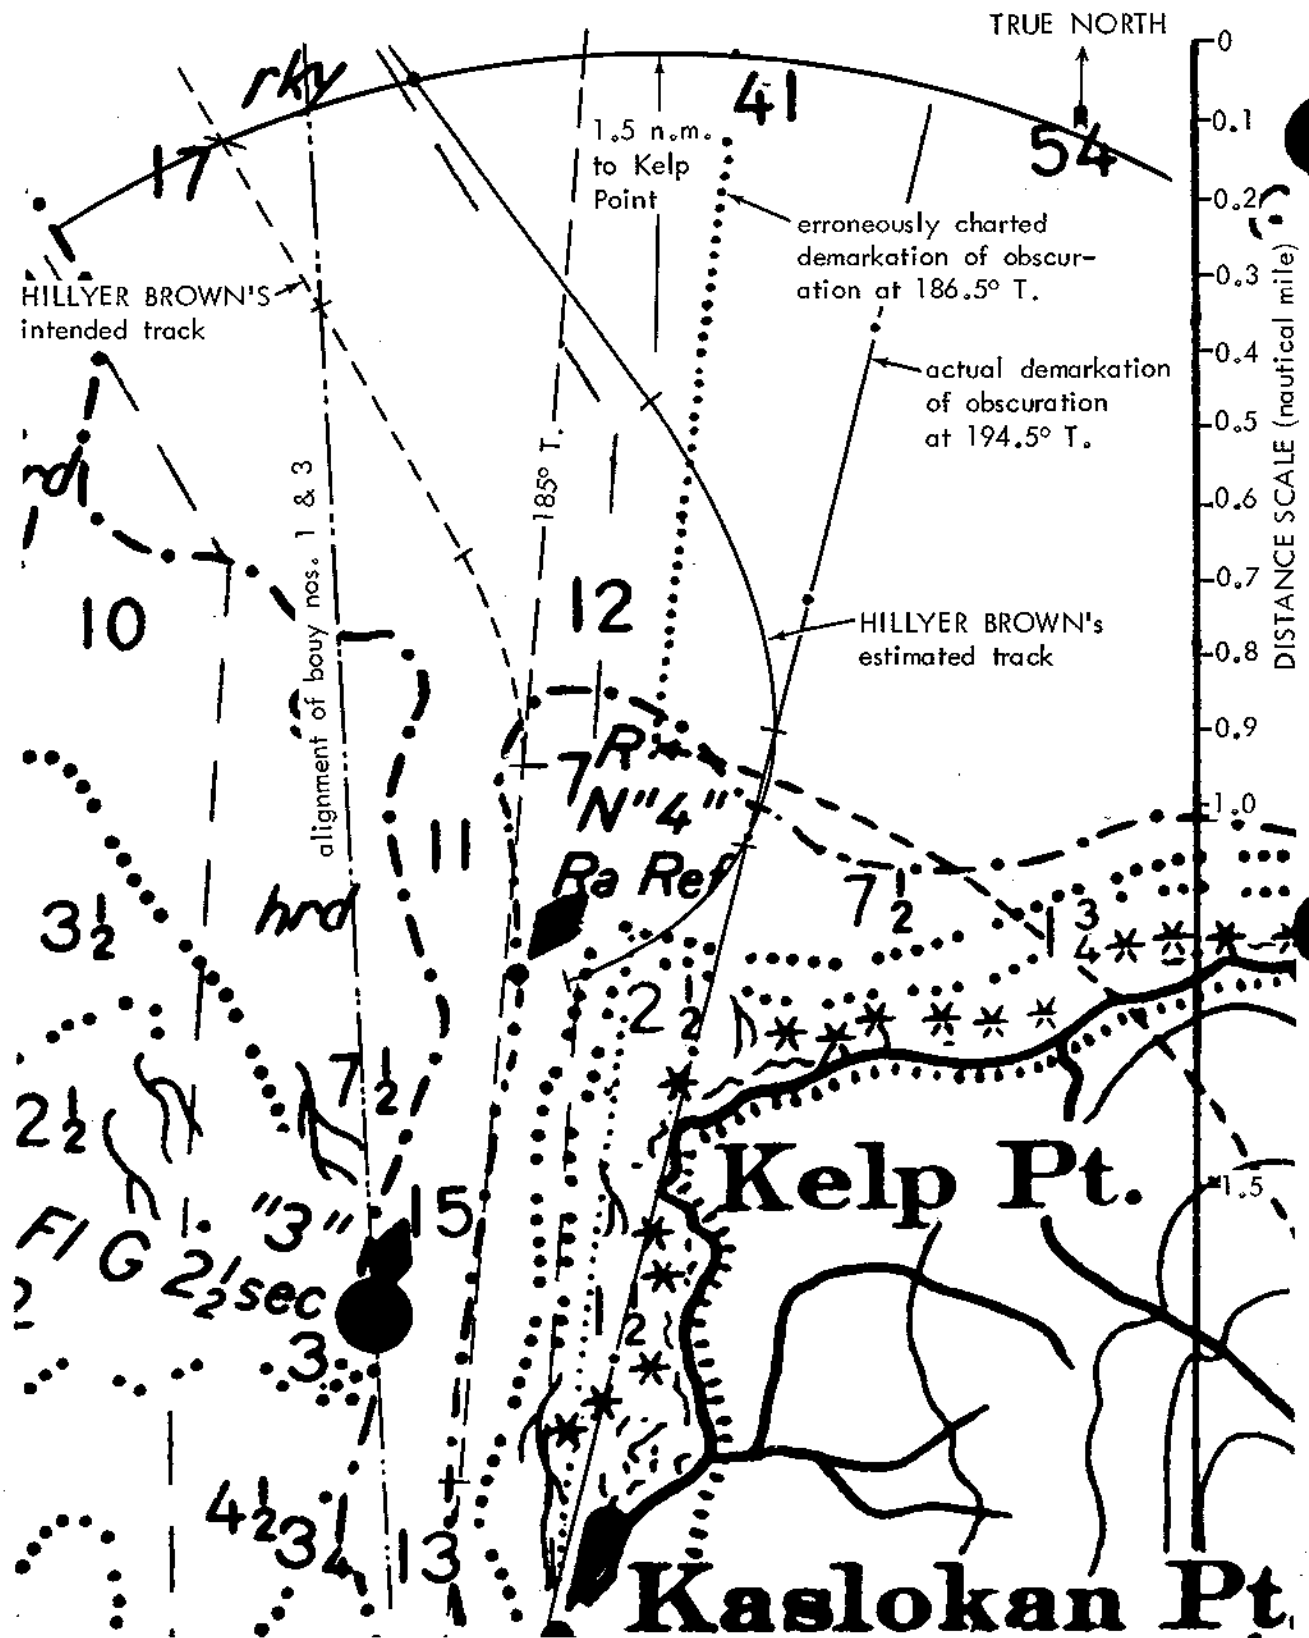
In Figure 2, the HILLYER BROWN's intended course, which was determined from the pilot's testimony and from a segment of the vessel's computed track, is shown as a dashed, curved line. The incorrectly charted bearing at which Kaslokan Point Light obscures is shown as a dotted line in Figure 2, and the correct bearing is noted as a broken line with dots bearing about 194.5° T to Kaslokan Point Light.

Figure 2. PLOTS OF HILLYER BROWN'S INTENDED AND ESTIMATED TRACKS SUPERIMPOSED ON ENLARGEMENT OF NOS CHART 8703
