MARINE CASUALTY REPORT

M/V JOAN LA RIE III

**CAPSIZING AND SINKING
IN THE ATLANTIC OCEAN
ON 24 OCTOBER 1982
WITH MULTIPLE LOSS OF LIFE**

REPORT NO. USCG-M-84-2

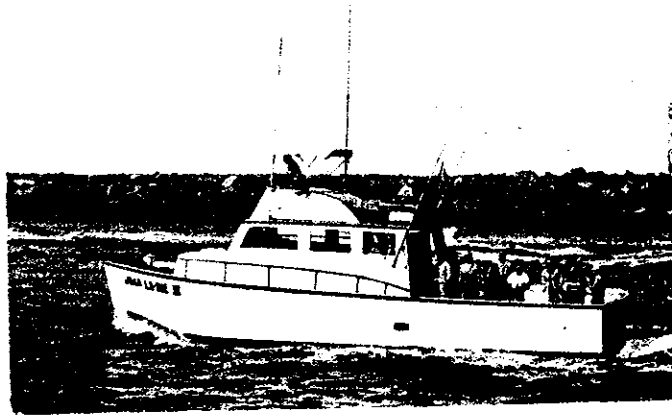
FIGURE 1 - M/V JOAN LA-RIE III OPEN FLYING BRIDGE

- a. Plywood flying bridge replaced original canvas side and open roof.
- b. Two 180 gallon fuel tanks replaced by 200 gallon capacity tanks.
- c. Portable wood fish box of approximately 200 pound capacity added to cockpit stern.

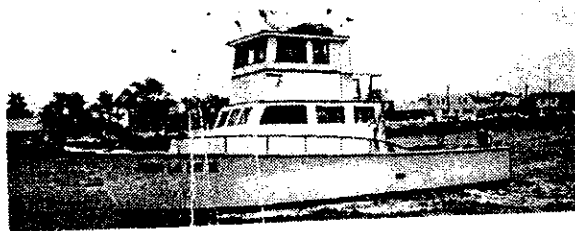
FIGURE 2 - M/V JOAN LA-RIE III AFTER FLYING BRIDGE ALTERATIONS

- a. Full load
- b. Full load with the effect of flying bridge modification and fuel oil free surface.
- c. Full load with the effect of 1 foot of water in the cockpit.
- d. Full load with the effects of flying bridge modification, fuel free surface, and weight of 1 foot of water in the cockpit.
- e. Full load with the effects of flying bridge modification, fuel oil free surface, weight of 1 foot of water in the cockpit and the full surface effect of this water.

5. That the regulations require all small passenger vessels undergo an initial stability test and specify what alterations would require that another stability test be performed.

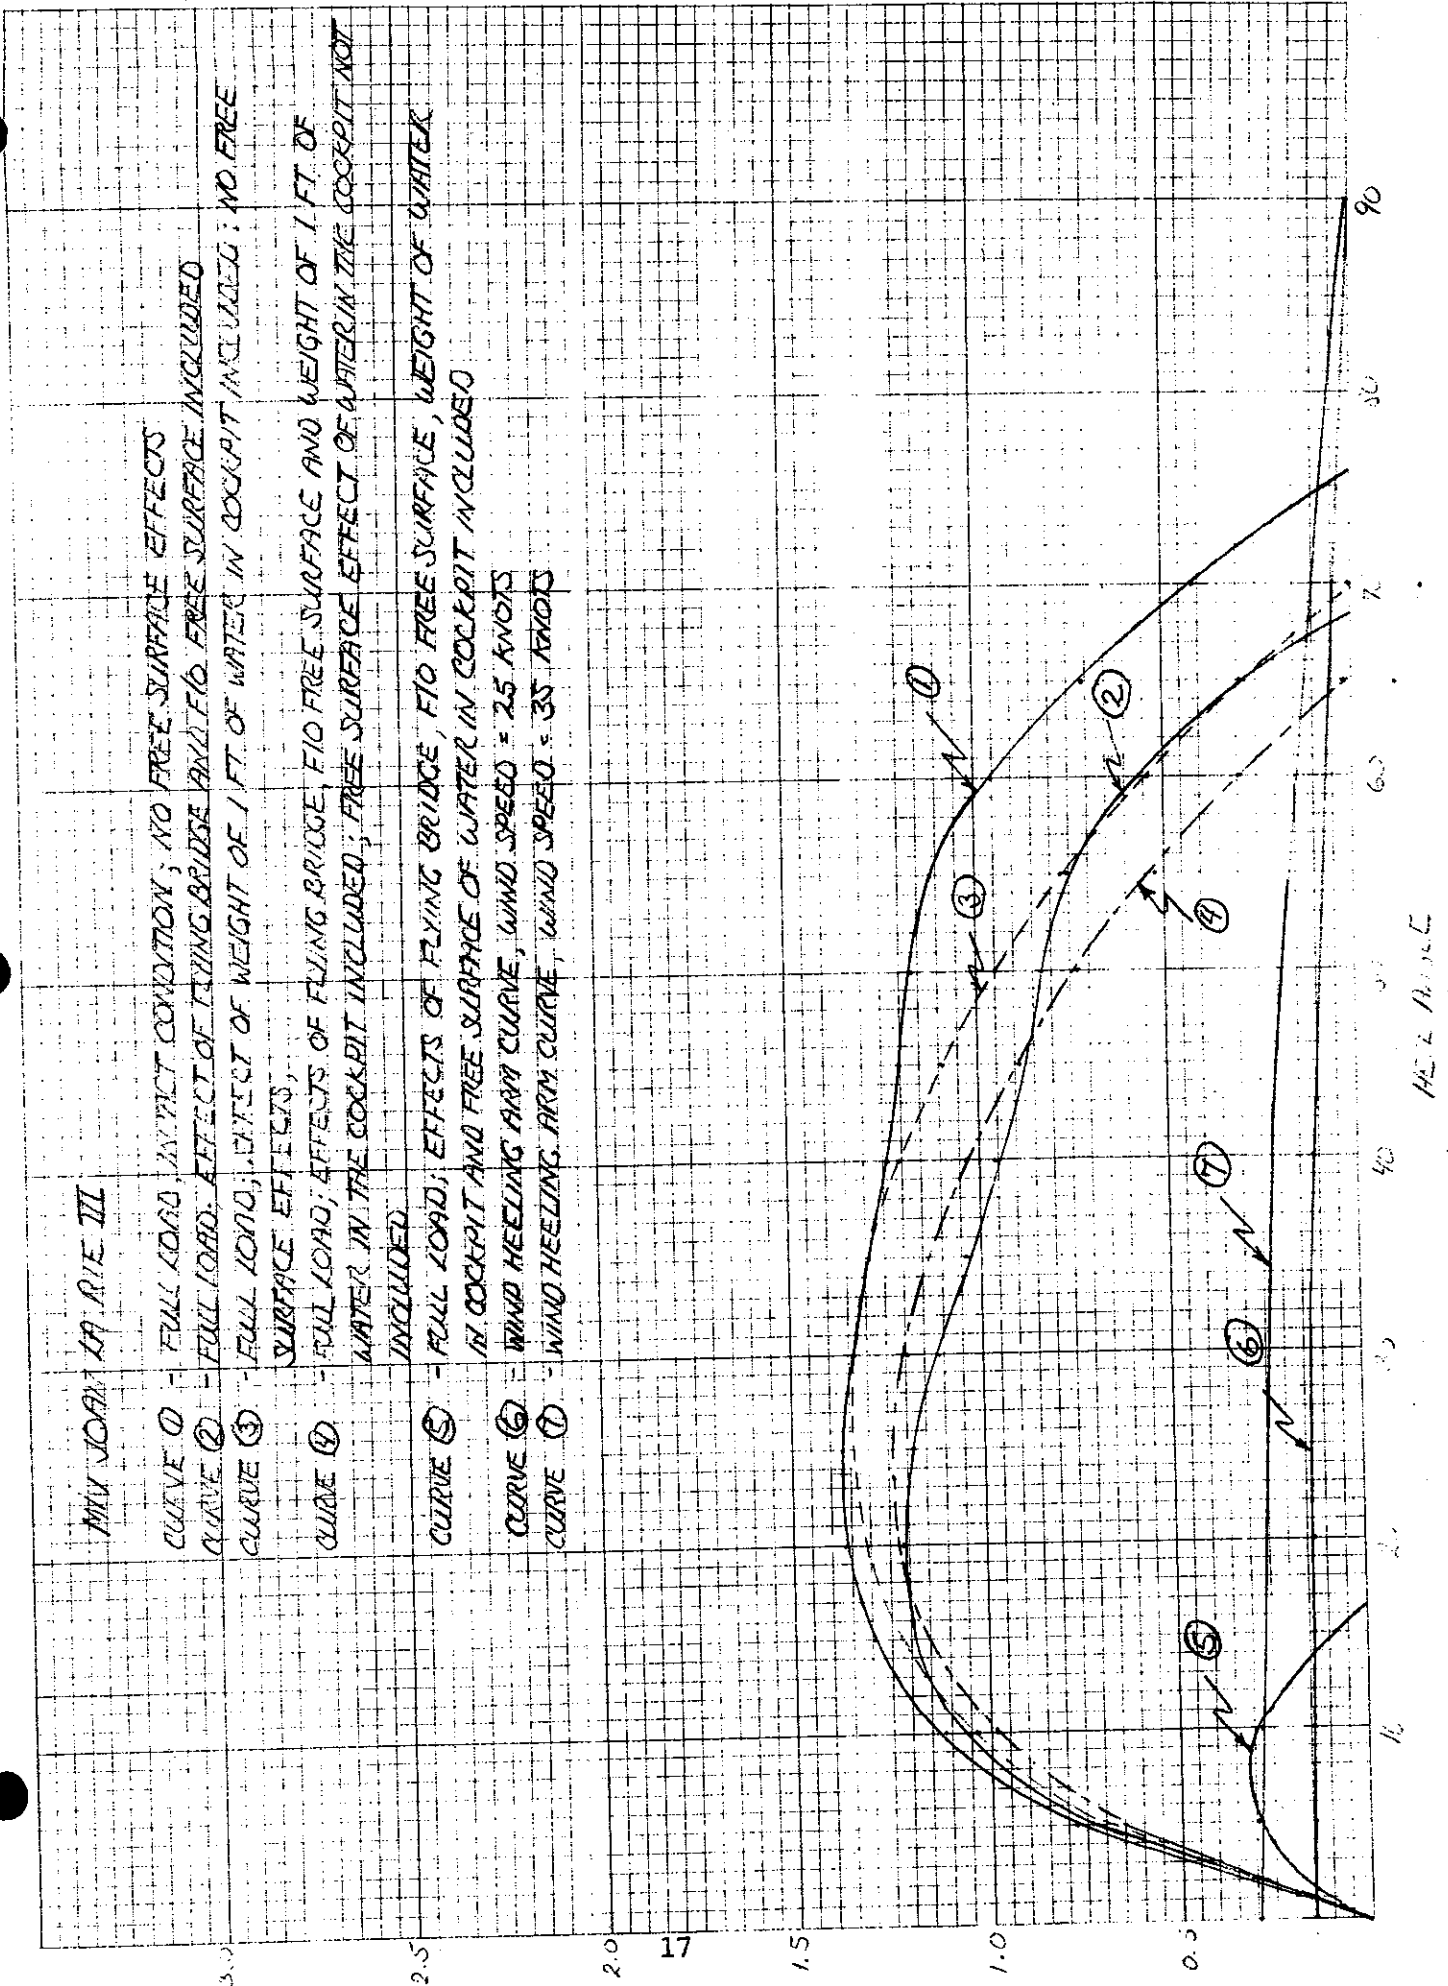
FIGURE (3)

CONDITION	ANGLE OF MAX R.A.	MAX R.A.	AREA TO ANGLE OF MAX R.A.	RANGE OF STABILITY
a.	23.6 DEG	1.37 FT	24.6 FT-DEC	76 DEG
b.	19.9 DEG	1.21 FT	19.9 FT-DEC	68.5 DEG
c.	27.4 DEG	1.35 FT	27.4 FT-DEC	70 DEG
d.	23.9 DEG	1.23 FT	22.3 FT-DEC	65 DEG
e.	4.7 DEG	0.35 FT	0.8 FT-DEC	16 DEG

The calculations show that Conditions a through d far exceed the International Maritime Organization Stability Criteria for Cargo and Passenger Vessels under 100 Meters, with the exception of the requirement for the least angle of maximum righting arm (25 degrees).

25. The analysis showed that of all factors considered, the free surface effect of water in the cockpit had the most detrimental effect on the vessel's stability. It caused a substantial reduction in the available righting energy and the range of stability (see figure 3)
