**MARINE CASUALTY REPORT**

**ENTANGLEMENT OF THE SUBMERSIBLE JOHNSON  
SEA LINK WITH SUBMERGED WRECKAGE OFF KEY WEST,  
FLORIDA ON OR ABOUT 17 JUNE 1973 WITH LOSS OF LIFE**

**REPORT NO. USCG/NTSB · MAR-75-2  
RELEASED 12 MAR 1975**

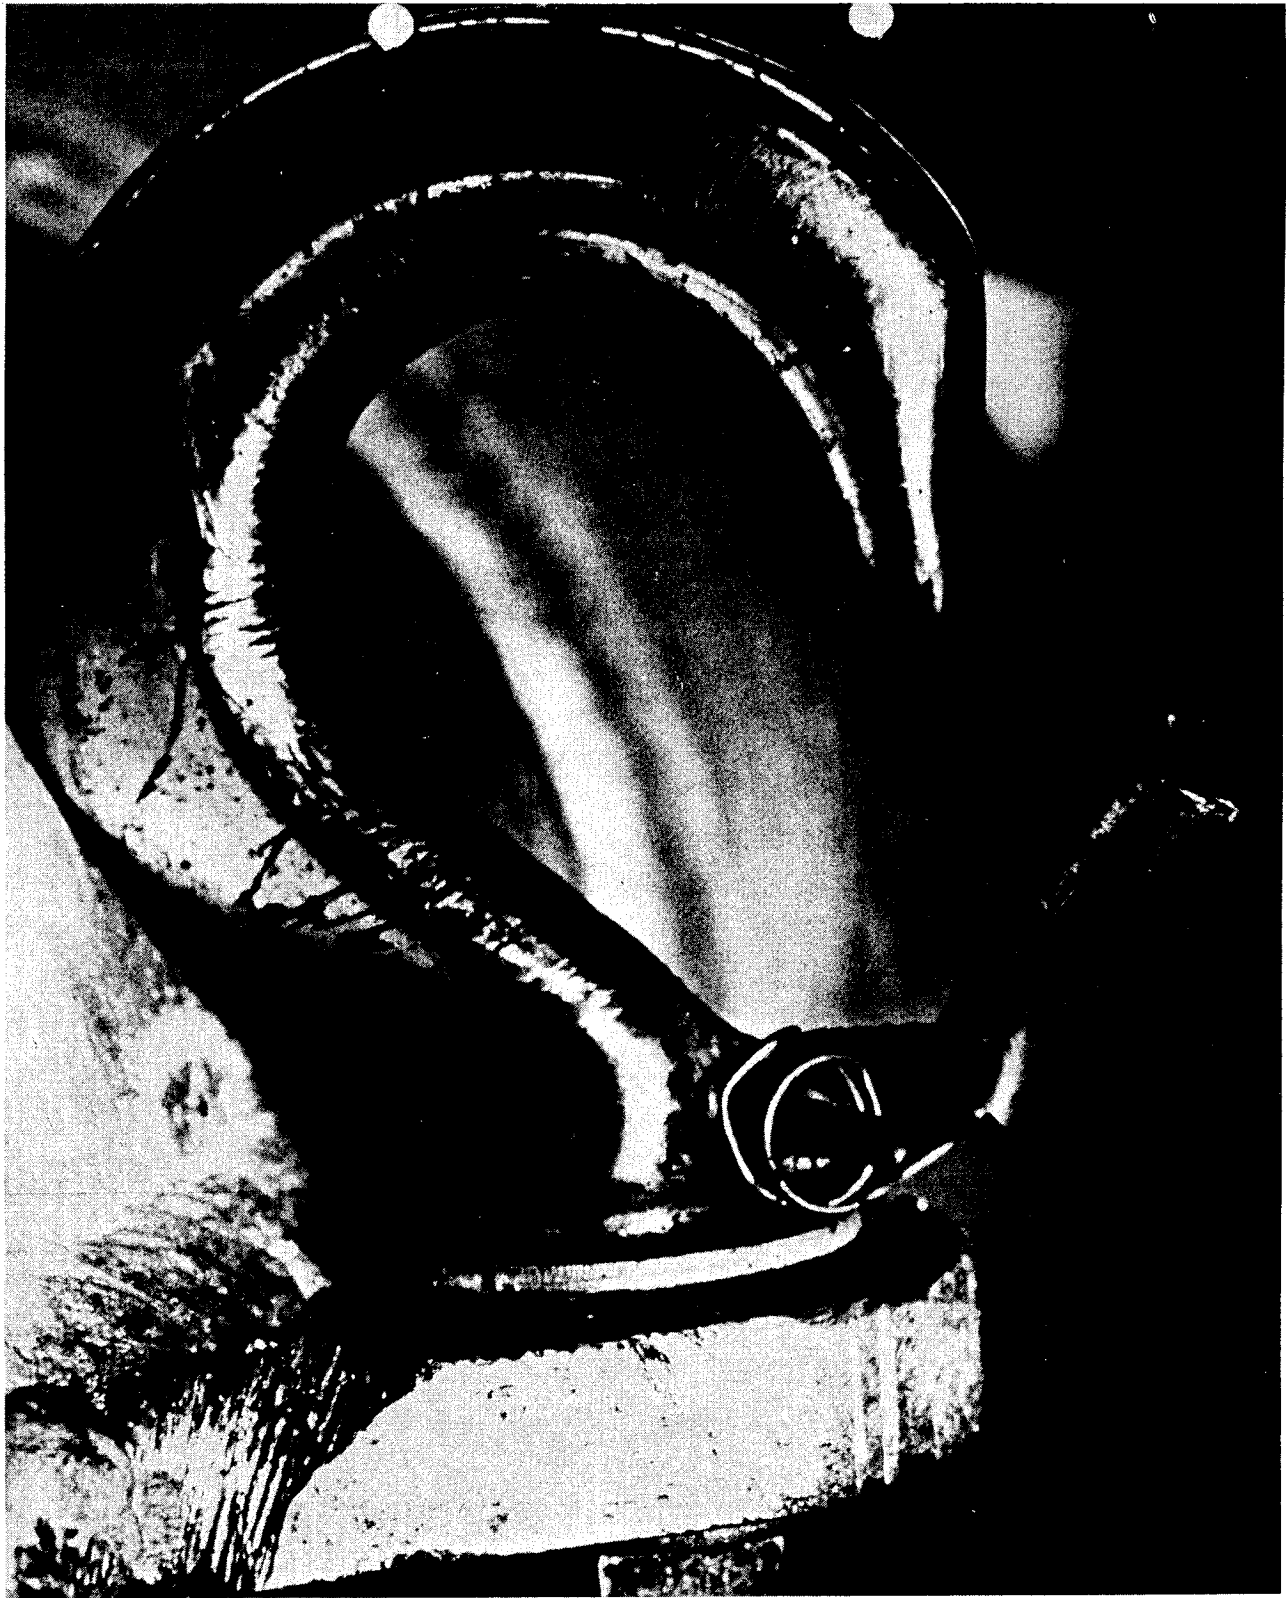
Figure 1 - Starboard<sub>4</sub>Spring Loaded, Moused Hook

The National Transportation Safety Board determines that the probable cause of the accident was the fouling of the starboard spring-loaded moused hook and other appendages on the submersible with a cable attached to the aftermost flagpole of the scuttled destroyer.

Before the JOHNSON SEA LINK submerged on June 17, the hooks were not known to be damaged. A survey of the submersible after the casualty showed that the starboard hook had been damaged by a cable and that the mousing device had failed. (See Figure 1.) The mousing device could have failed when the submersible was raised from the bottom by the grapnel operated on board the A. B. WOOD II. The force exerted during this maneuver would have caused the cable to break free from the hook. Since there was evidence of damage inflicted by a cable at other points on the submersible, it could not be determined if the initial source of fouling was the snagging of the cable by the hook.

23. The SEA DIVER, with the SEA LINK still on board, arrived in its home port of Fort Pierce, Florida on 28 June. During the course of a hull examination subsequent to 28 June certain sections of the SEA LINK displayed evidence of cable scraping. In the general area of where Dr. Meek observed the cable to pass up over the stern of the SEA LINK were a number of structural members that contained scratches and serrations inconsistent with the remainder of its surface. For example, the forward edge of the propellor shroud on the starboard fixed propulsion motor contained deep scratches resembling file marks. Above these abrasions were similar scratches on the plastic cover of a pneumatic valve. Immediately above this plastic cover is an aluminum pad that is welded to a support member of the starboard surface buoyancy tank. Bolted through a hole in this pad is a steel hook which is used to restrain guide lines during retrieval of the submersible but is not used as a lifting hook. The hook is approximately one and a half (1½) inches in diameter and five (5) inches long with a two (2) inch opening. The opening faces downward and is guarded by a spring-loaded mousing device. Both the pad and the hook displayed evidence of chafing by a hard object capable of producing a serrated effect. In addition to the scoring of the hook the spring-loaded mousing device was wrenched from its normally closed position.

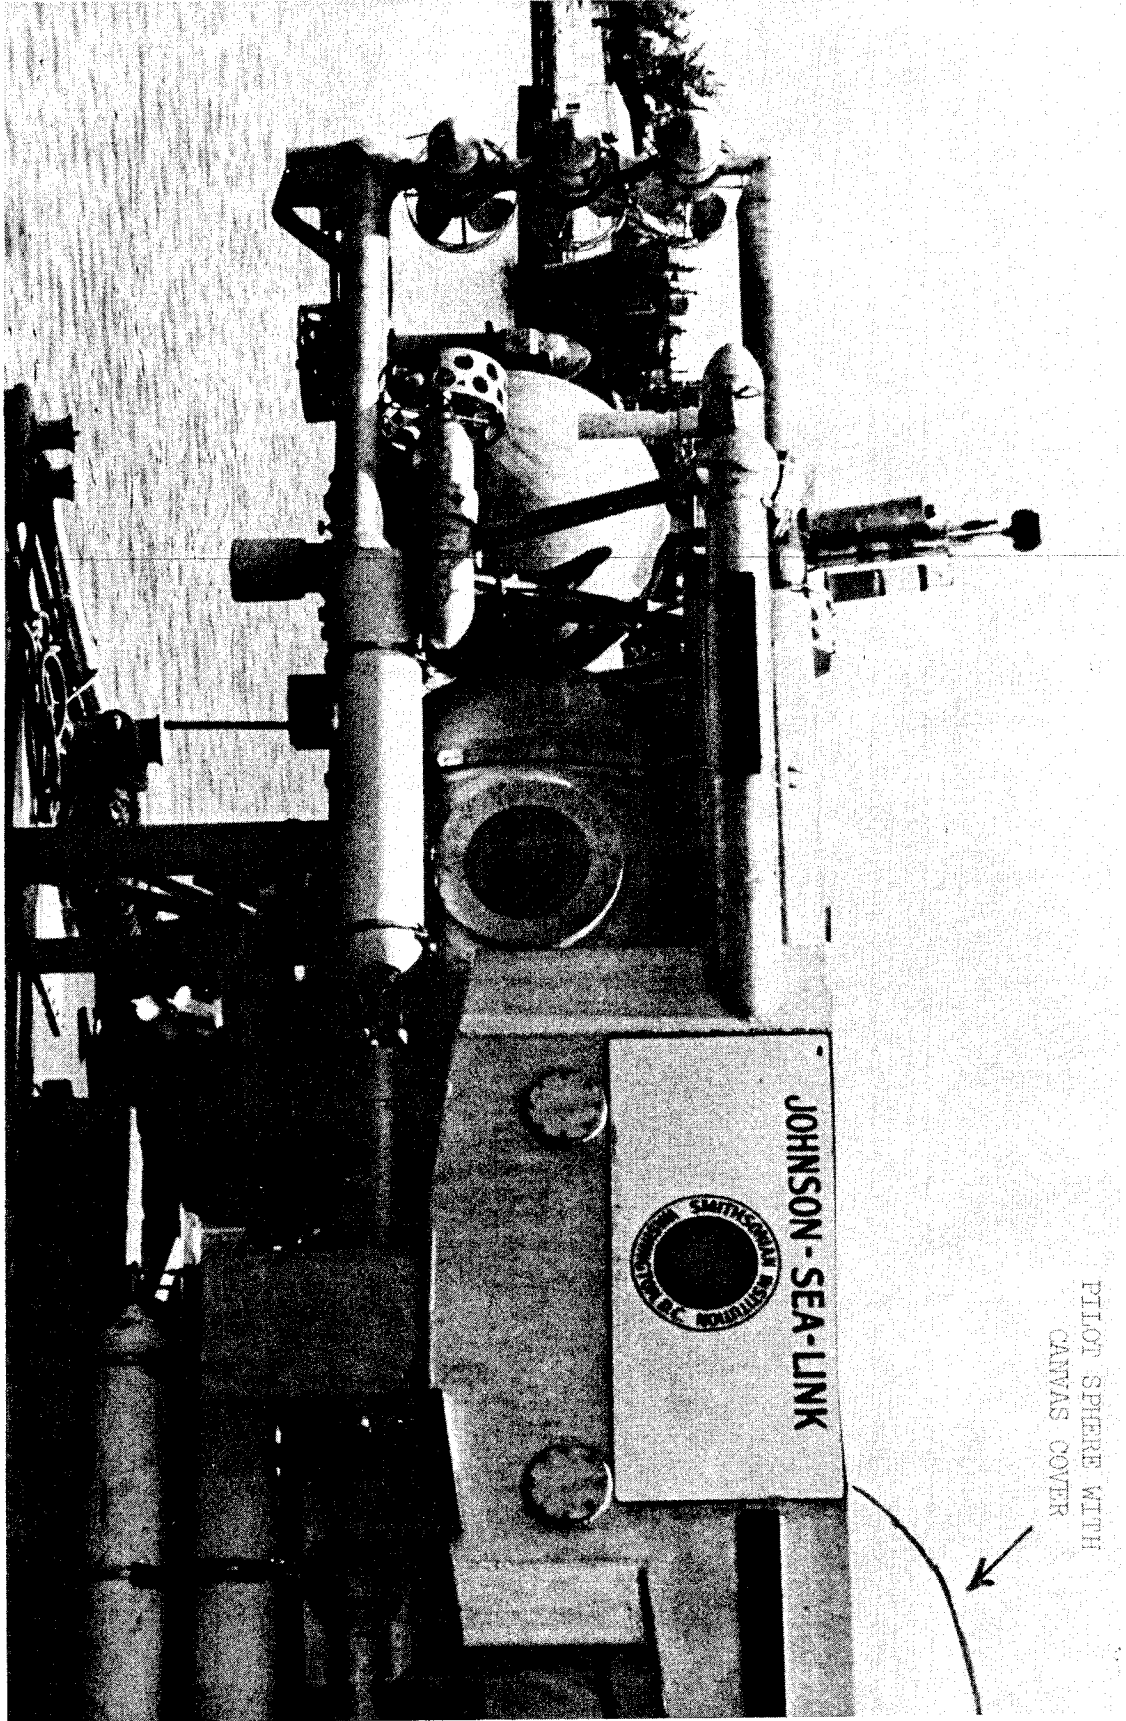
PILOT SPHERE WITH  
CANVAS COVER

c. The submersible, as a complete unit, defies comparison with any conventional ship or boat shape. Its modular construction lacks the symmetry or "fairing" normally found in both surface and subsurface vessels. This submersible can best be described as an ill defined network consisting of an aluminum framework to which various shapes, containers and appendages have been attached according to their functional value rather than a concern for symmetry. (Photograph appended)
