MARINE CASUALTY REPORT

SS MARINE ELECTRIC,
O.N. 245675,

CAPSIZING AND SINKING
IN THE ATLANTIC OCEAN
ON 12 FEBRUARY 1983
WITH MULTIPLE LOSS OF LIFE

REPORT NO. 16732/0001 HQS 83

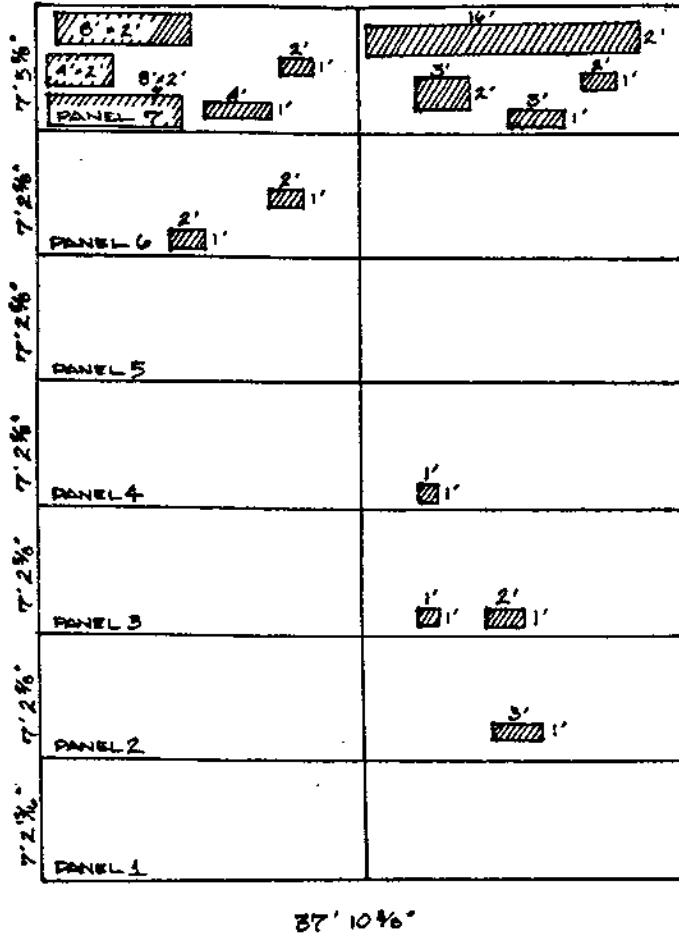
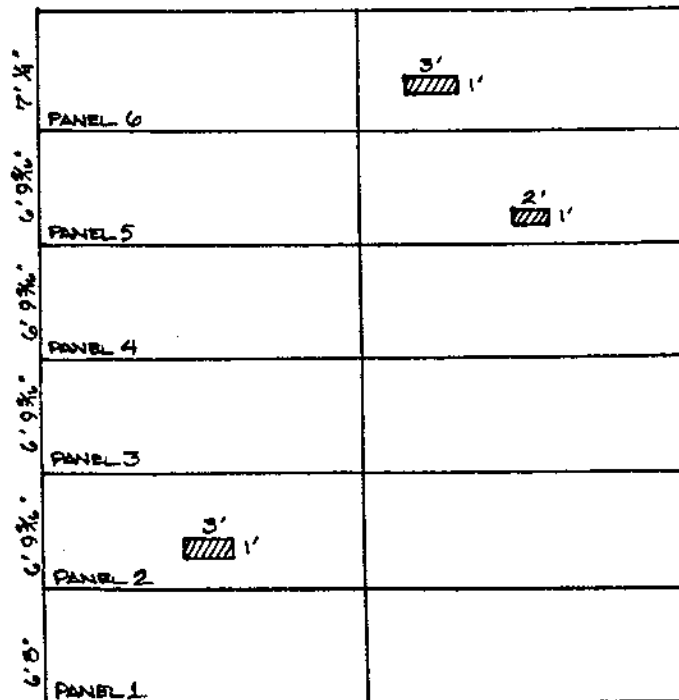
292. The hatch cover sketches, Exhibit 20, showed that three of six panels for No. 1 hold had areas that were deteriorated, and wasted, and that five of seven panels on No. 2 hold had wasted and holed areas. The exact locations of the deteriorated areas

Hatch Cover Areas
needing repairs, as
identified on sketches
by Chief Mate, from
Exhibit 20

within each panel were not clear from the sketches, but the dimensions of each area were described in feet. The preceding figure shows a scale drawing of each panel, for holds Nos. 1 and 2, with the areas which the Chief Mate identified shaded in. It should be noted that guaguings were not taken on any of these covers.

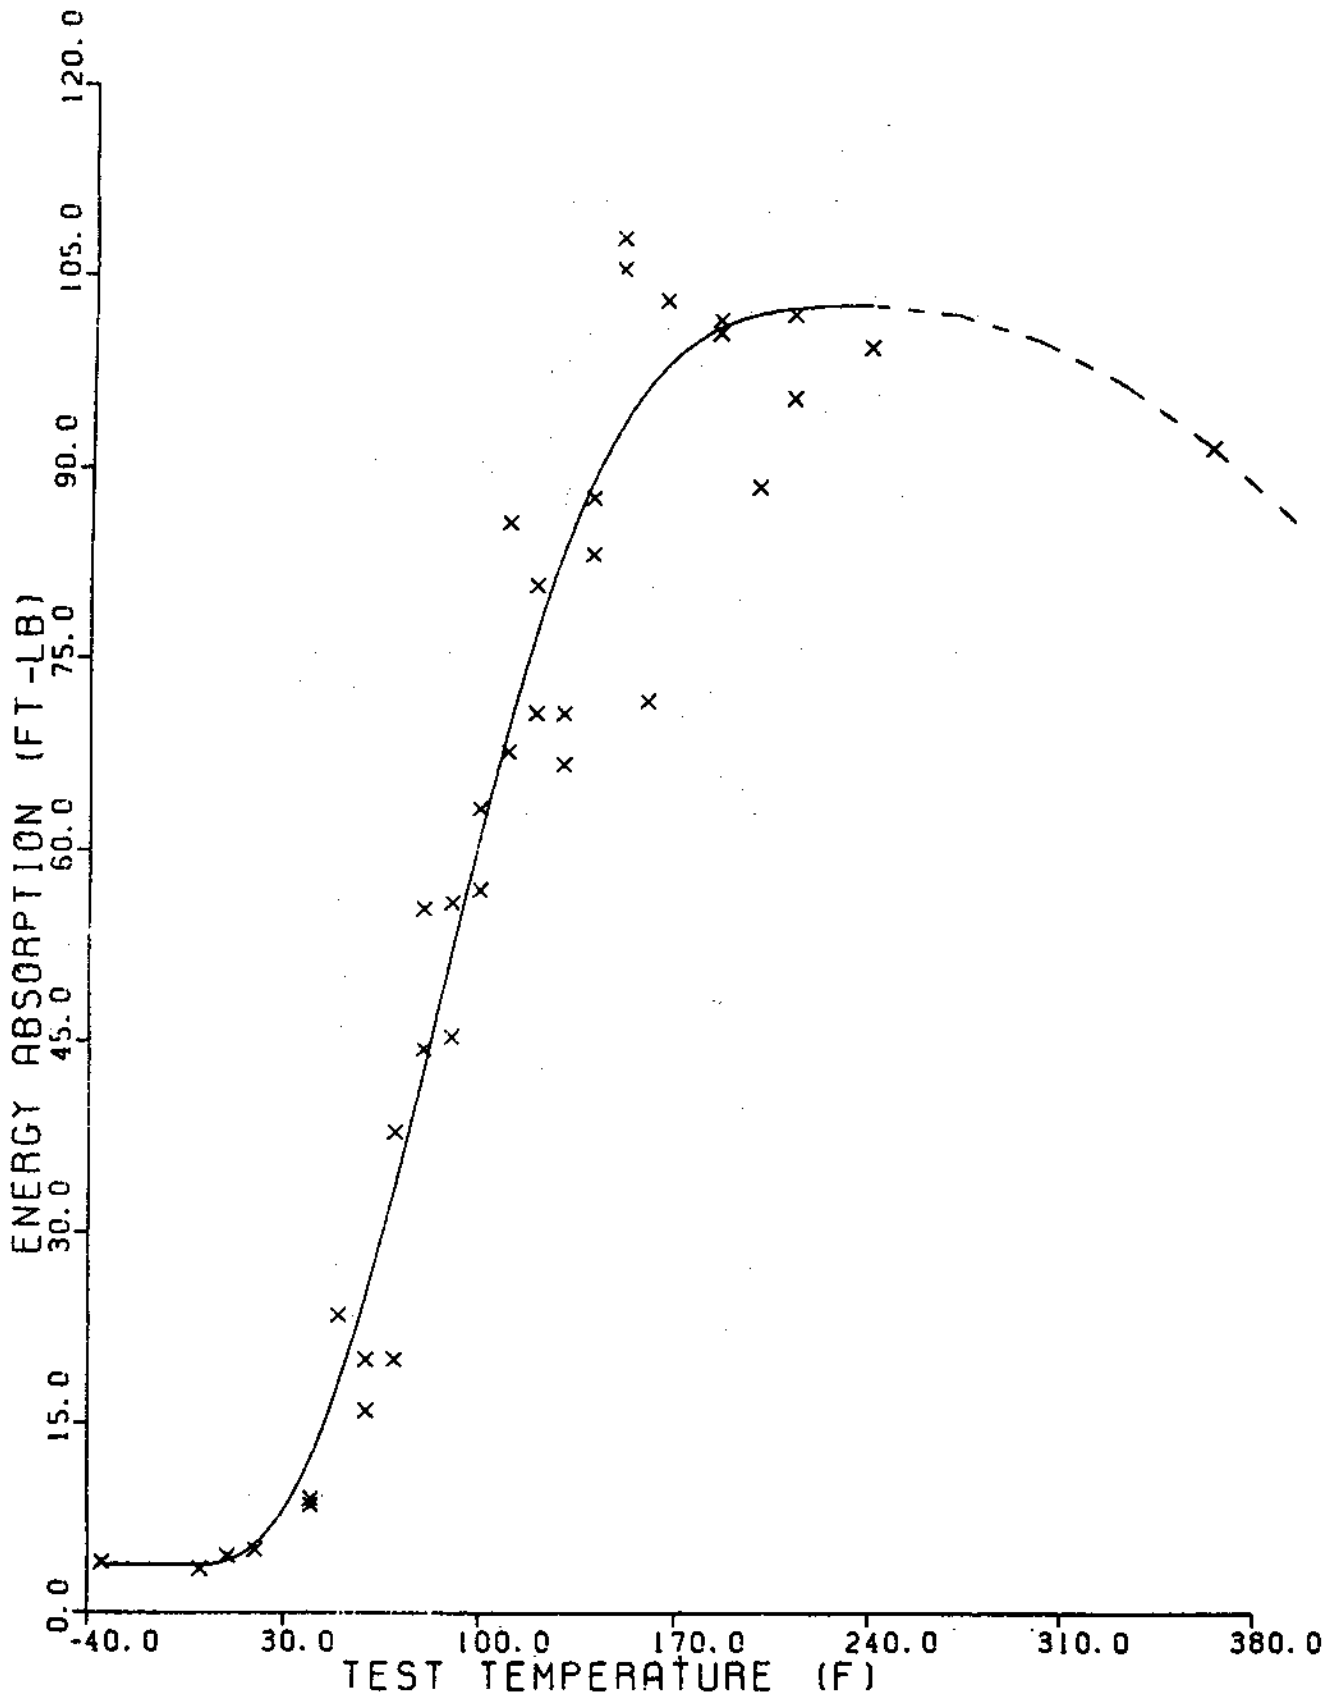
Charpy V-Notch Transition Curve

446. An additional study of the steel samples was made by EMTEC Corporation, of Norman, Oklahoma, in the area of Crack Tip Opening Displacement (CTOD) testing. This criteria attempts to define the minimum crack size that the steel could sustain at a specified stress level and temperature before brittle fracture occurs. Two samples were made - one in the starboard B strake, and the other from the starboard A strake. The testing revealed that the critical crack size was 2.5 inches for dynamic loading, and 40 inches for slow loading at 40 degrees Fahrenheit, and a stress of 20,000 psi. The metallurgists who prepared this report stated the actual loading on the MARINE ELECTRIC probably fell somewhere between the dynamic and static loading cases. They also noted that the appearance of the metal samples examined showed the metal had exhibited good ductile behavior when the hull broke apart.

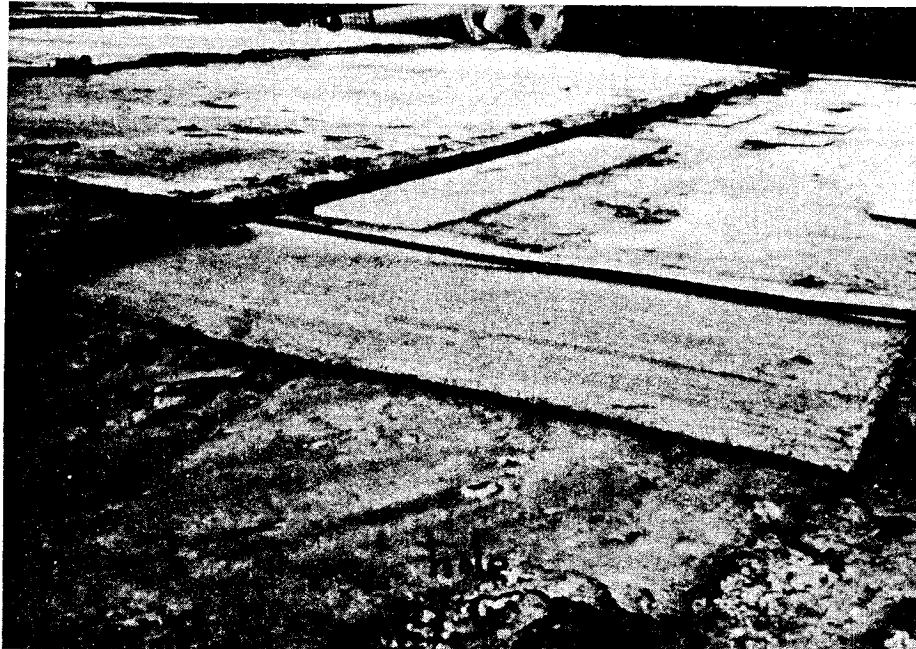
Photo of the No. 3 cargo hatchcover "a" panel (forwardmost) taken in February/March 1981 after the Jacksonville Shipyard period. MacGregor Company caption read: "#3a panel showing heavy patching and misalignment at cross joint. Note heavy corrosion and wavy distortions" (MacGregor Company Photo)

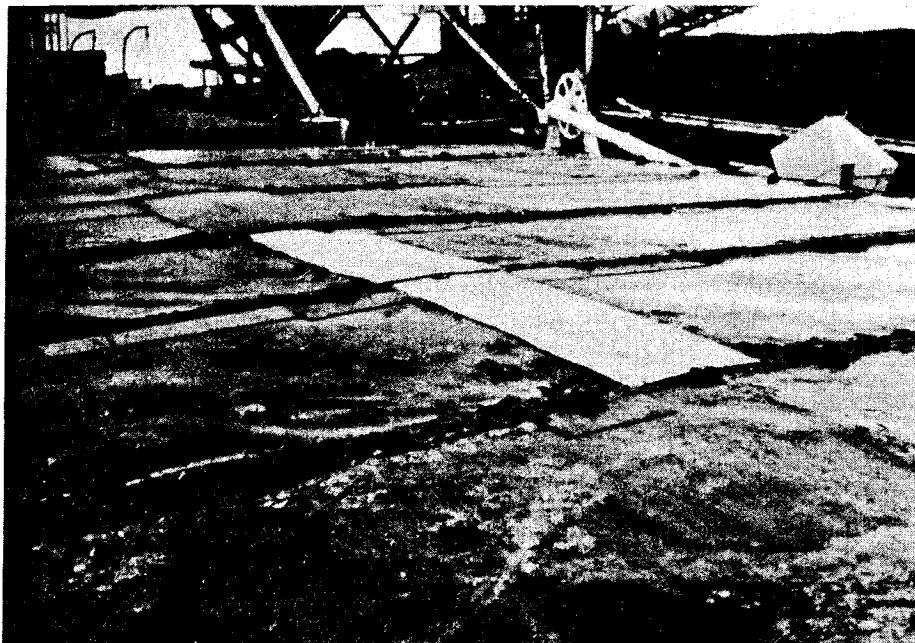
Photo of No. 3 hatchcover taken in February/March 1981. MacGregor Company caption read: "#3 looking aft showing b, c, d, e, f, and g panels. Note heavy patching and lack of cross joint wedges and misalignment at the cross joints." (MacGergor Company Photo)

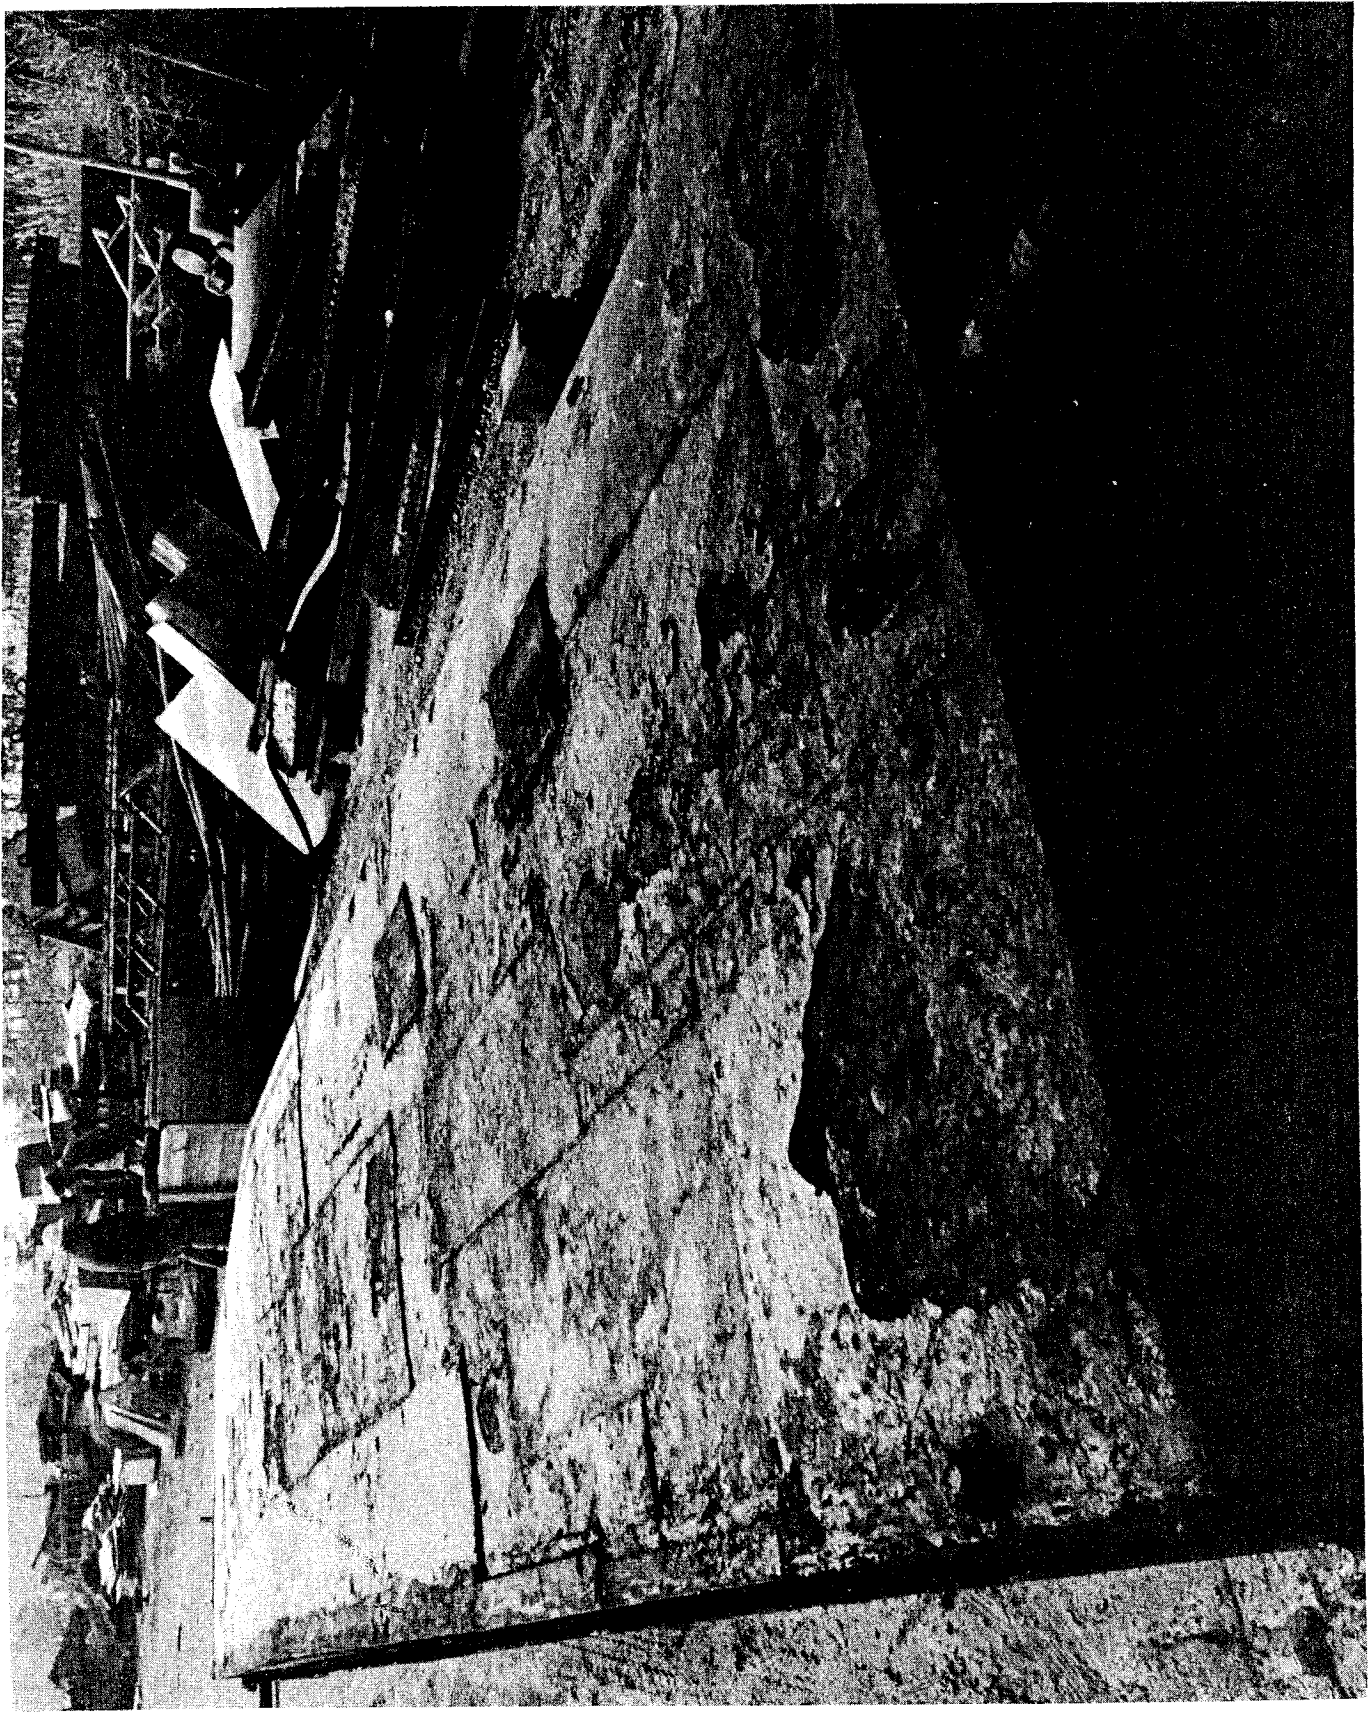
Forward panel on No. 3 cargo hatch cover removed from the MARINE ELECTRIC in November 1982. Photo taken in February 1983. (USCG Photo)

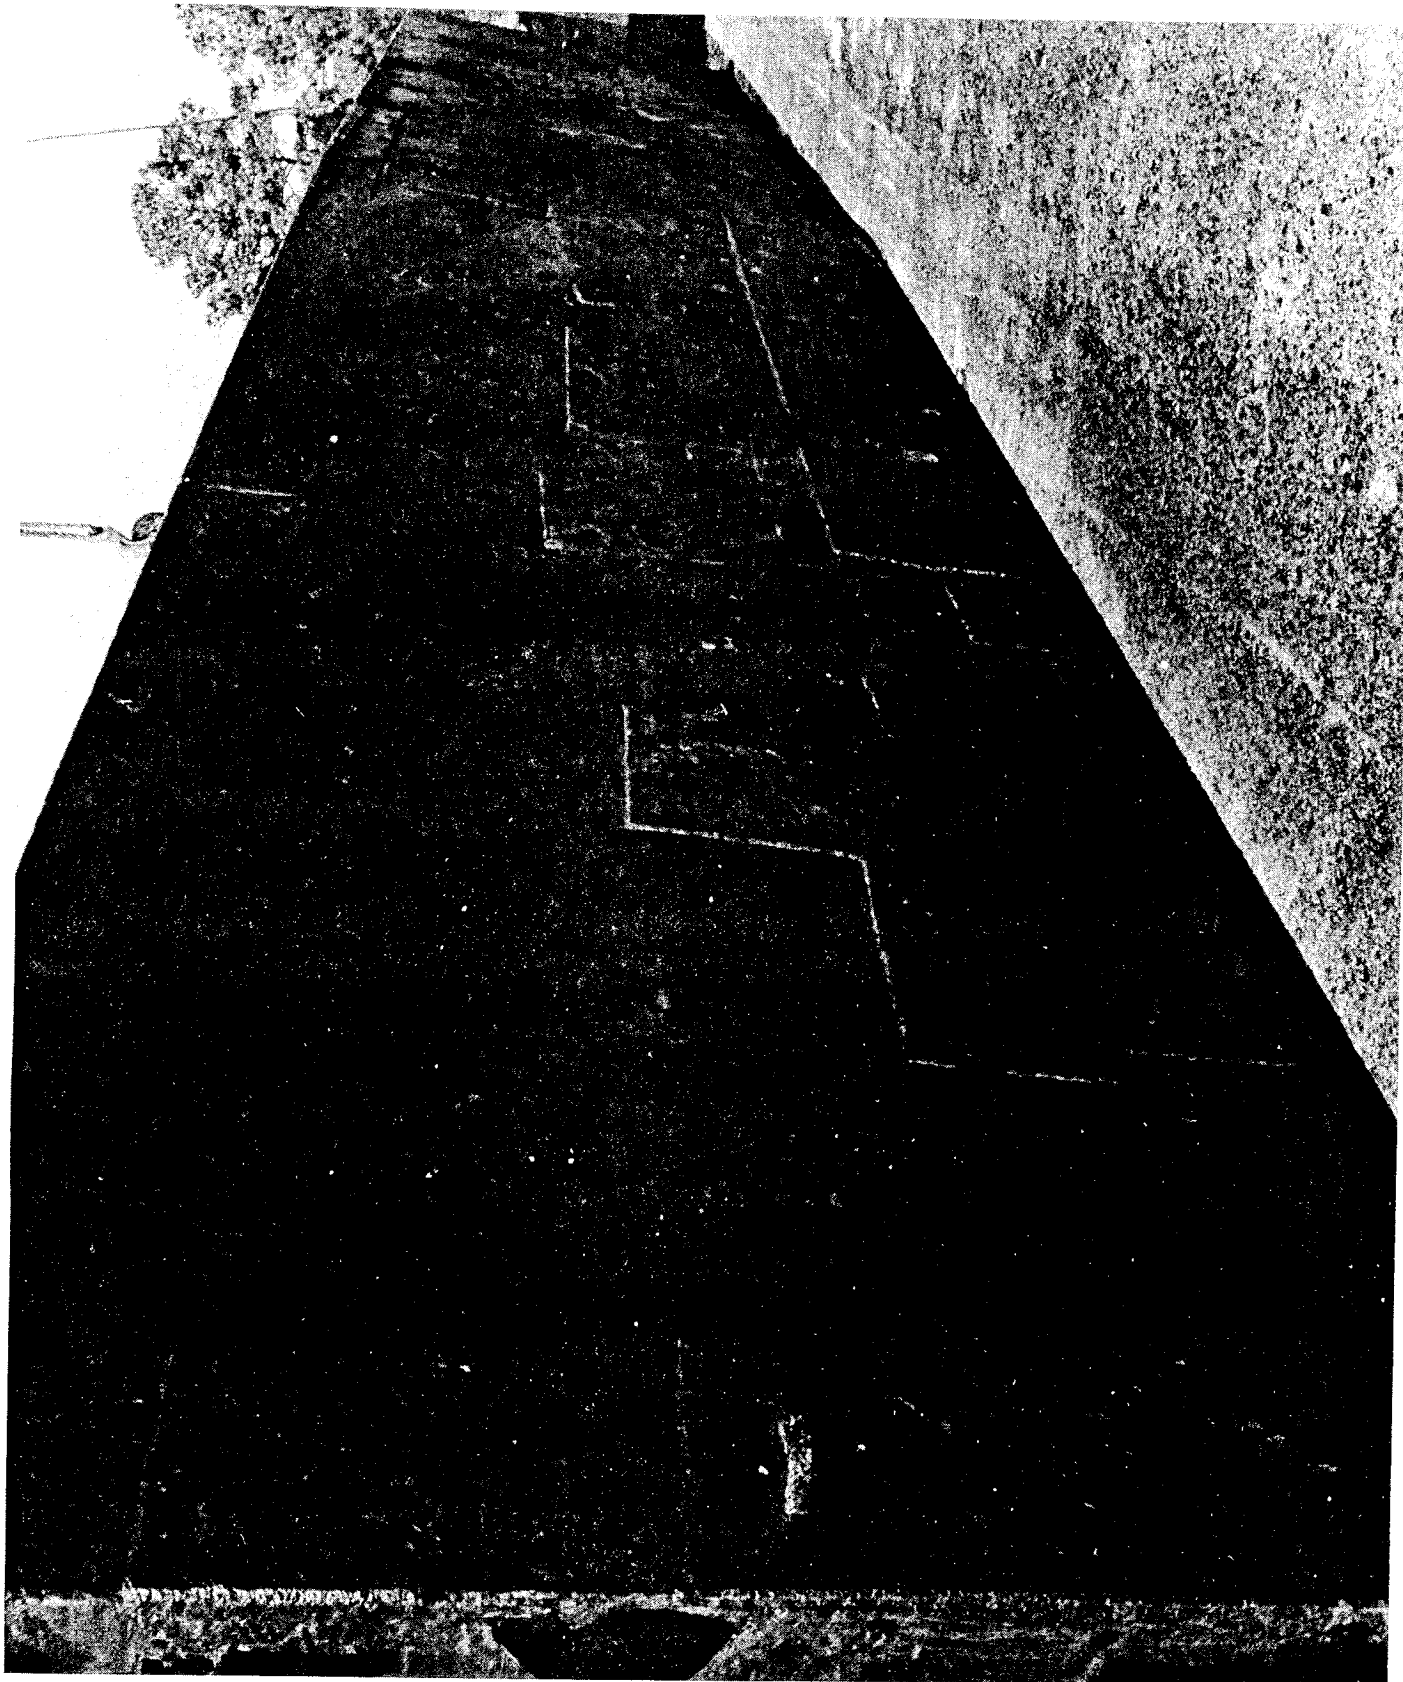
View of forward panel on No. 3 hatch cover removed from the MARINE ELECTRIC in November 1982. Photo taken in February 1983. (USCG Photo)
