# MARINE CASUALTY REPORT

LOSS OF THE  
MOTOR TOWING VESSEL  
MAJORIE McALLISTER  
IN THE ATLANTIC OCEAN  
ON NOVEMBER 2, 1969

U.S. COAST GUARD  
MARINE BOARD of INVESTIGATION REPORT  
and COMMANDANT'S ACTION

M/V MARJORIE McALLISTER  
SINKING WITH LOSS OF LIFE IN THE ATLANTIC OCEAN  
NOVEMBER 2, 1969

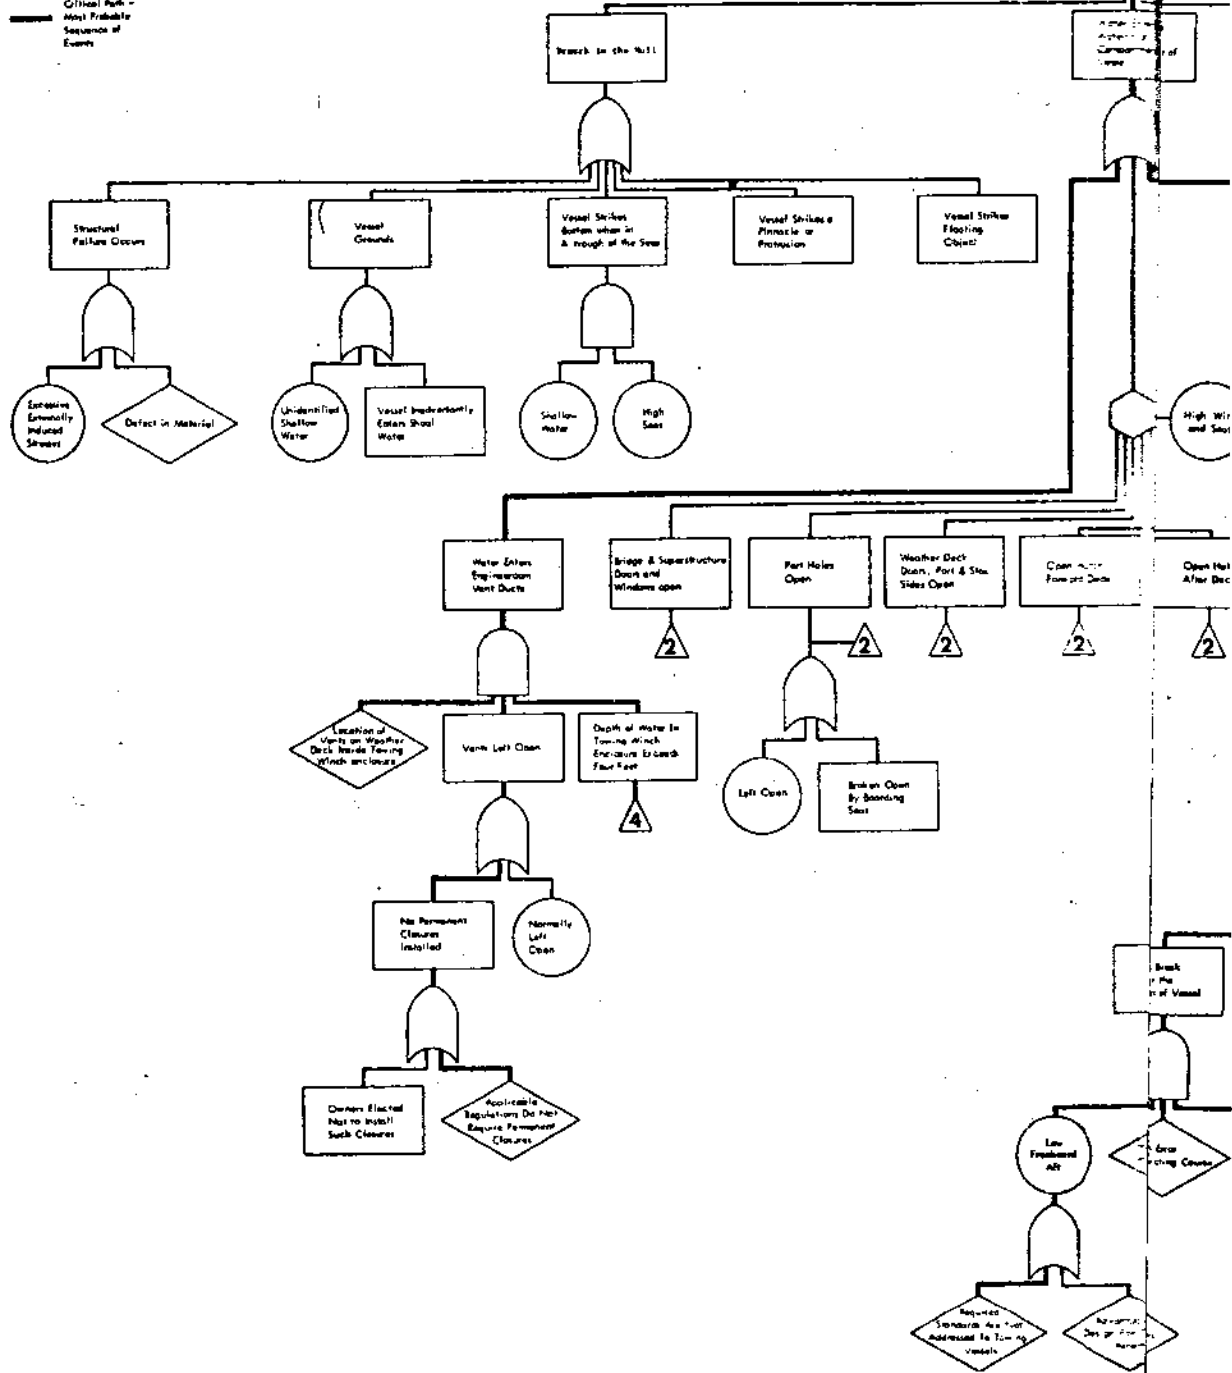
# FAULT TREE DIAGRAM

When there is virtually no detailed evidence to evaluate, it becomes necessary to analyze the casualty on the basis of known design details, operating practices, and possible failures. A fault tree diagram (see Attachment A) has been utilized to array the design, operating practices, and failures data in a sequential event format. This type of diagram serves to ensure an orderly and thorough analysis of all reasonably possible causal factors. It is an accepted technique utilized in the aerospace field for pre-accident design safety analysis. The Events and Causal Factors Diagram (see Attachment B) presents the critical path of the sequence of events, as derived from the fault tree, which culminated in the loss of the vessel. This diagram reduces the detailed fault tree diagram by displaying only the most probable sequence of events.

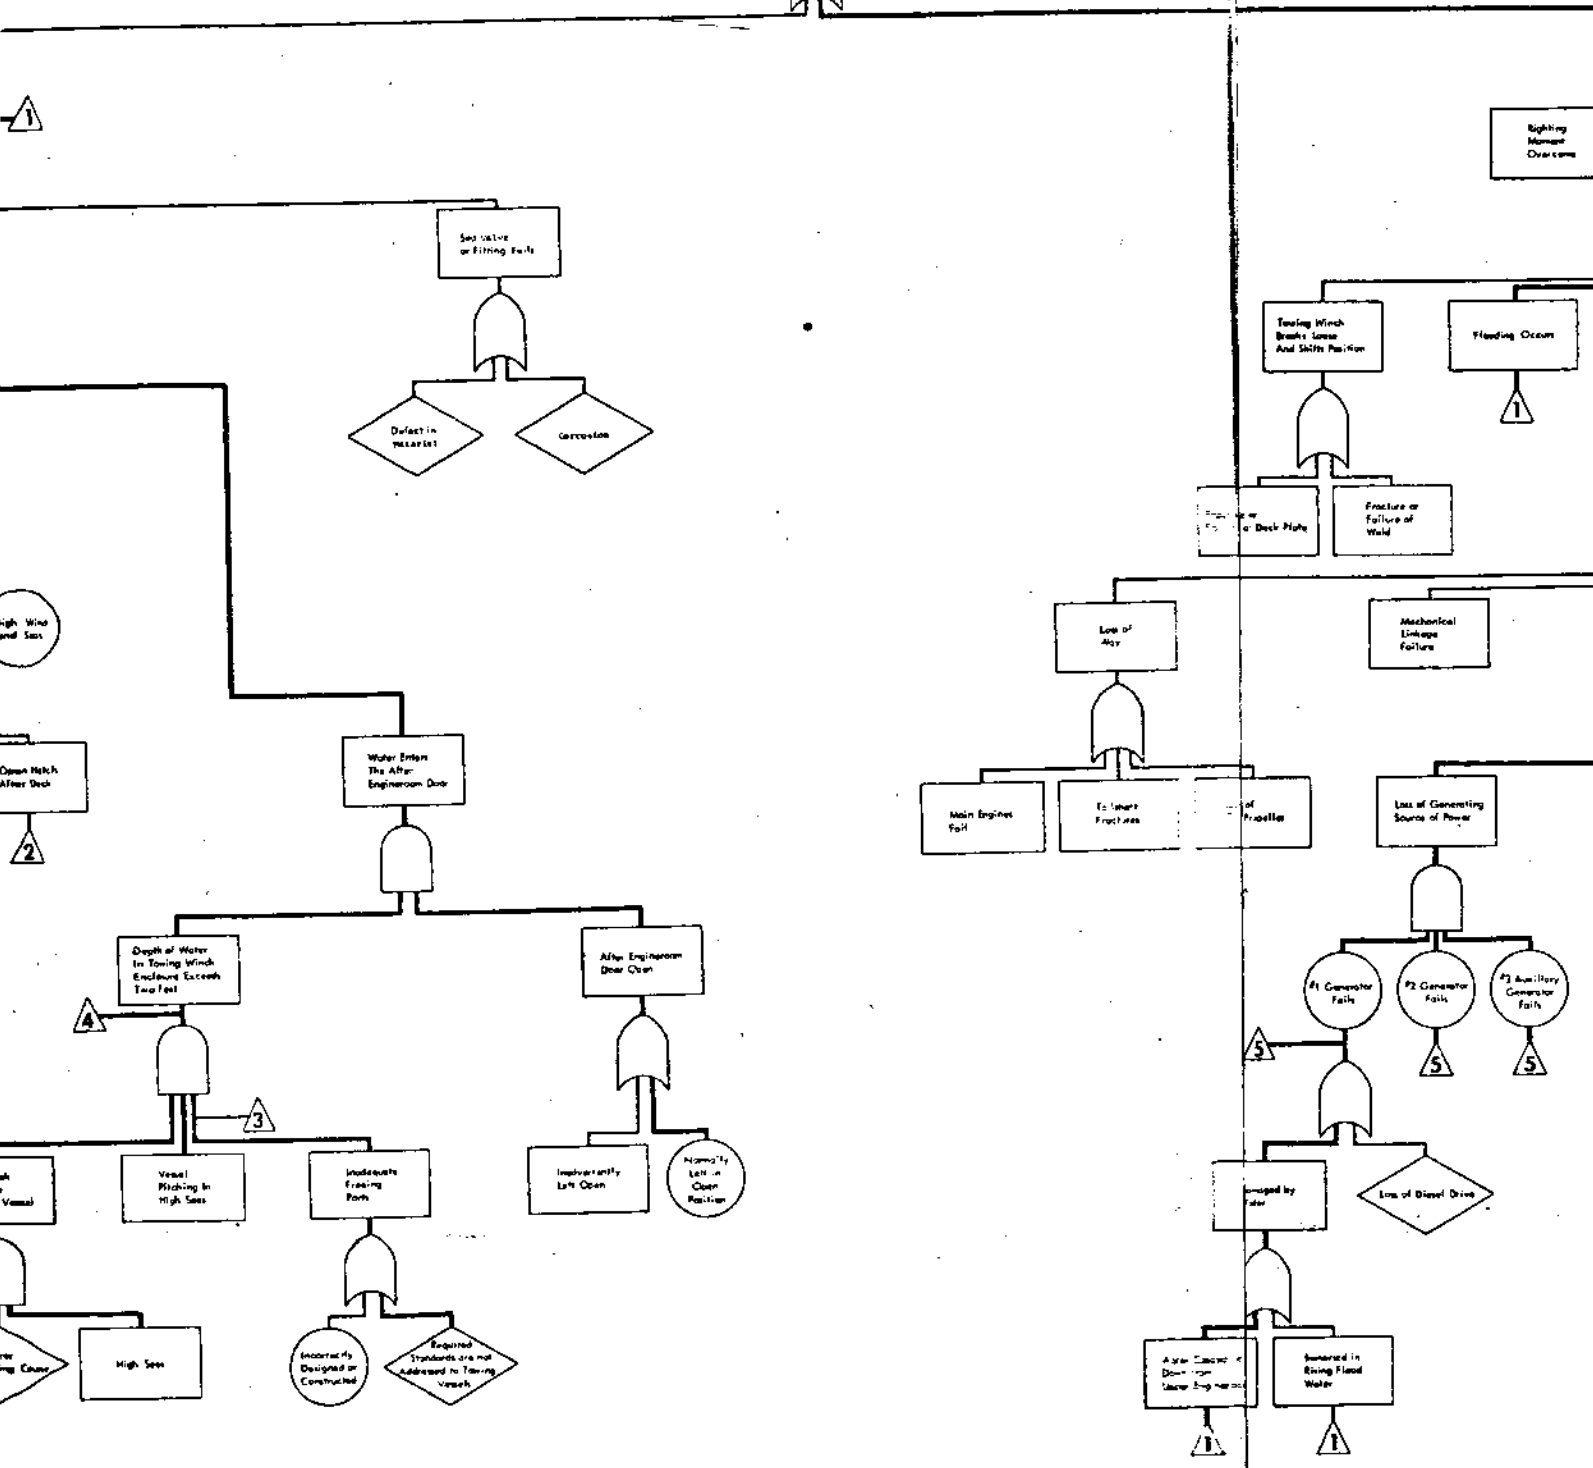
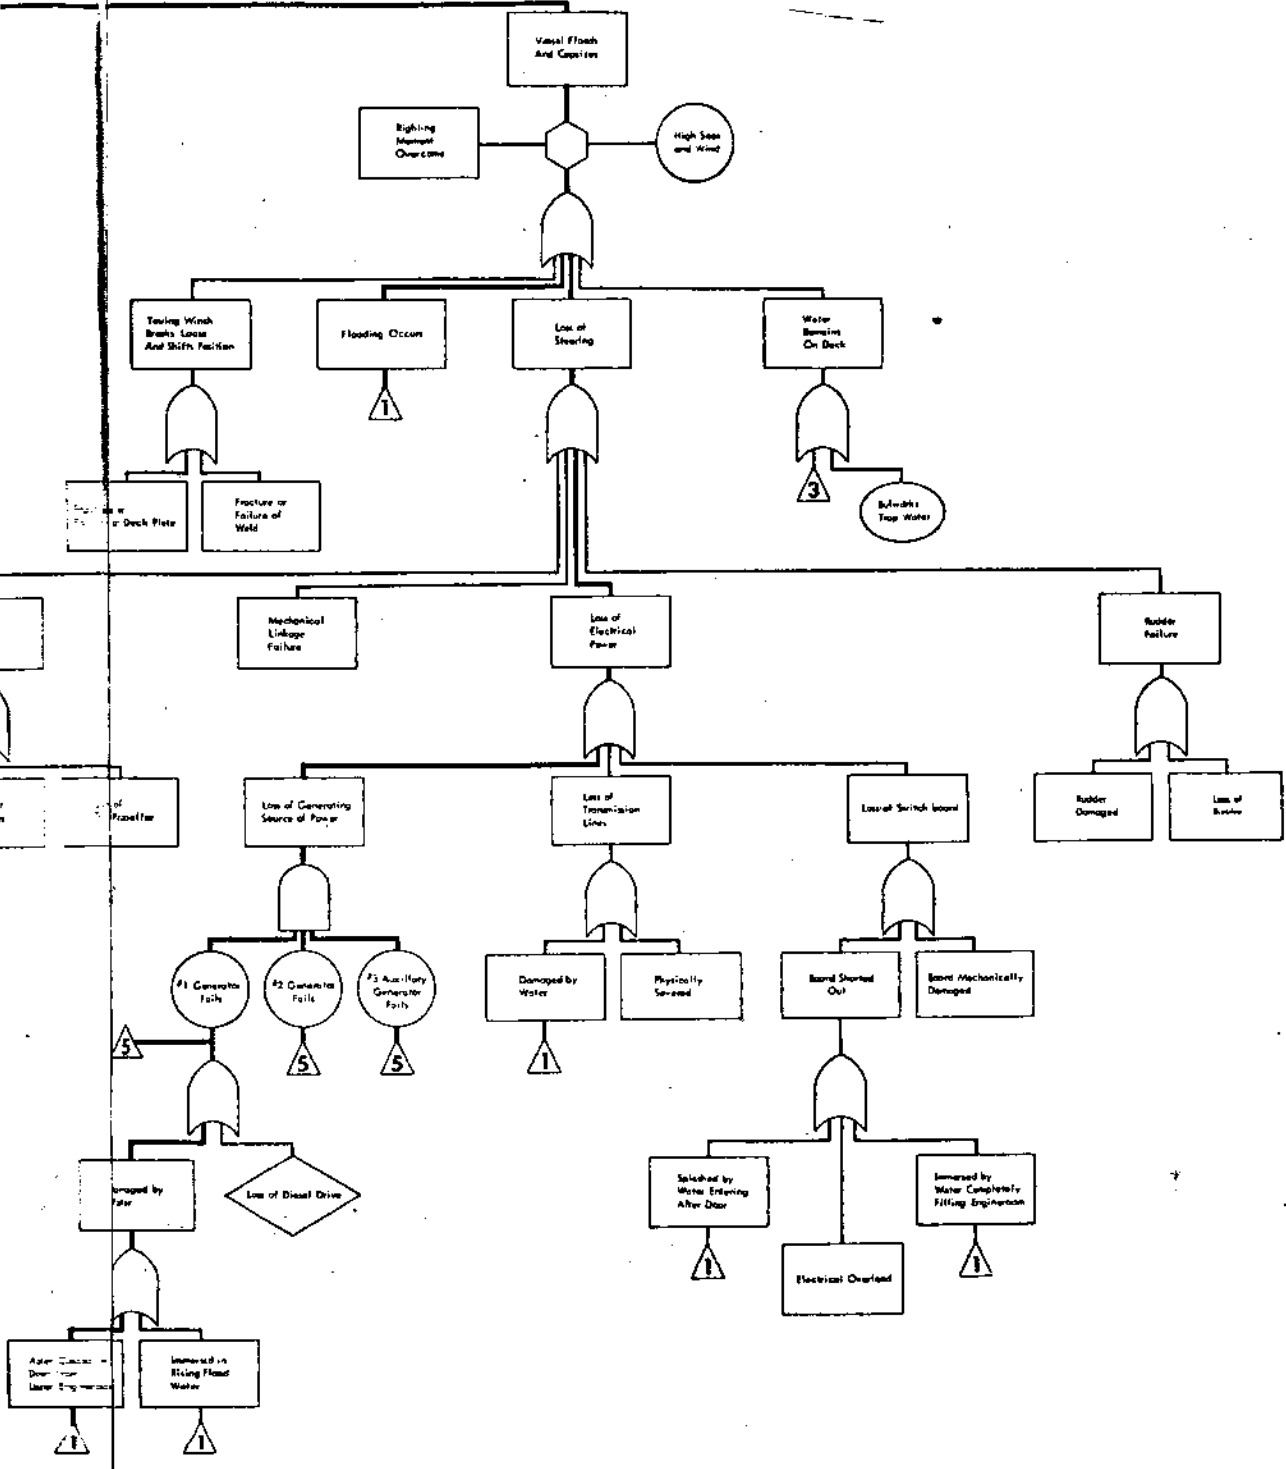
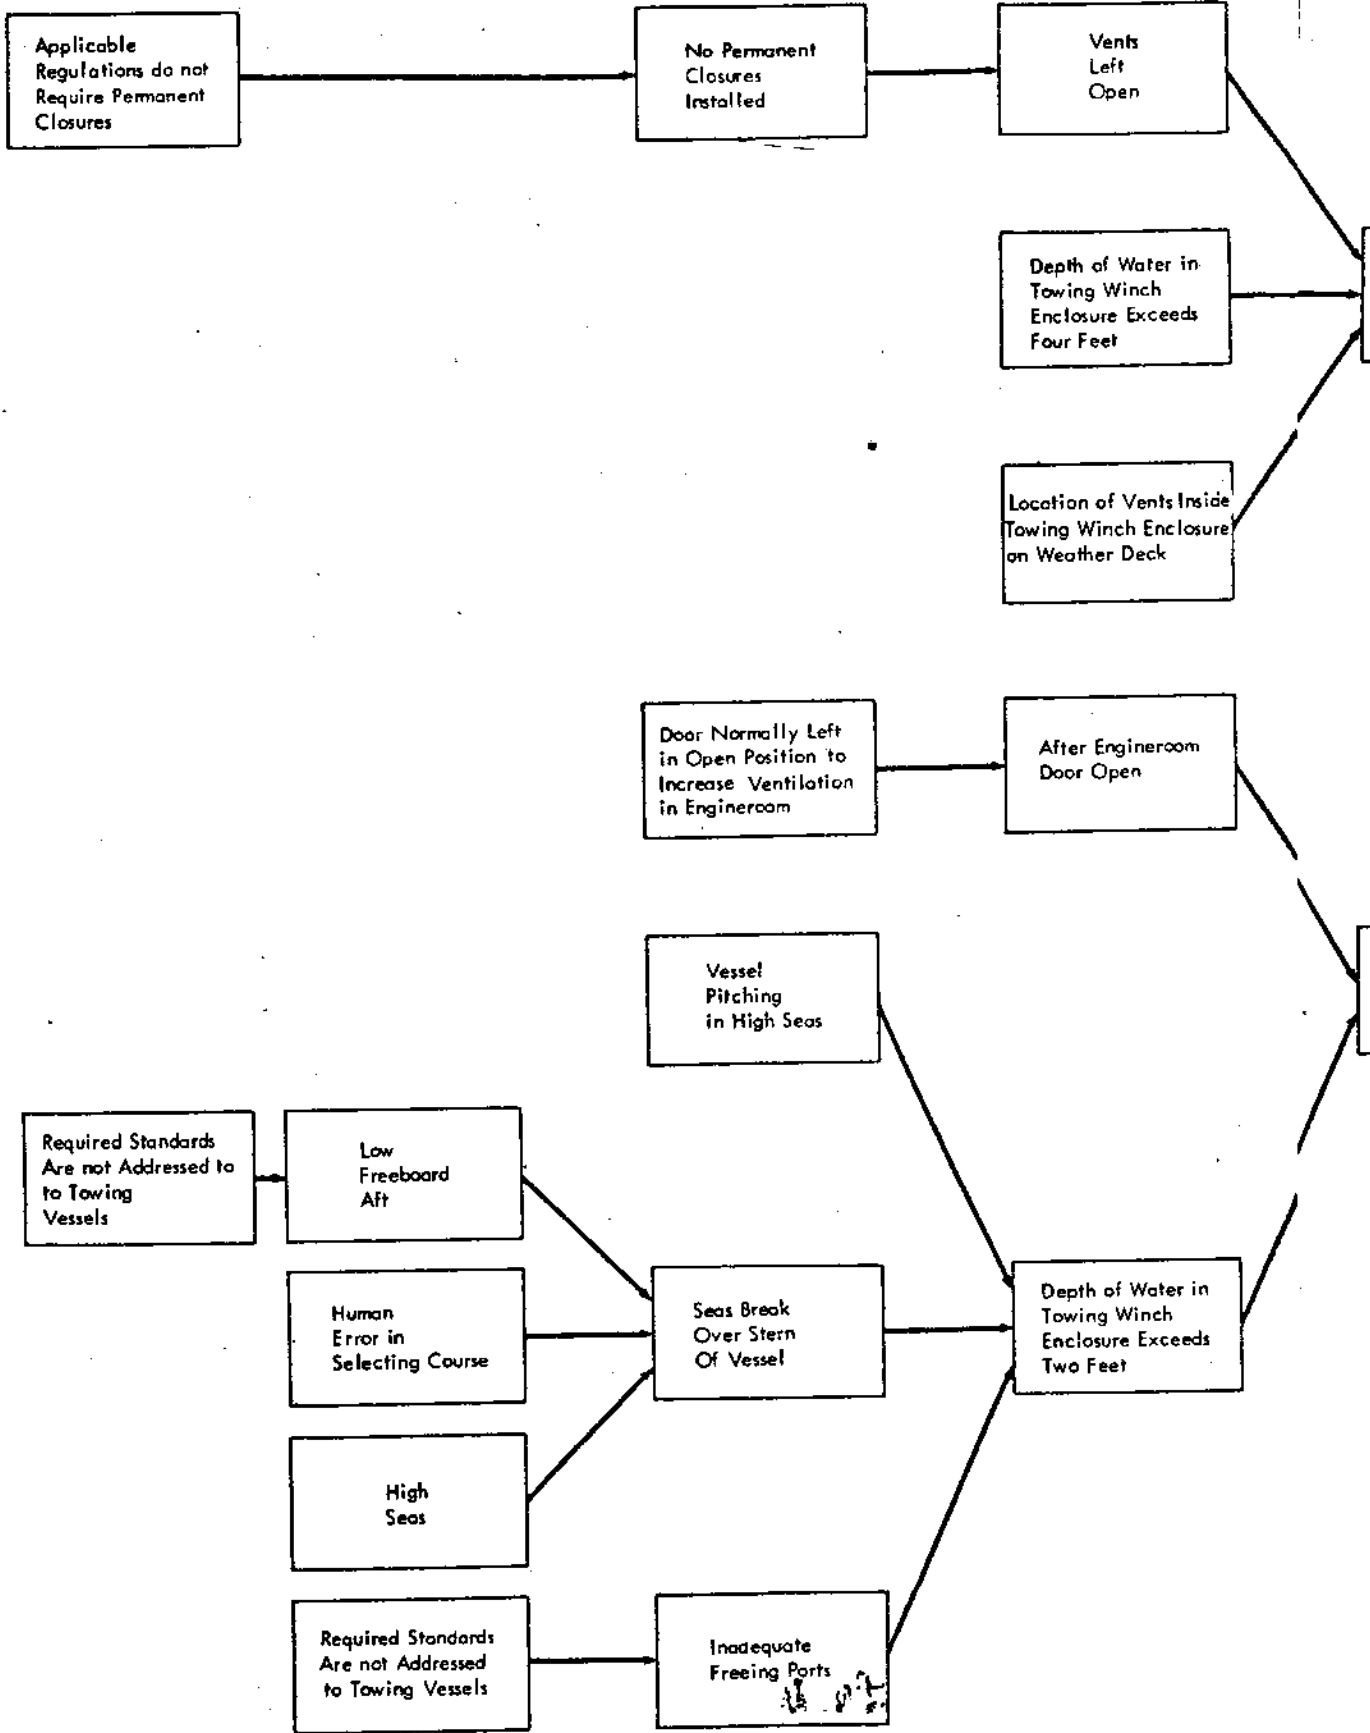
# AM - CAUSE & EFFECT ANALYSIS OF TOWING VESSEL MAR. JORIE McALLISTER

Loss of Buoyancy  
Vessel Sinks

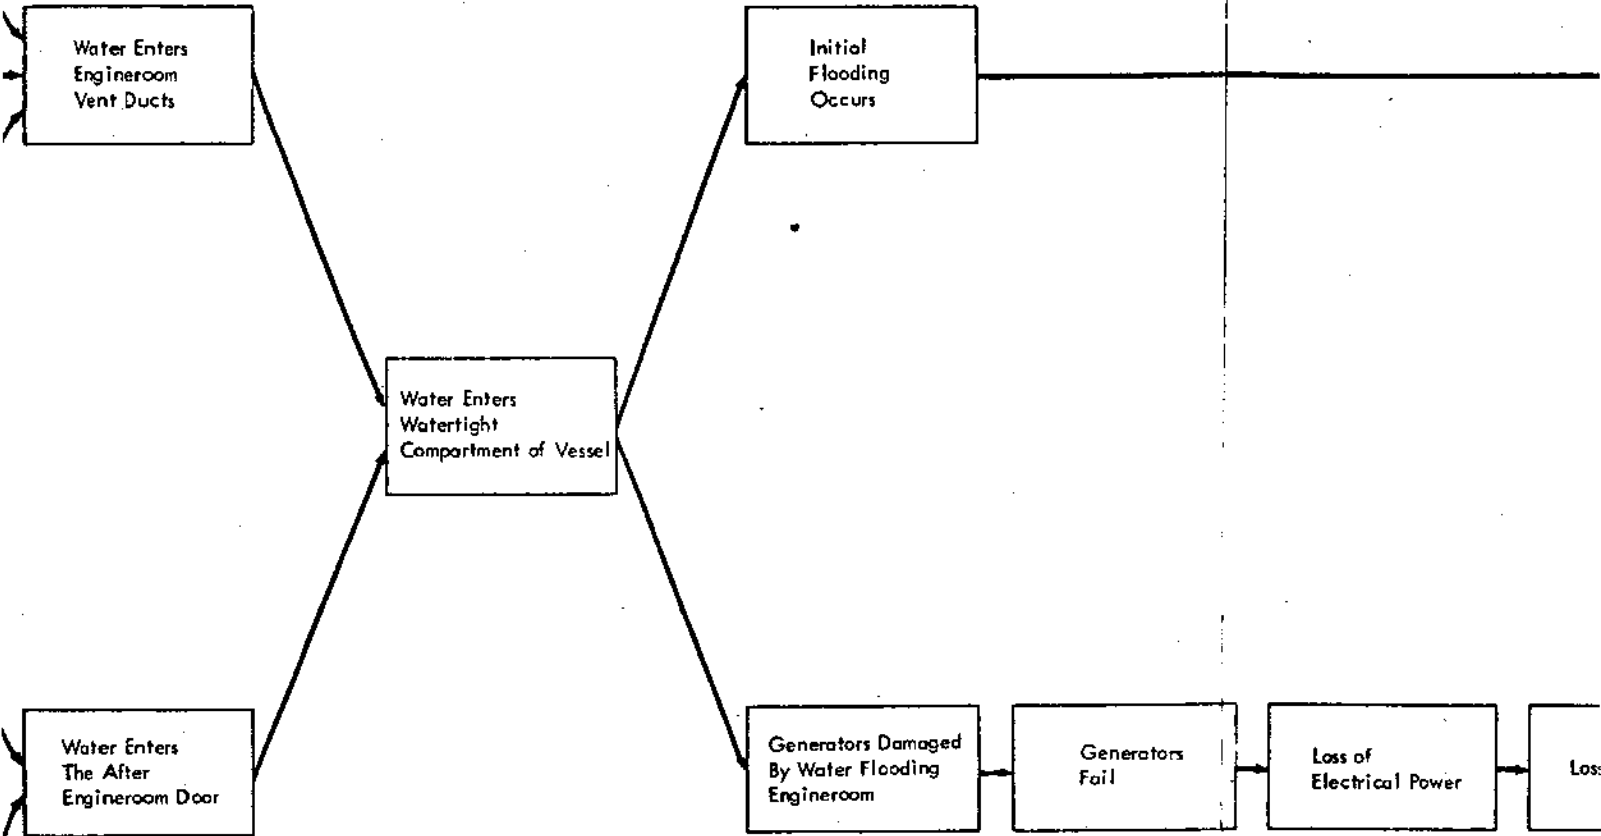
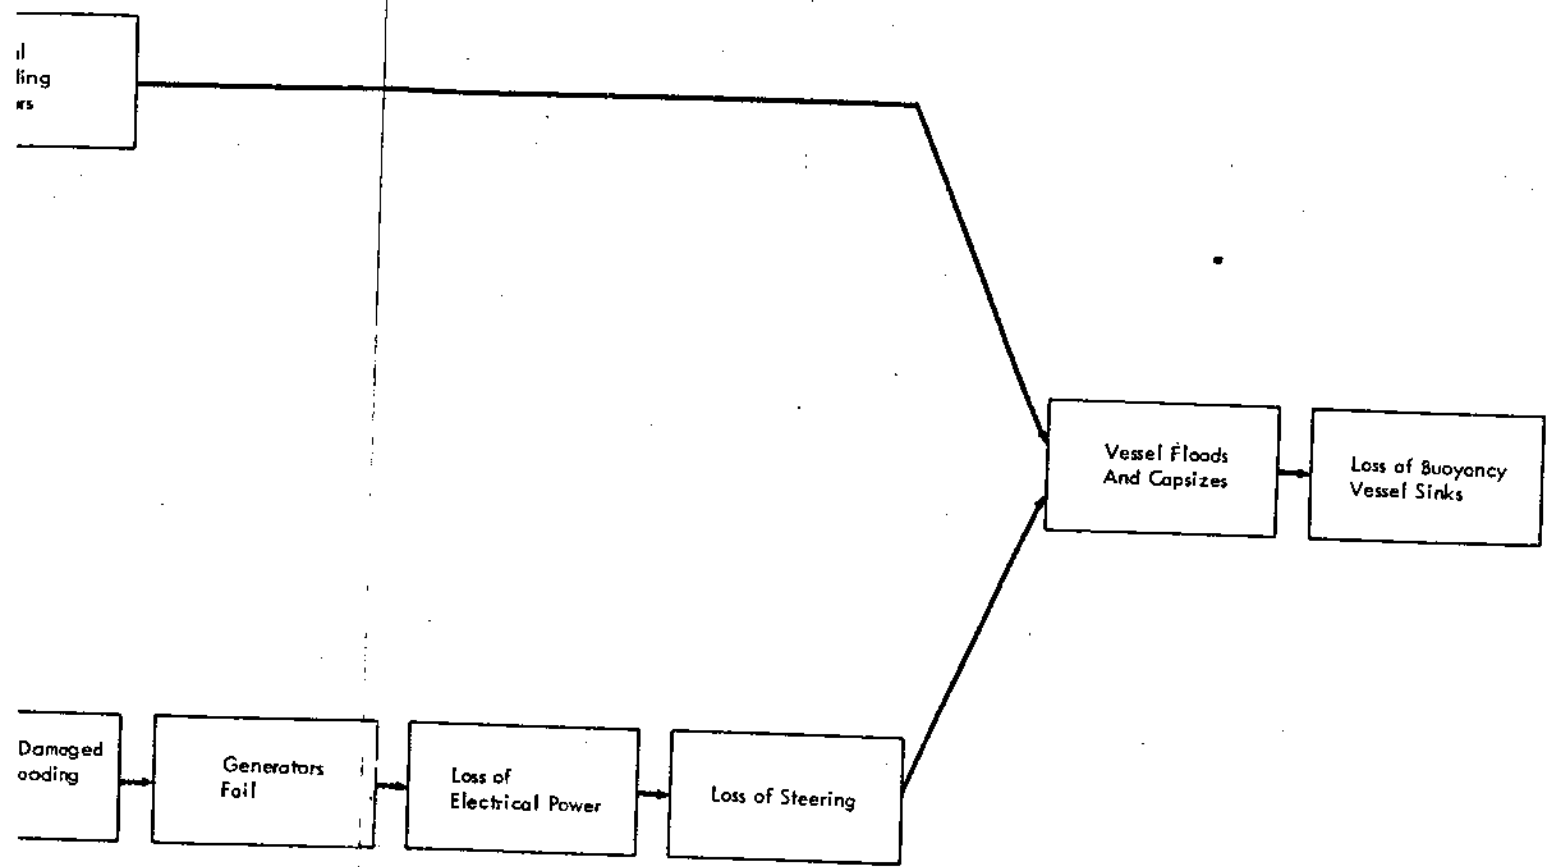
# EVENTS & CASUAL FACTORS DIAGRAM

Although in this case a fault tree analysis has been utilized after the fact to determine the most probable causal factors of the casualty, it can also be used effectively for pre-casualty evaluation of design. For example, exactly the same type of analysis could have been done prior to construction of the vessel to determine whether flooding could occur under heavy sea conditions, and what the consequences of flooding might be. As a result, the need for changes in design (larger freeing ports, greater freeboard, more effectively protected ventilators, placement of generators in different spaces, protected electric control boards) or operating procedures (keep watertight door closed) could have been found, and decisions to preclude the occurrence of this type of casualty could have been made. This method of fault tree analysis is one of a number of systematic design analysis methods which have grown up in the aerospace field. Such methods are also capable of being applied to predict accident-causing system failures in the marine field. The fault tree analysis, Attachment A, is an example of this desirable procedure in connection with Recommendation 2. The relationship of events and causal factors is charted in Attachment B.
