UNITED STATES COAST GUARD

INVESTIGATION INTO THE CIRCUMSTANCES SURROUNDING THE COLLISION BETWEEN THE PASSENGER VESSEL **NOORDAM (NA)**

FREIGHT VESSEL **MOUNT YMITOS (MT)**

OFF SOUTHWEST PASS IN THE GULF OF MEXICO ON
NOVEMBER 6, 1993, WITH MINOR INJURIES, NO LOSS
OF LIFE AND NO POLLUTION

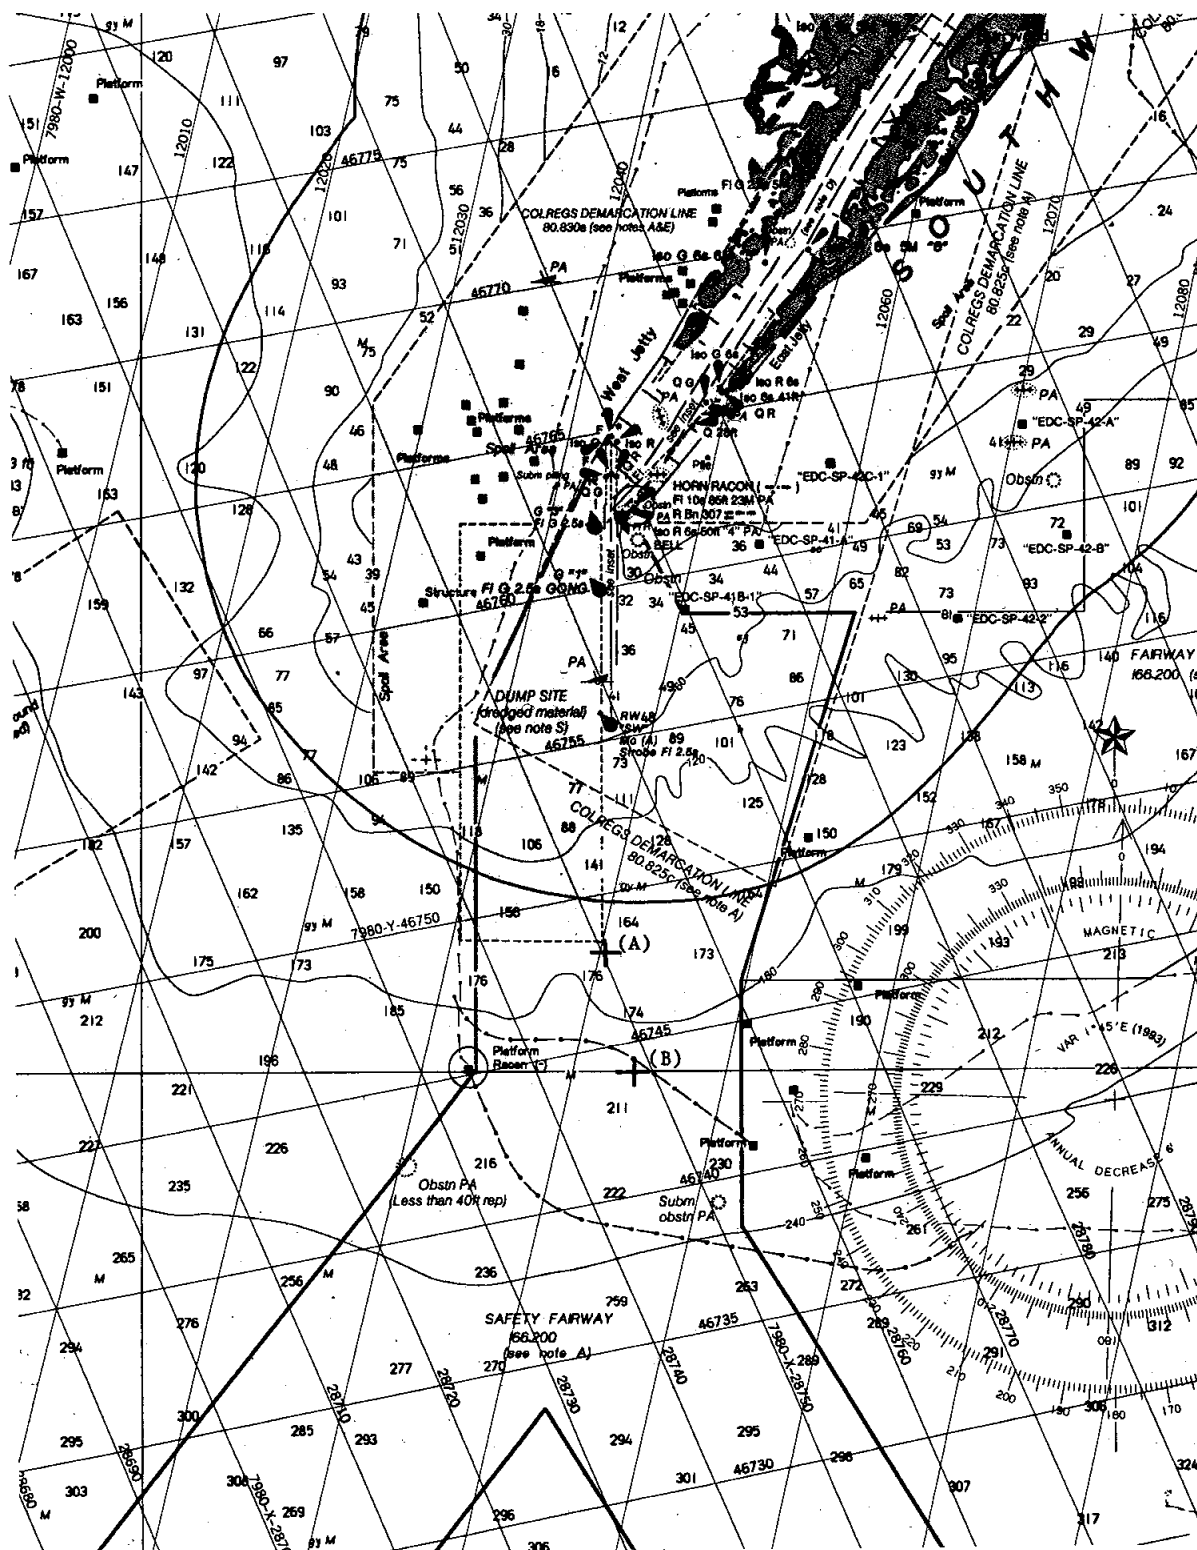
Approach to Southwest Pass - Gulf of Mexico
 (A) Position plotted by M/V MOUNT YMITOS at the point of collision
 (B) Position recorded by M/V NOORDAM's GPS at the point of collision

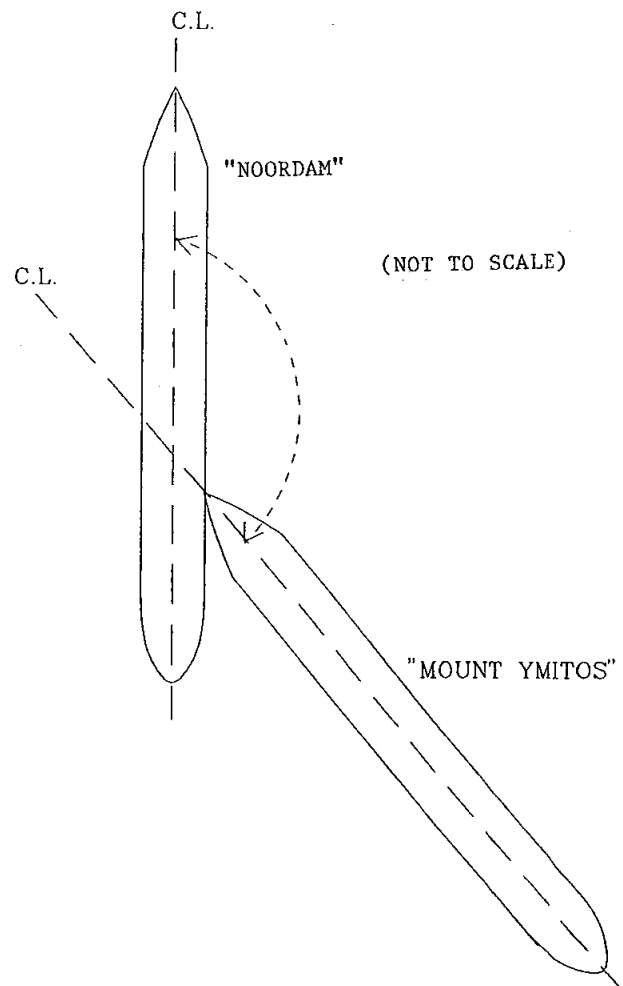
46. The collision took place at approximately 2042, with the MOUNT YMITOS' port bow impacting the NOORDAM in the starboard aft midships area. The NOORDAM was still swinging to port and making approximately 14 knots. The MOUNT YMITOS, having backed for about two minutes, was making approximately 3 knots. The NOORDAM was heading approximately 300 degrees when the collision occurred and the MOUNT YMITOS was heading approximately 230 degrees. The approximate angle of collision was 110 degrees measured from forward, and 70 degrees measured from aft.

Angle between the vessels at the time of collision

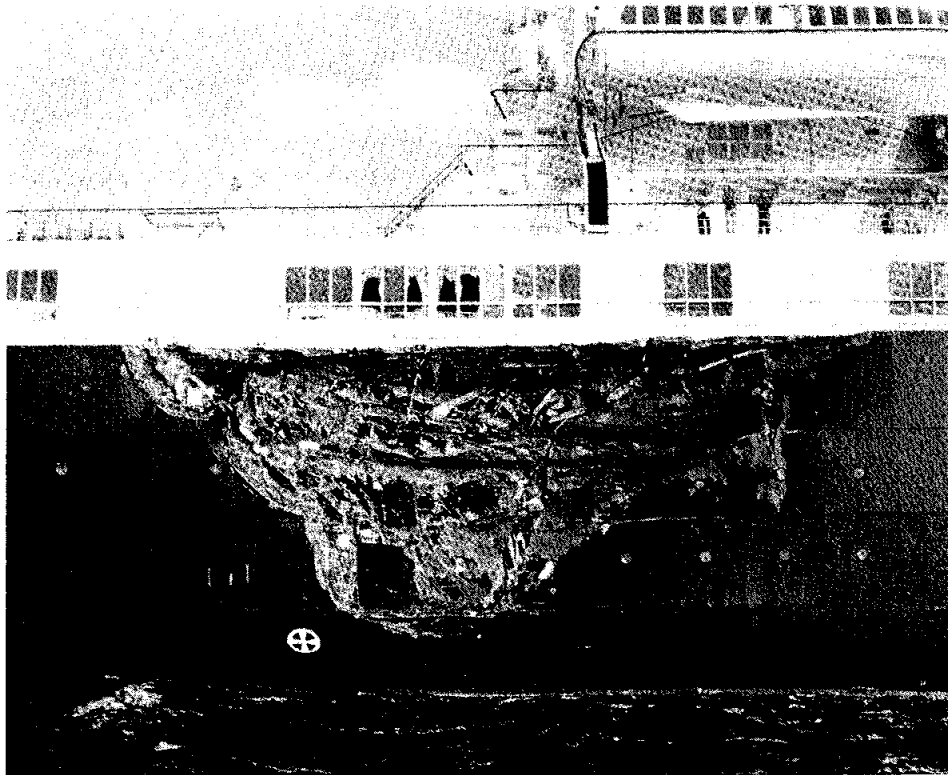
49. The NOORDAM sustained impact damage on its aft starboard side in way of frames 9-1/2 to 41-1/2 extending over four strakes. All of the damage was above the waterline. The MOUNT YMITOS suffered damage to its port bow and bulwarks well above the waterline.

Starboard quarter of the M/V NOORDAM

55. Permanent repairs were performed to the NOORDAM at Avondale Shipyard renewing the side shell plating and internals. Interior finish work was deferred for completion by a riding repair crew. The NOORDAM's propulsion train was not damaged by the collision; the starboard shaft was stopped immediately following the collision because a controllable pitch propeller (cpp) hydraulic line was severed in the area of collision damage.

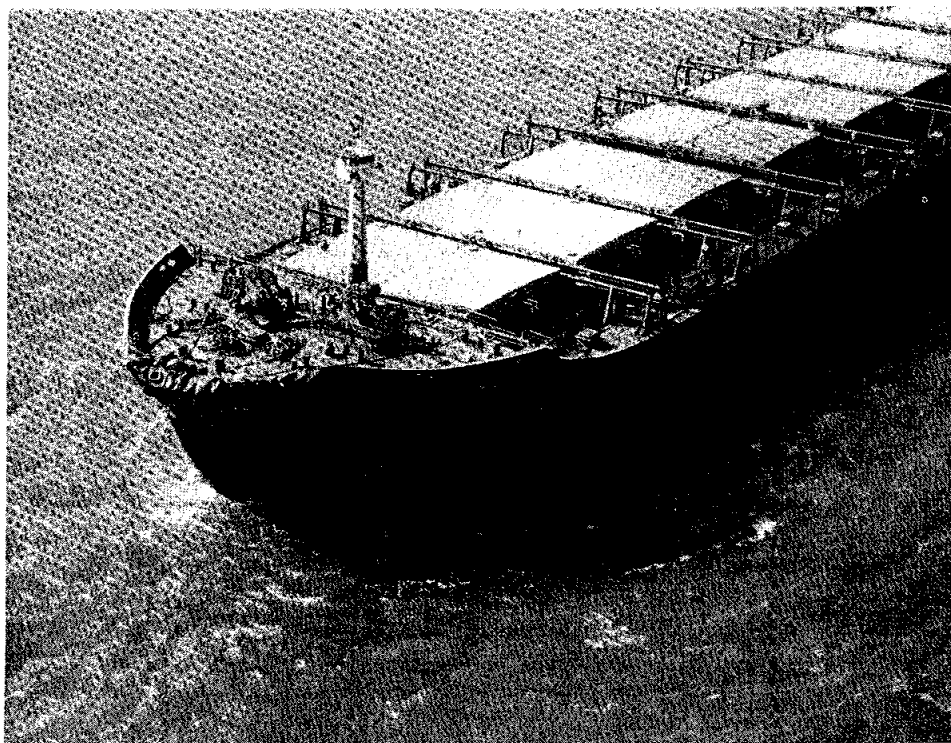
Damaged bow of the M/V MOUNT YMITOS

54. Temporary repairs were performed to the bow of the MOUNT YMITOS with the approval of Bureau Veritas in order to proceed with its cargo to Russia.
