# **MARINE CASUALTY REPORT**

## **SS OGDEN WILLAMETTE: MAJOR ENGINE ROOM FLOODING**

MARINE BOARD OF INVESTIGATION REPORT

REPORT NO. USCG 16732/0210

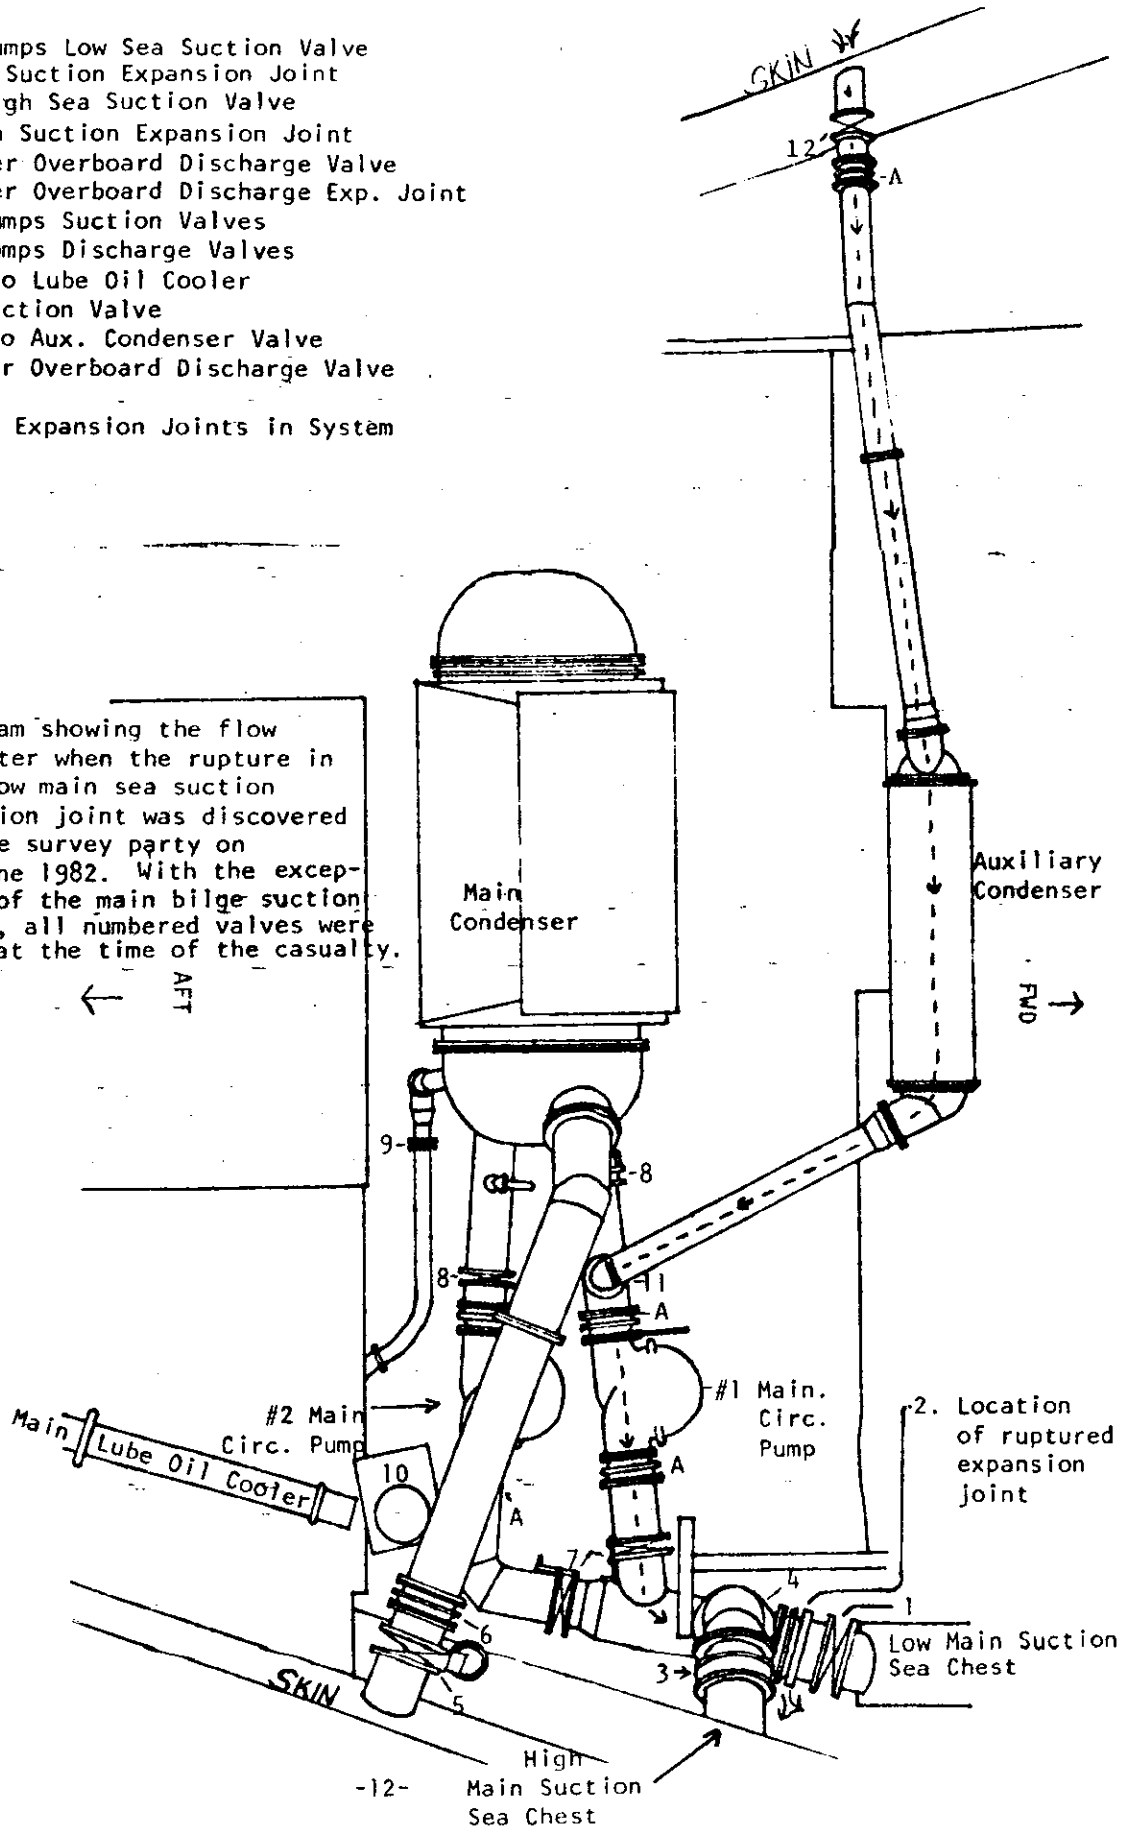
Figure 1. Diagram showing the flow of water when the rupture in the low main sea suction expansion joint was discovered by the survey party on 29 June 1982. With the exception of the main bilge suction valve, all numbered valves were open at the time of the casualty.
