# **MARINE CASUALTY REPORT**

## **SS POET: DISAPPEARANCE IN THE ATLANTIC OCEAN AFTER DEPARTURE FROM CAPE HENLOPEN, DELAWARE ON 24 OCTOBER 1980 WITH LOSS OF LIFE**

MARINE BOARD OF INVESTIGATION REPORT

REPORT NO. USCG 16732/11486

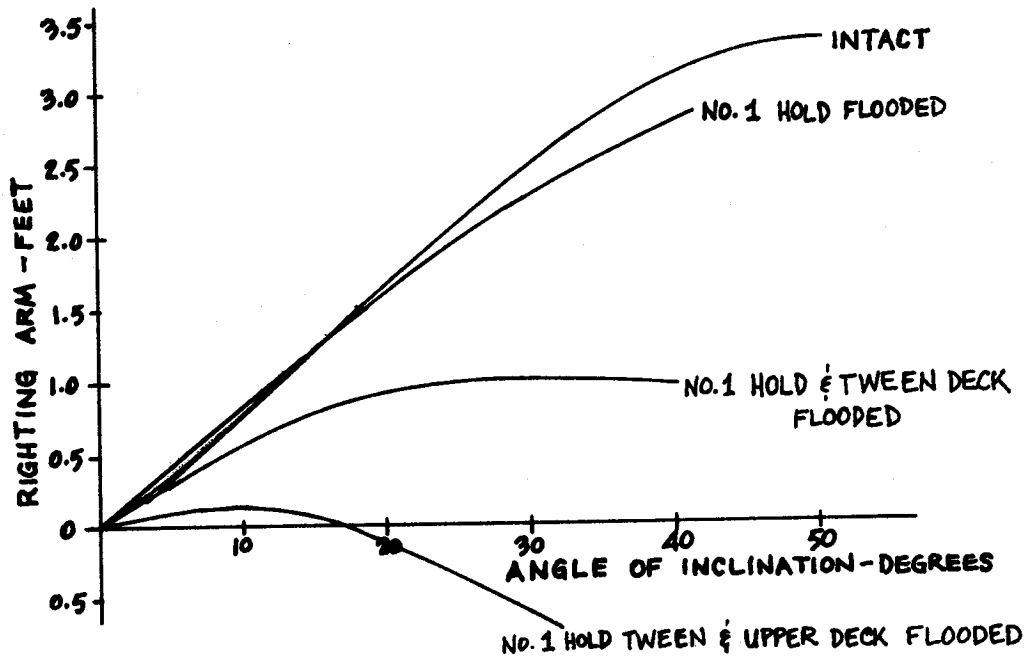
FIGURE 2  
 Flooding of No. 1 Hold, Drafts and Statical Stability Curves

NO. 1 HOLD, TWEEN DECK & UPPER DECK FLOODED

- NOTE: 1. Righting Arm Curves have been corrected for free surface effect of flooding water.  
 2. Taken from Board Exhibit 166, Figures 320-1 and 320-2, pages 43-44.

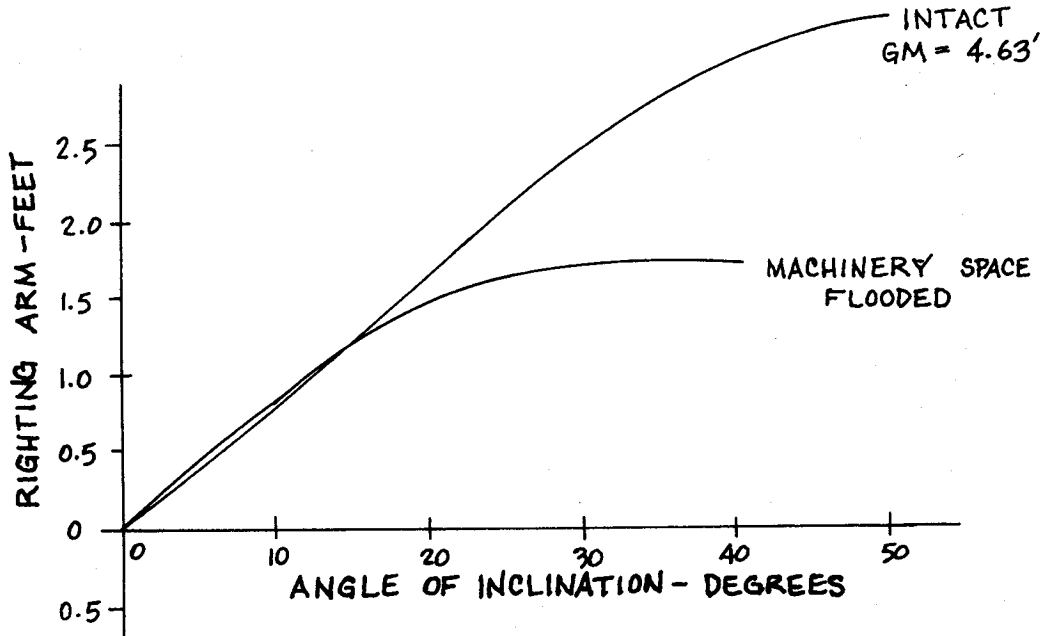
FIGURE 3  
Flooding of Machinery Space, Drafts and Statical Stability Curves

MACHINERY SPACE & ASSOCIATED DOUBLE BOTTOM TANKS  
FLOODED WITH FREE COMMUNICATION TO THE SEA

- NOTE: 1. Righting Arm Curves have been corrected for free surface effect of flooding water.  
2. Taken from Board Exhibit 166, Figure 321-1, page 46.
