**MARINE CASUALTY REPORT**

COLLAPSE AND SINKING  
OF MOBILE OFFSHORE DRILLING UNIT  
RANGER I IN THE GULF OF MEXICO  
ON 10 MAY 1979 WITH LOSS OF LIFE

U.S. COAST GUARD  
MARINE BOARD OF INVESTIGATION REPORT

REPORT NO. USCG 16732/93621

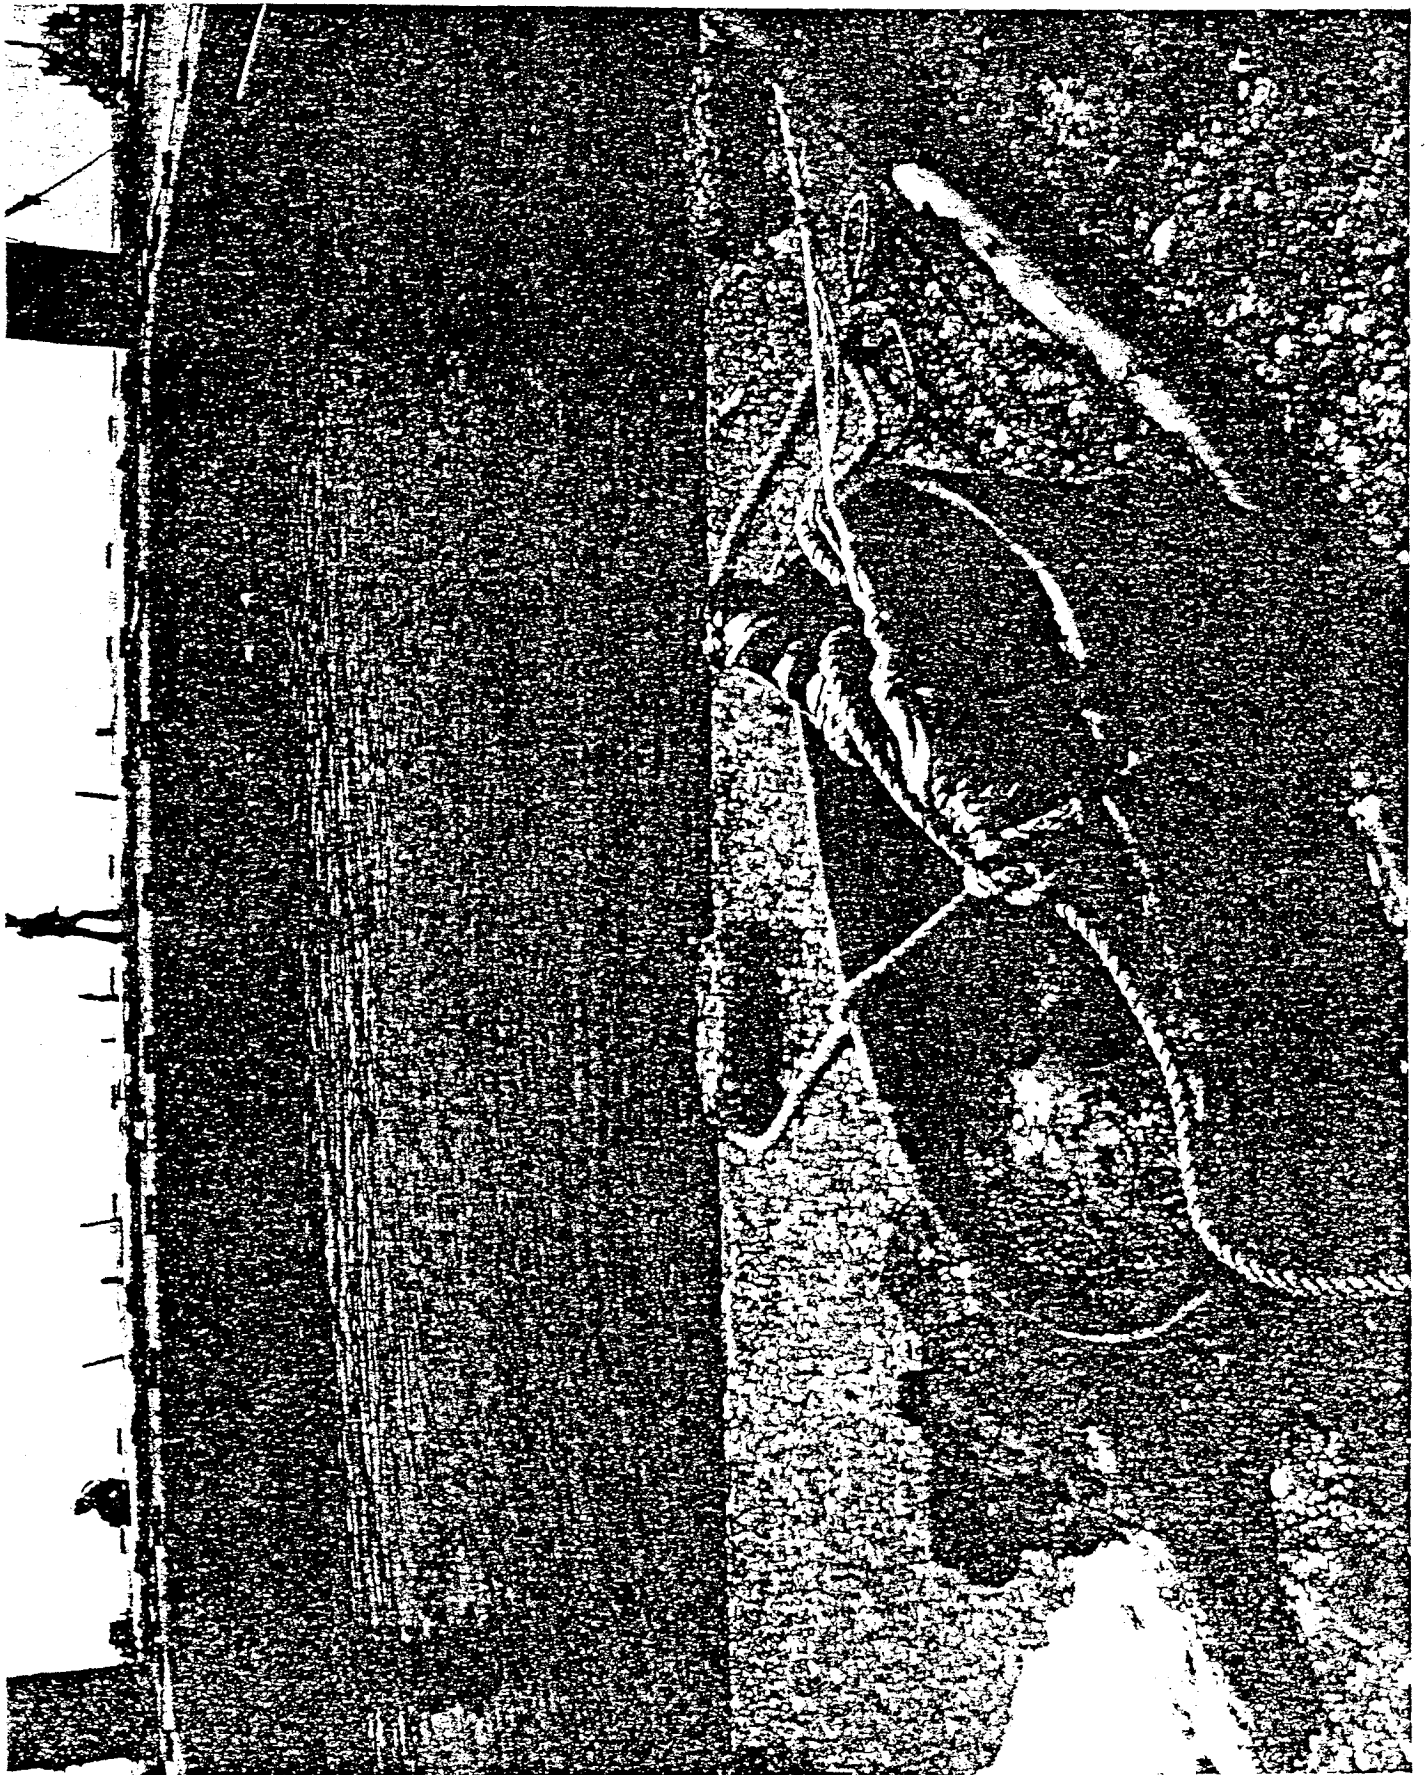
The stern support leg was fractured near its connection to the mat. This catastrophic fracture began on the port side of the leg at the upper toe of a continuous fillet weld that attached a stiffener ring to the stern leg. The fracture extended completely around the leg and was inclined upward toward the starboard side. A stub of the stern leg remained attached to the mat. It varied in height from 4 inches on the port to 15 inches on the starboard side. The fractured surfaces showed matted chevrons that pointed to the port side of the leg. The mat deck plating was pushed in on the port side and the barnacles in way of this deformation were scraped off. The lower end of the fractured leg mated with the deformation in deck plating when it was inclined from the vertical about 9 to 11 degrees to starboard. The upper end of this leg was sheared at the 90 foot level. The starboard leg was bent at the 38 foot level and it remained attached to the mat. The upper end was sheared at the 90 foot level. The port leg was broken off at the 68 foot level. (See figure 6)

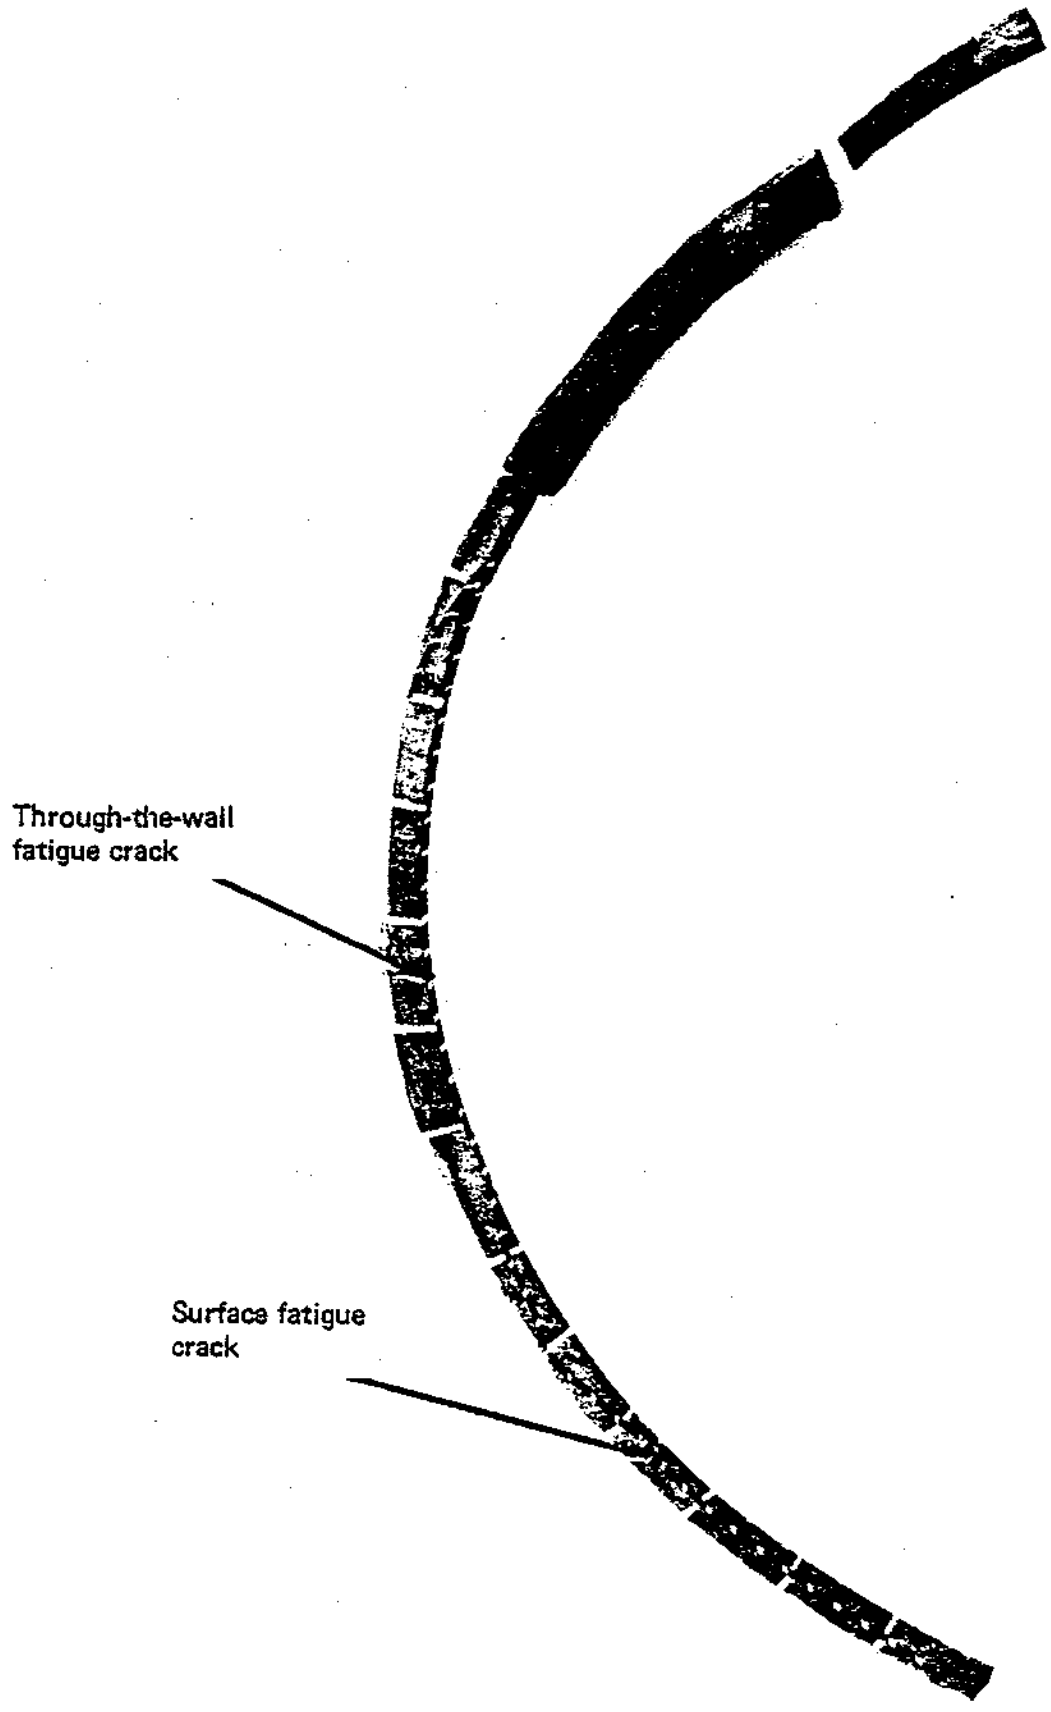
FIGURE 7 – CATASTROPHIC FRACTURE SURFACE OF PORT SIDE OF STERN LEG.

SEM studies were inconclusive in identifying fatigue on the catastrophic fracture surface because of heavy oxide and surface deposits. However, TEM studies showed a through-the-wall fatigue crack of about 23 inches centered on the port side of the stern leg and a surface crack of about 14 inches centered on the after port side of the stern leg. The two fatigue cracks joined on the port side. The surface crack extended 50 to 70 percent through-the-wall of the stern leg. Also, the TEM studies were used to count fatigue striations on the surface of the catastrophic

fracture. Although fine fatigue striations were removed by corrosive action of the sea water, the studies showed that the 23 inch fatigue crack was propagating for at least 400 days. TEM studies of the starboard side of the catastrophic fracture showed a quasi-cleavage mode of failure. (See figure 7)
