# **MARINE CASUALTY REPORT**

**Capsizing and Sinking  
Of The  
MOBILE OFFSHORE DRILLING UNIT  
ROWAN GORILLA I  
In The North Atlantic Ocean  
On  
15 December 1988**

**U.S COAST GUARD  
MARINE BOARD OF INVESTIGATION REPORT  
AND  
COMMANDANT'S ACTION**

**REPORT NO. USCG 16732/02 HQS 92**

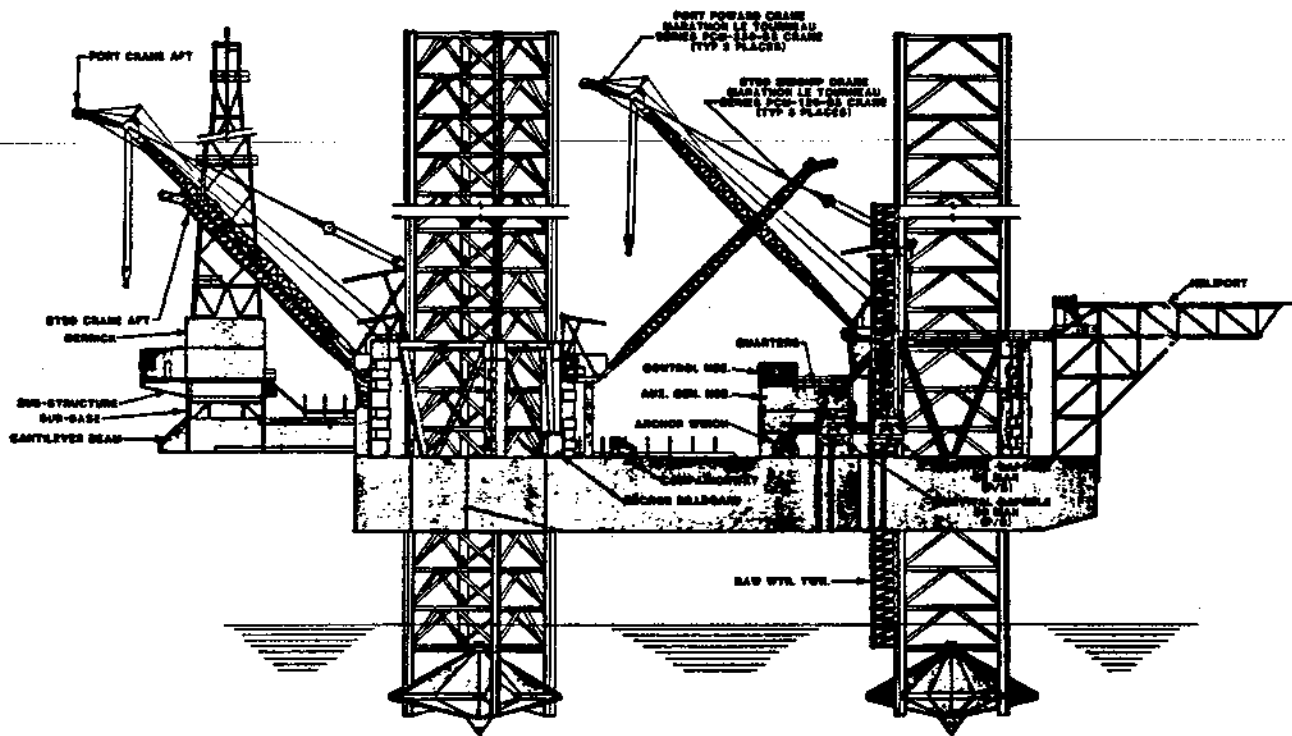
Figure 1

The ROWAN GORILLA I (See Figure 1) had a triangular shaped hull with overall dimensions 297'L x 292'W x 30'D. The unit was equipped with three truss type spud legs, 504' long. Each leg was capable of independent operation. The unit was fitted with a quarters module aft of the forward leg and a drill floor/derrick structure between the two after legs, capable of being cantilevered off the stern. The full load line displacement of the unit was 19,419.4 long tons at a maximum draft of 16.5'. The ROWAN GORILLA I and its four sister rigs were some of the largest units of their type ever constructed. Three of the remaining units are owned by Rowan Companies and one by Transworld Drilling, U.K.

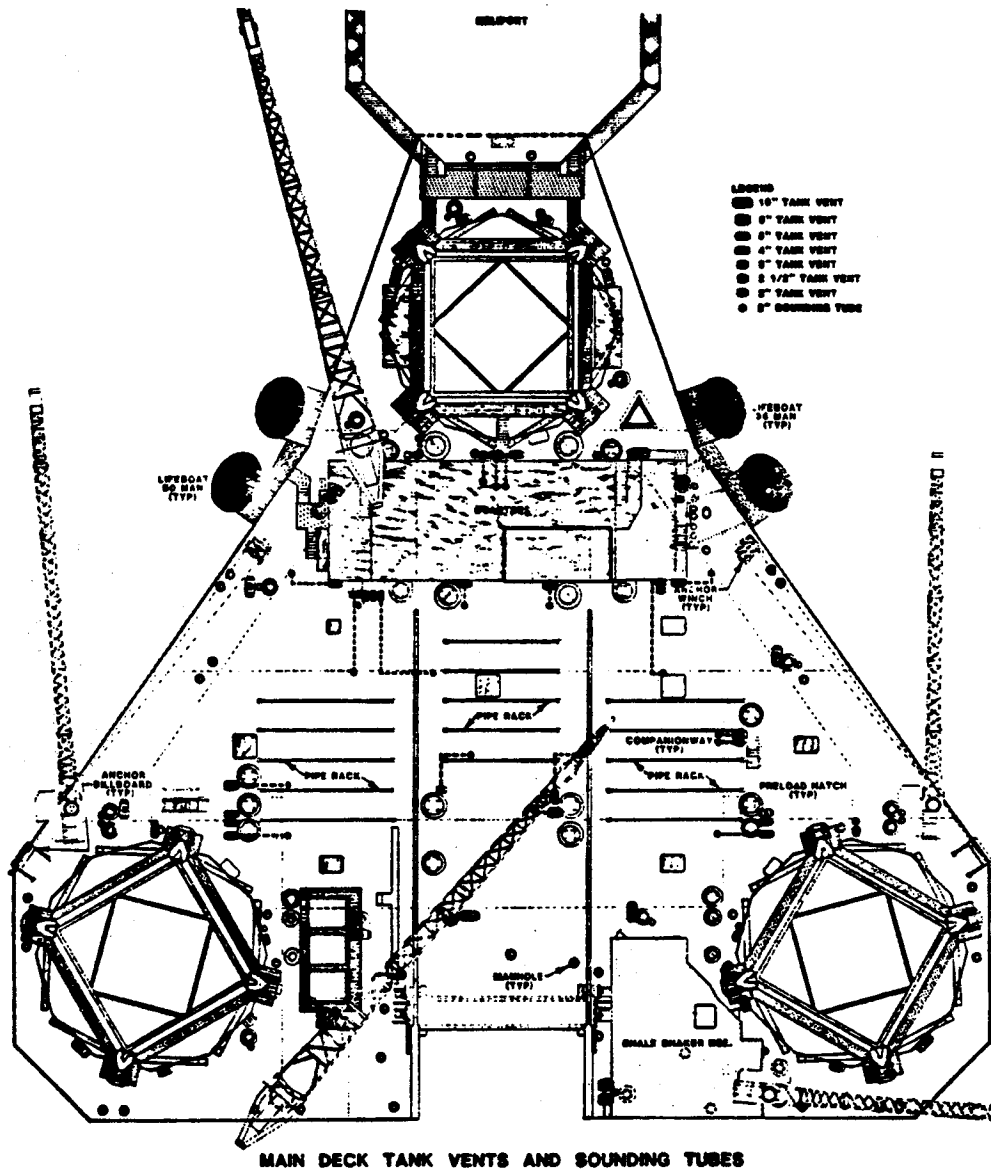
Figure 2

Aboard the ROWAN GORILLA I, one of the crewmen detected flooding in preload tank 14 during a routine sounding. The only means of determining the condition of the preload tanks was through two inch sounding tubes located on the main deck (See figure 2). Secondary or remote means were not provided. The tank was opened and inspected and a vertical fracture was discovered in way of the stern, permitting a steady spray of water to enter the tank. Preload tank 15 was also entered and a horizontal fracture was discovered in way of the stern, though only "weeping". The Rig Superintendent directed that the eductor system take suction on preload tank 14. The Senior Barge Engineer observed the fractures in both tanks. He stated the crack in preload tank 14 seemed to open and close as the stern was struck by waves.

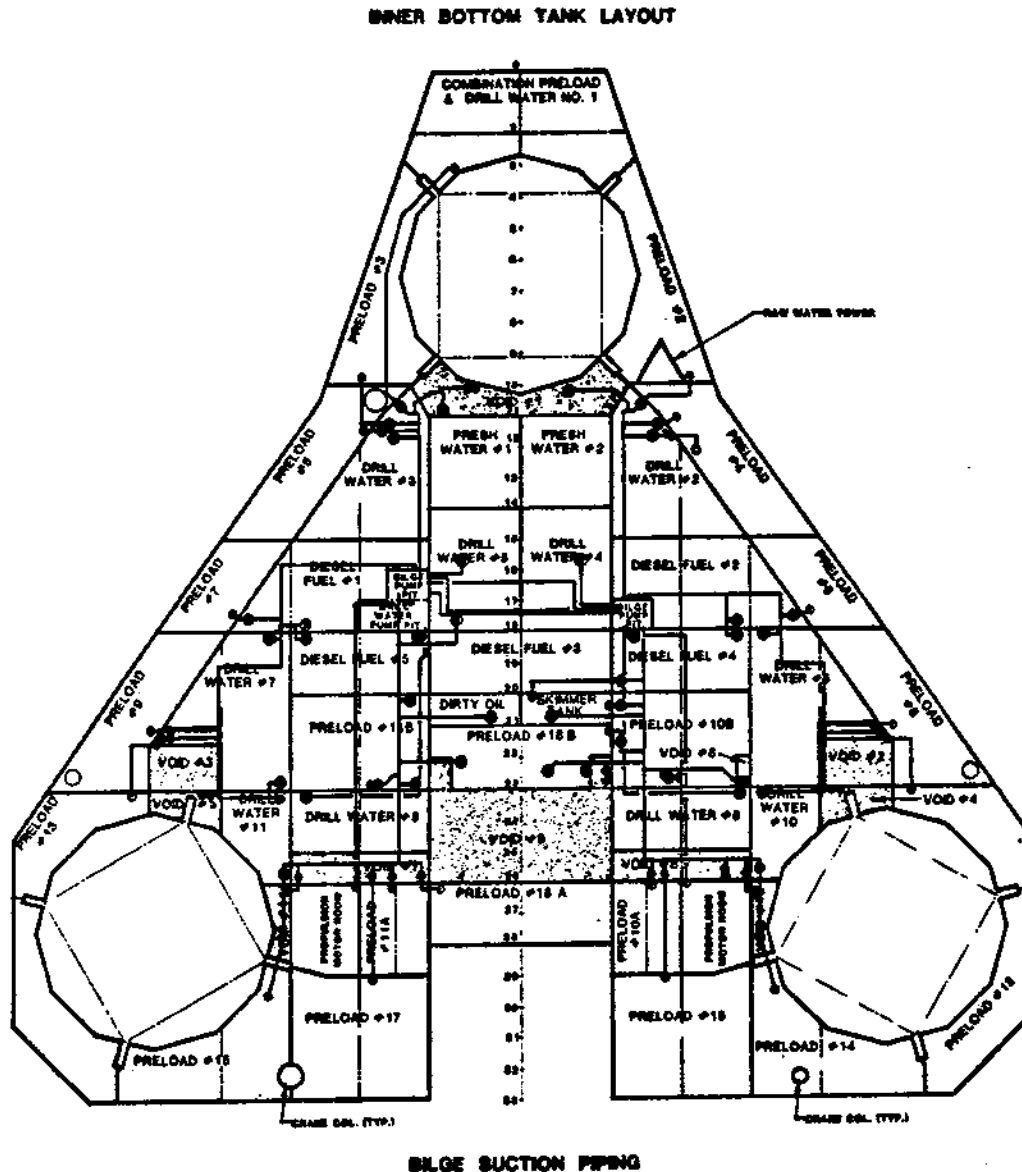
Figure 3

Conclusion 9: The bilge/eductor system may not have been capable of handling the extent of flooding of the internal compartments. The system's limited capacity and intended service for (removing) small amounts of water from internal spaces apparently was inadequate to dewater and control the progressive flooding.

The eductor system (see figure 3) consists of four inch diameter piping and runs to all internal spaces of the unit. During normal operations to elevate the unit, a calculated amount of preload ballast water would be pumped into the tanks to drive the spud cans and legs securely into the seabed. Preload would then be dumped through large skin valves located in the bottom of hull while the unit was slightly elevated. The eductor piping served to strip preload ballast that remained in the tanks. It was not intended to effectively de-ballast large amounts of water from internal spaces.

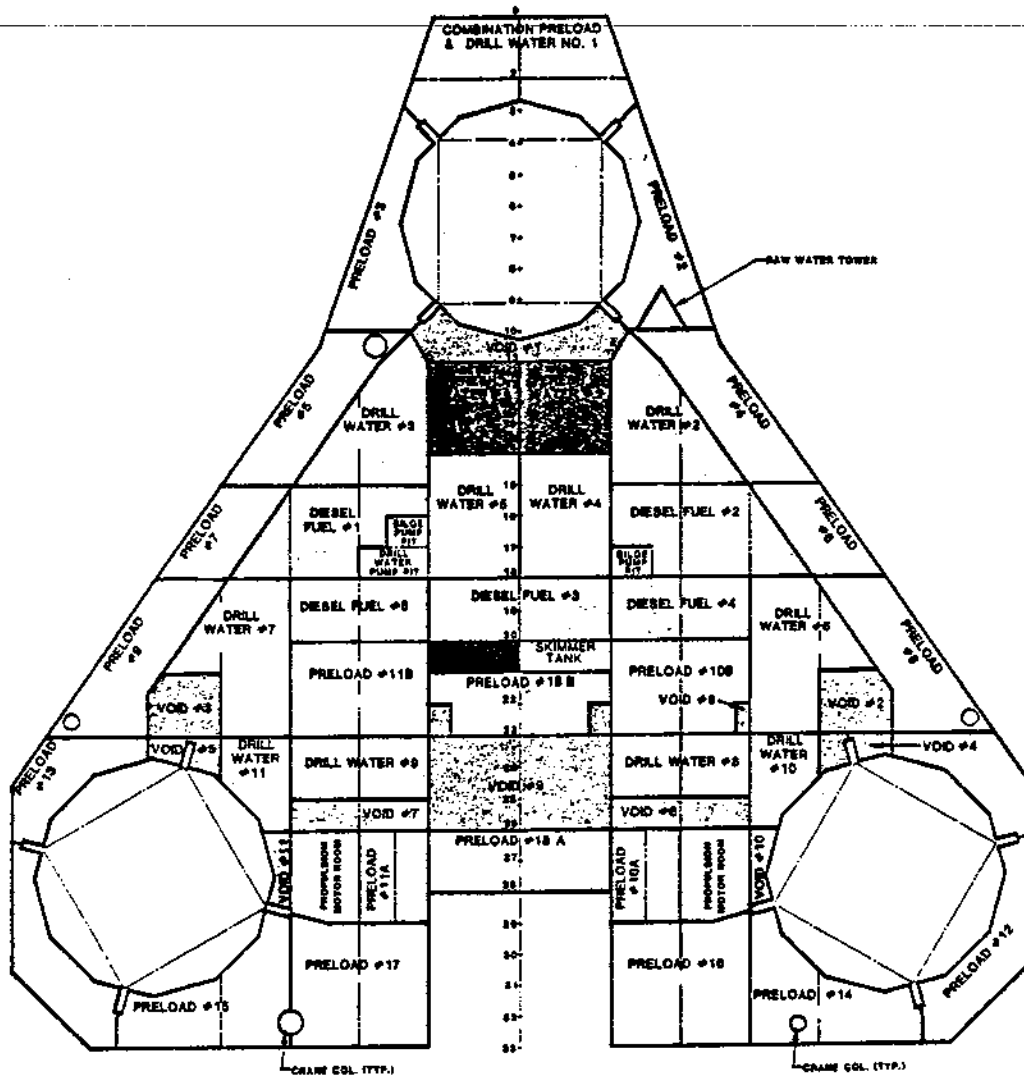
Figure 5

In the early morning, the Rig Superintendent and Senior Barge Engineer both detected that the ROWAN GORILLA I was getting heavy by the stern. The Rig Superintendent stopped the thrusters which resulted in a less turbulent ride. He requested the Senior Barge Engineer to run a damage stability calculation assuming 16 feet of water in preload tank 14. The Tow Rider was also aware of the increased stern trim and discussed the matter with the Rig Superintendent. The Senior Barge Engineer suggested that pumping out of drill water tanks 8, 9, 10 and 11, which were all full at the time of departure from Halifax, would help the trim (See figure 5). This was accomplished, but the effect was minimal. Both of them suspected that perhaps other stern preload tanks were also flooding. However, there were no means available for them to verify additional flooding as the main deck was now constantly awash from the breaking seas. There was no attempt to establish suction on other preload tanks with the eductor system to determine if they were flooding.

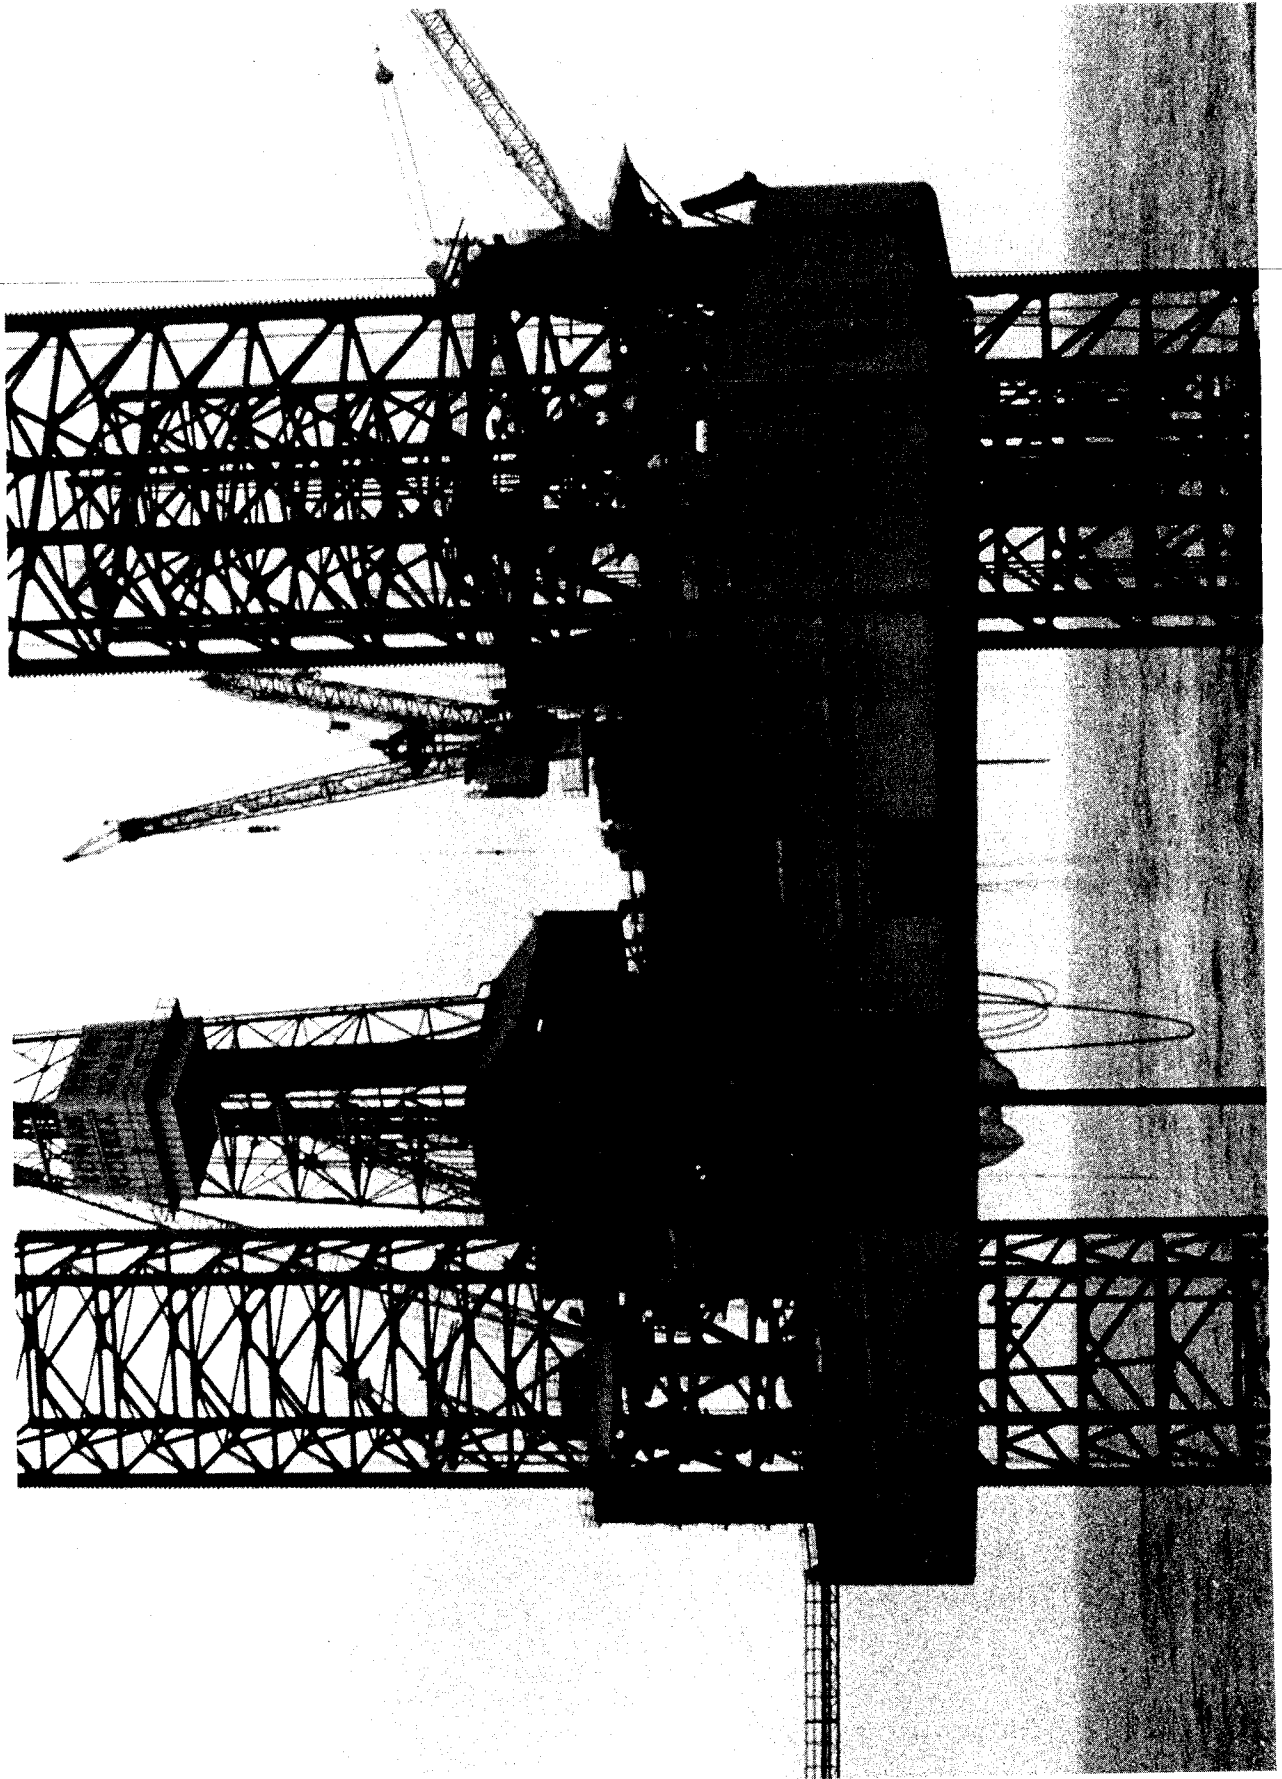
46. The Marine Board concludes that towing of self elevating units in severe storm conditions can be inherently dangerous. Some may choose to dismiss this, citing the vast numbers of successful trans-oceanic tows of jack-ups that have occurred over the years. However, the Marine Board doubts that many of these tows have been conducted in waters or at times of the year where they were subject to extreme winds and waves. The photograph on the next page clearly illustrates the potential damaging effects of boarding seas on a jack-up unit (not the ROWAN GORILLA I) under tow. Note that this unit's helideck is completely submerged.
