MARINE CASUALTY REPORT M/V SAN MATEO

CAPSIZING IN MORRO BAY, CA
ON FEBRUARY 16, 1983
WITH NO LOSS OF LIFE

MARINE BOARD OF INVESTIGATION

REPORT NO. USCG-M-84-6

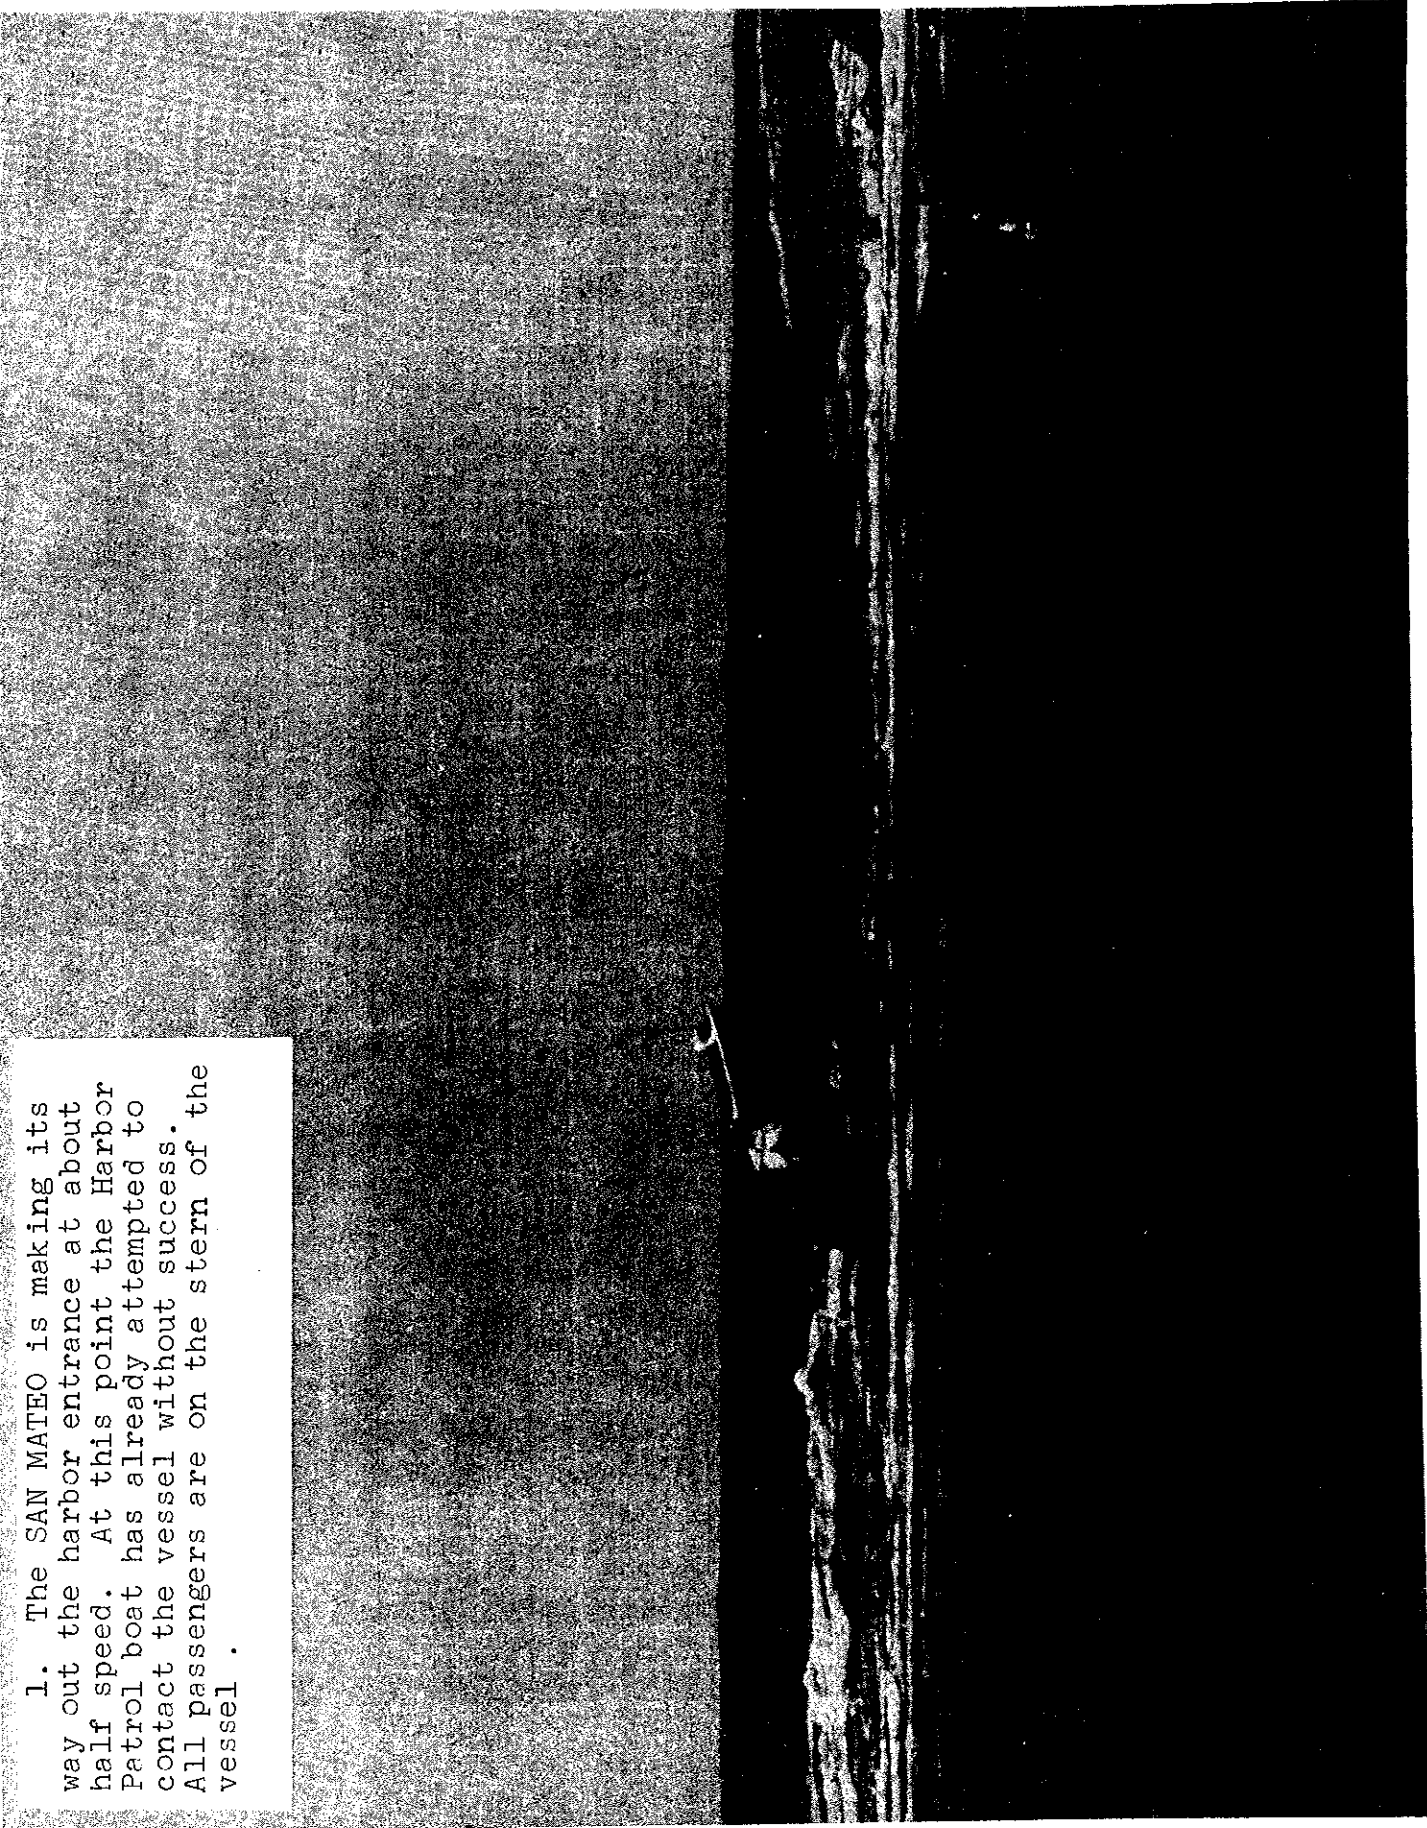
1. The SAN MATEO is making its way out the harbor entrance at about half speed. At this point the Harbor Patrol boat has already attempted to contact the vessel without success. All passengers are on the stern of the vessel .
