M/V SANTA CLARA I

BOARD OF INQUIRY REPORT

CONCERNING THE LOSS OF HAZARDOUS MATERIALS

ON 3 JANUARY 1992

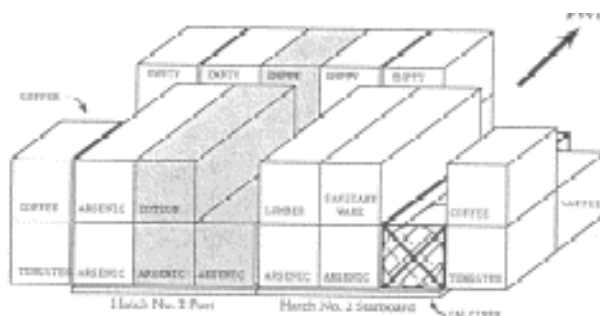
Cargo stowage on #2 Hatch upon departure Port Elizabeth
(Shaded containers remained after casualty)

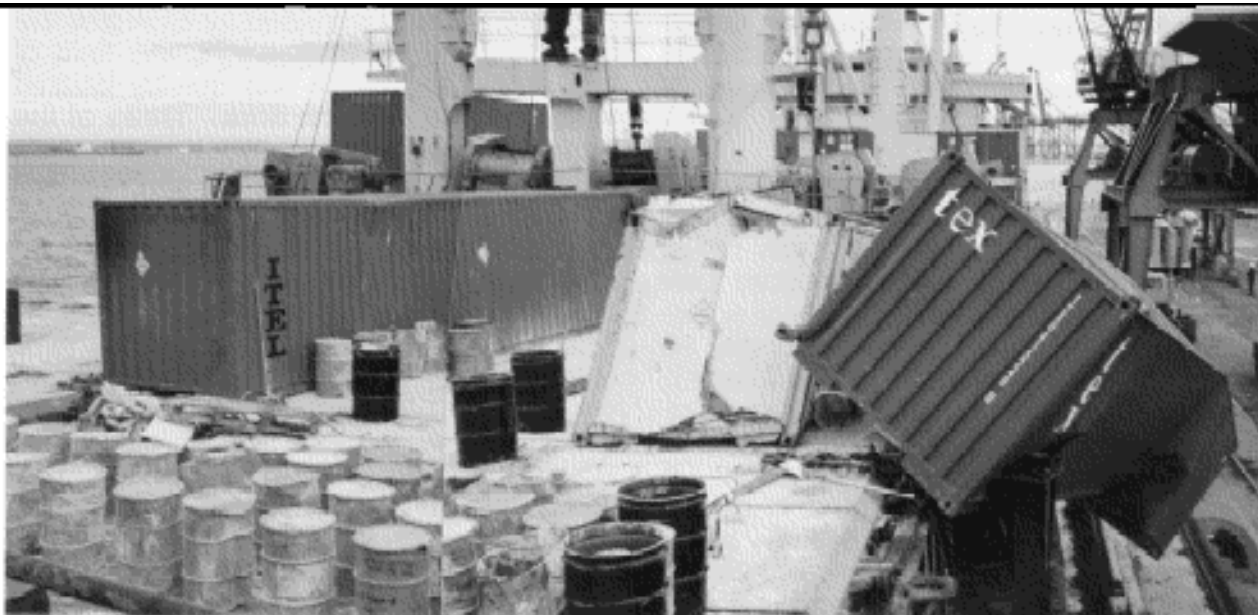
Containers at Hatch #2 on arrival in Baltimore (looking aft)

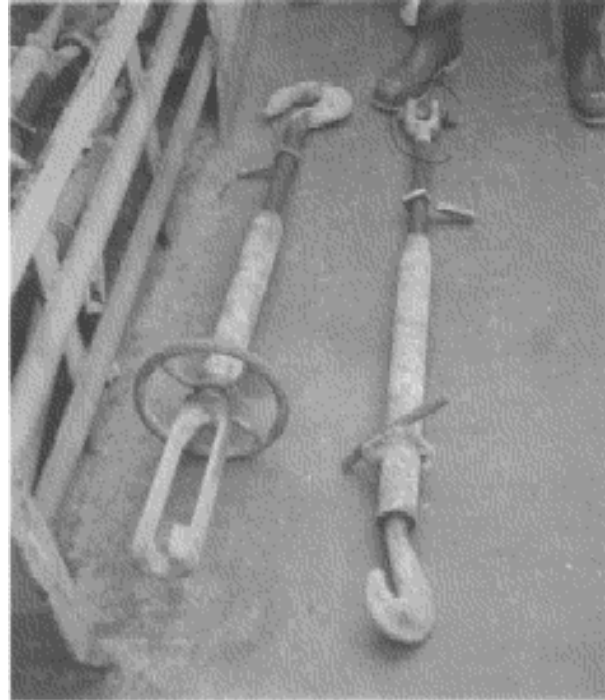
lashings, they result in a severe bend of about 75 degrees and a seriously unbalanced strain on the wire, effectively reducing its cross-section. The bearing surface is also significantly reduced, presenting the potential for a slackened wire to jump out of the hook. The Board observed both types of turnbuckles in use on the #3 hatch, and photos showed similar installation on the #4 hatch in Baltimore shortly after the casualty.

Two types of turnbuckles onboard SANTA CLARA I
(cylindrical claw on left; rigid hook on right)

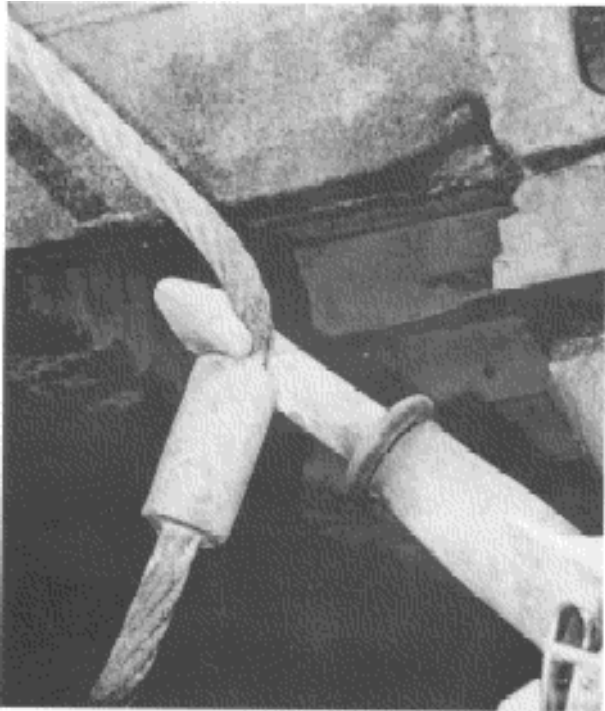
Hook-type turnbuckle with strain on lashing

The strength reduction resulting from the mismatch is compounded by the actual damage already evident in the lashings. The lashing in the photo, for example, was corroded in way of the bend, with broken strands on the outside of the bend, the point of greatest load.

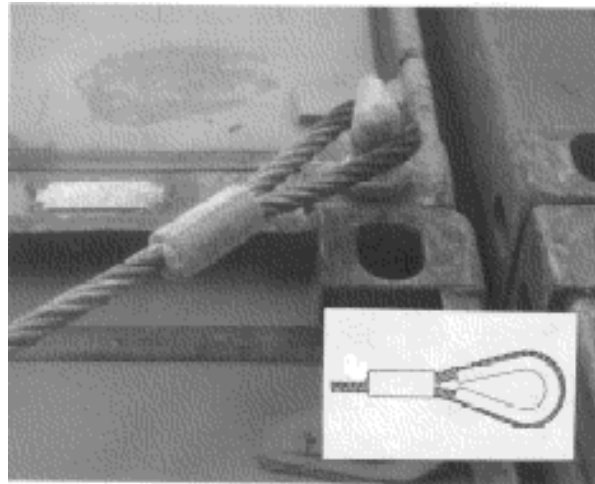
Actual damage was again evident, as the Board found several loose lashings on deck showing permanent deformation and broken strands at the unreinforced eye.

Unreinforced eye over penguin hook
(Inset - with thimble)

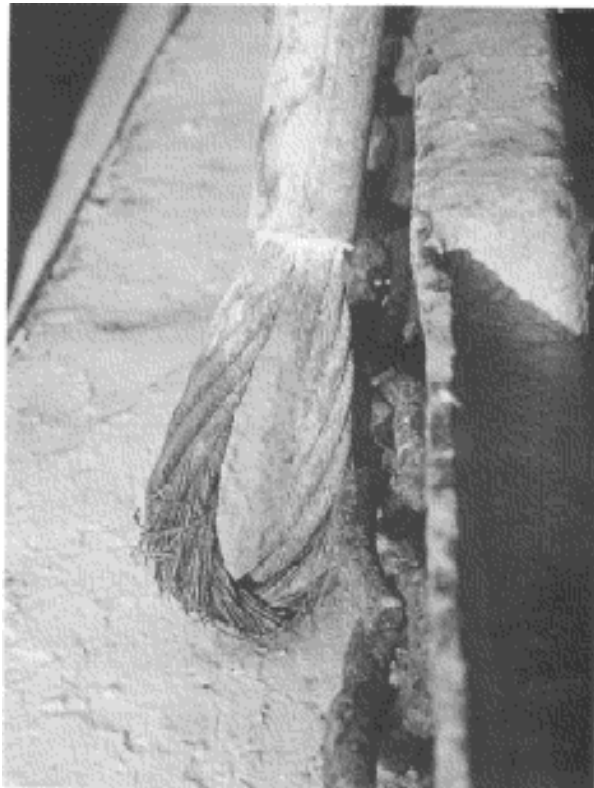
Damaged eye

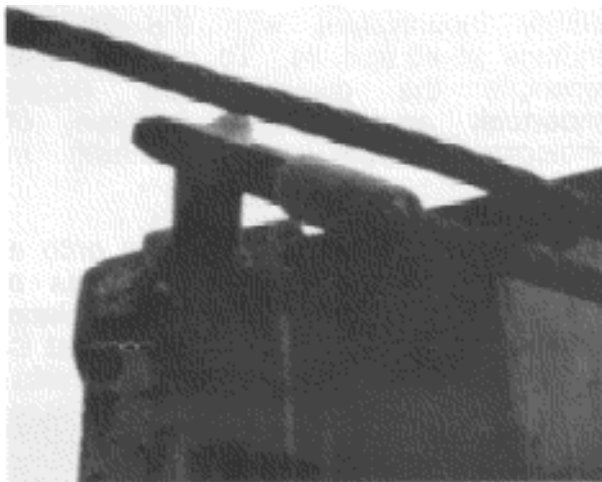
By design, penguin hooks are fitted into the container corner castings simply by turning them in place. The degree of turn is part of the problem; the flexibility of the lashings is the other part. As installed aboard the SANTA CLARA 1, some hooks were observed to be turned at a substantial angle to the axis of the lashing, and in at least one case the lashing was also partially twisted, riding up on the projected hook and taking a bite a little above the elbow of the hook. With cyclic tensioning and slackening of the lashing, it's easy to conceive that it might either incrementally turn the penguin hooks or just fall off.

Twisted eye/hook connection

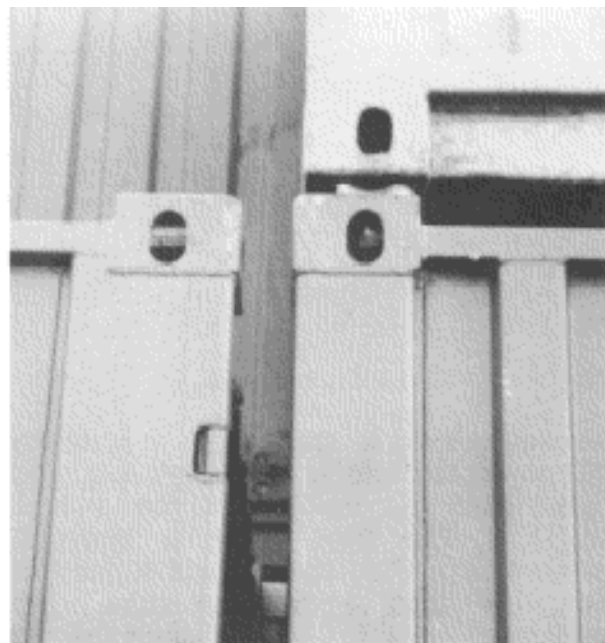
An inherent weakness in this configuration is the stowage of 20-foot containers in the 40-foot spaces on both outboard sides. It leaves no room for lashing the abutting ends of the containers, which are separated by only about 3 inches. At the base they're resting on cones only. Essentially these containers are secured at one end only.

Typical spacing for 20' containers in 40' space

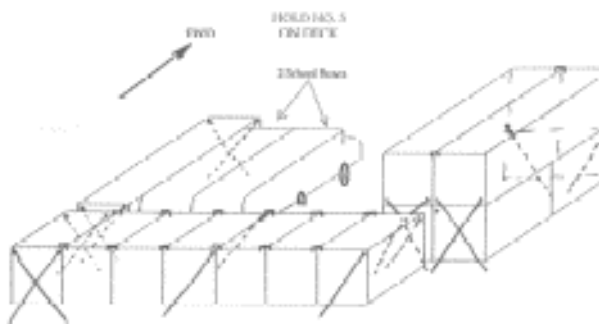
A study of the lashing at the #3 hatch was most revealing. In Charleston, the containers on #3 were found fully-bridged but only partially-lashed. Photos from Baltimore show the exact same configuration, and none of the cargo had been worked or scheduled between the two ports.

Lashings on #3 hatch

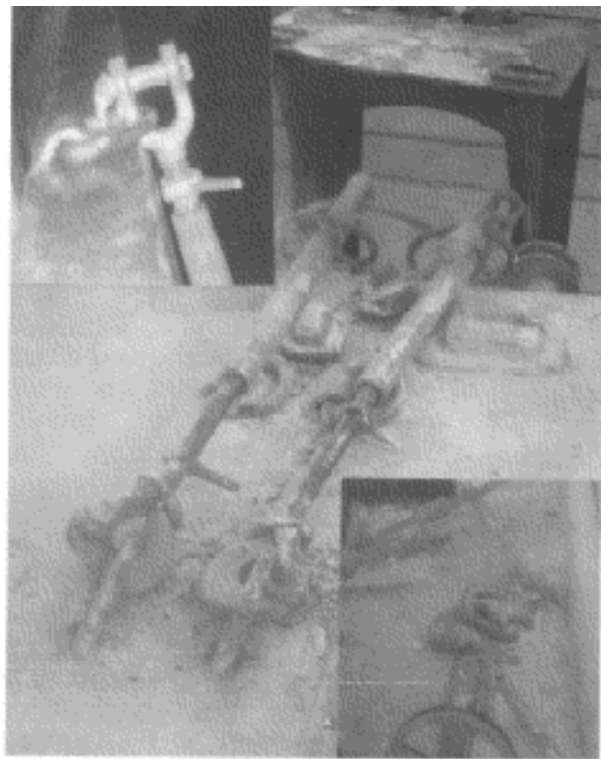
A variety of turnbuckles remaining attached

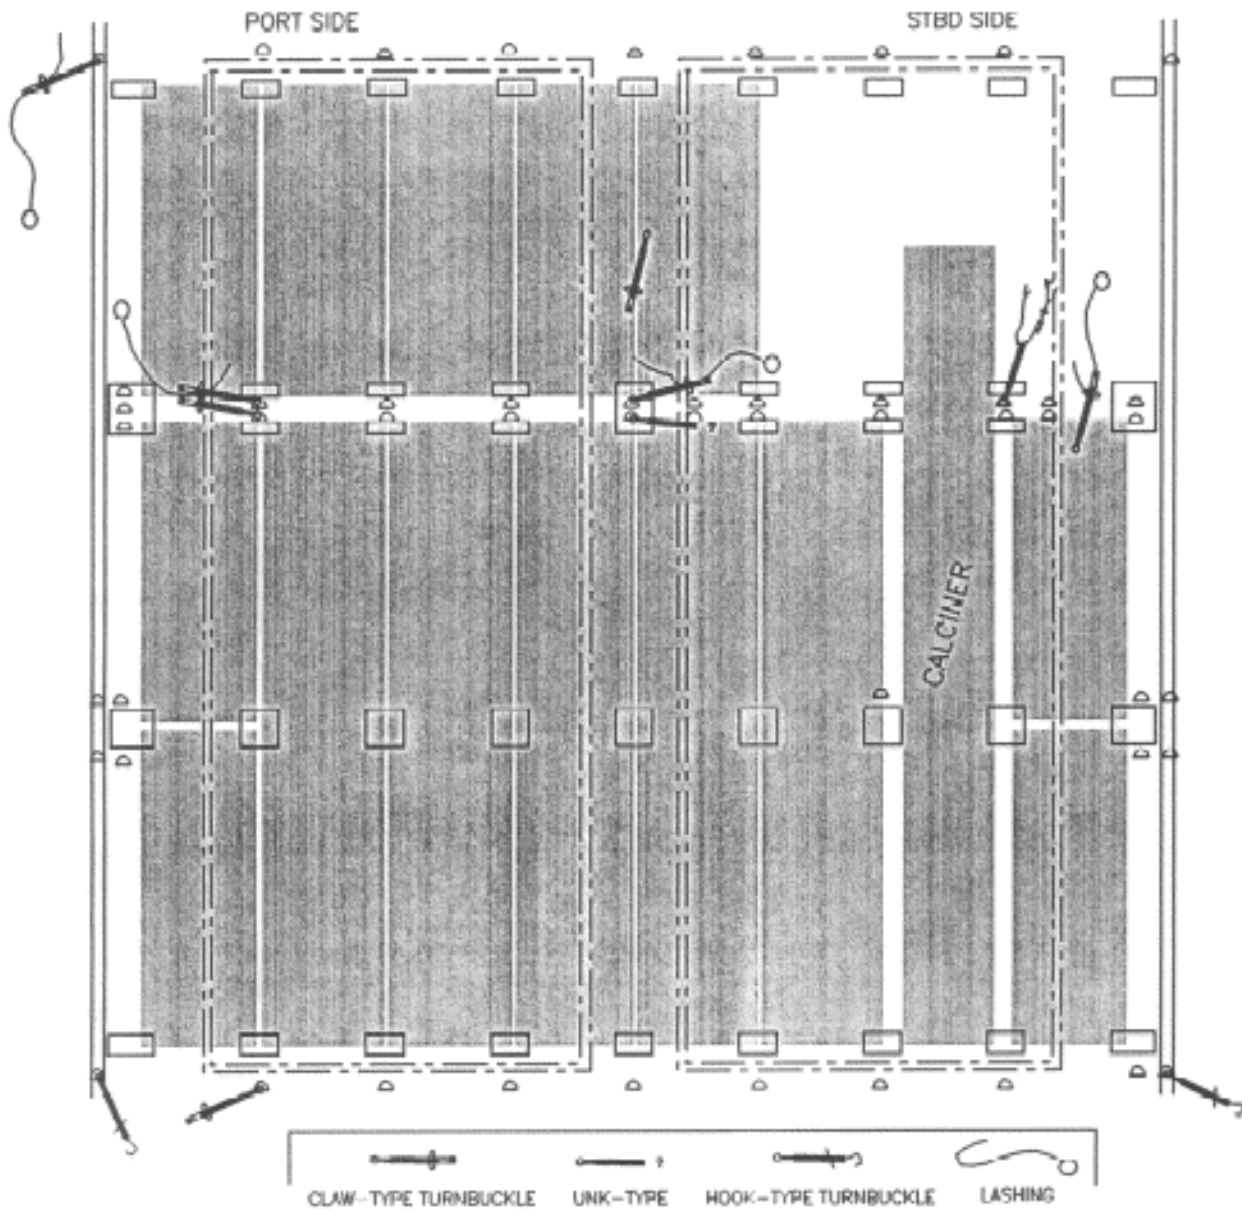
Mapping details from the photos onto a plan view of the #2 hatch reveals a distinguishing pattern - the left-in-place turnbuckles appear to be concentrated in way of exterior container stacks. It also

Plan View of #2 hatch upon arrival in Baltimore
(shaded areas show original stowage of containers and calciner)

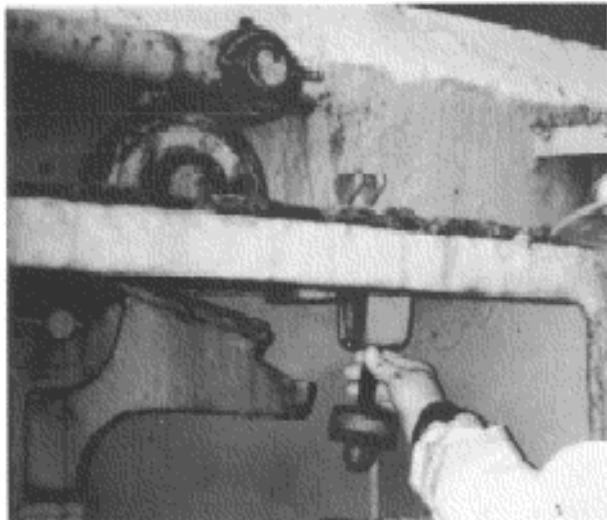
(Incidentally, the Board notes that it is common practice to leave hatch covers unsecured during coastwise voyages, and that classification societies don't require that hatch covers be dogged.)

Unsecured dogs on the hatch covers

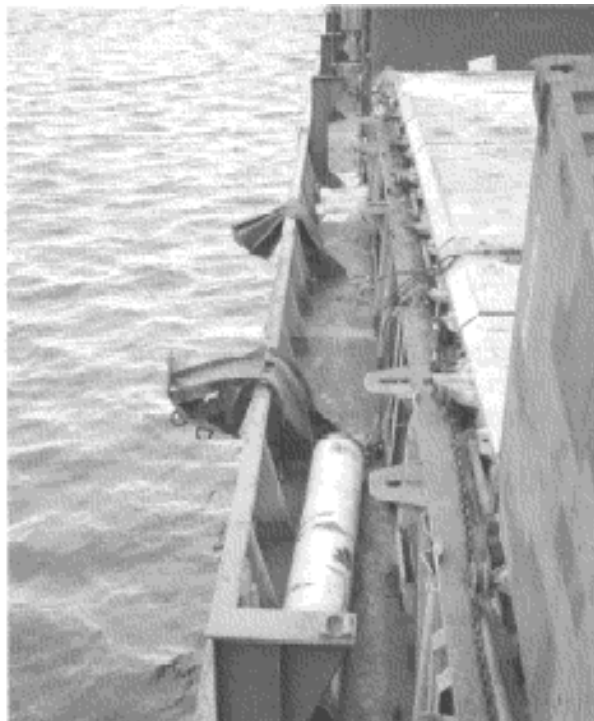
The deck pedestals were the subject of much attention during the few weeks after the casualty, since two adjacent pedestals in way of the #2 hatch had failed catastrophically. Both were bent completely over the bulwark, by 100-120° from their original upright position. Several others in way of #2 showed limited signs of compression damage at the base as well.

Failed deck pedestals
(starboard side locking aft)

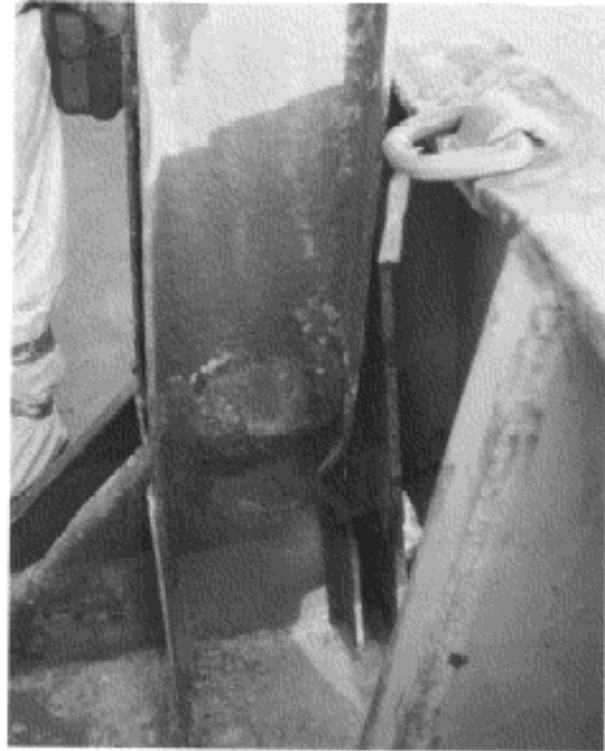
5) Compression damage at the bottom of the various pedestals was at the outboard flange of the beam. Unless the inboard side of the container first broke free from the cones in deck sockets on the hatch cover, all of the transverse and normal forces would have been expressed in a tipping action, downward on the far *inboard* edge of the pedestal. Any compression failure would be expected on the inboard flange, not the outboard one.

Compression damage at bottom of pedestal

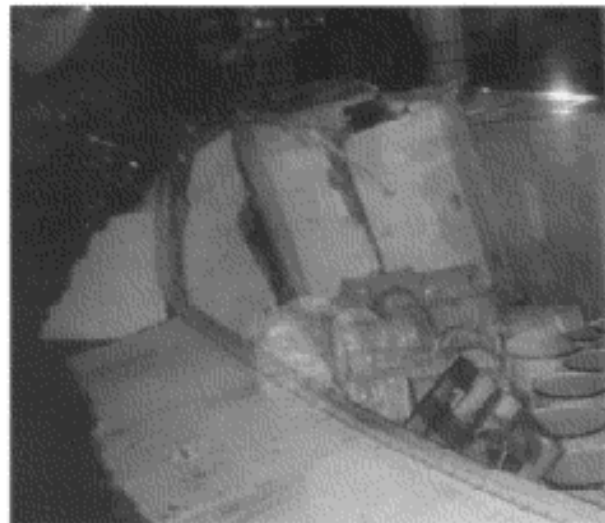
The FRP container in particular drew attention to the construction and maintenance standards. One of the four containers remaining aboard at the #2 hatch, it was the only one which broke apart, splitting at the top, sides, and end walls.

FRP container destroyed during storm

Recommendation 4: Examine the failure and repair history for FRP containers to determine their suitability for continued **unrestricted use**.

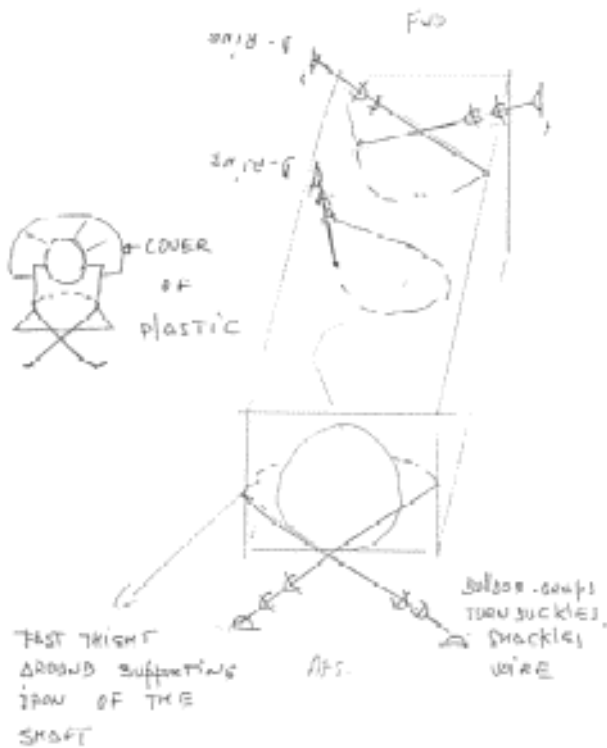
Lashing of calciner as drawn by Chief Mate
