**MARINE CASUALTY REPORT**

**M/V SCANDINAVIAN SEA,  
BAHAMIAN REGISTRY O.N. 339313,  
FIRE IN THE ATLANTIC OCEAN 9 MILES  
SOUTHEAST OF PORT CANAVERAL, FLORIDA  
ON 9 MARCH 1984 WITH NO LOSS OF LIFE**

**Marine Board of Investigation Report**

**REPORT NO. USCG 16732/0002HQS 84**

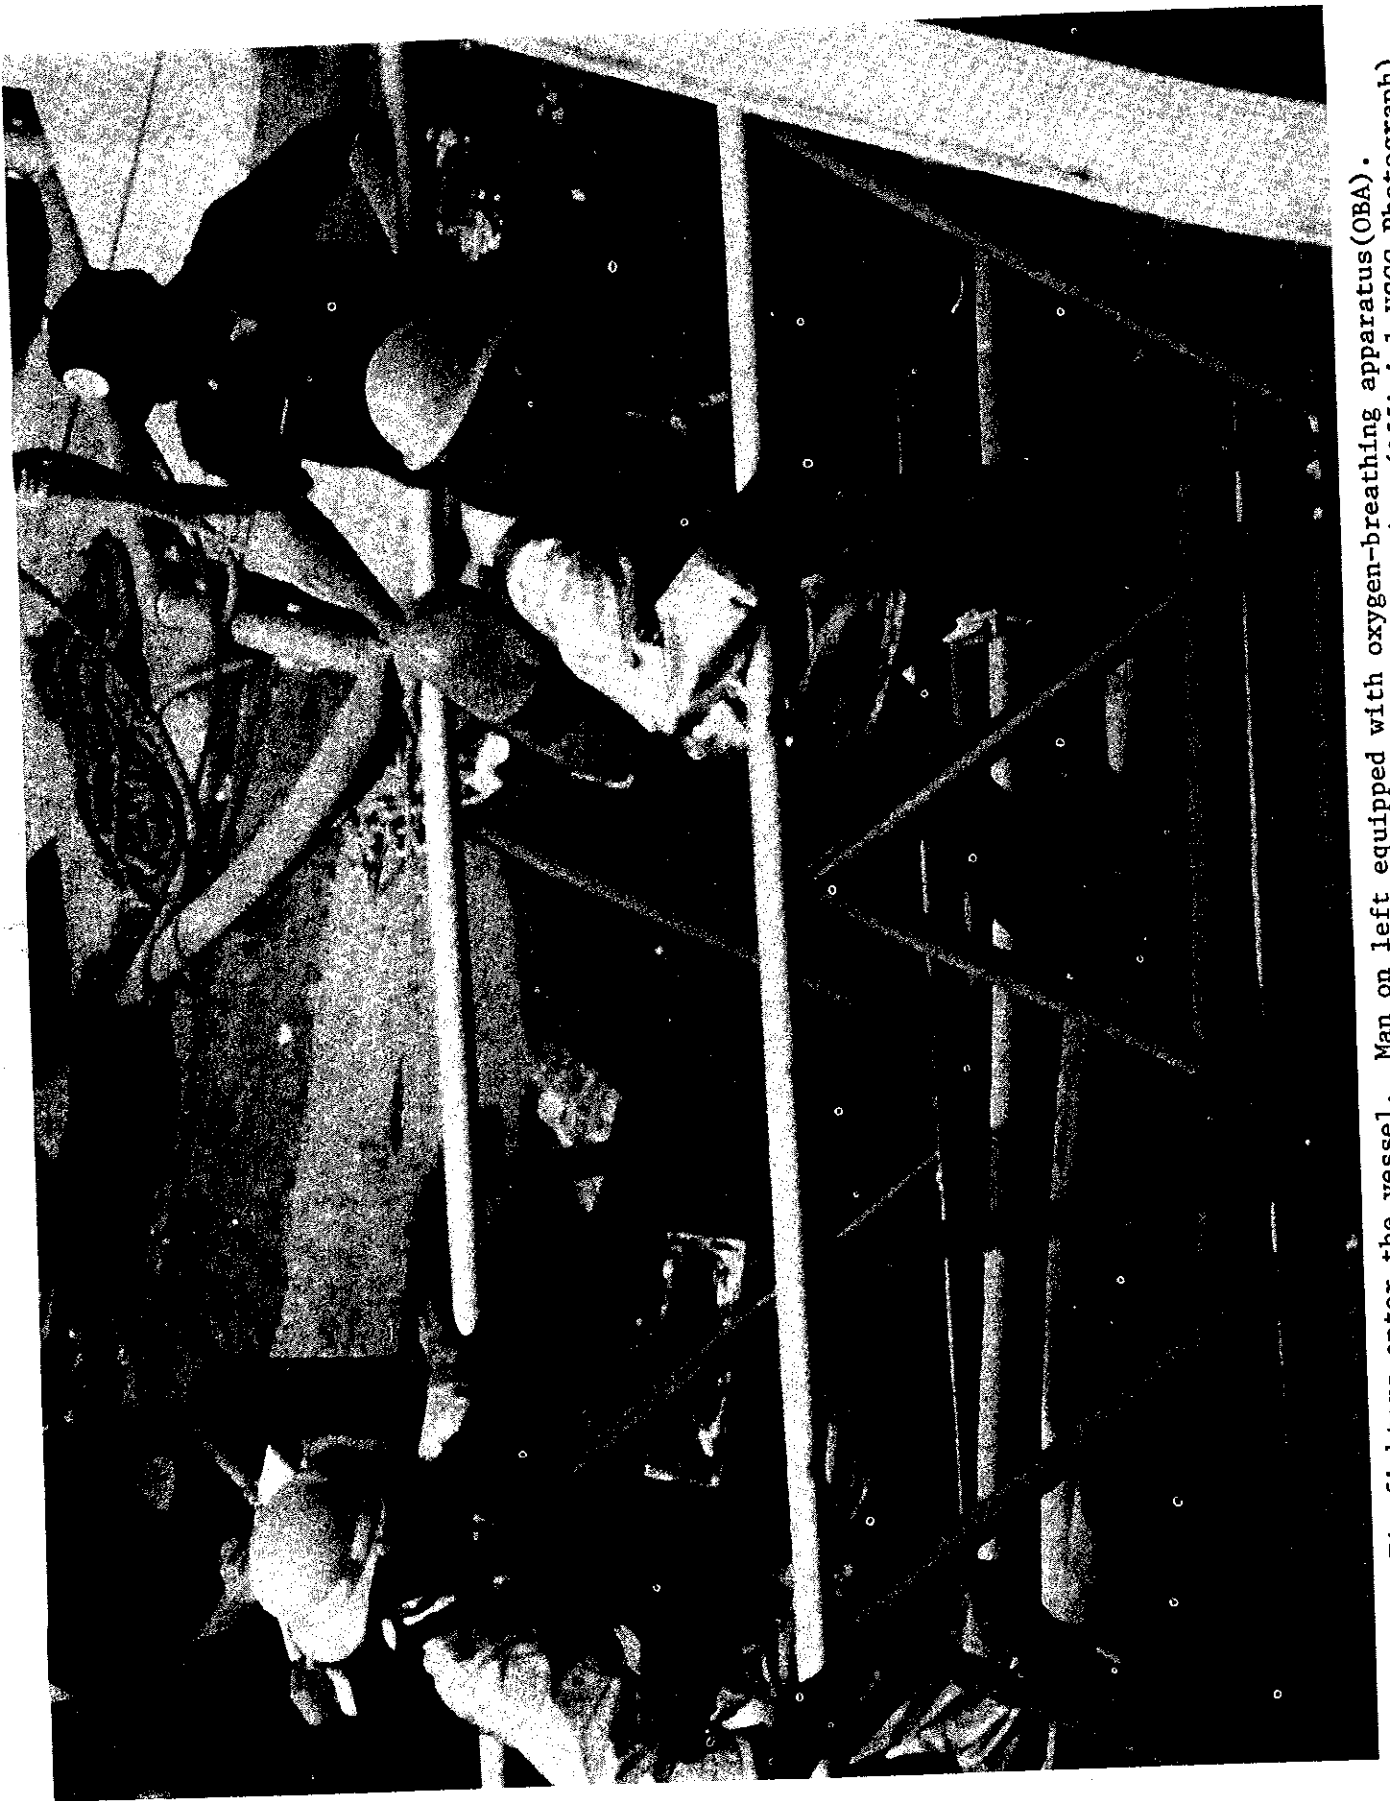
Firefighters enter the vessel. Man on left equipped with oxygen-breathing apparatus (OBA).  
Man on right equipped with self-contained breathing apparatus (SCBA). (Official USCG Photograph)
