**SS C. V. SEA WITCH - SS ESSO BRUSSELS (BELGIUM);
COLLISION AND FIRE IN NEW YORK HARBOR
ON 2 JUNE 1973 WITH LOSS OF LIFE**

**U.S. COAST GUARD
MARINE BOARD OF INVESTIGATION REPORT
AND COMMANDANT'S ACTION**

**REPORT NO. USCG/NTSB - MAR-75-6
RELEASED 2 MAR 1976**

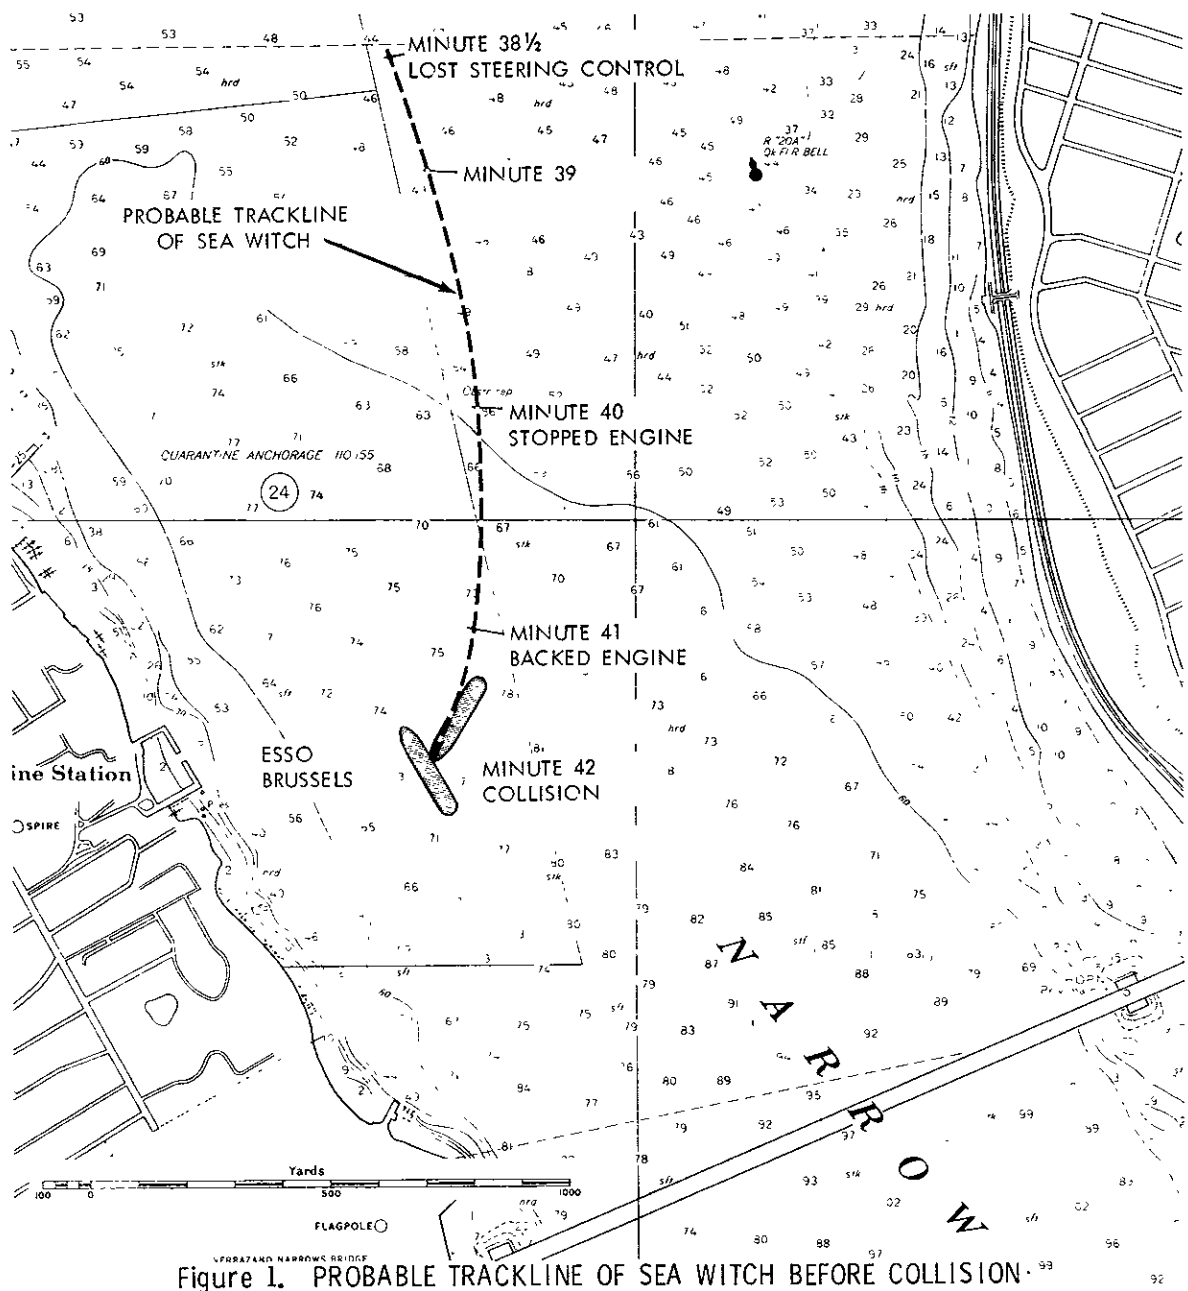
Figure 1. PROBABLE TRACKLINE OF SEA WITCH BEFORE COLLISION.

The relative bearing of the ESSO BRUSSELS' bridge remained constant about 19° off the starboard bow almost until minute 41. Although any constant relative bearing less than 90° on a stationary object will result in a spiral path that closes in on that object, the pilot and master on the bridge of the SEA WITCH probably believed that as long as the ship's bow did not point any closer to the tankship, the situation was not serious. It was not until a few seconds before minute 41 that the SEA WITCH's centerline crossed the tankship's stern. At minute 41, when the SEA WITCH was about $1\frac{1}{2}$ ship lengths from the tankship, the pilot backed the SEA WITCH's engine.

Evidently, during about the first $1\frac{1}{2}$ minutes after the loss of steering control, the indications of an impending collision developed slowly; when the indications began to develop rapidly, there was insufficient separation between the ships to avoid the collision.

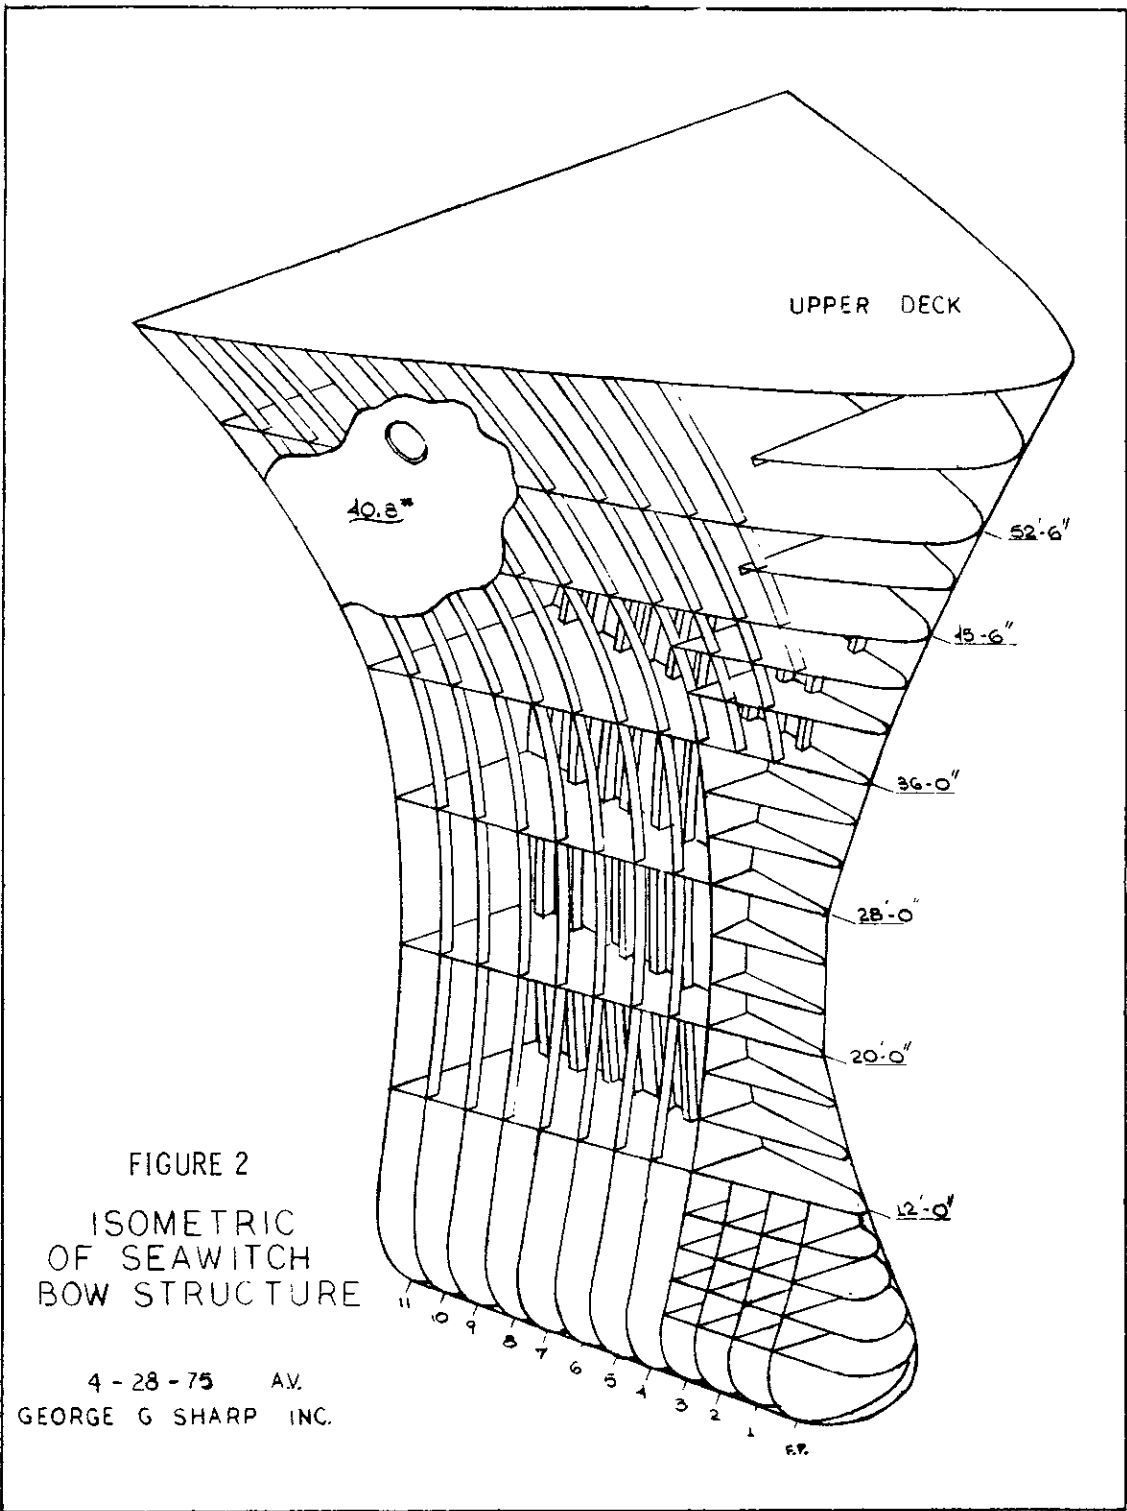
The SEA WITCH penetrated about 40 feet into the hull of the ESSO BRUSSELS while suffering only about 20 feet of damage to its own bow. If the bow of the SEA WITCH had not penetrated the hull of the ESSO BRUSSELS, there would have been no fire, pollution, or loss of life.

Calculations of the axial strength of the SEA WITCH's bow showed that it could exert a load of 5,000 tons at various stages of crushing before the bow collapses further. This load is about 2.5 times the maximum side resistance generated by a typical tankship of this size ^{1/} when its side shell ruptures. A nonpenetrating bow for the SEA WITCH, therefore, would require a reduction in its crippling strength of more than 2.5 times. A feasibility analysis was made to determine if this could be achieved, given the following practical requirements:

(See Figure 2 for an isometric view of the original SEA WITCH's bow design and Figure 3 for the design of the nonpenetrating bow. To increase clarity, some of the redesigned features, such as the increased stem radius and the prebuckled decks, are not shown in Figure 3.)
