**SS SILVER DOVE; CARGO SHIFT AND SINKING
IN THE NORTH PACIFIC OCEAN ON 2 APRIL 1973
WITHOUT LOSS OF LIFE**

**U.S. COAST GUARD
MARINE BOARD OF INVESTIGATION REPORT
AND COMMANDANT'S ACTION**

REPORT NO. USCG/NTSB - MAR-76-1

RELEASED 28 NOV 1976

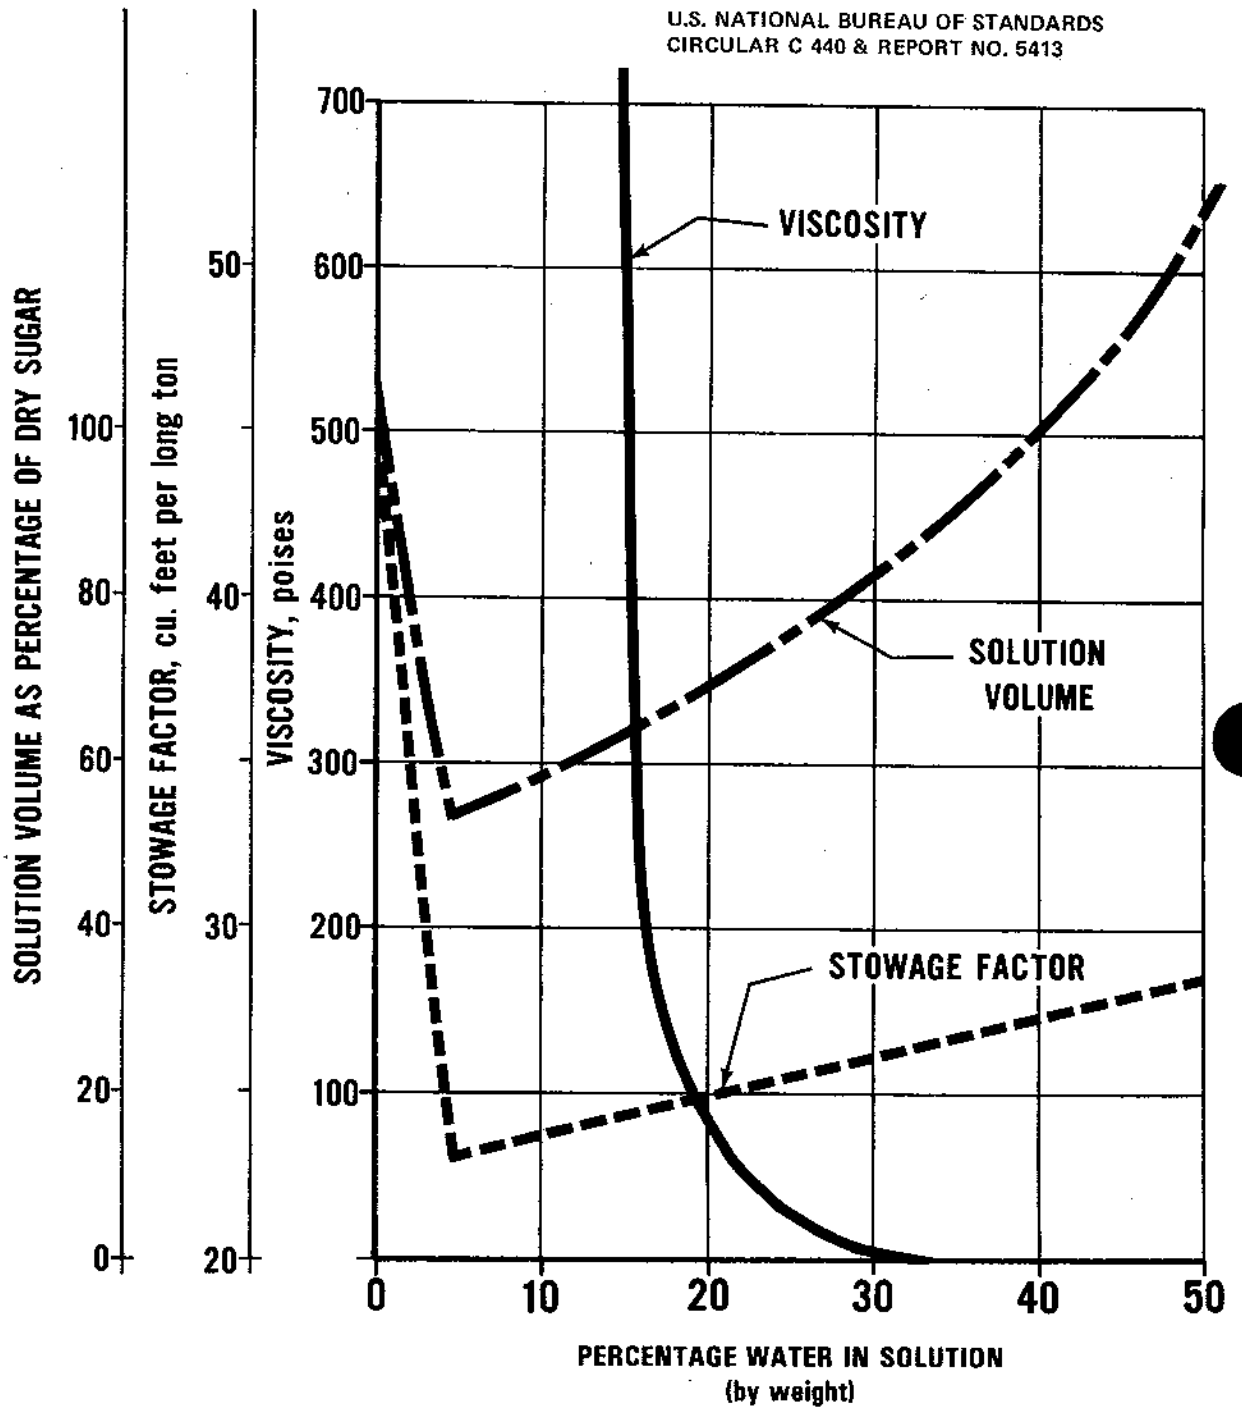
FIGURE 1. CHARACTERISTICS OF SUGAR SOLUTIONS

Raw sugar can also develop sufficient strength to support itself over regions where voids or cavities are created by the addition of water. Because of this, raw sugar in the SILVER DOVE's lower 'tween space and above may have remained above the hatch beams instead of feeding into the void that was created when sugar in the lower hold contracted as water was added. (See figure 2.)

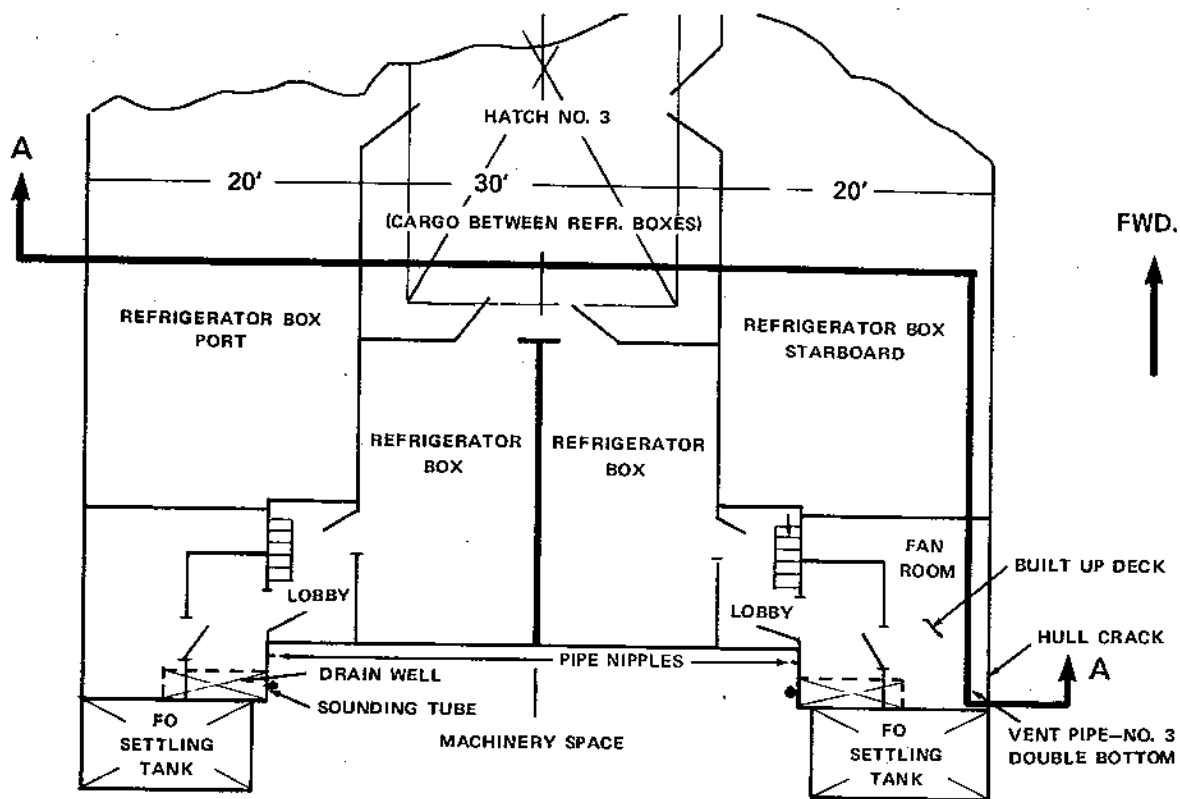
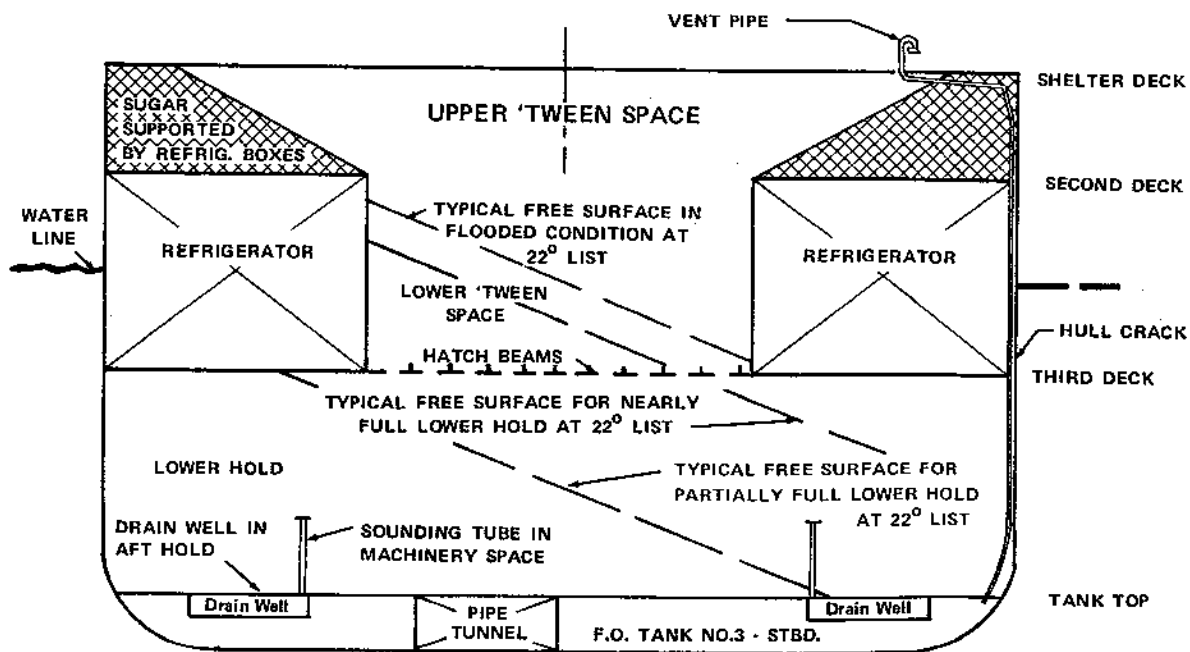
FIGURE 2. CARGO HOLD NO. 3

The results of this infiltration process were observed on the SILVER DOVE. When the cap was removed from the starboard pipe nipple before the ship arrived in Guam, a stream of granular sugar, followed by brown water, flowed out. This nipple was located in a bulkhead in the lower hold near the wet sugar. After the ship departed Guam, no water flowed out because water was not entering as quickly since the crack had been temporarily sealed and because the list to port induced in Guam to facilitate repairs had allowed the water already in the hold to diffuse into the sugar. However, since the water was entering on the starboard side, the amount of water in the sugar farther from the starboard side decreased, as confirmed by samples taken from a port pipe nipple.

The existence of a homogeneous solution of water and sugar was not a likely, or necessary, condition for a cargo shift. It was only necessary for the sugar-water solution on the starboard side to flow into a void on the port side. A large void could have developed on the port side if the dry sugar contracted into a concentrated solution containing just 10 percent water. A solution containing 20 percent water on the starboard side would have become sufficiently liquid to flow into the port void as the ship listed. (A heterogeneous solution which contained about 10 percent water on the port side and 20 percent water on the starboard side would have been a likely distribution of water considering the water was infiltrating from the starboard side;

this distribution would have required the infiltration of less than 315 LT of water. More than 315 LT of water could have leaked through the crack before the SILVER DOVE listed 22°.)

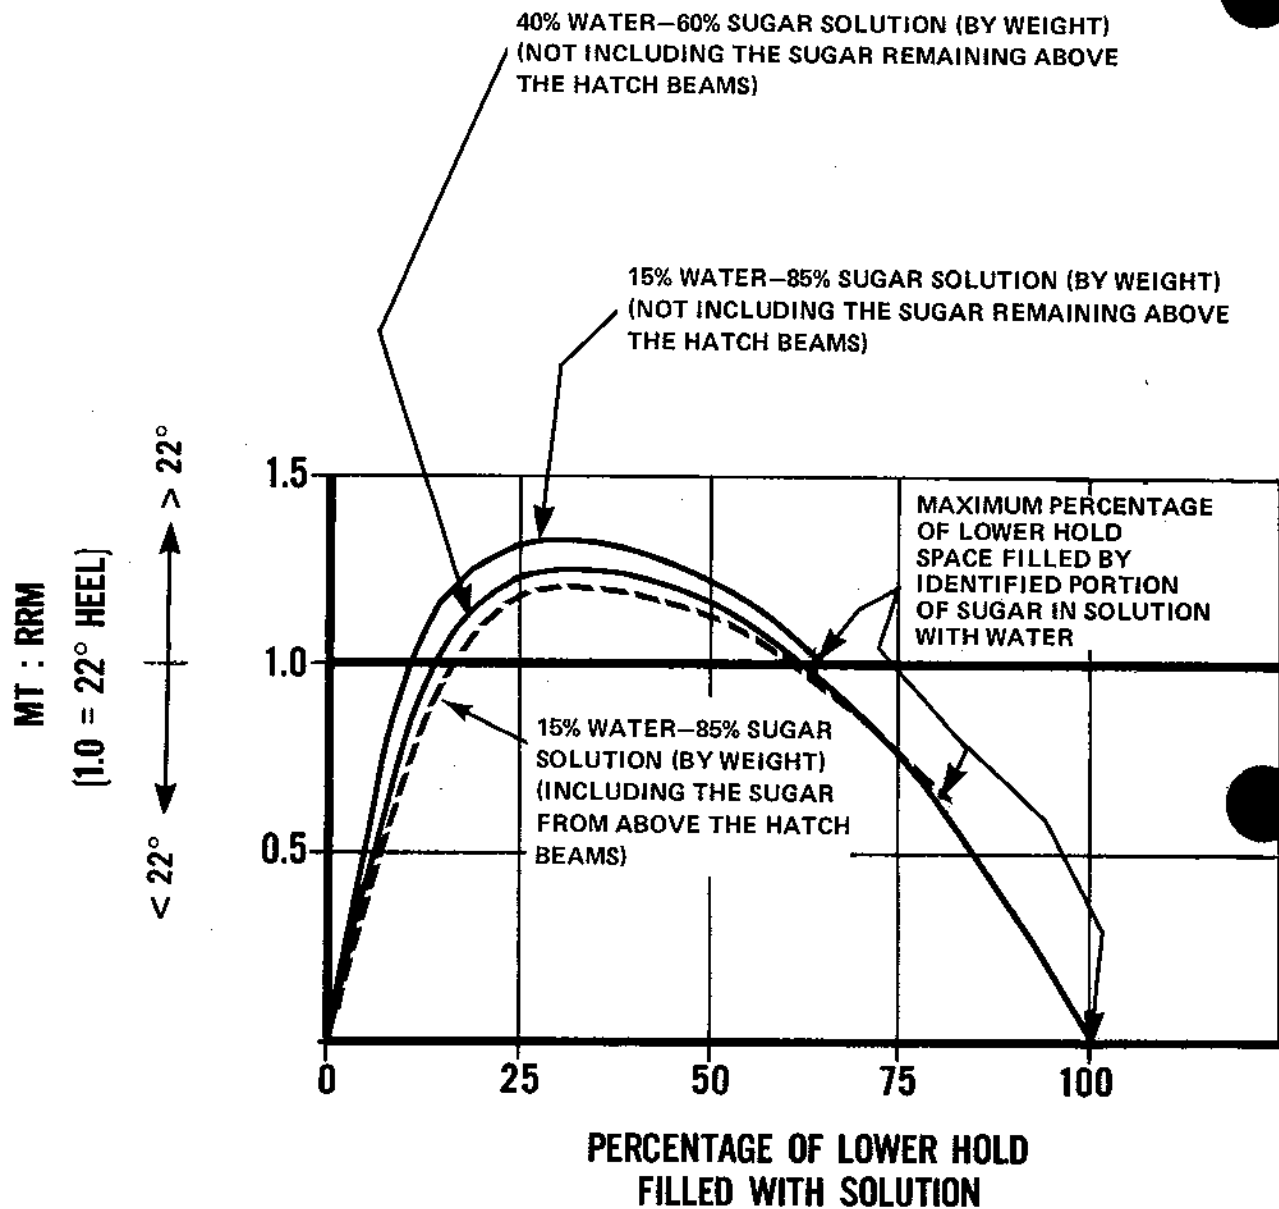
FIGURE 3. RANGE OF CARGO CONDITIONS NECESSARY TO CAUSE 22° LIST

For each sugar-water solution ratio, there is a maximum volume of solution that can be formed in the hold; it is determined from the dry sugar volume and the ratio of water and raw sugar in solution. (See figure 1.) The maximum volume of a solution containing 15 percent water and only the sugar in the lower hold would occupy about 65 percent of the lower hold space. A solution of 40 percent water and only the sugar from the lower hold would require slightly more space than that available in the lower hold. If the sugar above the hatch beams as well as that in the lower hold mixed with water to form a solution that was 15 percent water and 85 percent sugar, it would occupy about 81 percent of the lower hold space. (See figure 3.)

For the ratios of water and sugar considered, the 22° list of the SILVER DOVE would have developed when the sugar-water solution filled about 65 percent of the lower hold space. Greater quantities of solution would not have provided a sufficient void for a cargo shift to cause a 22° angle of heel. If the solution filled between 10 and 65 percent of the lower hold space, the angle of heel would have exceeded 22°. Quantities of solution in less than 10 percent of the lower hold space would not have weighed enough to cause the SILVER DOVE to heel 22°.

Pumping the solution overboard would only have increased the SILVER DOVE's angle of heel until the solution remaining occupied less than 10 percent of the lower hold volume. Not only would it have been necessary to pump at least 1,800 LT of solution overboard to make this reduction, but the ship's heel angle would have had to increase to some maximum angle and then decrease again. Since a steadily increasing list to port was observed, the quantity of water and sugar which caused the 22° angle of heel had to have occupied nearly 65 percent of the lower hold volume. Without pumping a considerable amount of sugar and water solution overboard, the 22° angle of heel would have been caused by mixing of the sugar in the lower hold in a solution with between 15 and 20 percent water.
