UNITED STATES COAST GUARD

(T/V VENTURA - F/V LYNN - 2-1 24)

Subj: Marine Board of Investigation; steam tanker VENTURA and motor fishing vessel LYNN, collision Boston Outer Harbor, 28 November 1951, with loss of life

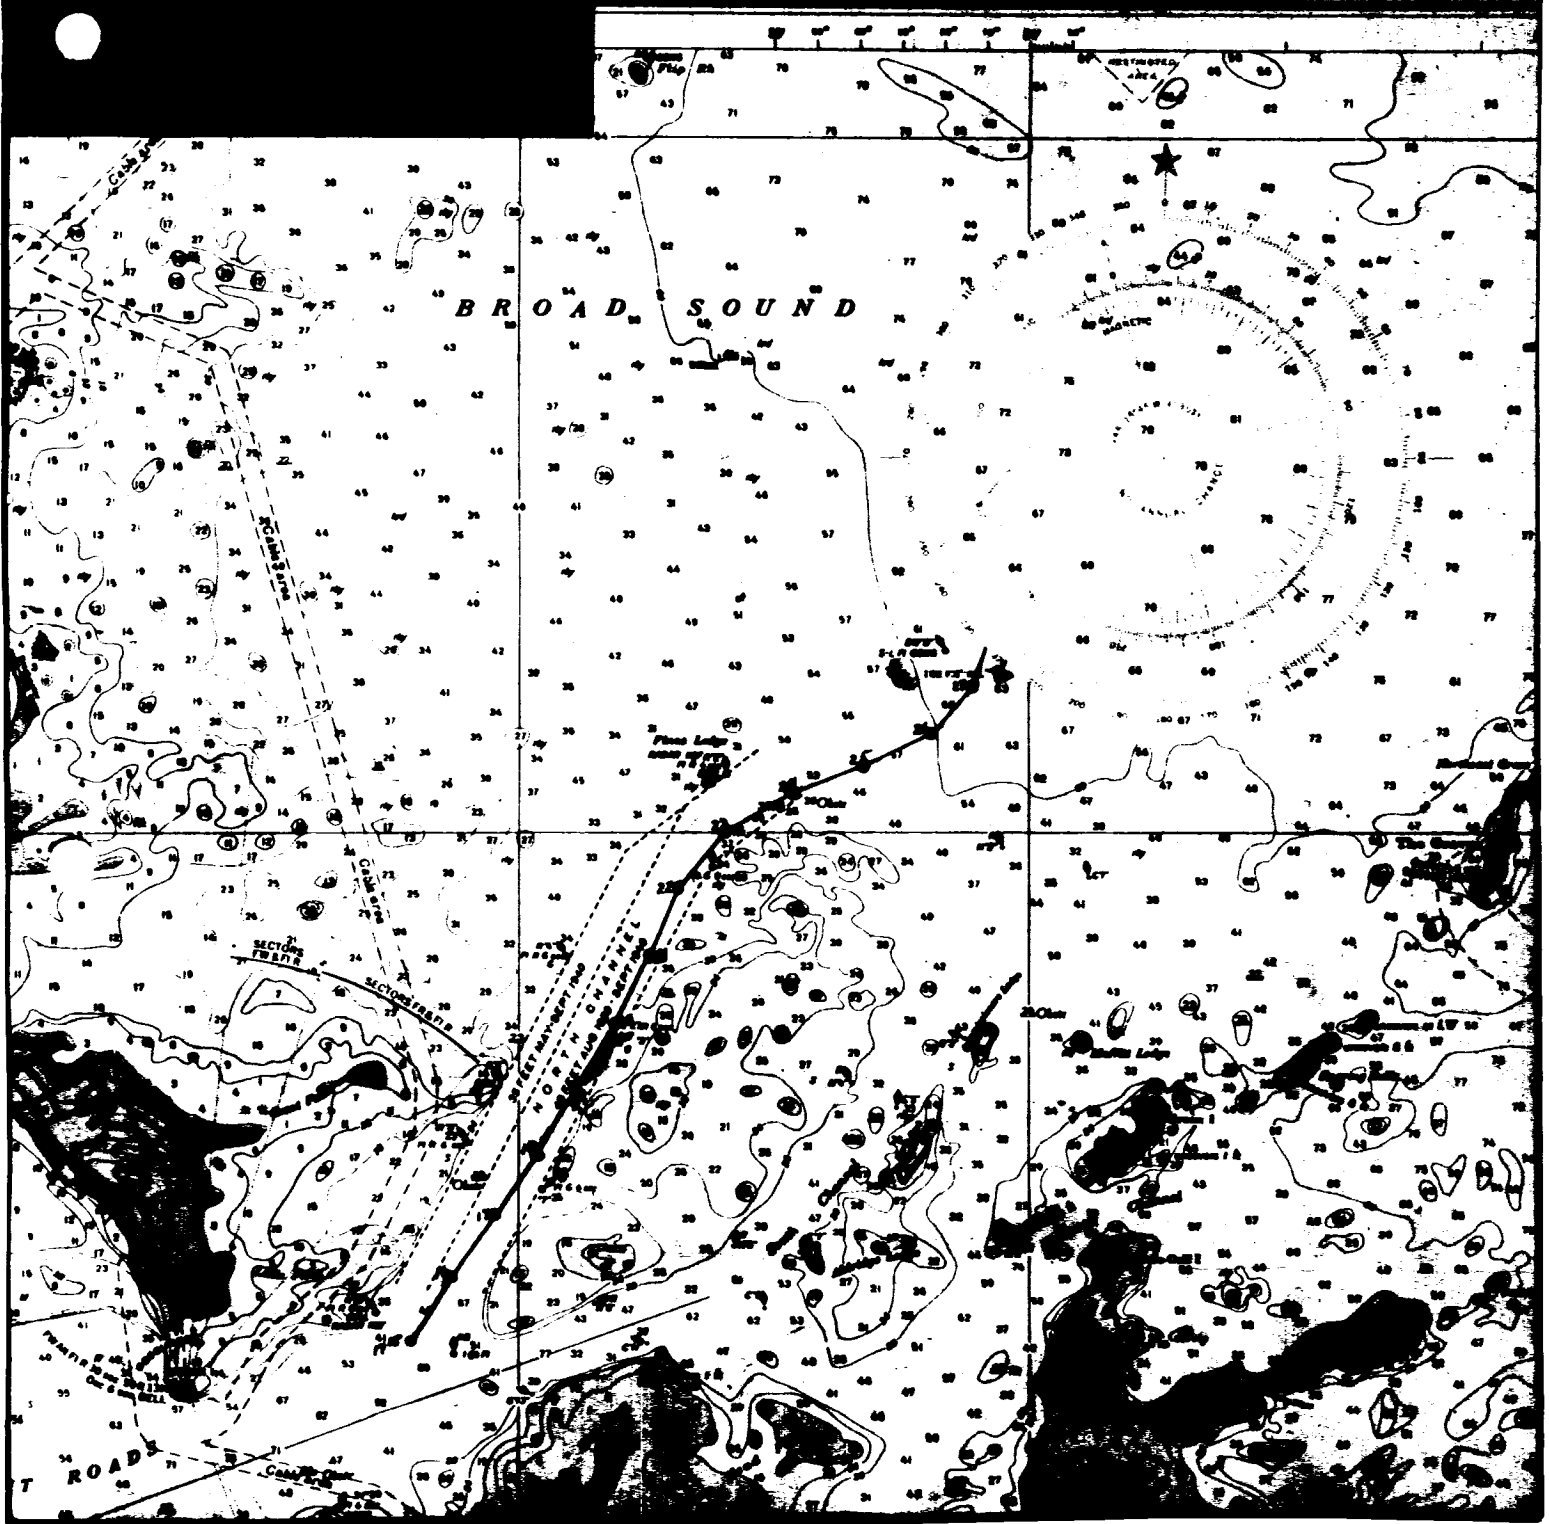
"49. That the course recorder record of the VENTURA for November 28, 1951 (Exhibit 15), is an accurate record of the headings of the VENTURA for the period from 3:04 p.m. until midnight on that date and that the track of the VENTURA from the time she entered North Channel up to the point of collision, as reconstructed from the data in the course recorder record and engine room bell book, is shown by the following plot:

"4. The weight of evidence strongly supports the version of the collision given by witnesses from the VENTURA. The course recorder record of the VENTURA (Exhibit 15) affords an automatically recorded and unbiased record of the headings of that vessel from 3:04 p.m. till midnight on the day of the collision. The heading recorded from 3:04 p.m. until the tugs came alongside at 3:25 p.m. agrees with the charted direction of the Union Oil Products Company Dock and the headings recorded from 3:56 p.m. to 4:27 p.m. agree with the headings necessitated by the narrow confines of the channel in the Chelsea River. The geographical layout of the channels traversed is such that a reconstruction of the VENTURA's track based on data in the course recorder record and engine room bell book can readily be oriented to the proper position on the chart and affords

a clear picture of the movements of the vessel from the time it left the dock at Revere until the collision took place. The validity of this reconstruction is enhanced by the fact that the current was at approximately slack water and there was little wind. The reconstructed plot agrees well with the position of the hull of the LYNN when located by divers on the day following the collision.

"5. The pilot of the VENTURA testified that he traversed North Channel on course 029° true and subsequently came right to course 066° true. The reconstruction of the VENTURA's track shows that her heading varied between 020° true and 036° true in running out North Channel, with the average course made good from 5:15 p.m. to 5:22 p.m. being 031° true and that she then came right very slowly until shortly before 5:25. From 5:23 to 5:24 her heading increased from 053° true to 065° true with the average for the minute being 059° true, and from 5:24 to 5:25 her heading ranged from 065° true to 073° true and back to 072° true with the average for the minute being 070° true. From 5:25 until after the collision, the VENTURA's heading was changing continuously to the left and at the moment of impact had decreased to about 30° true.
