MARINE CASUALTY REPORT

SS WILLIAM T. STEELE; DEATH OF THREE SHIPS OFFICERS
AT GUAYANILLA, PUERTO RICO ON 18 NOVEMBER 1972

REPORT NO. USCG/NTSB - MAR-74-6
RELEASED 26 SEP 1974

SS WILLIAM T. STEELE
Guayanilla, Puerto Rico
18 November 1972

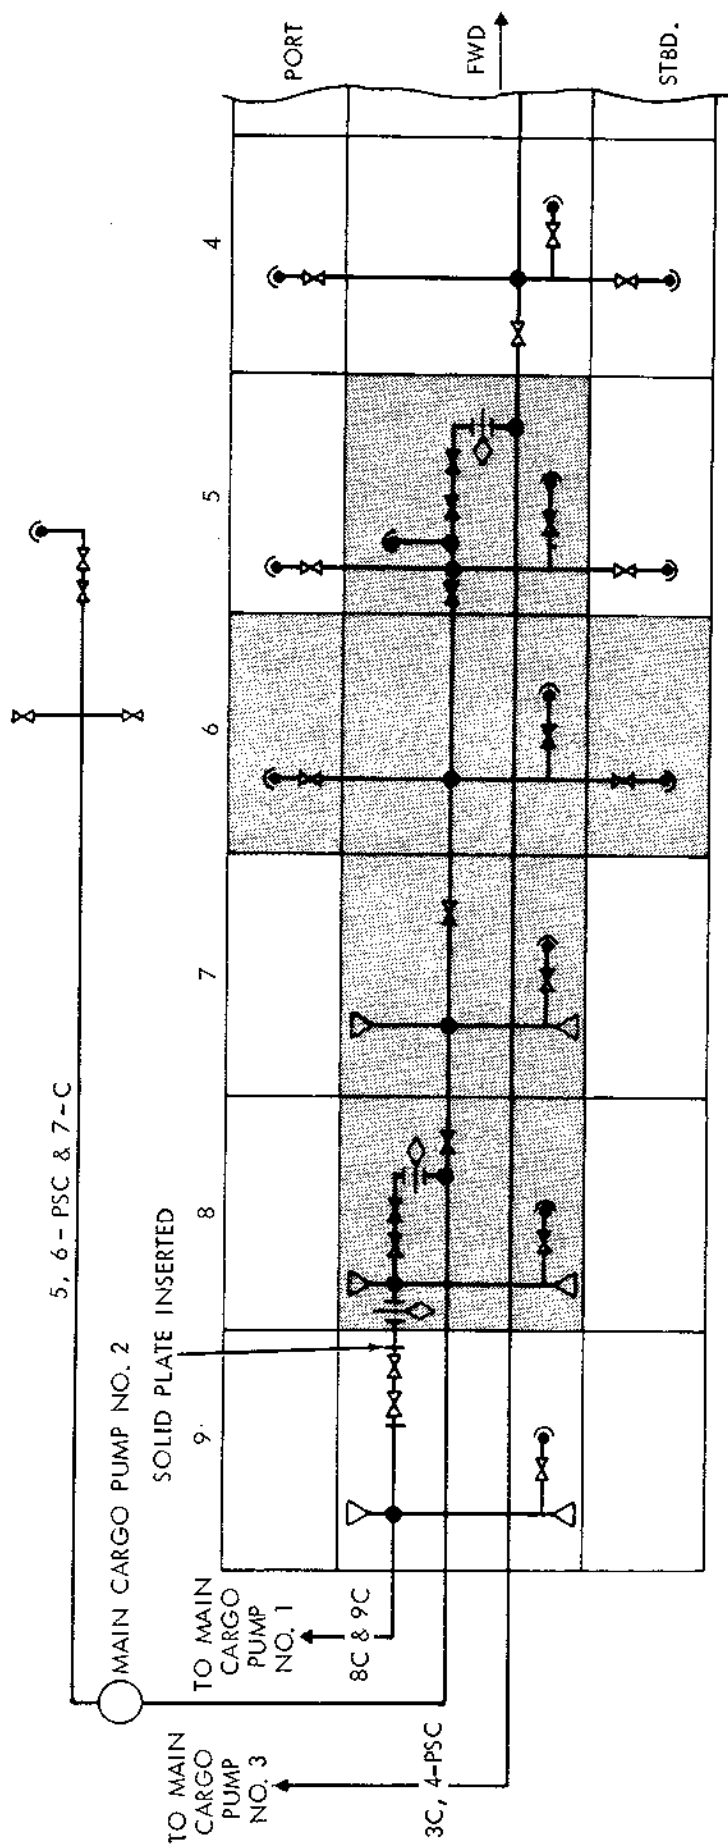
Figure 1. DIAGRAM OF CARGO PIPING SYSTEM FOR TANKS 4-PSC, 5-PSC, 6-PSC, 7-C, 8-C & 9-C

Improper loading of cargo. Instead of distributing a cargo-loading plan to the crew or providing a checklist to assure that all valves and blinds were configured as planned, the chief mate issued verbal orders to the pumpman which specified only the setting of certain conventional and line blind valves. Because of his limited experience on the STEELE, the heavy workload, and the insufficient information regarding the desired lineup of cargo tanks to receive benzene, it is unlikely that the pumpman would have realized any omission in the chief mate's orders. The chief mate, on the other hand, without a checklist and probably fatigued from working more than 24 hours immediately before his death and from supervision of numerous tasks, was not prepared to supervise cargo loading adequately. These problems led to the oversight in not closing the line blind valve in the No. 8 center tank. (A diagram of the pertinent section of the cargo piping system, with shaded areas indicating the tanks originally intended to receive benzene is shown in Figure 1.)

Blinding the cargo line involved opening a flange to insert a plate in the pipeline carrying benzene. (An arrow points to this flange in Figure 1.) The two block valves in the No. 8 center tank, just forward of this flange, were closed. The Marine Board did not determine what precautions were taken to purge benzene from that section of pipeline. There could have been a considerable amount of benzene in the 12-inch-diameter pipe which would have leaked out once the flange was separated. Further, the two block valves were relied on to sustain without leakage the pressure head of benzene in the No. 8 center tank, which was partially loaded.

The chief mate decided to insert a plate between the flanges forward of the double block valves in the No. 9 center tank. In part, this decision was probably based on his prior success in similar blanking operations; insertion of plates between flanges was standard practice on the STEELE before the line blind valves were installed. In fact, the third mate testified that an experienced crewman using the proper shaped wedges could split the flanges, insert a blank, and secure the line without leaking more than 2 or 3 gallons of benzene. Thus, it appeared to be an accepted practice to allow benzene to leak into enclosed spaces where men were working.

Although benzene was leaking from the opened flanges, there were other possible sources of benzene vapor. The residual tank washings in the aft end of the tank may have contained benzene. The two block valves in the No. 8 center tank were not sufficiently tight to

prevent benzene from leaking through to the flanges. If the condition of these valves is indicative of the condition of remaining valves between the bulkhead and the suction opening in the No. 9 center tank, or if the remaining valves were left open, benzene could have been leaking through the cargo suction for more than an hour before the pumpman's entry into the tank. Since the cargo suction is in the aft section, where the residual tank washings are collected, the chief mate would have been exposed to benzene vapors from the time he entered the tank.
