MARINE CASUALTY REPORT

SS OMI YUKON, D.N. 5479 19

**EXPLOSIONS AND FIRE ON 28 OCTOBER 1986
IN THE PACIFIC OCEAN APPROXIMATELY
1000 MILES WEST OF HONOLULU, HAWAII
WITH MULTIPLE LOSS OF LIFE AND
PERSONNEL INJURIES**

Report No. USCG 16732/0002 HQS 88

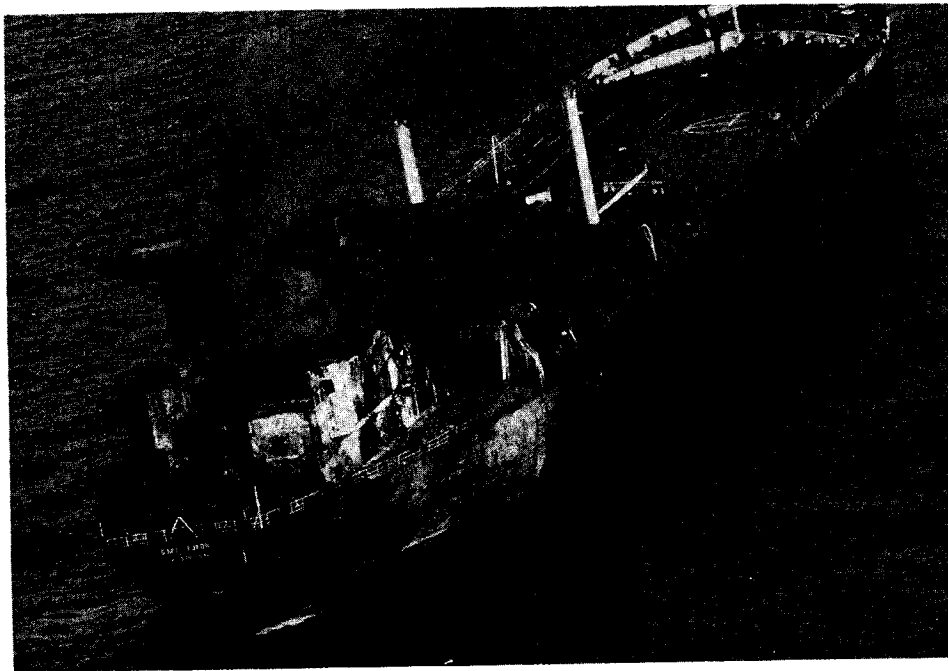
Photograph of the starboard side of the OMI YUKON taken on 29 October 1986 by LT. Kelly, USCG, C-130 pilot.

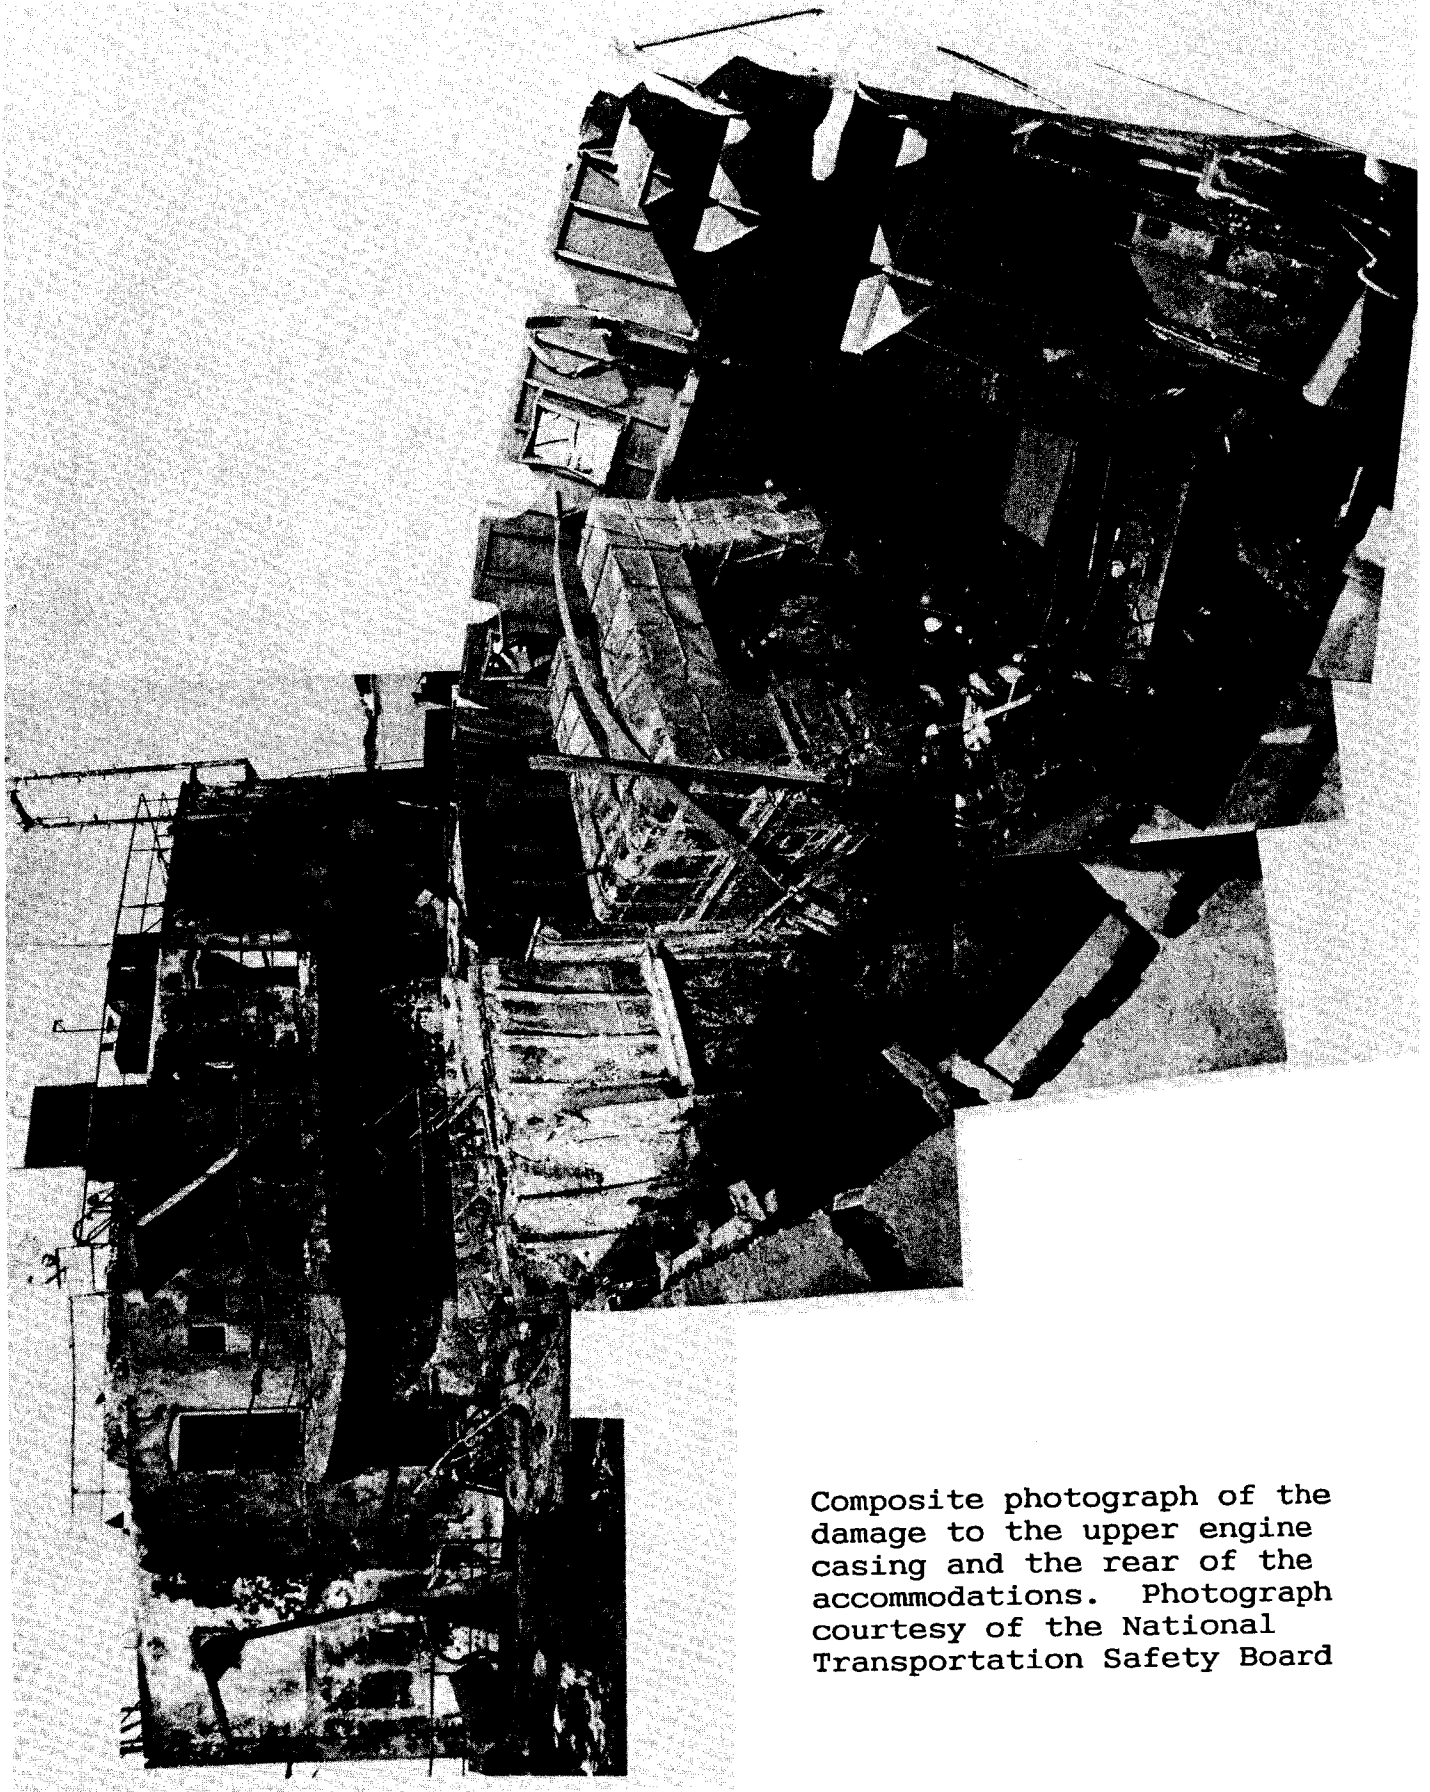
Composite photograph of the damage to the upper engine casing and the rear of the accommodations. Photograph courtesy of the National Transportation Safety Board

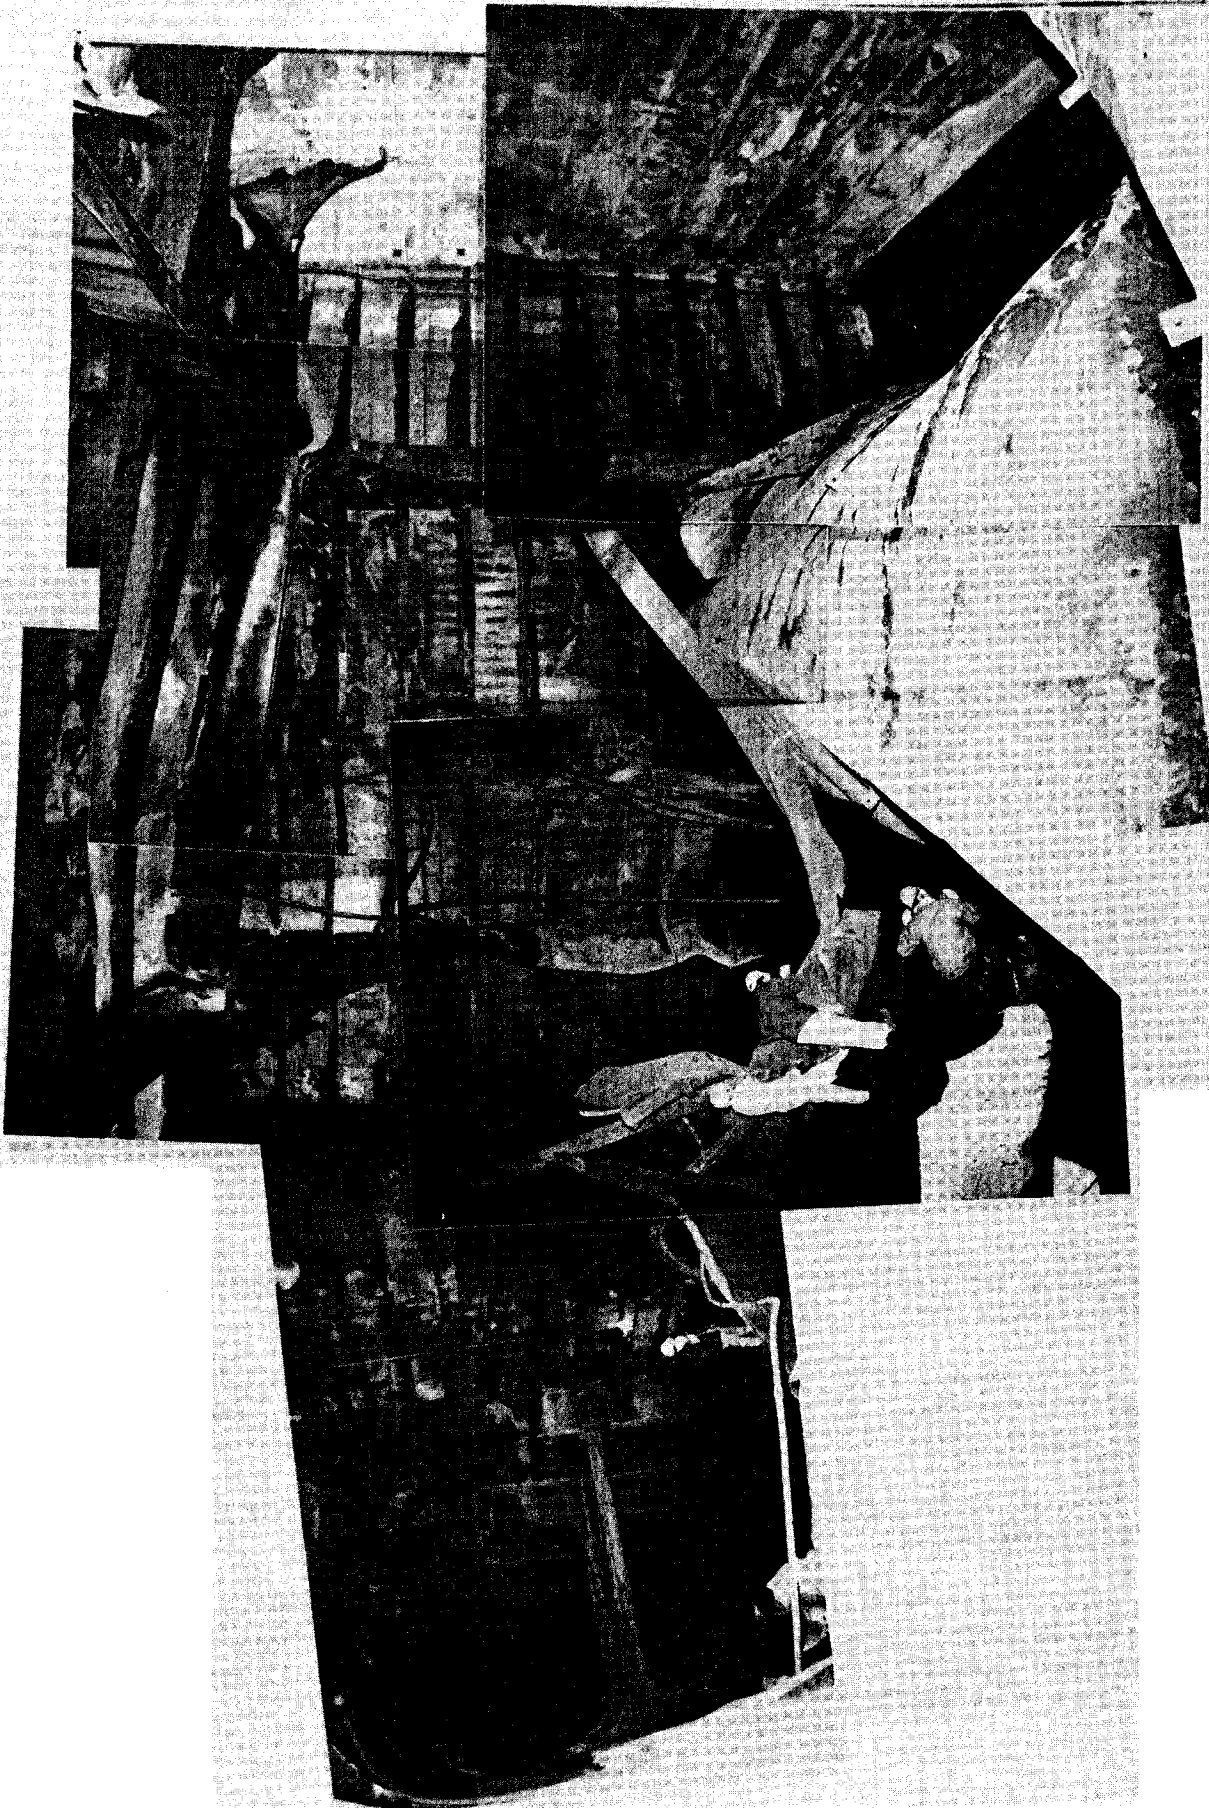
x. Internal examination of the starboard fuel oil storage tank revealed that the aft one of the two upper transverse web frames, located forward of the swash bulkhead was blown aft, where as the swash bulkhead originally located aft of this web was blown forward.

y. The starboard storage tank was opened to the sea when the swash bulkhead angle brackets ripped away from the side shell during the swash bulkheads movement forward as a result of the explosions. There were similar openings in the longitudinal bulkhead separating the engine room and the storage tank where the swash bulkhead was connected and ripped away during the explosions.

Composite photograph depicting the damage to the starboard settler, storage and transverse ballast tanks. The damaged transverse ballast tank starboard forward bulkhead is located at the far left of the picture. Photograph courtesy of the National Transportation Safety Board.
