The Submarine Division of the Naval Safety Center Presents:

FLASH

Factual Lines About Submarine Hazards

April 2002 - May 2002

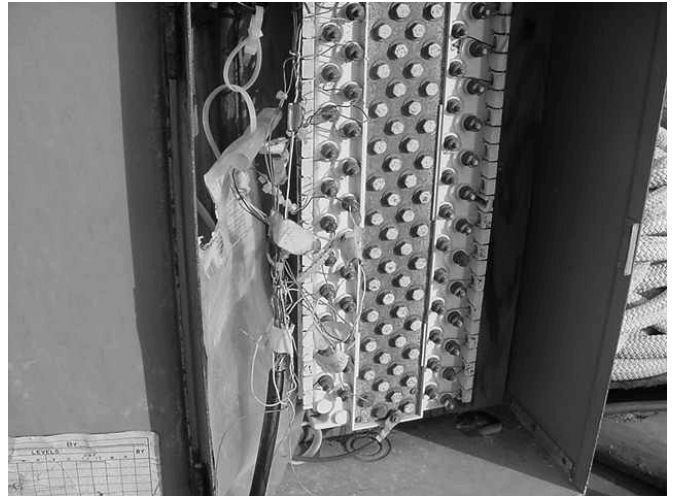
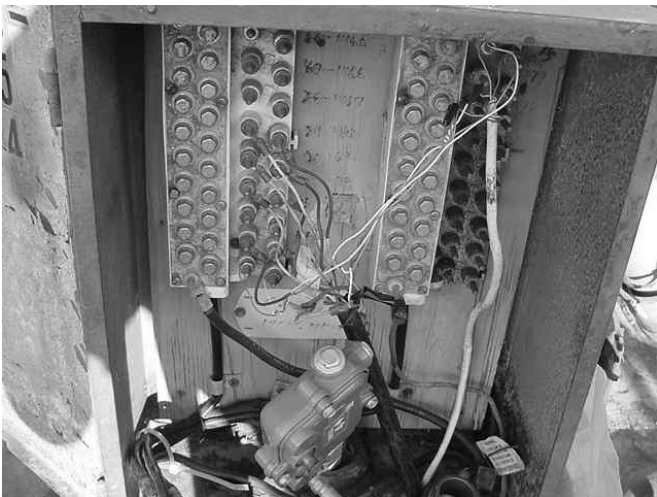
The problem, identified in Pearl Harbor and San Diego, is each wire of the phone cable has to be individually connected to separate terminals in the connection box. Each of these terminals

have a steady state 55 VDC and over 99 VDC; 30 milliamps if an incoming call is received (This data was taken in Pearl Harbor). All SUBPAC afloat units whose shore phone connections require direct contact with telephone terminals are required to follow the appropriate safety precautions in NSTM 300 for **working on energized equipment**.

We recommend all SUBLANT and SUBPAC submarines verify their shore phone connections do not require individual wire-to-terminal hook ups before connecting or disconnecting shore phones. If you find this type connection outside Pearl Harbor and San Diego, please contact me at (757) 444-3520 Ext. 7098 (DSN 564) or e-mail chouck@safetycenter.navy.mil.

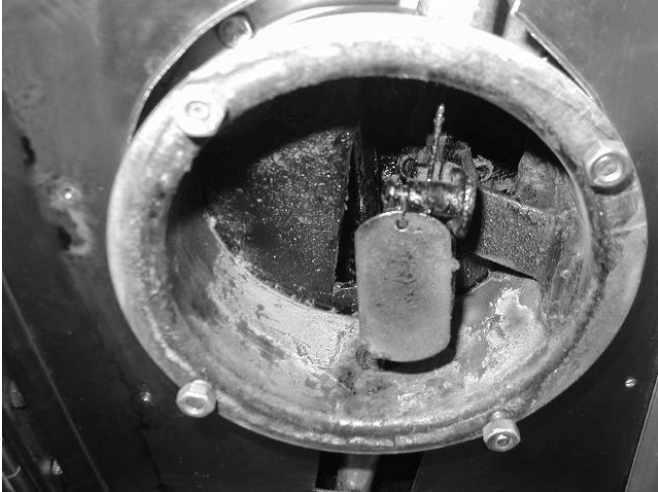
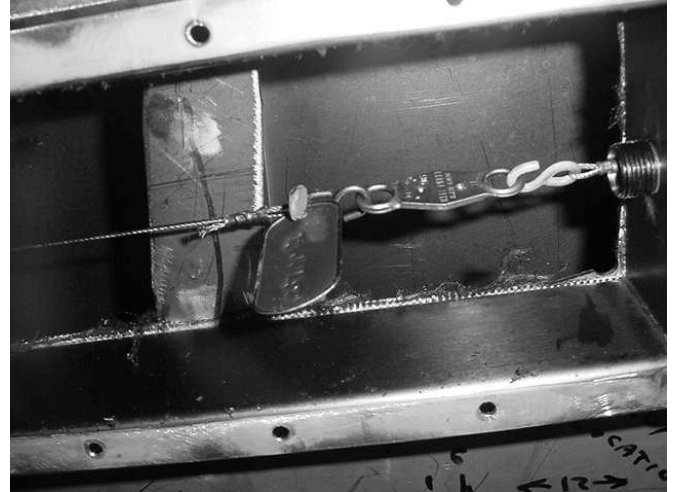
I ask the question, "What's a range guard?" because of what I've noticed in the submarine fleet regarding the range guard APC system PMS completion rate (or lack of a completion rate). As you can tell by the pictures that accompany this article, some systems are fire hazards instead fire extinguishers.

In FLASH (Feb-Mar 02) I addressed this issue as a top three damage control deficiency for 2001. (It currently is being driven right to the top of the list.) Some systems have not had the PMS accomplished in as long as 2-3 years (in one case almost 9 years). How can this be you ask? This is a case of expecting what you inspect instead of inspecting what you expect. (The PMS is a semi-annual requirement.)

has a working knowledge of the system and that the system will in fact operate when actuated. I say this because most systems surveyed have multiple deficiencies that indicate a lack of system and PMS knowledge. These deficiencies include: not having sufficient cable travel (at least three inches); ventilation scissors

assemblies that are filthy (dirt and grease caked on and around them); ventilation systems with debris in them (e.g., plastic bags, paperwork, cleaning rags). All of these deficiencies are fire hazards.

Periodic spot checks should be done to ensure that your damage control petty officer

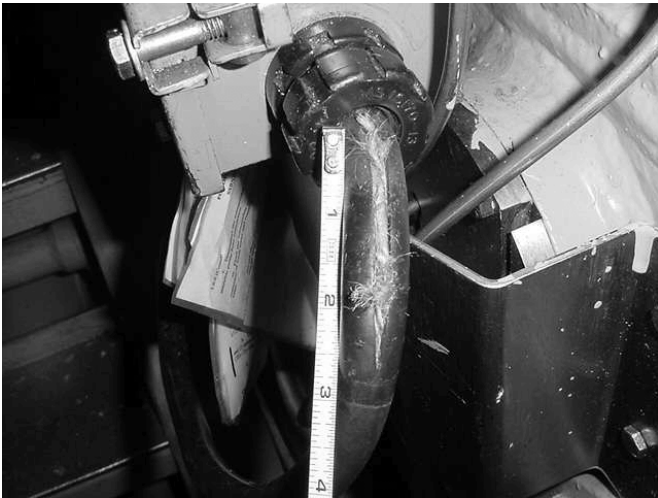
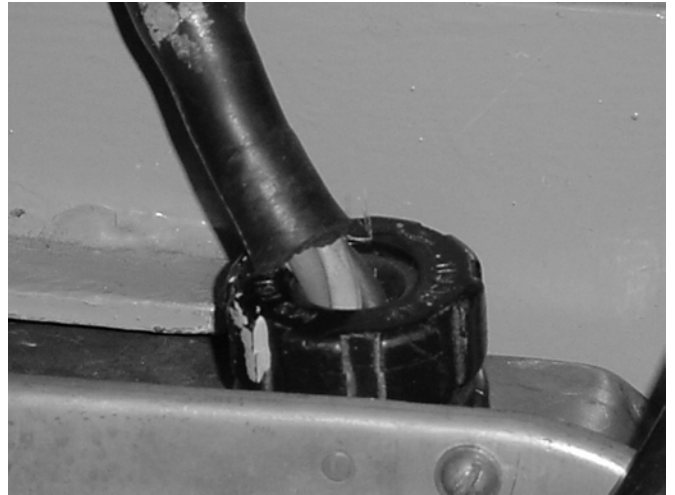
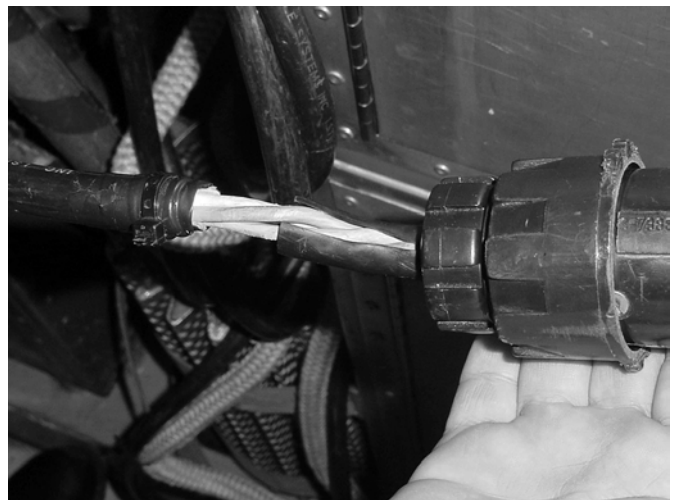
When you use your portable submersible pumps will they save your life and your ship or will they electrocute the operator? The pictures on this page are just some of the examples of submersible pumps that have severe electrical safety deficiencies. Unfortunately, these conditions have become the rule vice the exception.

Three of four submersible pumps surveyed were unsafe due to various cable issues (e.g., exposed wiring where the cable is pulling past the rubber compression fitting, slices in the cable exposing wiring). The cables are supposed to be maintained and kept watertight.

When performing the required electrical safety check IAW MRC EL-002/029 (S1-R): (1) Extend power cable, if applicable; inspect sheath for cuts, tears, and abrasions. Ensure cable has no splices or exposed conductors. (2) Inspect reinforcement sleeve for cut and cracked surfaces; sleeve construction should be of non-conducting material. (3) Inspect pump power cable stuffing tube for watertight seal to pump casing. (4) Inspect attachment plug for loose,

broken, and missing parts. (5) Inspect plug insulation for cracks, chips, and overheating. Although the above steps are not all inclusive to the entire MRC they are the ones that seem to be over looked.

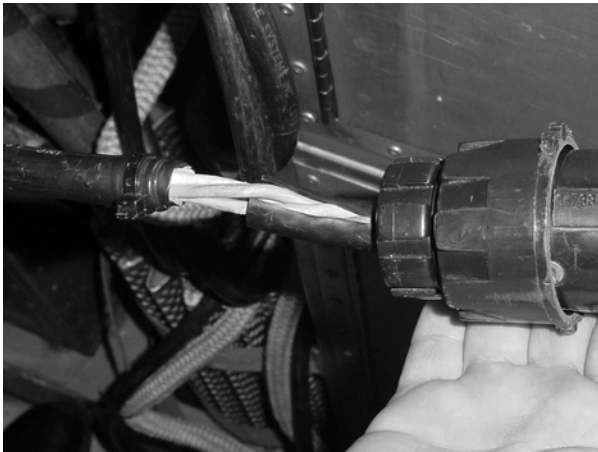
Electrical safety checked sub pump cable?

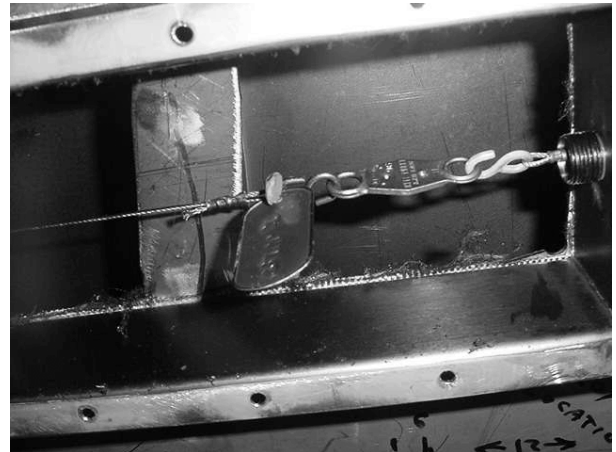
Where's the scissors assembly?
