# The Submarine Division of the Naval Safety Center Presents:

# FLASH

## Factual Lines About Submarine Hazards

December 2001 – January 2002

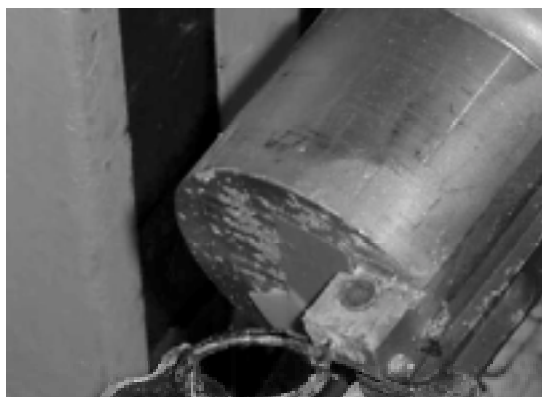
Once again I've found evidence of leaking pyrotechnic and ammunition (pyro/ammo) locker flood valves during our safety surveys. One boat's pyro/ammo lockers were dry, but there were water and salt deposits at the leak-off line. Another boat had standing water in the pyro locker (second submarine with water in the pyro locker I've seen in the last year!) as well as salt deposits in the locker and on the devices themselves. There was also corrosion on the yellow and red cotter pins that keep the devices safe (see picture below).

One boat mentioned that they had a "moisture problem." Let's think about that statement for a minute. A sealed locker (that is suppose to be dry) having a moisture problem? Where did the moisture come from? The lockers are not attached to the hull where condensation could be a problem. The only explanation is a leaking valve.

So, how can you tell if the flood valve is leaking by? The maintenance requirement card "D-1" of MIP 7000/X04, requires you to check the leak-off valve for leakage (as well as checking for evidence of corrosion and salt deposits). On both of the boats where I found water in the pyro locker, the leak-off valves were shut. These valves must be open/cracked-open, then checked for seawater at the drain

funnel. If the leak-off valve is shut, and the flood valve is leaking, that water will end up in the pyrotechnic or ammo locker.

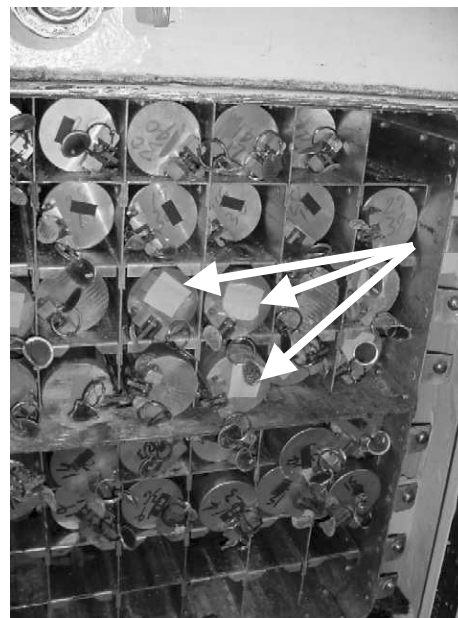
The picture above shows several pyro locker deficiencies. The salt deposits and corrosion don't show up well but they're there. Notice how many devices do not have the required color-coded tape? The arrows are pointing to post-it notes (yes that's right, yellow stickies!) used instead of color-coded tape. Do you see any restraining bars? (I didn't!) Performing the D-1 PMS correctly while conducting the daily inventory/inspection will correct all of these deficiencies.

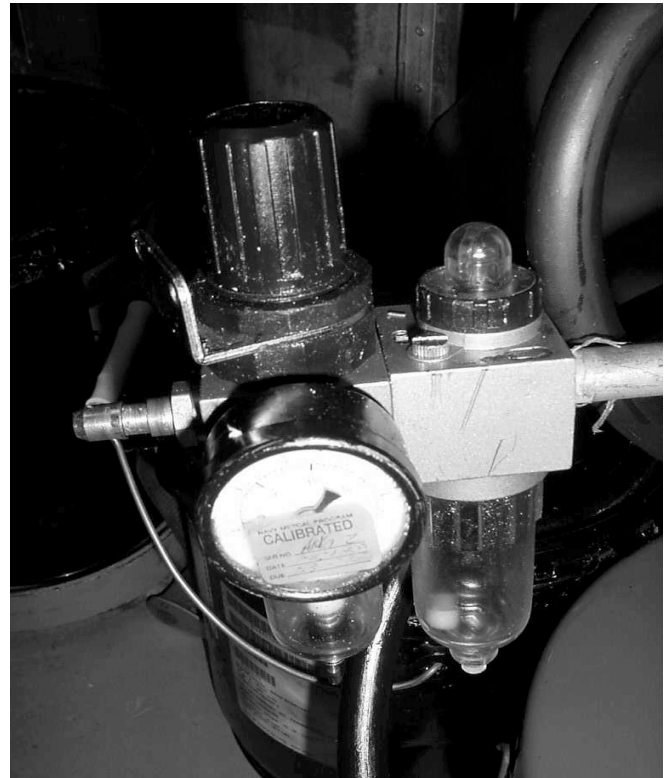
(Incorrect Regulator)

Naval Inventory Control Point (NAVICP) 021340Z NOV 01 (NOTAL) advises of an incorrect style of pneumatic grease gun inlet regulator (NSN 9C-4820-01-250-8597) in the supply system. I've seen several boats in the Atlantic and Pacific fleets that have the incorrect regulators installed. These particular regulators come equipped from the supply system with flow meter style gages and an oil separator. Although the NSN for the correct and incorrect regulators are the same, the incorrect regulators are not in accordance with the submarine greasing manual (NAVSEA T6350-AA-HBK-010) and should be removed as soon as possible. The incorrect regulator can cause the operator to over-pressurize the inlet of the pneumatic grease gun and subsequently over-pressurize the discharge side, possibly damaging the grease distribution lines. The pneumatic grease gun is used in the steering and diving system, torpedo tube systems and general ships lubrication.

Any command having or receiving the incorrect regulators should submit a quality deficiency report (QDR) through their supply system and order a new regulator.

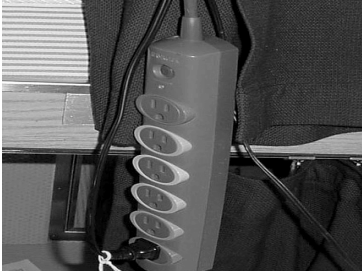
Unapproved Power Strip

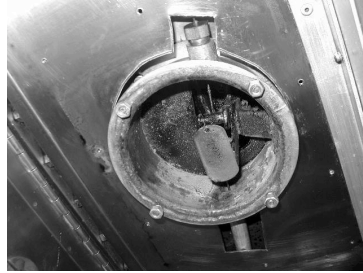
APC System PMS?

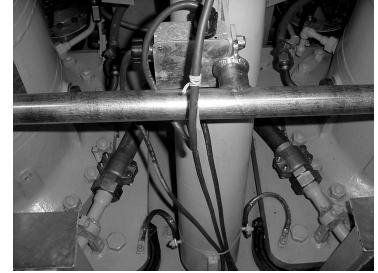
Unapproved Electrical Mod

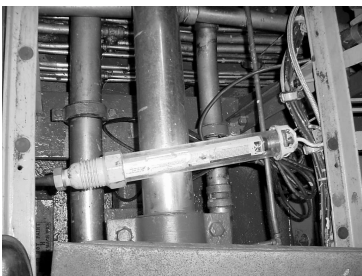
Permanent Bilge Droplight?

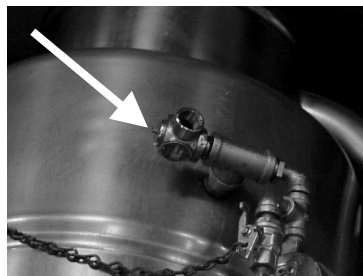
Broken Kettle Relief Valve

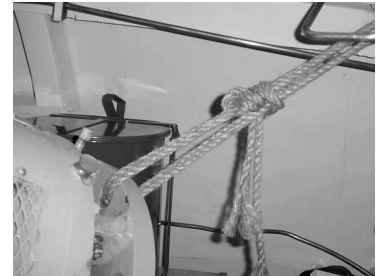
Authorized?
