SAGAMORE HILL HOME OF THEODORE ROOSEVELT

Sagamore Hill National Historic Site
Oyster Bay, New York

Historic Structure Report

Building Conservation Branch, Cultural Resources Center
North Atlantic Region, National Park Service
U.S. Department of the Interior
Boston, Massachusetts

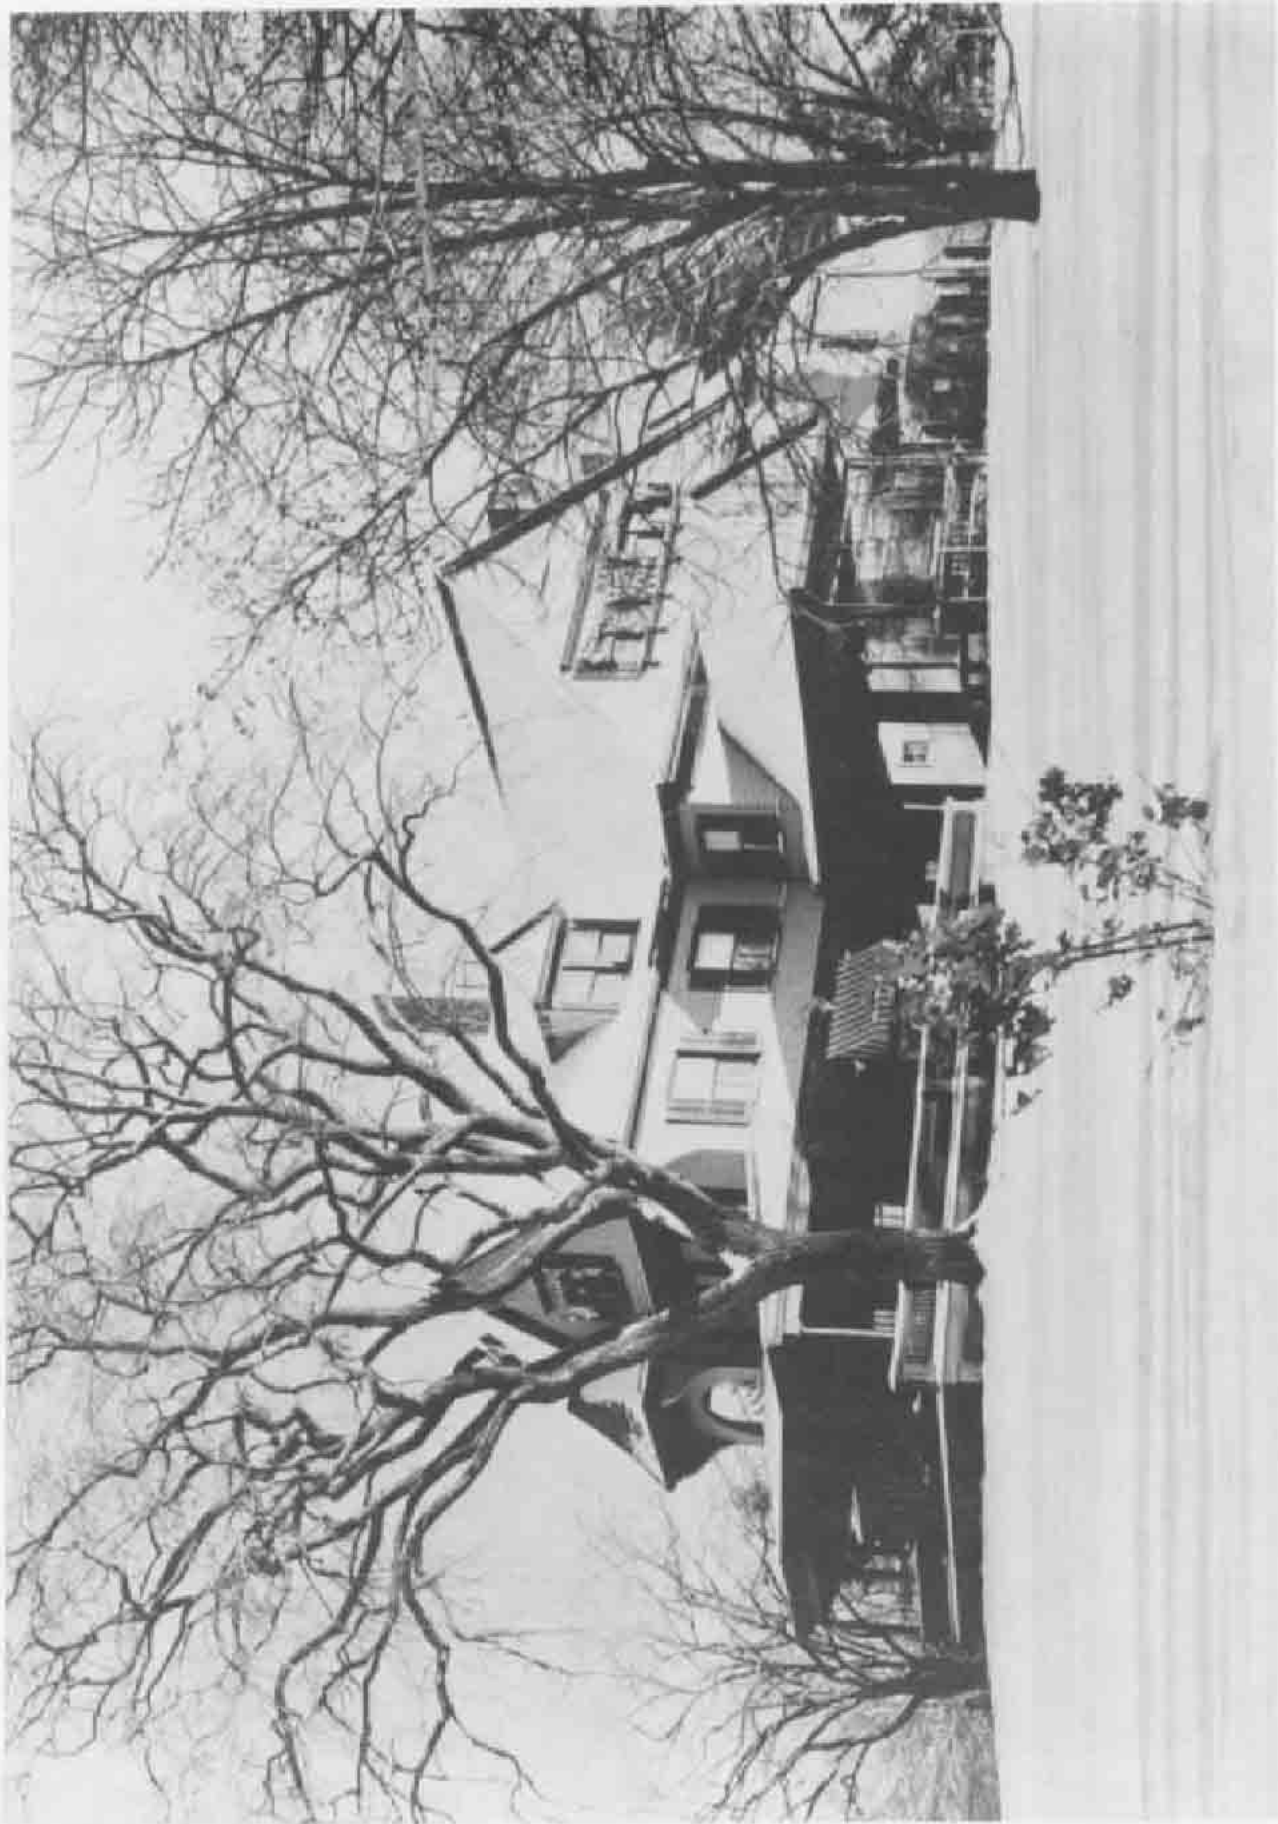
Figure 20. TR Home in winter, 1959. Storm shelter hides south entrance door.

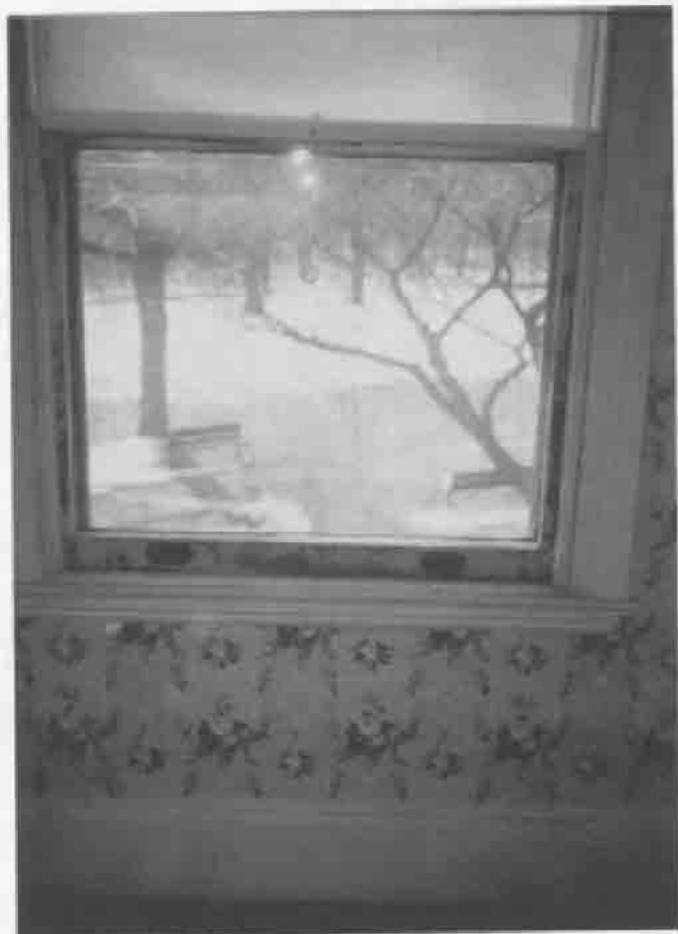
Typical Window Sash Condition Before Restoration

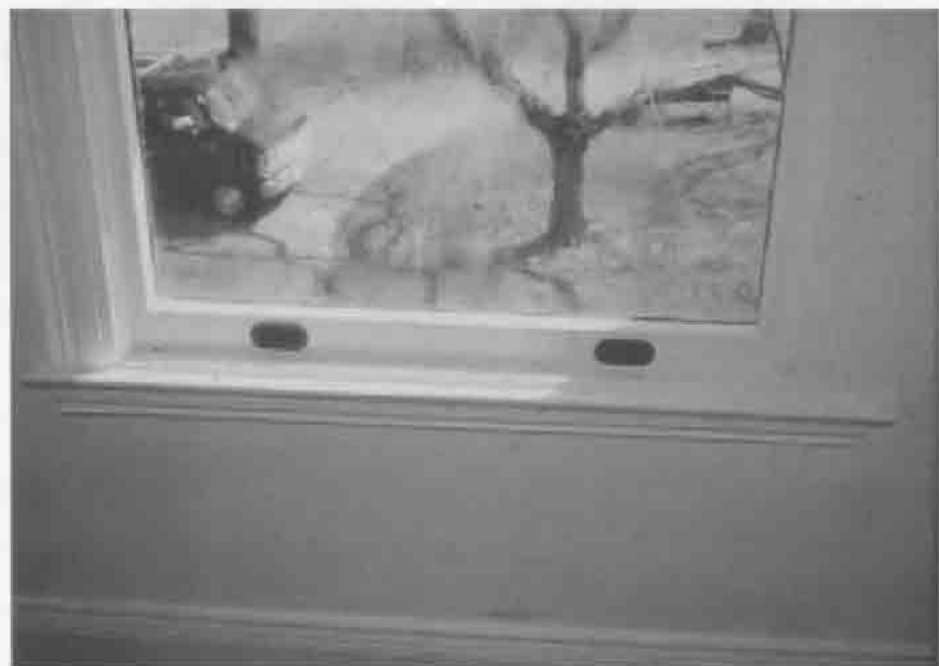
Typical Window Sash Condition After Restoration

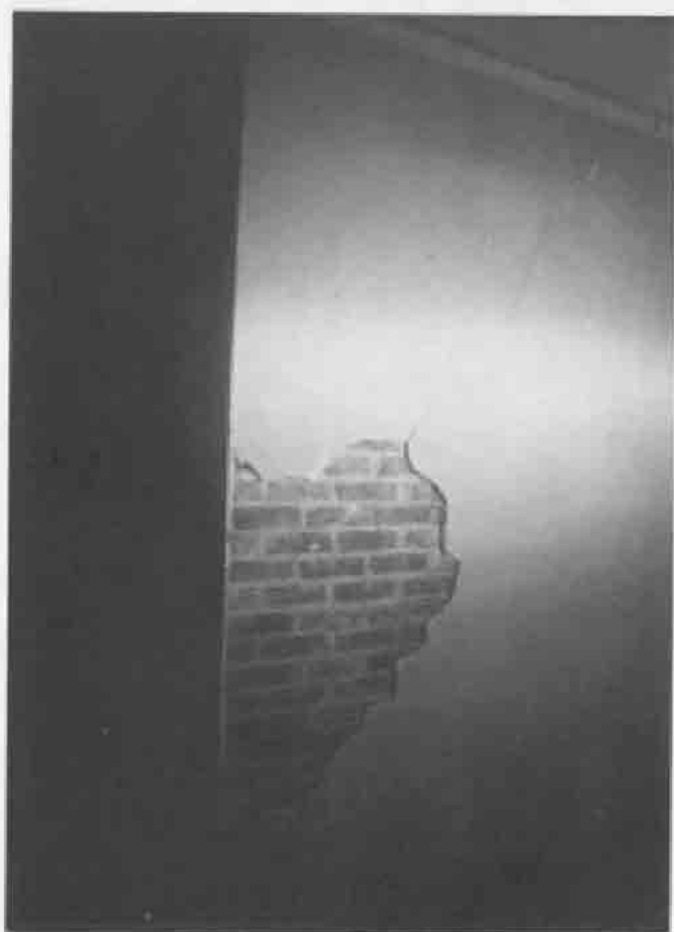
Alice's Room: Plaster Damage

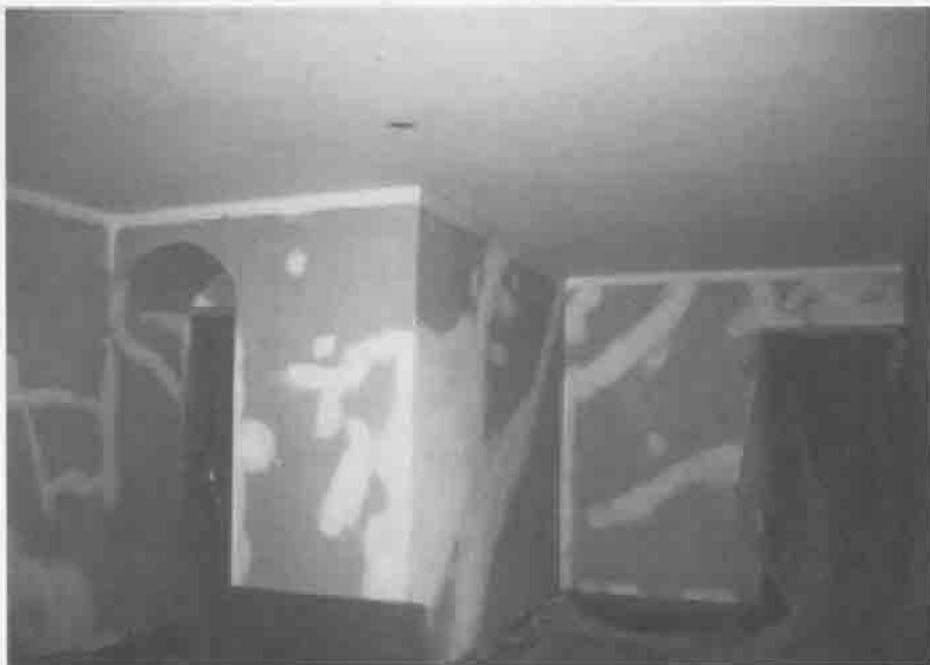
**Alice's Room: After Restoration (plaster repaired,
ready for wallpapering).**

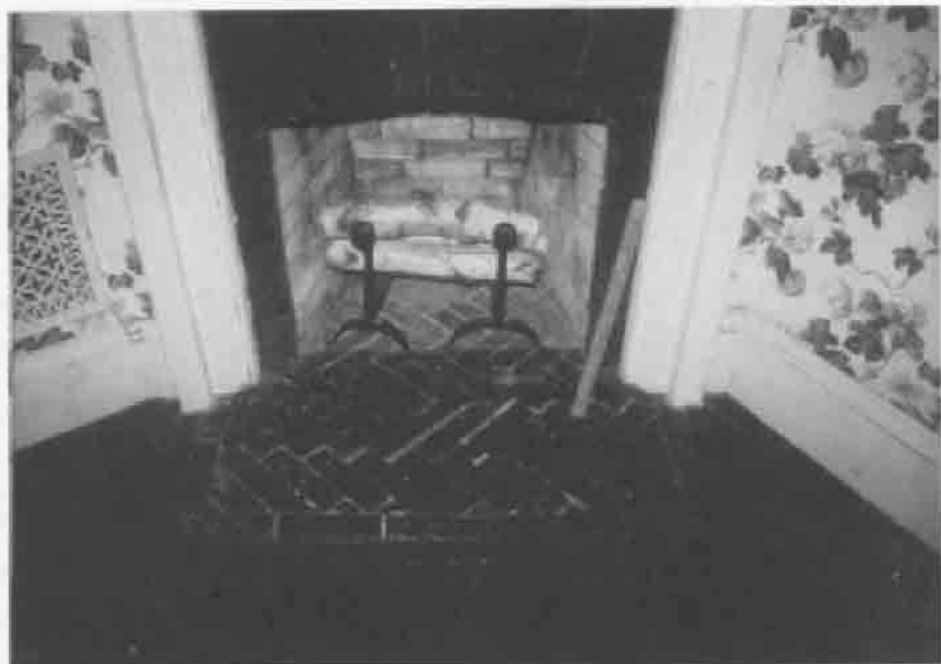
**Mother's Room: Condition of Fireplace Hearth
Before Restoration**

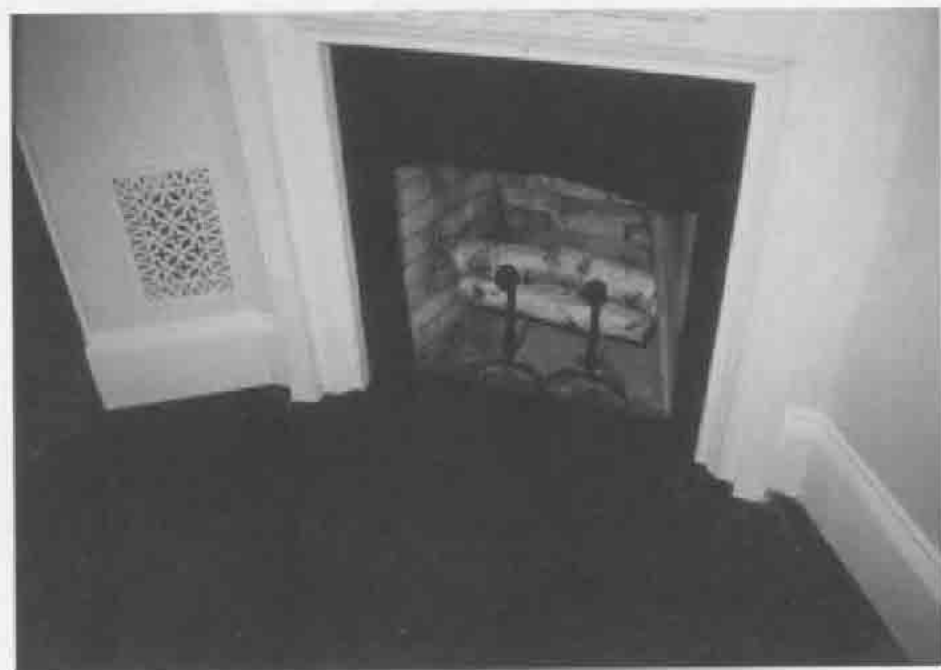
**Mother's Room: Condition of Fireplace Hearth
After Relaying, Repointing, and Repainting**

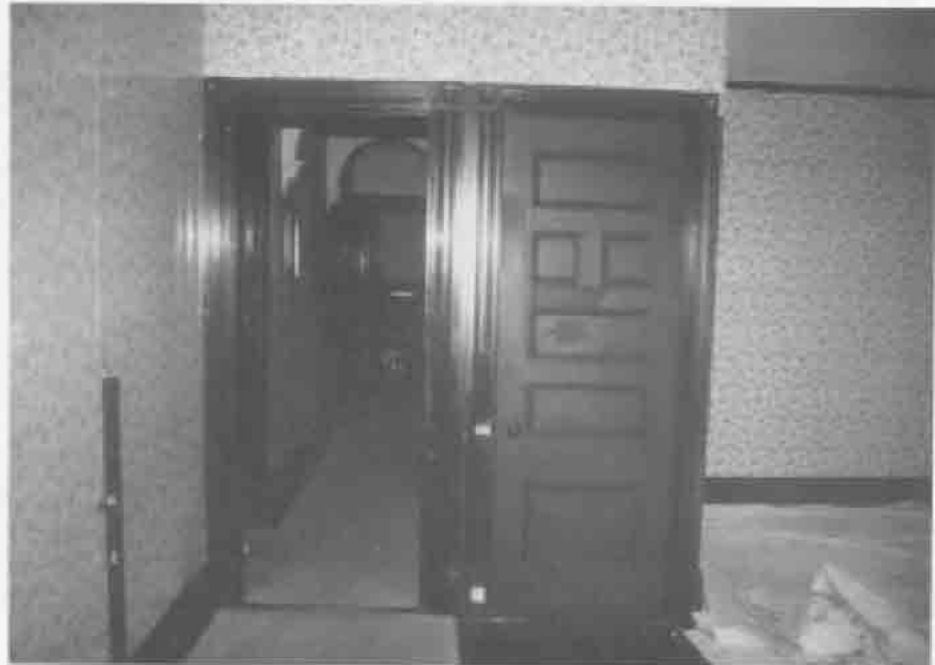
Typical Condition of Stained Woodwork

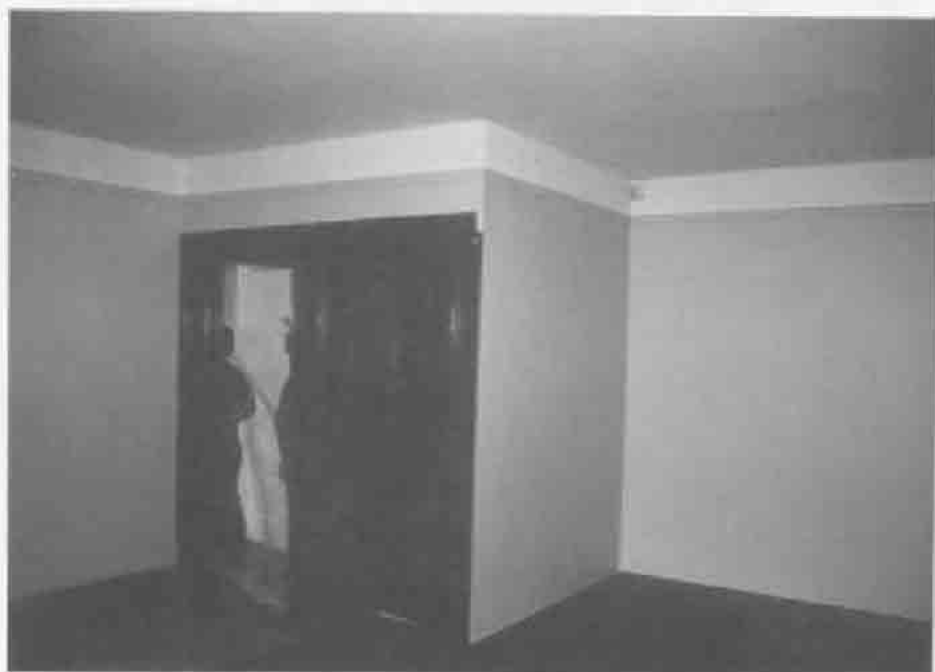
Typical Refinishing of Stained Woodwork

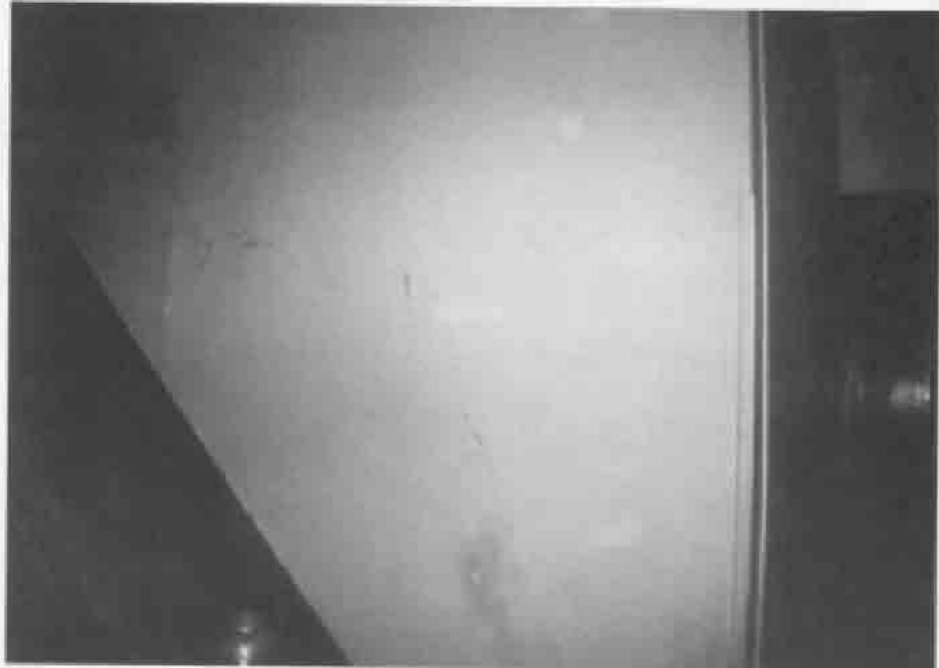
**Second Floor Rear Hall, Stairway: Before Restoration
(plaster severely deteriorated)**

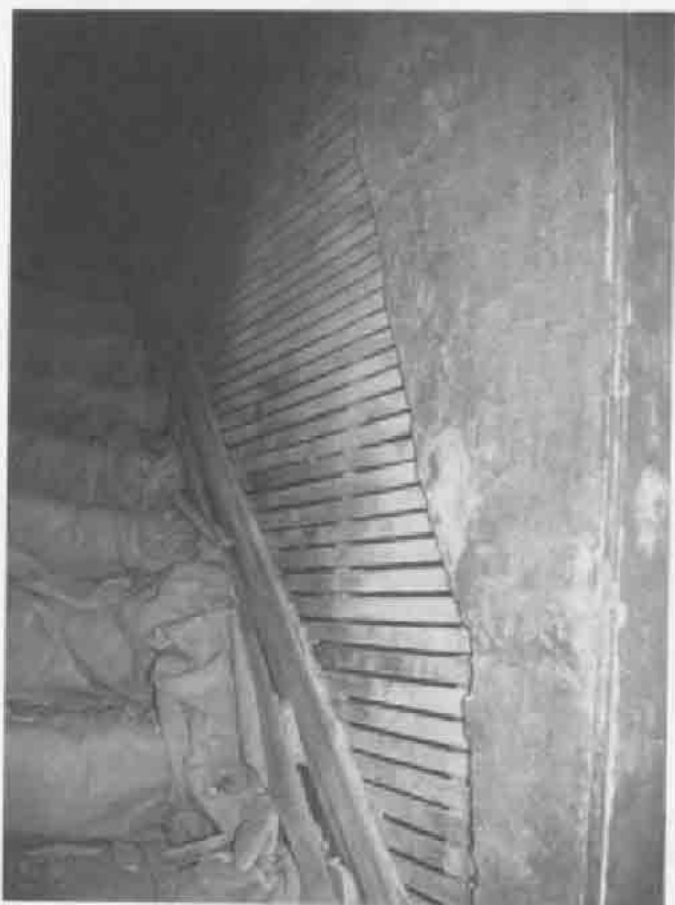
**Second Floor Rear Hall Stairway: During Restoration
(plaster removed)**
