Did I Do That?

By AD1(AW/SW) Emmanuel Basye
VAW-113

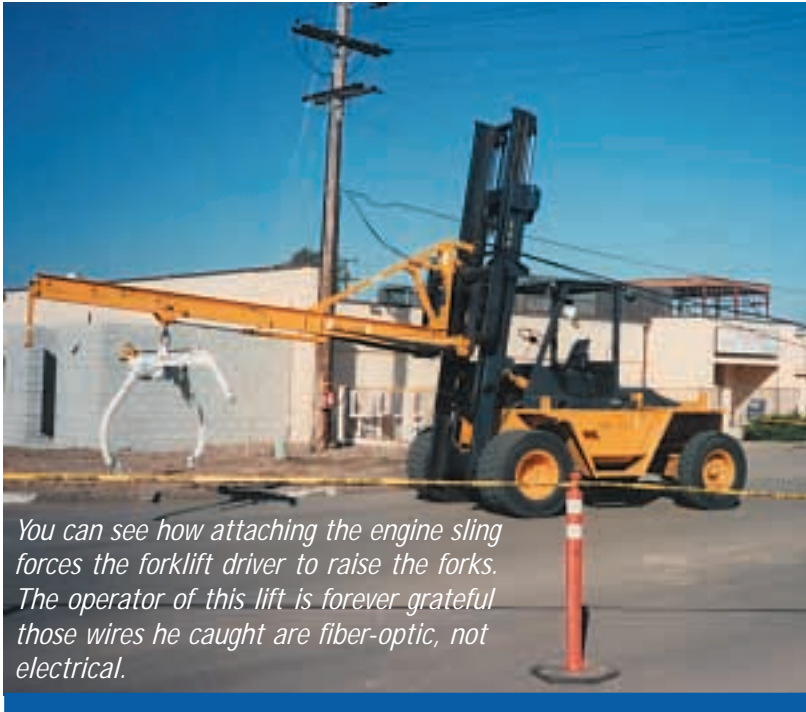
You can see how attaching the engine sling forces the forklift driver to raise the forks. The operator of this lift is forever grateful those wires he caught are fiber-optic, not electrical.

What had caused the forklift to hit the line? During the pre-op inspection, workers had connected the engine-boom assembly to the forks. Then, they raised the forks to attach the engine-sling assembly onto the chain fall before the AK1 took it out on the road. Attaching the engine-sling assembly raised the height of the forklift mast to almost 19 feet. (Without the engine sling attached, the height of the 20k forklift is 12 to 13 feet.)

When the AK1 hit the fiber-optic line, it was because of the extended height of the forklift mast. (According to PWC, the height of the cable wire was about 18 feet.) The popping sound he heard was the one-quarter-inch-steel cable wire breaking. The cable wire was supporting the fiber-optic line from one post to another. When the line broke, the two posts swayed and other cables were strained, disrupting electrical power to three other buildings.

After this incident, the command determined that the engine sling will no longer be installed on the boom of the 20k forklift while somebody is driving it on the road. ■
