National Transportation Safety Board
Washington, D.C. 20594

Highway Accident Brief

Accident No.: HWY-98-SH-018
Accident Type: Rear-end collision
Location: Bothell, Washington
Date and Time: February 17, 1998; 4:00 p.m.
Vehicle 1 (V1): 1990 White/Volvo tractor with a double semitrailer hauling lumber
Vehicles 2–7 (V2–V7): 1994 Dodge Ram van, 2 passenger cars, 2 pickup trucks, and 1 tractor-semi-trailer
Fatalities/Injuries: 3 fatalities, 7 minor injuries

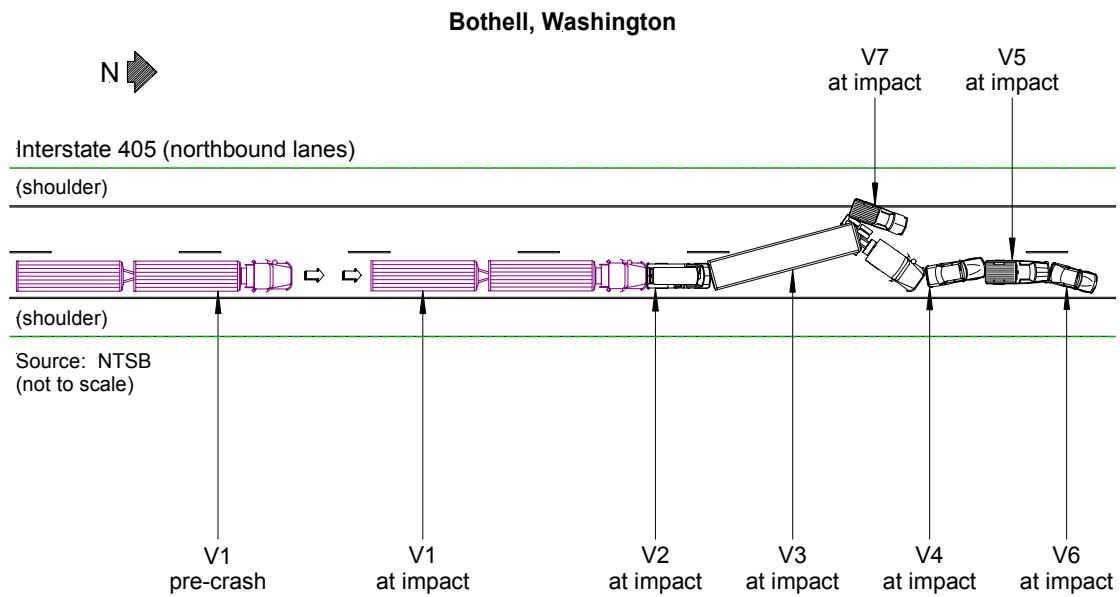
Figure 1. Accident diagram.

The driver of the tractor-double semitrailer stated that she noticed traffic on Interstate Highway 405 slowing in front of her and began applying the brakes. She then noticed the air pressure for the brake system depleting rapidly. The tractor-double semitrailer subsequently rear-ended the first vehicle stopped in traffic ahead, a Dodge van, pushing it into five other vehicles. (See figure 1.) The tractor-double semitrailer and van erupted in fire. Three van occupants were fatally injured; seven others involved in the collision sustained minor injuries.
