AIRCRAFT ACCIDENT REPORT

IN-FLIGHT ICING ENCOUNTER AND LOSS OF CONTROL
SIMMONS AIRLINES, d.b.a. AMERICAN EAGLE FLIGHT 4184
AVIONS de TRANSPORT REGIONAL (ATR)
MODEL 72-212, N401AM
ROSELAWN, INDIANA
OCTOBER 31, 1994

VOLUME II: RESPONSE OF BUREAU ENQUETES-ACCIDENTS
TO SAFETY BOARD'S DRAFT REPORT

COMMENTS OF THE BUREAU ENQUETES ACCIDENTS (FRANCE)

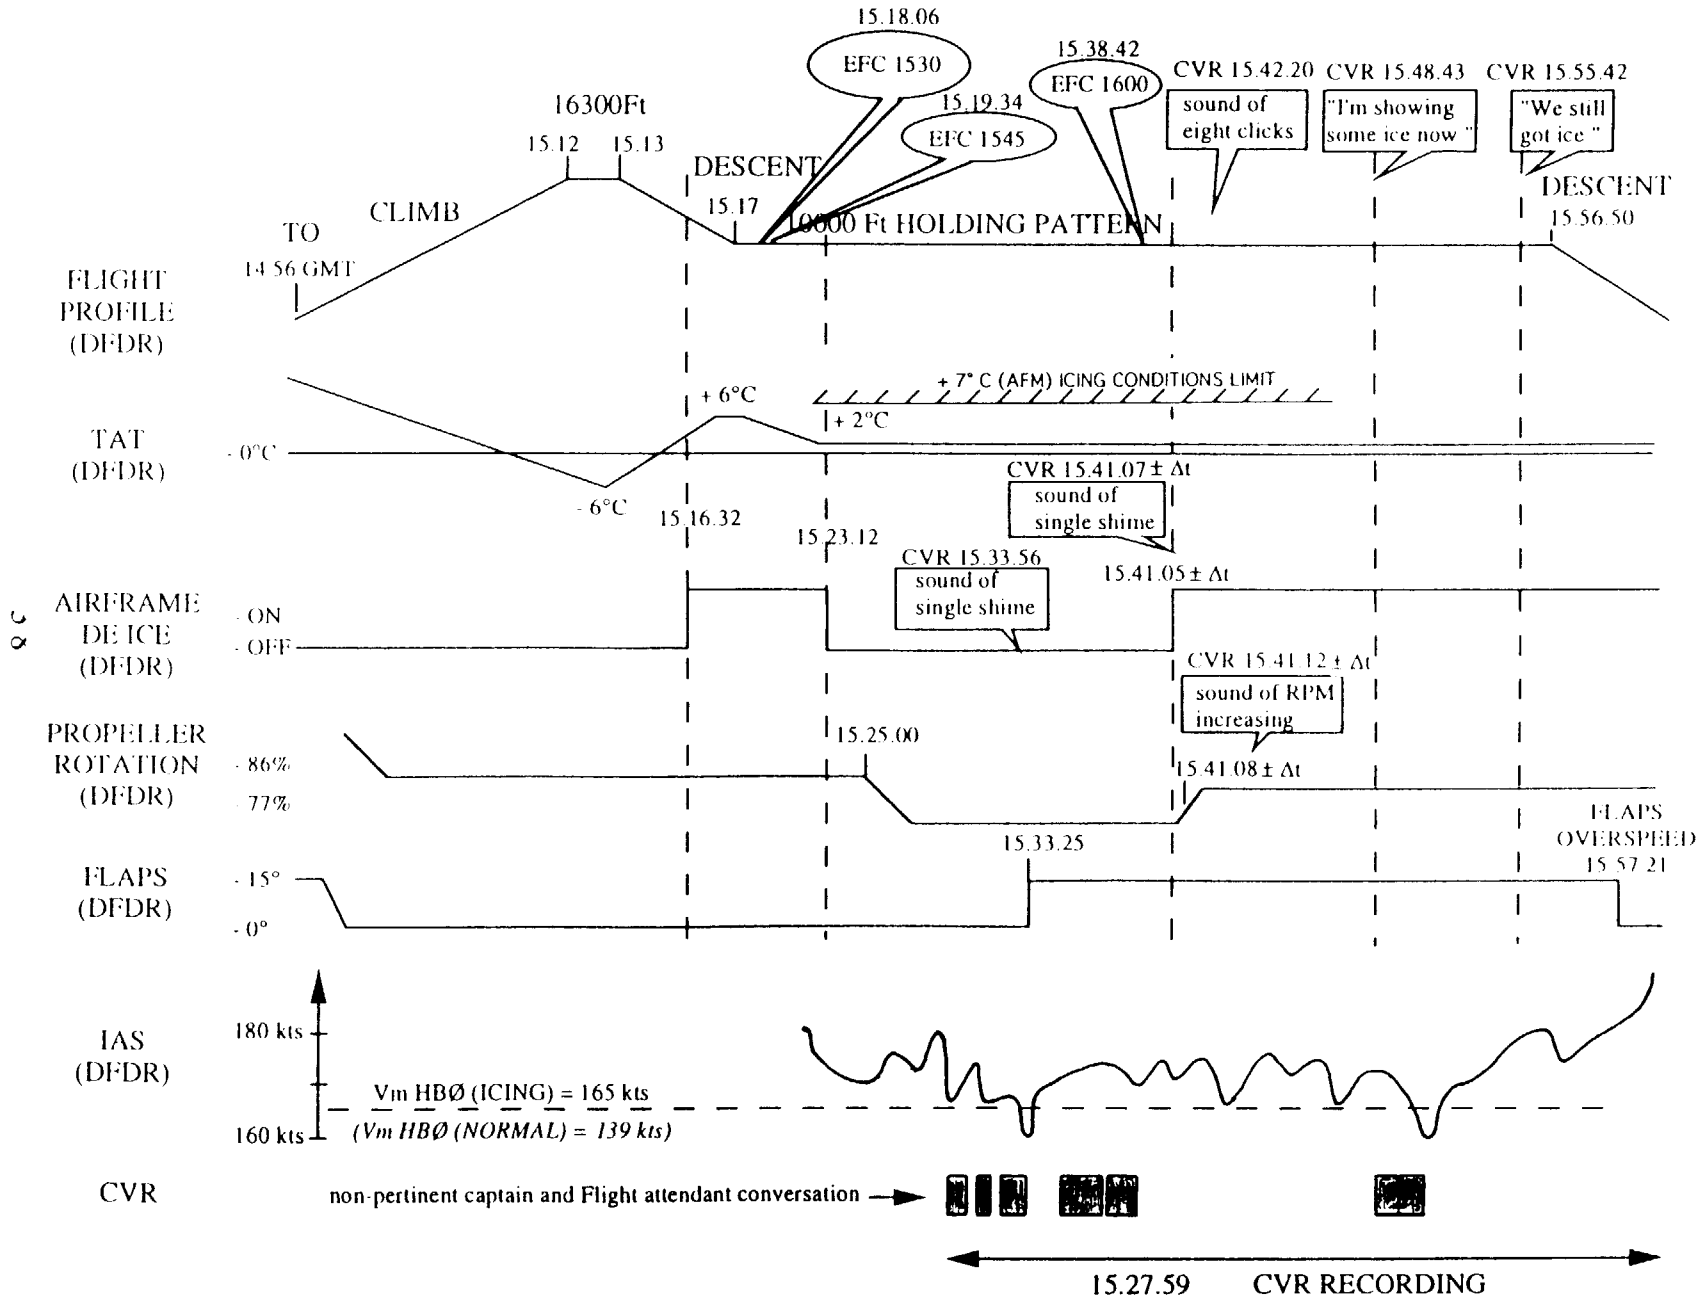
FIGURE 1 : FLIGHT 4184 PROFILE AND MAJOR DFDR EVENTS

The last seconds of DFDR data indicate a rapid, large input on the elevator.

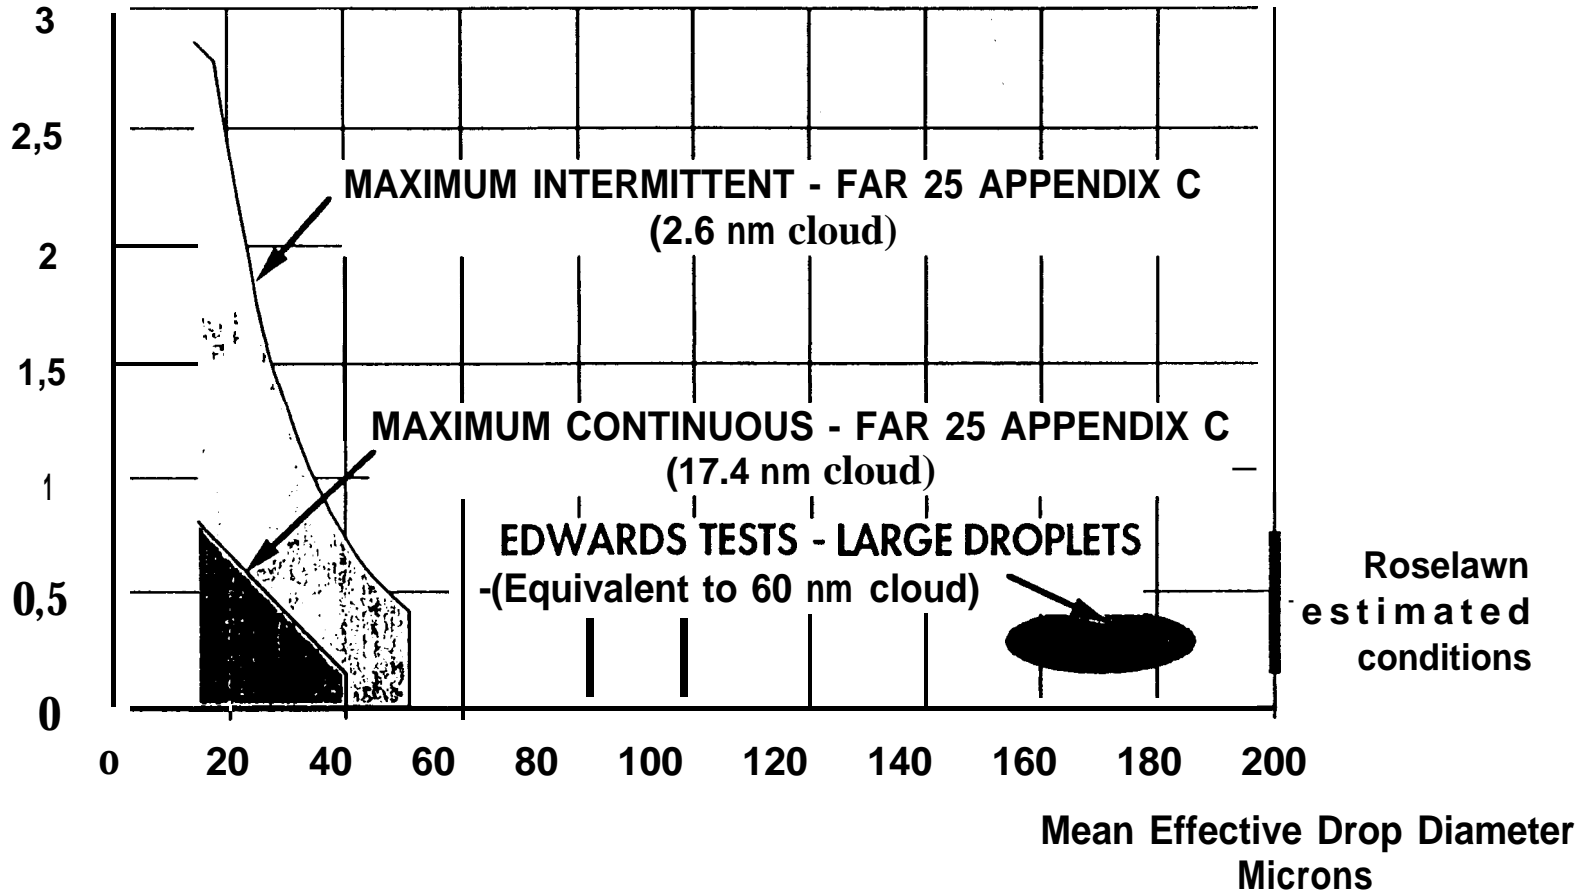
Liquid Water Content
(g per cu m)

ROSELAWN conditions were far outside App "C" certification envelope

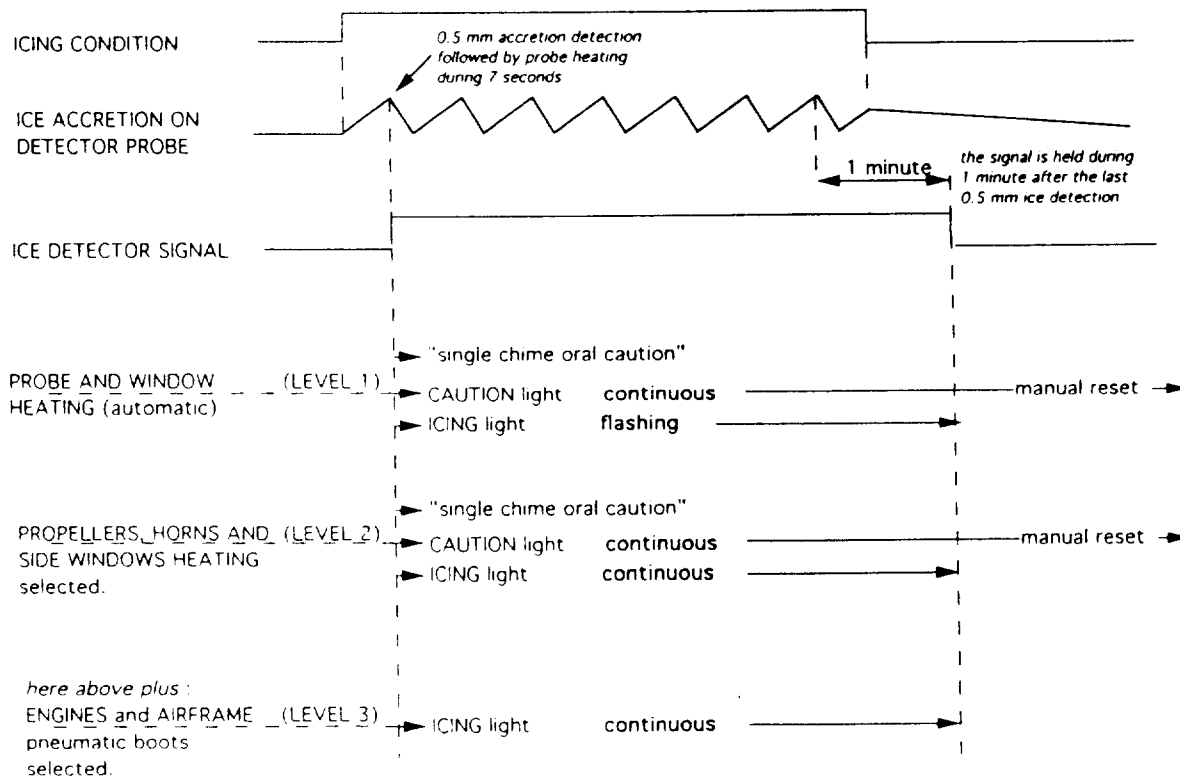
FIGURE 12 : ATR 72 ANTI-ICING ADVISORY SYSTEM (AAS)

The propeller rotation speed is not controlled nor monitored by the AAS. The normal procedure requires the increase in the propeller rotation speed, from 77% to 86%, as soon as and as long as icing conditions are present. This should be done when the propeller anti-icing is selected as part of the Level II procedure.

ATR 72 ANTI-ICING ADVISORY SYSTEM (AAS) : An effective warning logic to back up crew awareness

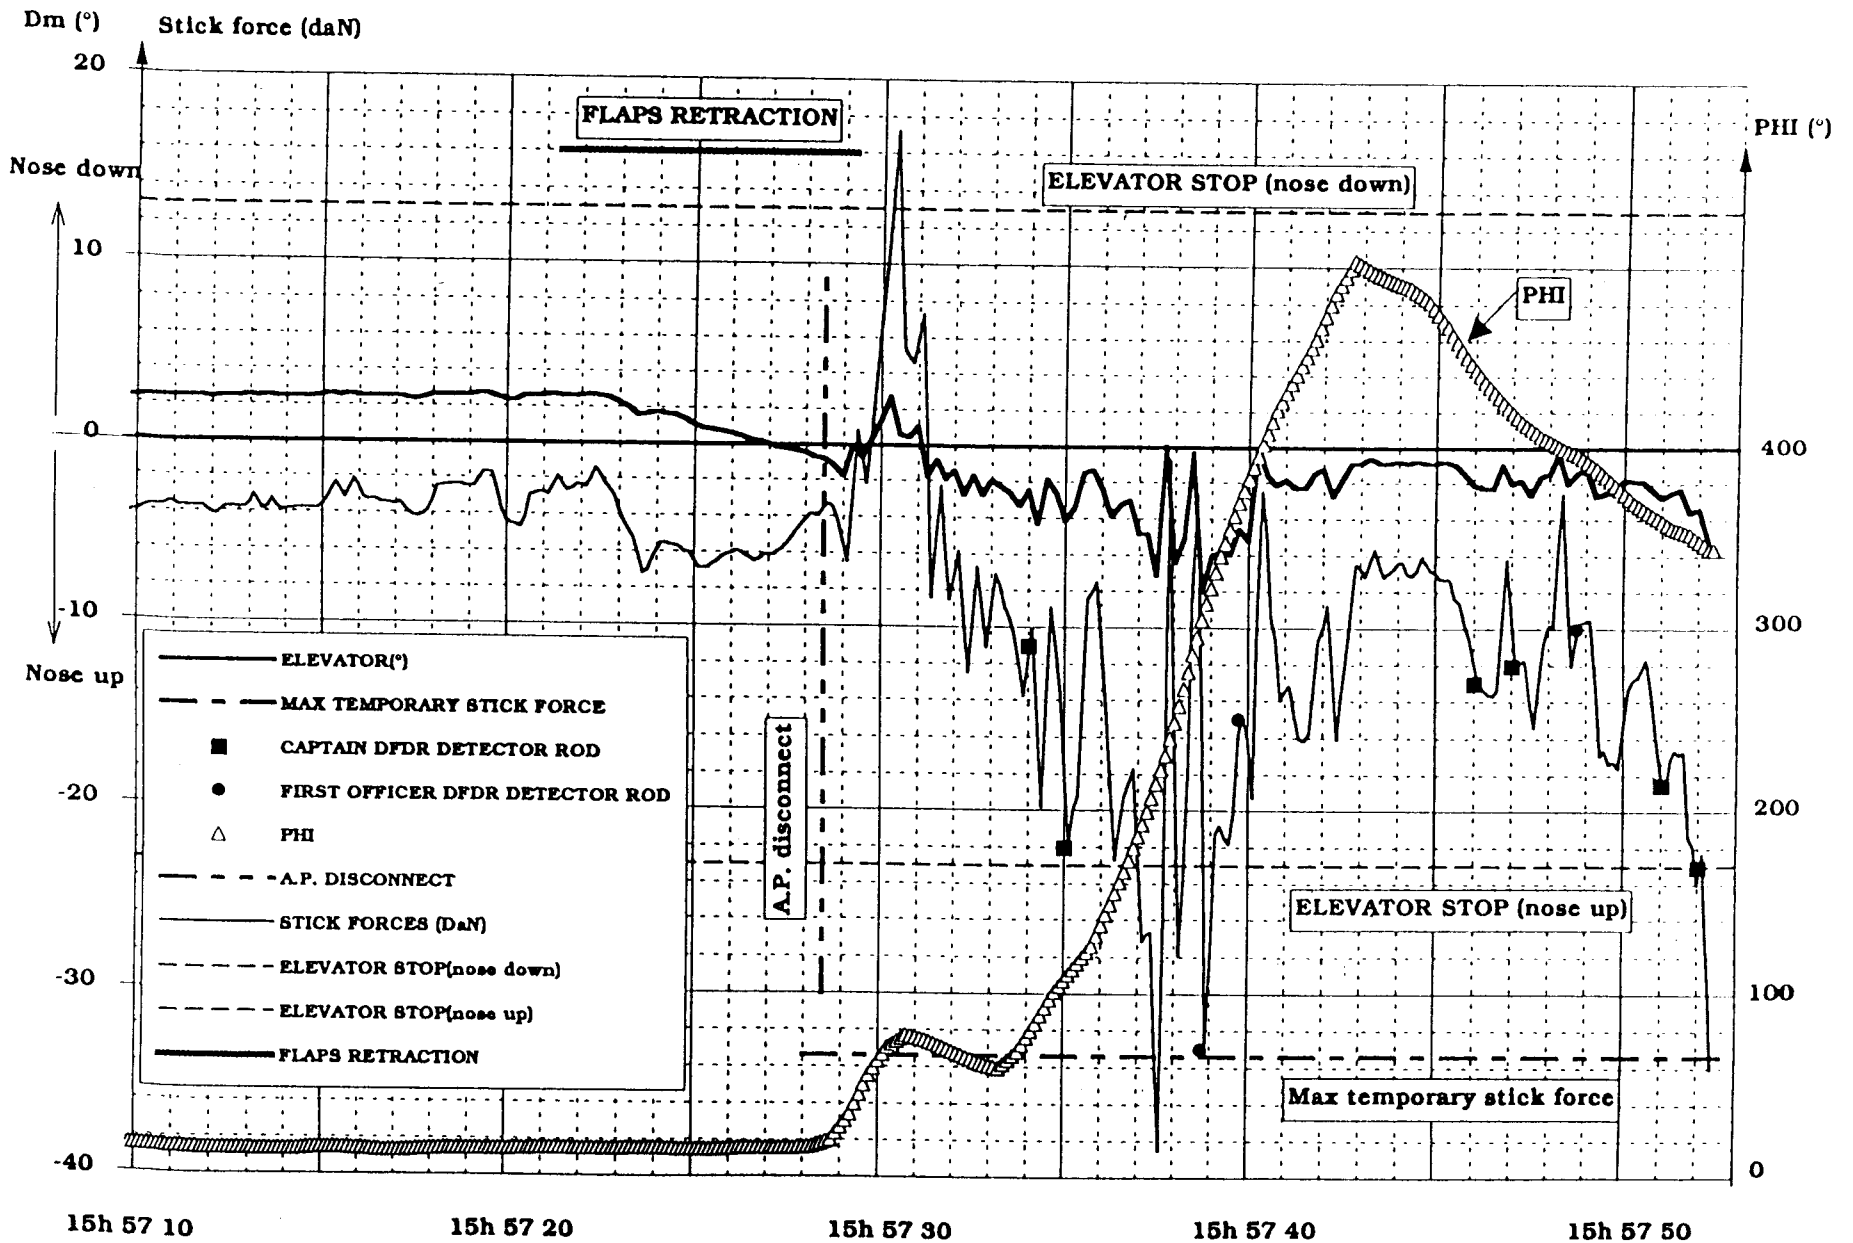
FIGURE 16 : PITCH CONTROL INPUTS / ACTIVITY AFTER ROLL UPSET

A limited control activity mainly during inverted flight
