Aircraft Accident Report

**Loss of Control and Impact with Pacific
Ocean Alaska Airlines Flight 261
McDonnell Douglas MD-83, N963AS
About 2.7 Miles North of
Anacapa Island, California
January 31, 2000**

**NTSB/AAR-02/01
PB2002-910402
Notation 7263E
Adopted December 30, 2002**

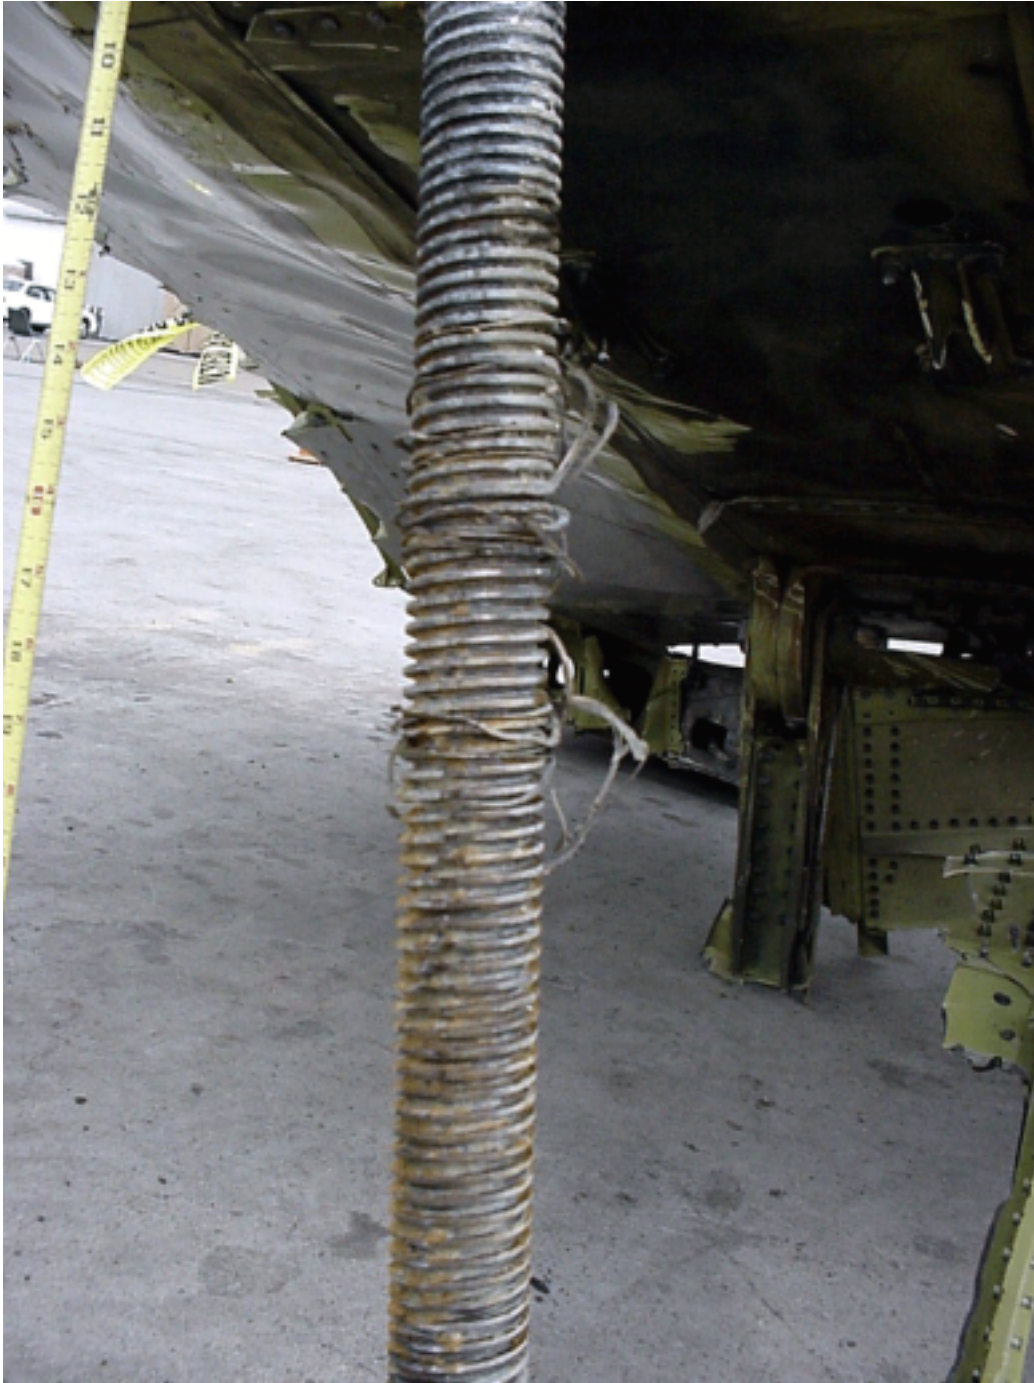
Figure 12b. The acme screw immediately after it was brought to shore.

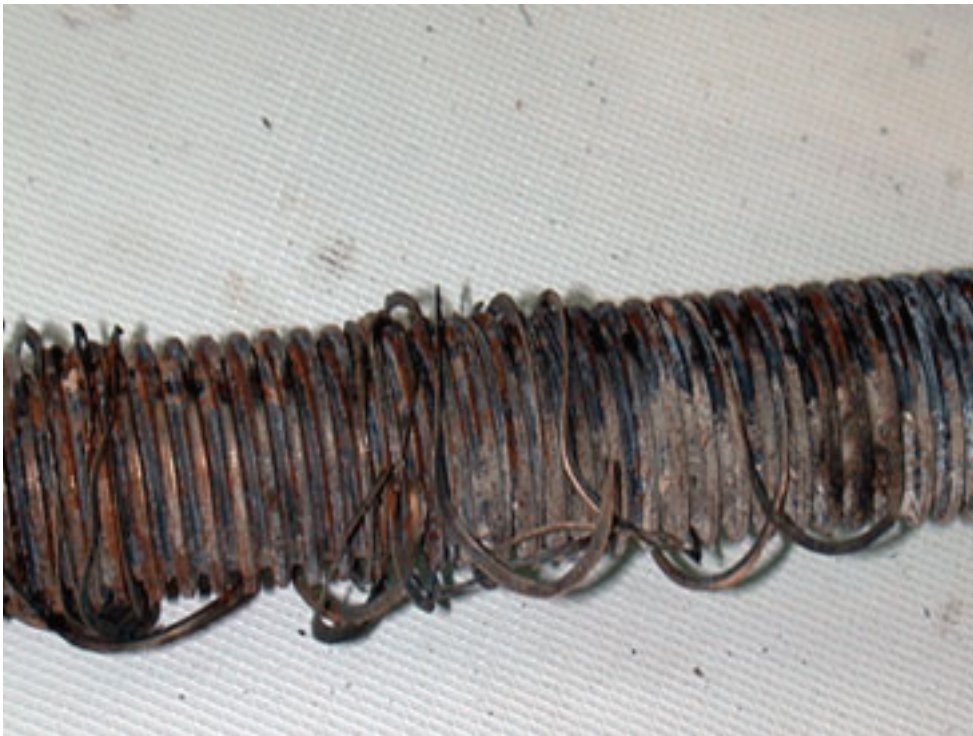
Figure 12c. The acme screw during initial inspection.

The upper mechanical stop was found attached to the splines of the acme screw, and the clamp bolt for this stop was in place. The lower mechanical stop and its clamp bolt were recovered as a separate unit from the acme screw. Several impact/scrape marks were found on the upper surface of the lower mechanical stop, and a round impact mark was found on the lower surface of the stop. Evidence of damage to the splines on the inside diameter of the lower mechanical stop was observed.¹¹⁷

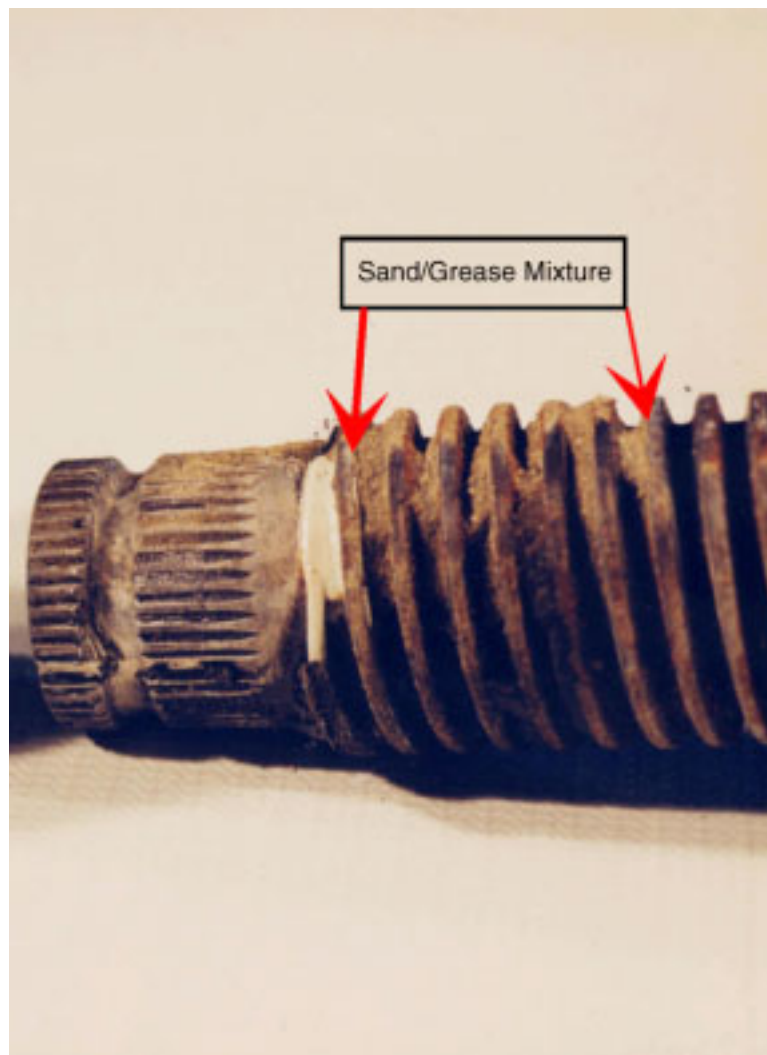
On-scene visual and tactile inspections by Safety Board metallurgists of the acme screw's threaded areas found no evidence of grease in any condition, either semi-fluid (that is, fresh) or solid/dry (that is, old or degraded), or other lubricants in the central "working region" of the screw threads.¹²⁹ Laboratory examinations found small flakes of dried and hardened grease attached to some of the thread remnants in this region. The acme screw's lower threads (which are outside of the working region) were found partially packed with a mixture consistent with sand and grease. (Figure 14 shows the sand/grease mixture packed between the acme screw's lower threads.) Parts of the acme screw's upper six to eight threads had an oily sheen, and small deposits of greaselike material were found between the threads.

Figure 14. A photograph of the sand/grease mixture packed between the acme screw's lower threads.

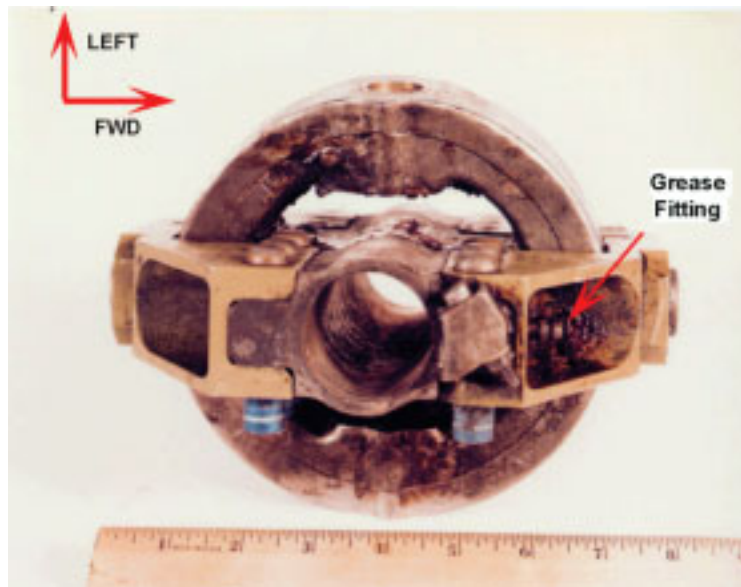
green-tinted, black and red grease deposits were found on the surrounding airplane structure.

Figure 15. A photograph of an overall view of the recovered acme nut assembly.

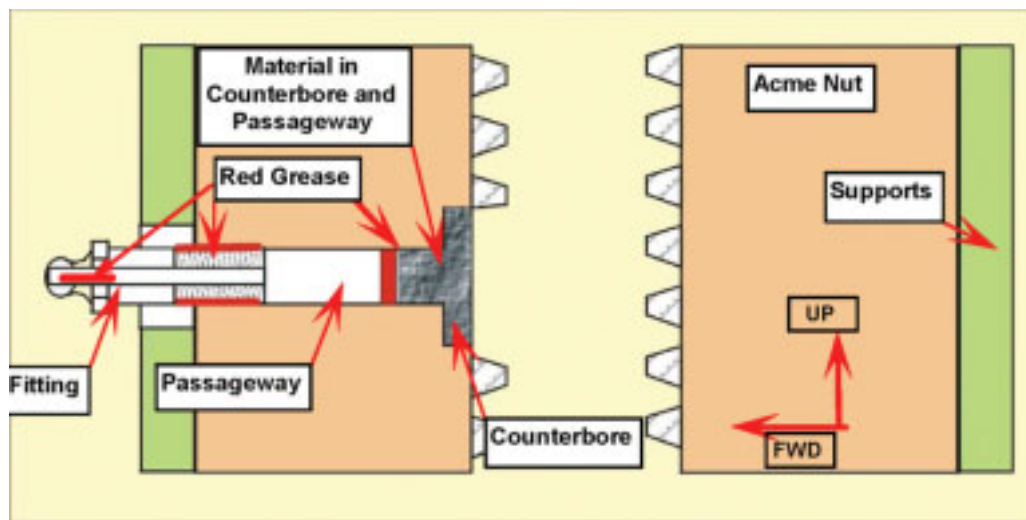
Figure 17. A diagram of a cross-section through the acme nut's grease passageway and fitting. Red areas denote the locations where red grease was found, and gray areas denote the location where the dry residue was found.

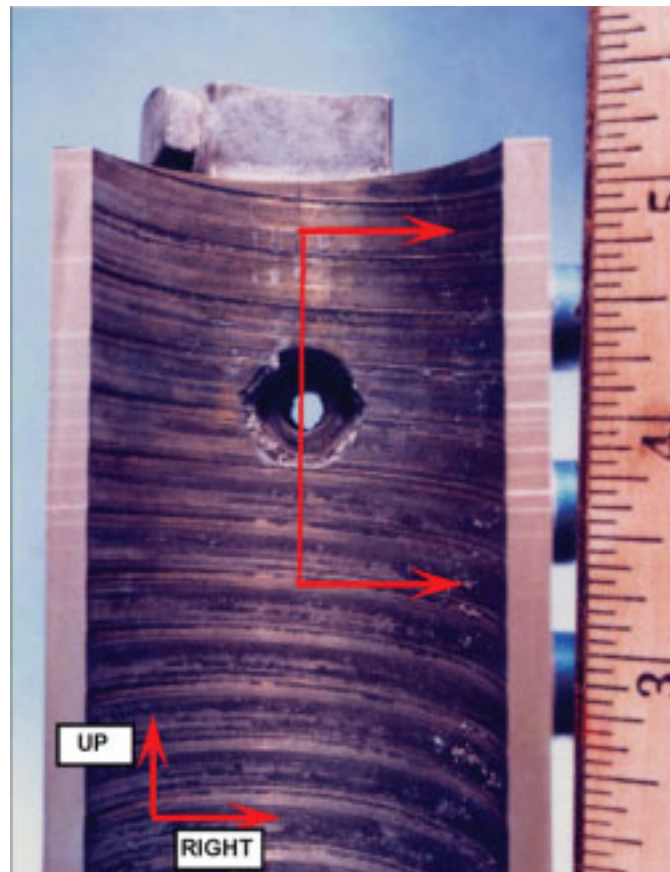
Figure 18. A photograph of the grease passageway and counterbore after the acme nut was sectioned.

Magnified visual inspections of the acme nut's interior after the nut was longitudinally sectioned confirmed the presence of the spiraling pattern consistent with the original location of the internal nut threads. For comparison with the accident acme nut interior, an exemplar nut was similarly sectioned.¹³⁶ The spiral patterns comprised a small raised ridge followed by a lustrous depression with spiral machining or wear marks transitioning into a dark band of surface deposits that rose to the next ridge. Under higher magnifications, longitudinal smearing and shear fractures were identified on the raised edges. The smearing and shearing directions were consistent with upward movement of the acme screw threads in relation to the nut body. Material was observed folded upward and smeared over adjacent surfaces along most of the ridges. Typical ridges were between 0.013 and 0.020 inch wide.

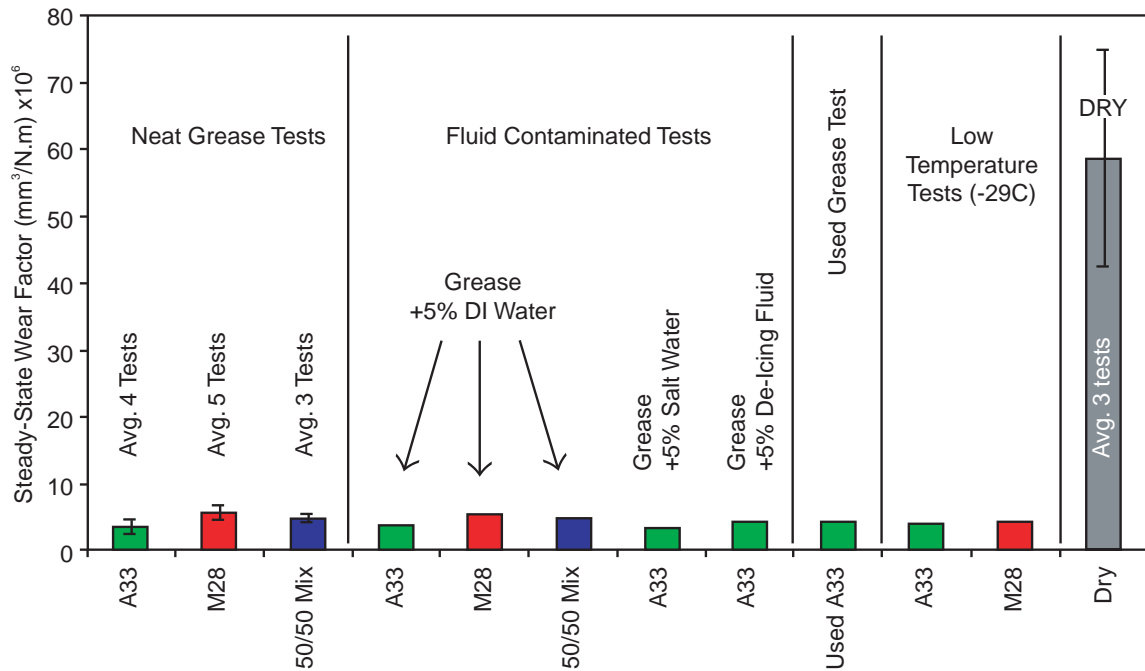
The results of the wear tests showed that, in all ranges of contact pressure, lower wear rates were generated when Aeroshell 33 was used than when Mobilgrease 28 was used. Additionally, the effects of contamination, aging, and subzero temperature exposure were determined to have little effect on the lubricating effectiveness of Aeroshell 33. Only the tests run without any lubrication generated wear rates significantly higher than those generated when Mobilgrease 28 was used. In these cases, wear rates were seen to transition up to 10 times higher than those with equivalent conditions lubricated with Mobilgrease 28. Figure 19 shows a summary of the results of the high-load wear tests, including the contamination and low-temperature tests.

Figure 19. A summary of the results of the high-load wear tests, including the contamination and low-temperature tests.

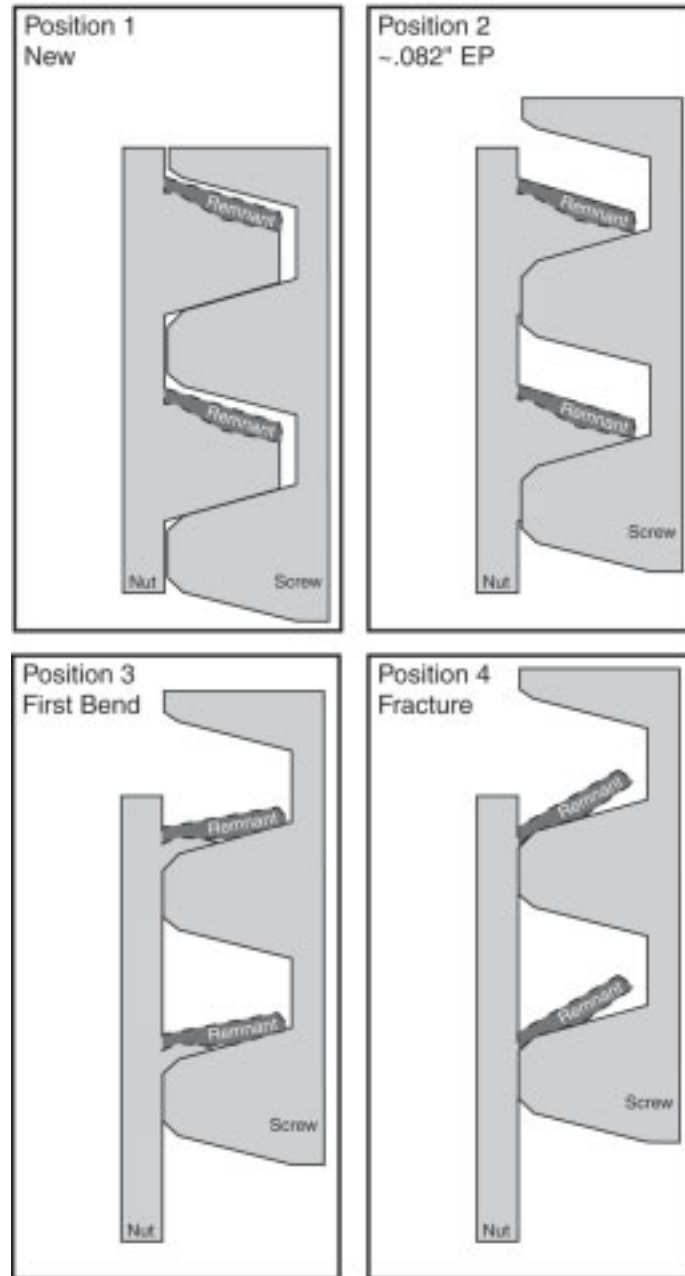
²¹⁶ It was theorized that, as the last of the acme nut thread remnants shear fractured and the screw threads tried to override the resulting ridges in the nut as the screw was pulled upward by aerodynamic loads and rotated circumferentially by the primary trim motor, the combined pinching and friction loads became greater than the combined aerodynamic and primary trim motor forces.

Figure 20. A graphical depiction of the stages of acme nut thread wear to the point of fracture.
