**Aircraft Accident Report**

**In-Flight Electrical System Failure  
and Loss of Control**

**Raytheon (Beechcraft) Super King Air 200,  
N81PF**

**NTSB/AAR-03/01  
PB2003-910401  
Notation 7358A  
Adopted January 15, 2003**

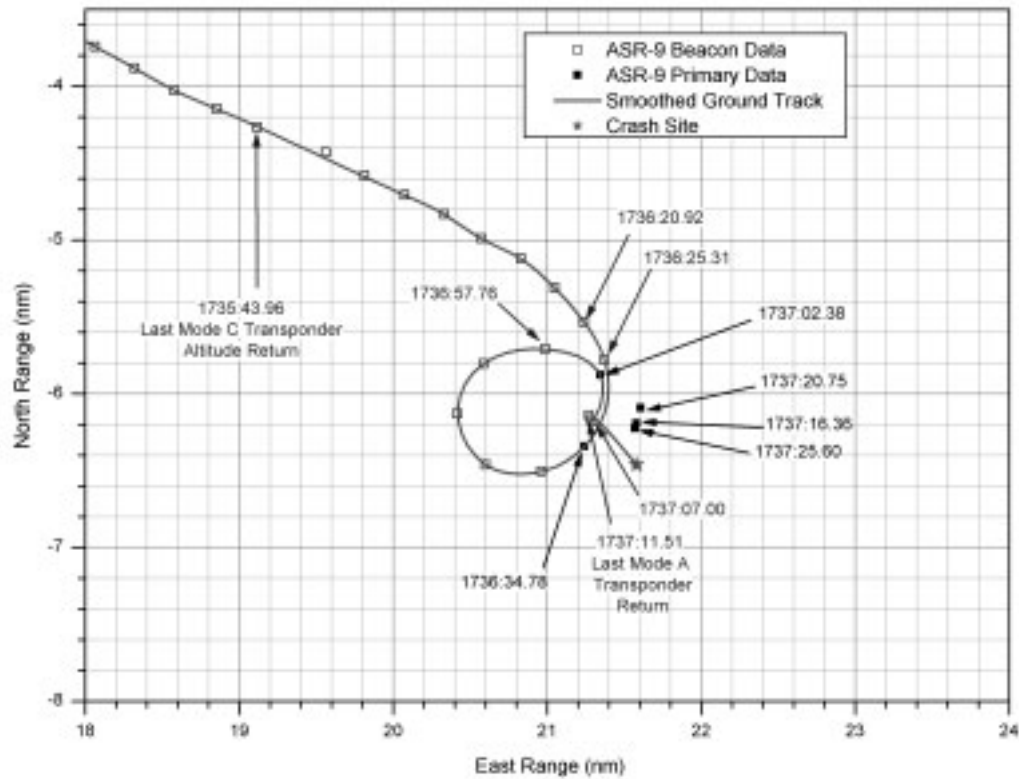
Note: Airport surveillance radar-9 (ASR-9) primary data are reflected radio signals. ASR-9 primary data returns were received until about 1737:26, about 14 seconds after the last mode A (beacon data) return. The distances shown are relative to the ASR-9 radar site at Denver International Airport.

Figure 1. Radar data for the last 2 minutes of the accident flight.

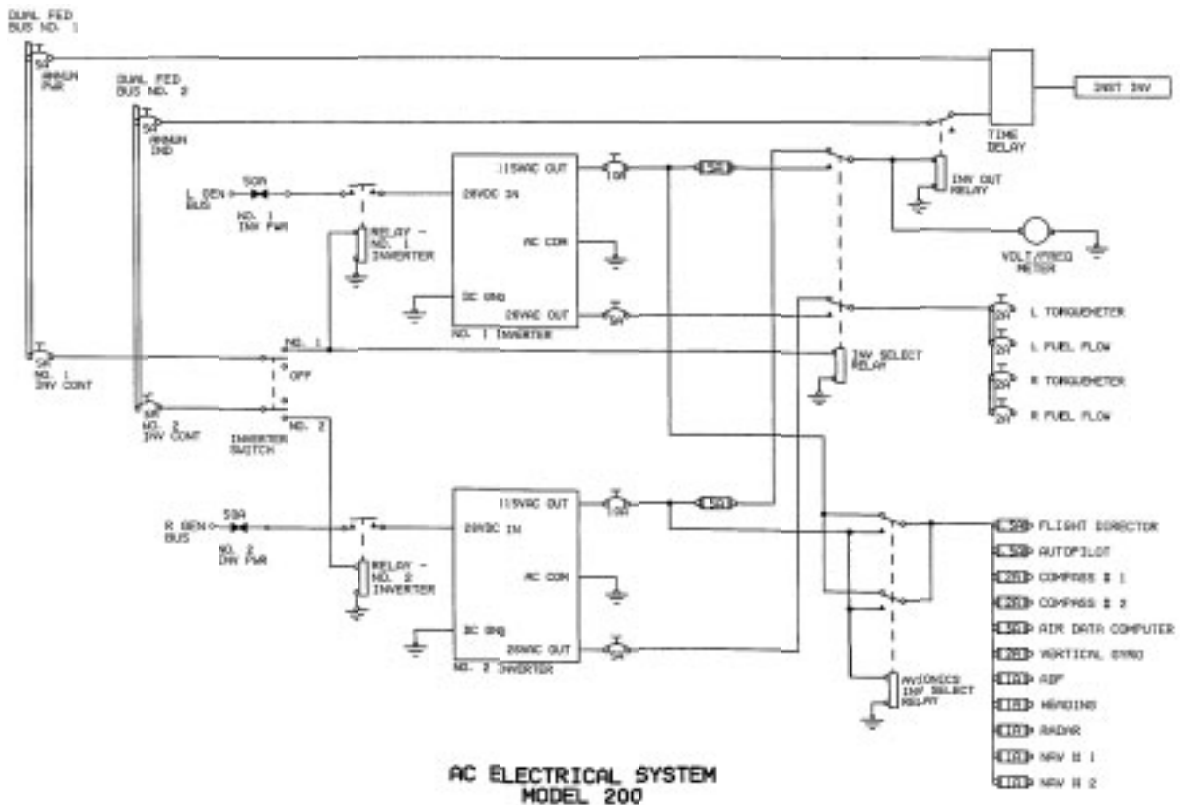
**Figure 2.** Schematic of the King Air 200 a.c. electrical system.

Third, the King Air 200 electrical system schematic indicates that, if at least one of the inverters is operational, no a.c. power is present at the volt/frequency meter, and d.c. power is available to the inverters, then one of three components—the inverter selector switch, the inverter select relay, or the avionics inverter select relay—could produce an a.c. power electrical system failure (see figure 2). Thus, all three components are potential sources of single-point failures in the electrical system. None of these items was recovered from the wreckage.
