**Loss of Pitch Control on Takeoff
Emery Worldwide Airlines, Flight 17
McDonnell Douglas DC-8-71F, N8079U
Rancho Cordova, California
February 16, 2000**

Aircraft Accident Report
NTSB/AAR-03/02

**National
Transportation
Safety Board**
Washington, D.C.

**NTSB/AAR-03/02
PB2003-910402
Notation 7299A
Adopted August 5, 2003**

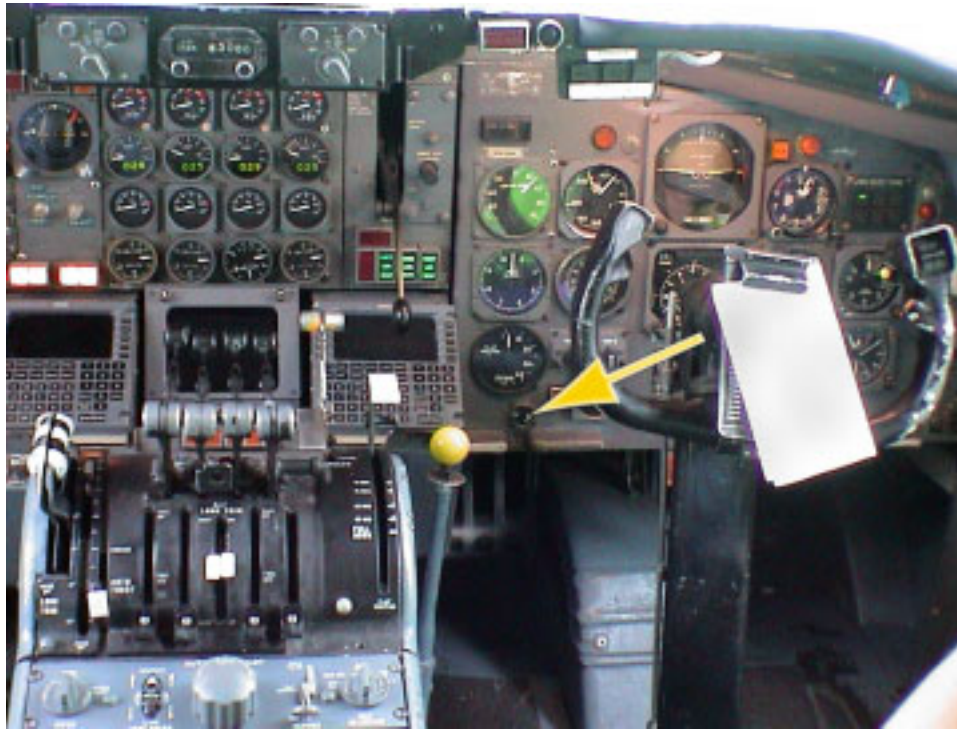
The EPI on the accident airplane was located on the lower left side of the first officer's instrument panel. (Figure 4 shows an EPI installation similar to that on the accident airplane.) The EPI gauge was installed in 1979 by the then-operator of the accident airplane, United Airlines, in compliance with Airworthiness Directive (AD) 78-01-15, which required DC-8 operators to install an EPI system in accordance with Douglas Service Bulletin (SB) 27-254, dated March 5, 1975. The FAA issued AD 78-01-15 as a result of a series of accidents and incidents involving DC-8 jammed or restricted elevator surfaces that began in 1970. (For additional information regarding these instances of jammed/restricted DC-8 elevators, see section 1.6.2.2)

AD 78-01-15 specified that operators install the EPI gauge on the first officer's instrument panel such that full forward movement of the control column and wheel would not obstruct the first officer's view of the gauge. The AD did not comment regarding visibility of the gauge from the captain's seat. As a result, DC-8 operators installed the EPI where they found room for it and where the first officer could see it on an airplane's existing instrument panel. Because Emery purchased its DC-8s from several other operators and EPI placement was not standardized, EPI gauges in Emery's fleet were installed in several different locations; according to Emery personnel, however, they were generally installed on the lower portion of the first officer's instrument panel.

Figure 4. EPI installation on the lower left side of the first officer's instrument panel (shown by the yellow arrow), similar to that on the accident airplane.

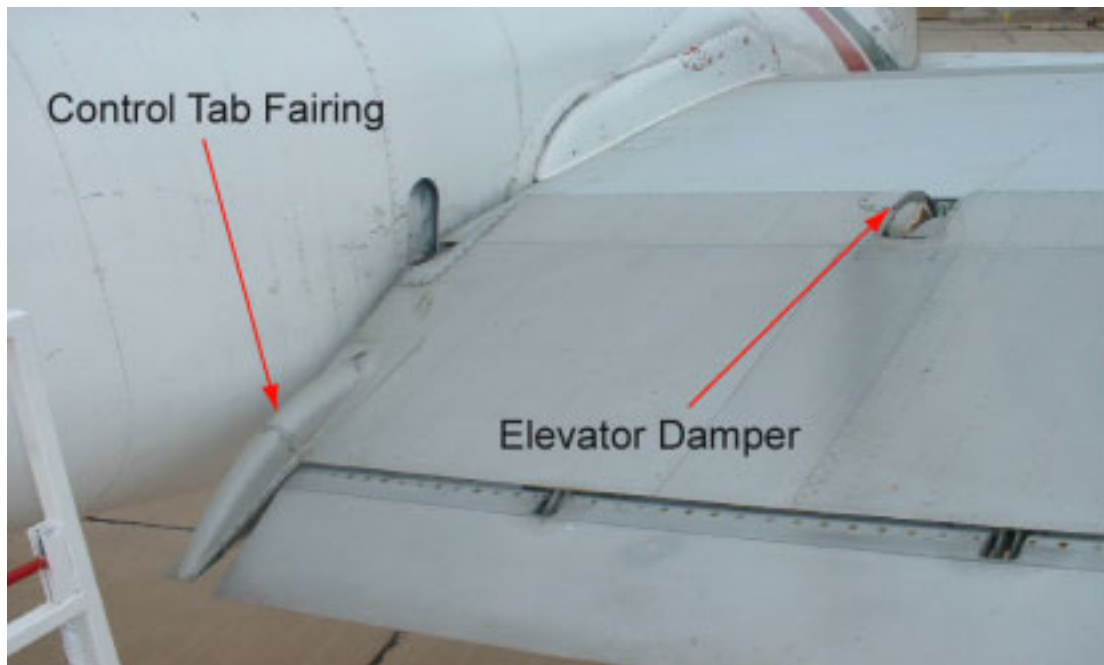
The accident airplane’s maintenance records revealed that on November 25, 1999, eight days after the D inspection was completed (which included the installation of the elevator assemblies), a pilot reported that he had to apply “more back pressure than normal” on the control column to flare during the preceding landing and during the elevator check before the previous takeoff. The corrective action for this pilot report (performed by Emery maintenance personnel) was described in the accident airplane’s maintenance logbook as follows: “Found [left/right] elevator dampers reversed, moved [left to right] side, [right to left] side, ops ck’d good, no defects noted.” Figure 5 shows the elevator damper’s location on the right elevator of a DC-8.

Figure 5. Photograph showing the elevator damper's location on the right elevator of a DC-8.

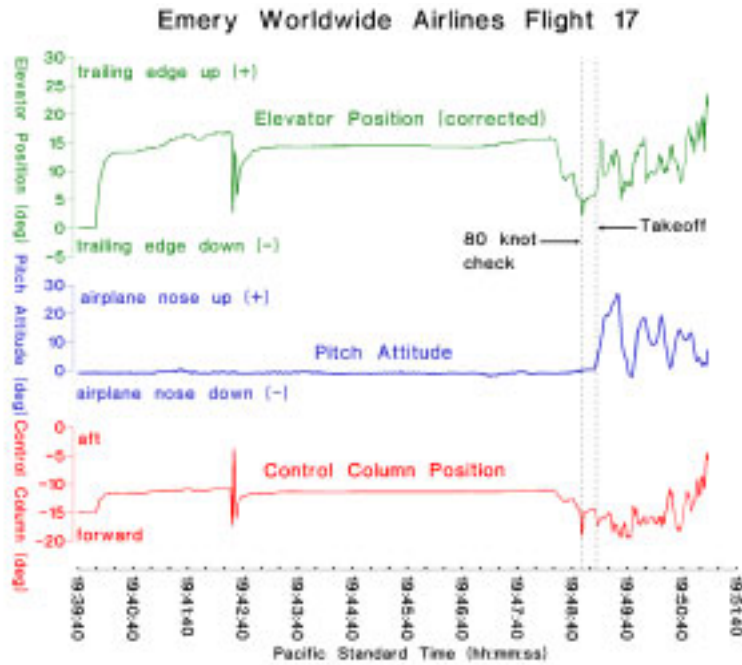
The Safety Board's examination of the corrected elevator position data revealed that the airplane's elevator never traveled below its neutral position to a TED deflection during the accident flight, although recorded forward control column inputs should have resulted in a TED elevator deflection. For example, although the FDR data indicated that, during the 80-knot elevator check at MHR, the control columns were moved to about 6° forward of their rigged neutral position, the elevators did not deflect below 2.2° TEU. In contrast, during the 80-knot elevator check on the previous takeoff (at RNO) the FDR recorded elevator movement to 8° TED, with less forward control column movement. Figure 7 shows plots of the pitch attitude, control column position, and elevator position FDR data for the accident flight. Elevator position is shown using the conversion that corrected for the 11° offset. Figure 7 also shows when the 80-knot elevator check and takeoff occurred. Figure 8 shows the same information for the takeoff from RNO.

Figure 7. Pitch attitude, control column position, and (corrected) elevator position FDR data from the accident flight. About the first 20 seconds of data were recorded while the gust lock was engaged.

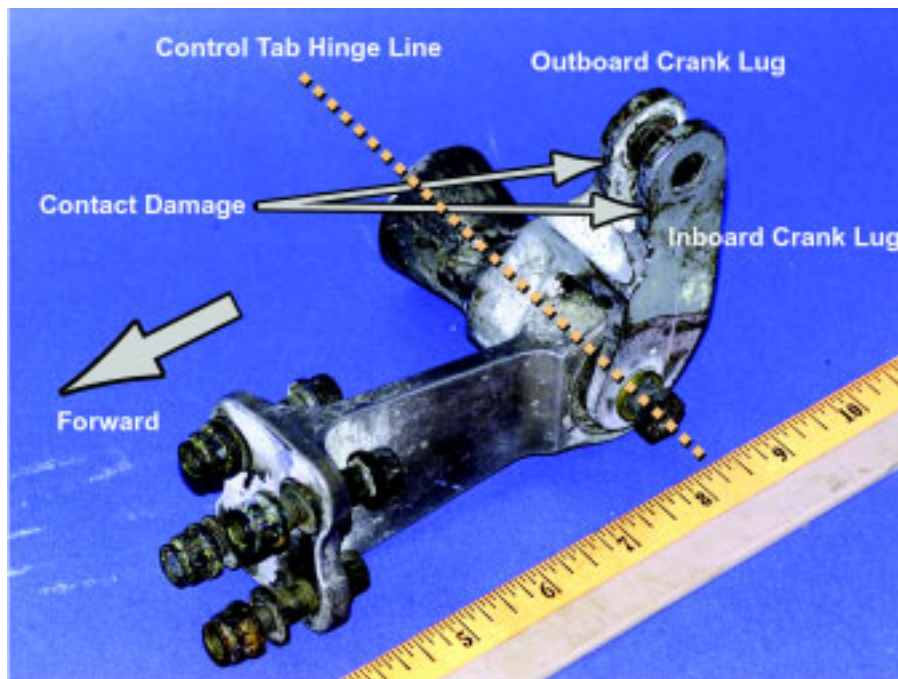
The National Transportation Safety Board determined that the probable cause of the accident was a loss of pitch control resulting from the disconnection of the right elevator control tab. The disconnection was caused by the failure to properly secure and inspect the attachment bolt.

(See figure 2, in section 1.6.2, for a diagram of the elevator control tab installation.) The right control tab pushrod was recovered separately, with its aft rod end (which would normally have been bolted to the tab crank fitting) intact. Examination of the forward edges of the elevator control tab crank fitting lugs revealed evidence of repeated contact damage (including gouge marks and indentations). (Figure 9 is a photograph of damage to this area.) The internal surfaces of the pushrod aft rod end bearing and the bushings in the crank fitting lugs showed no visible signs of damage or deformation. The bolt and associated hardware that normally secures the right elevator control tab pushrod to the tab crank fitting⁶¹ was missing and not recovered.

Although the inboard portions of the left elevator, control tab, crank fitting, and attachment hardware were not recovered and were presumed consumed by postcrash fire, the left elevator control tab pushrod was recovered. Unlike the right control tab pushrod, the left control tab pushrod's aft rod end (normally attached to the tab crank fitting) was fractured and about 75 percent of it and its associated bearing were missing. The forward end of this pushrod was fractured at its rod end attachment holes, and the pushrod had about an approximately 90° bend at its midpoint. No fire damage was observed on the left control tab pushrod assembly.

Figure 9. A photograph of the accident airplane's right elevator control tab crank fitting. Note damage on forward face of control tab crank fitting lugs.

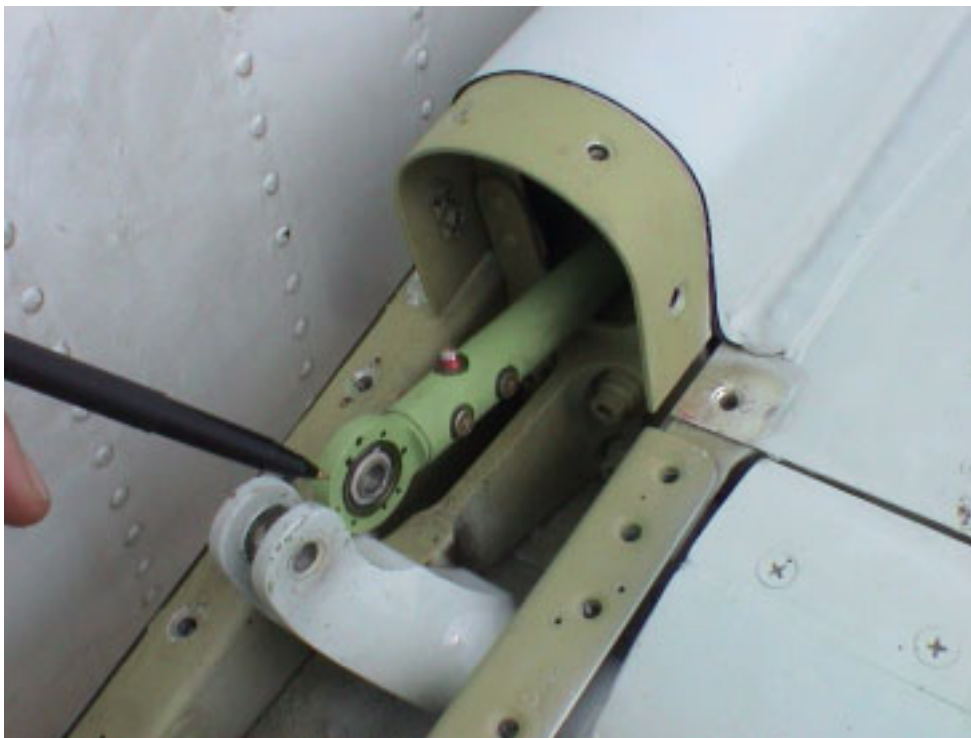
After the test airplane's baseline deflections were measured, investigators removed the right elevator control tab aft pushrod attachment bolt from its crank fitting. With no additional manual input, the right elevator control tab moved to a 29° TED deflection, where it contacted the geared tab linkage fairing. With this control tab movement, the aft end of the pushrod moved free of the crank fitting.

When the aft end of the test airplane's pushrod cleared the crank fitting, it shifted slightly inboard so that it was aligned with the inboard leg of the forward face of the crank fitting. When the test airplane's control tab was manually raised TEU (simulating the effects of aerodynamic forces that would be experienced during the takeoff roll), the crank fitting contacted the aft rod end, obstructing any attempt to further deflect the elevator control tab in the TEU direction. Figure 10 shows the test airplane's pushrod in this position.

Figure 10. Photograph of the test airplane's right elevator control tab pushrod contacting the crank fitting.

When the test airplane's elevator surfaces were manually moved to their TEU limit (about 27° TEU) in this condition, the control columns moved aft from 15.0° forward of vertical (the position in which they were held by the centering device) to about 8.8° forward of vertical, and both elevator geared tabs moved to 27.5° TED. The left elevator control tab deflected fully to about 8.5° TEU; however, the right elevator control tab could not be moved further in the TEU direction than 15.9° TED because of interference with the disconnected pushrod.

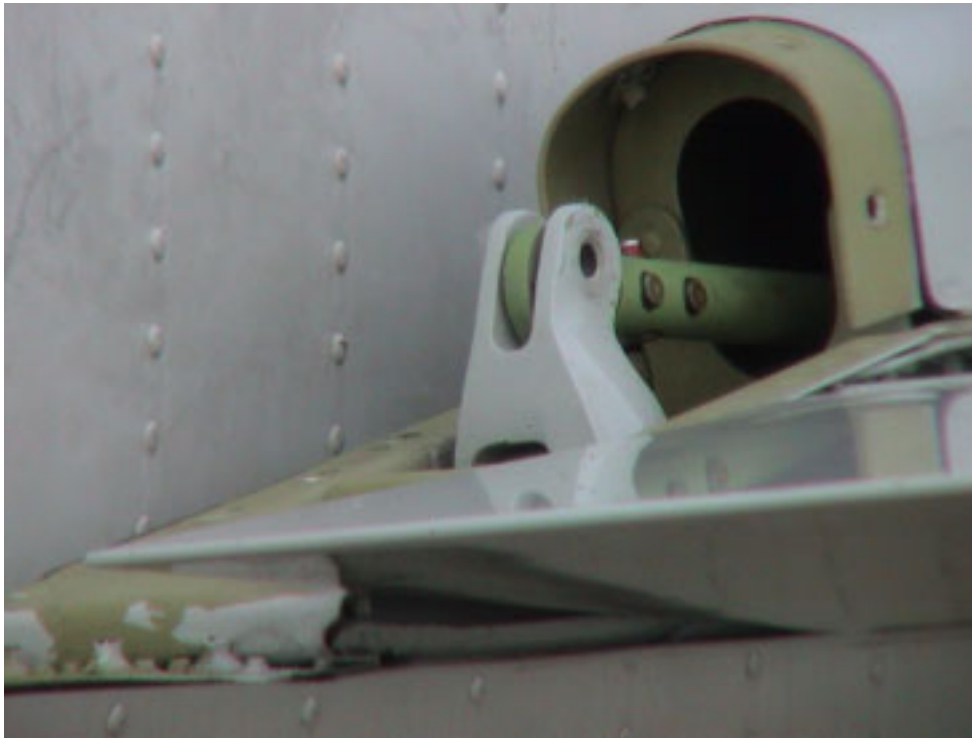
Because a free elevator control tab pushrod might not necessarily always displace itself inboard into alignment with the crank fitting as it did on the test airplane (especially if the pushrod is disconnected while the airplane is in flight and aerodynamic forces are acting on the flight control surfaces), the Safety Board examined other potential interference modes between a free elevator control tab pushrod and crank fitting. These tests revealed that in general, contact between a free pushrod and the forward face of either crank fitting lug (accounting for rod end misalignment, etc.) resulted in a mismatch of approximately 25° between the left and right control tabs. These tests also revealed that a disconnected control tab could be rotated about 3° to 4° in the TEU direction if the crank fitting remained centered about the pushrod; however, further movement was restricted by contact between the crank fitting and shoulders of the aft end of the pushrod. Figure 11 is a photograph of the test airplane's control tab in this position.

Figure 11. Photograph of the test airplane's disconnected right elevator control tab pushrod centered between the lugs of the crank fitting with the control tab rotated 3° to 4° in the TEU direction after the attachment bolt was removed.

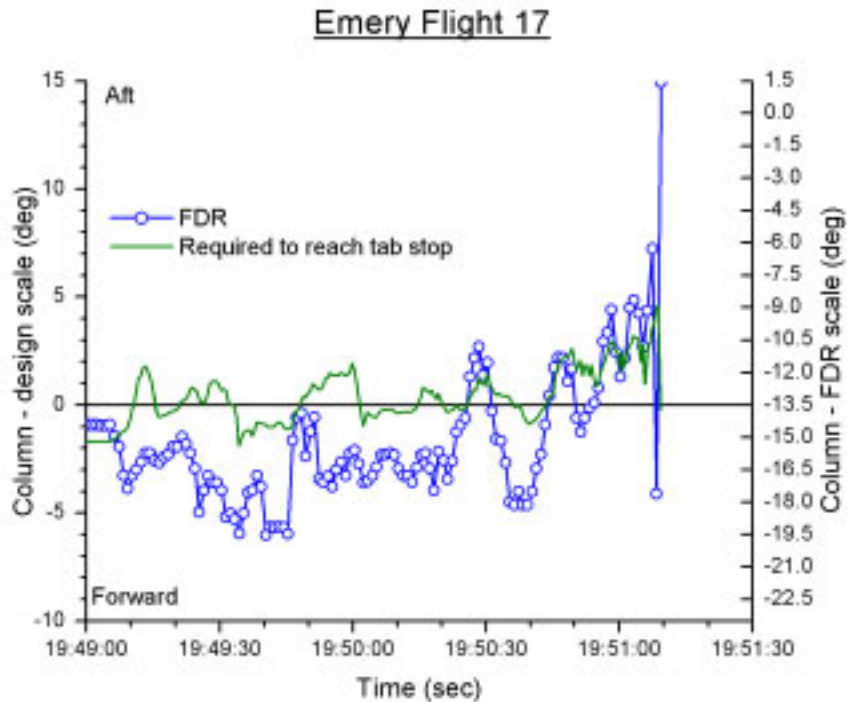
Figure 12 shows the control column position required for the left elevator control tab to reach its TEU physical stop (with no cable stretch) and the recorded control column position for the recorded elevator position during the accident flight. The plot indicates that at most points during the accident flight, the flight crew was trying to command additional forward control column.

The Safety Board's examination of the FDR data for the flights preceding the accident flight revealed that a change in the relationship of control column movement to elevator response occurred about 8 minutes and 20 seconds before the accident airplane landed at MHR. The Board's performance study derived the control tab positions at the time of this change. The study showed that the change in FDR data could be explained by a shift of about 3° to 4° in the TEU direction of the right control tab, assuming that the right control tab's pushrod to crank fitting attachment bolt separated at this time. This change in the FDR data was evident until the airplane landed at MHR. As previously discussed, a scenario in which a disconnected pushrod remained between the lugs of the aft crank fitting (shown in figure 11) resulted in a 3° to 4° control tab shift in the TEU direction.

Figure 12. The control column position required for the left elevator control tab to reach its TEU physical stop (for the recorded elevator position) and the actual recorded control column position for the accident flight.
