**National Transportation Safety Board**  
Washington, D.C. 20594

**Aircraft Accident Brief**

<b>Accident Number:</b>	CHI01MA006
<b>Aircraft and Registration:</b>	Bombardier CL-600-2B16 (CL-604), C-FTBZ
<b>Location:</b>	Mid-Continent Airport, Wichita, Kansas
<b>Date:</b>	October 10, 2000
<b>Adopted On:</b>	April 14, 2004

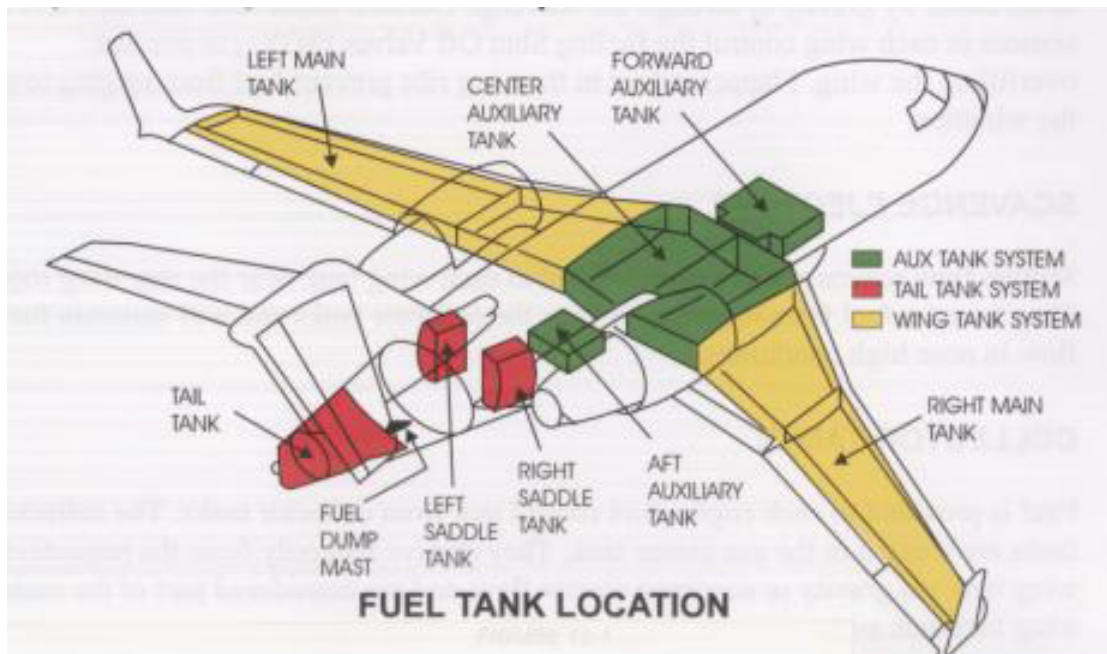
**Figure 1.** Airplane Fuel System Diagram

The airplane fuel tank system comprised a left wing tank, right wing tank, auxiliary fuel tank and tail fuel tank (see figure 1). The auxiliary fuel tank system beneath the center cabin had a forward, center, and aft tank that were interconnected by pipes and that were not isolated from each other by shutoff valves or check valves. The tail fuel tank system had two saddle tanks and a third tank at the rear of the tail cone. (see figure 1).

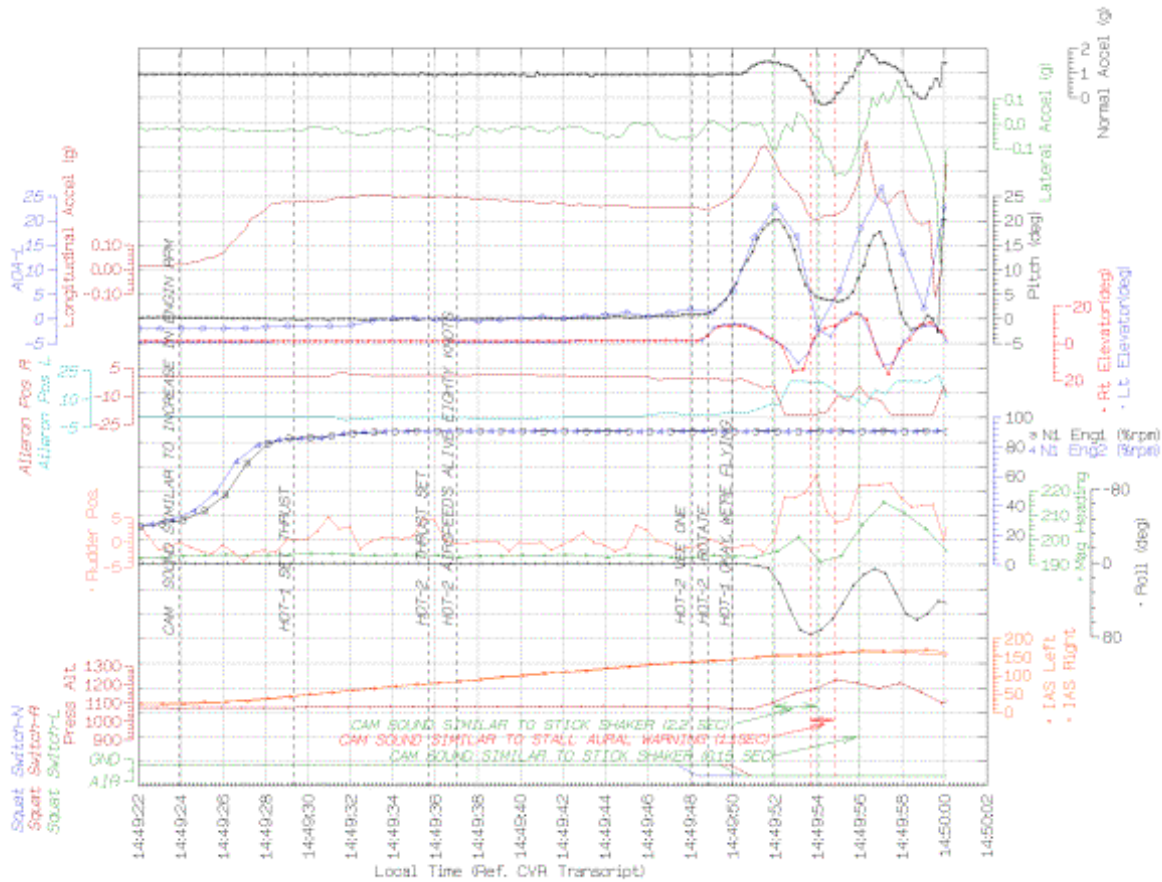
Figure 2.

According to FDR data and information derived from the Safety Board staff's integration study of FDR data (flightpath integration), the airplane's peak airspeed was 170 knots. The flightpath integration indicated that the airplane's peak altitude was about 70 feet. FDR information indicated that the engines were operating at 90 percent fan speed until impact.

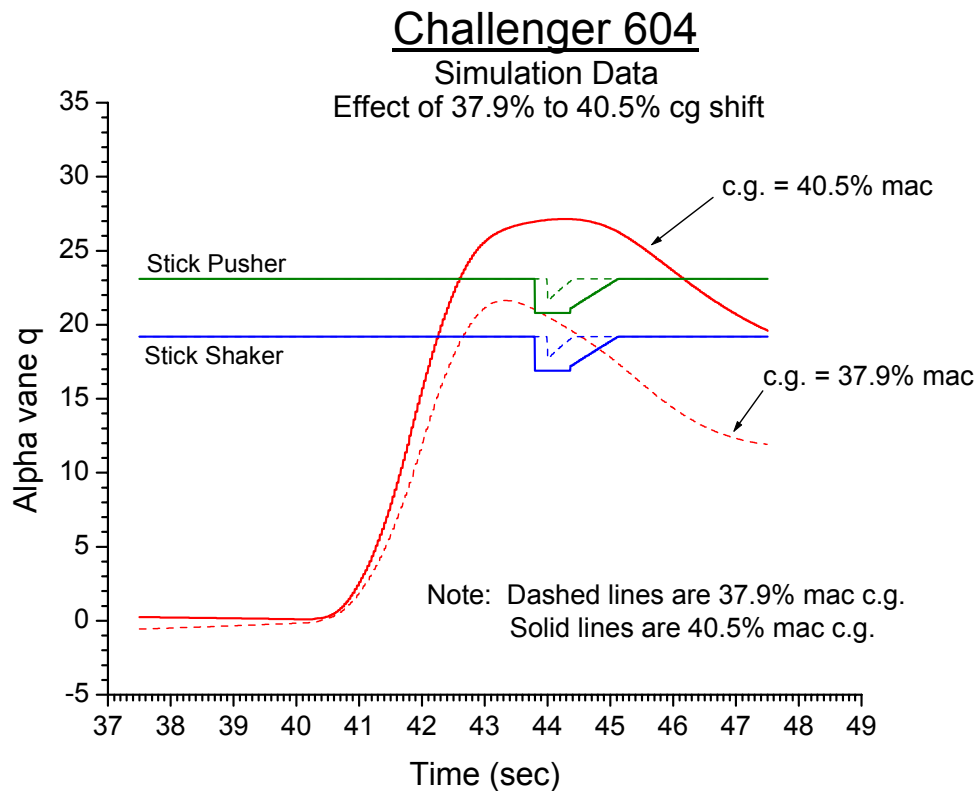
**Figure 3. C.g. Sensitivity and Stick Shaker/Pusher Threshold Values**
