**Collision With Trees on Final Approach  
Federal Express Flight 1478  
Boeing 727-232, N497FE  
Tallahassee, Florida  
July 26, 2002**

**NTSB/AAR-04/02**

**National  
Transportation  
Safety Board**

**NTSB/AAR-04/02  
PB2004-910402  
Notation 7501B  
Adopted June 8, 2004**

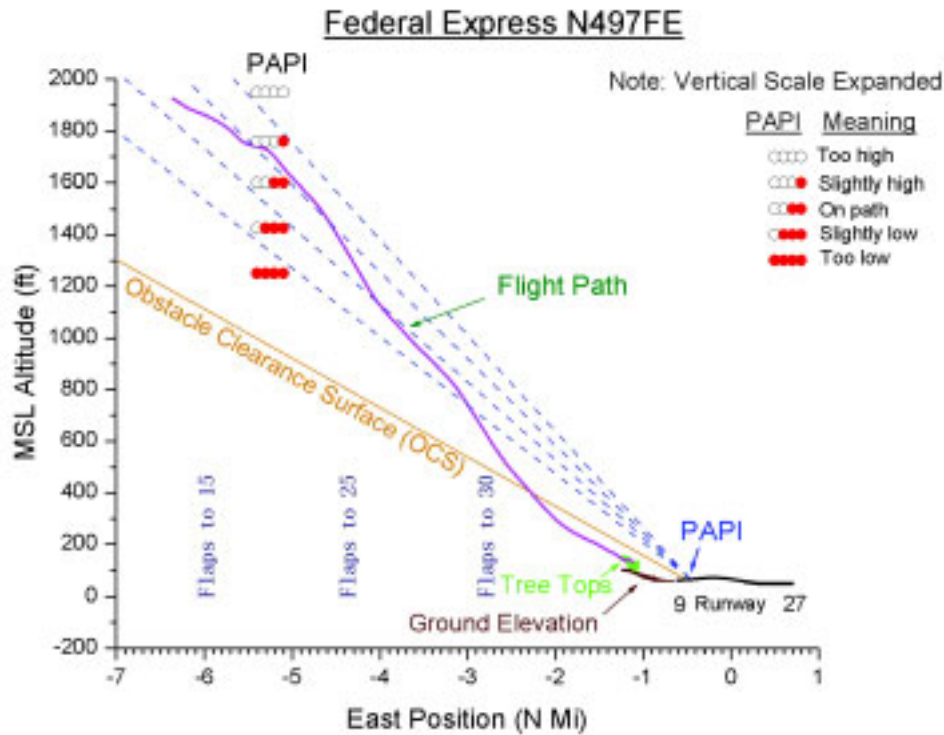
Figure 1. Descent profile of FedEx flight 1478.

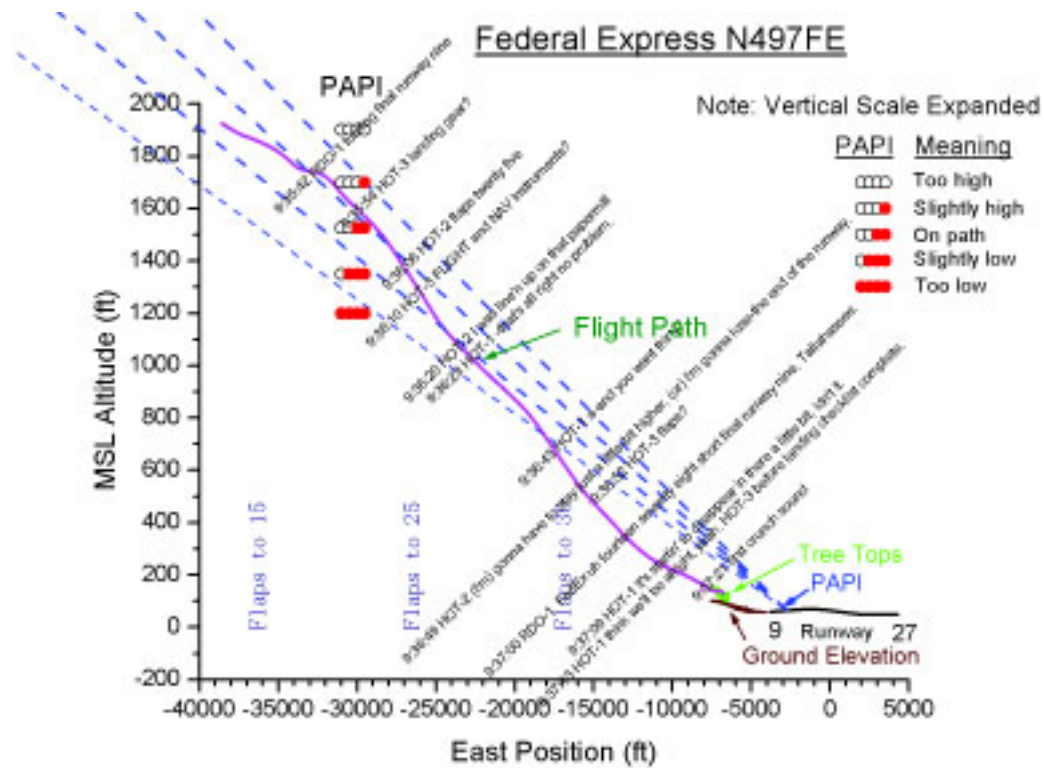
Figure 2. Descent profile of FedEx flight 1478, with select CVR comments overlaid.

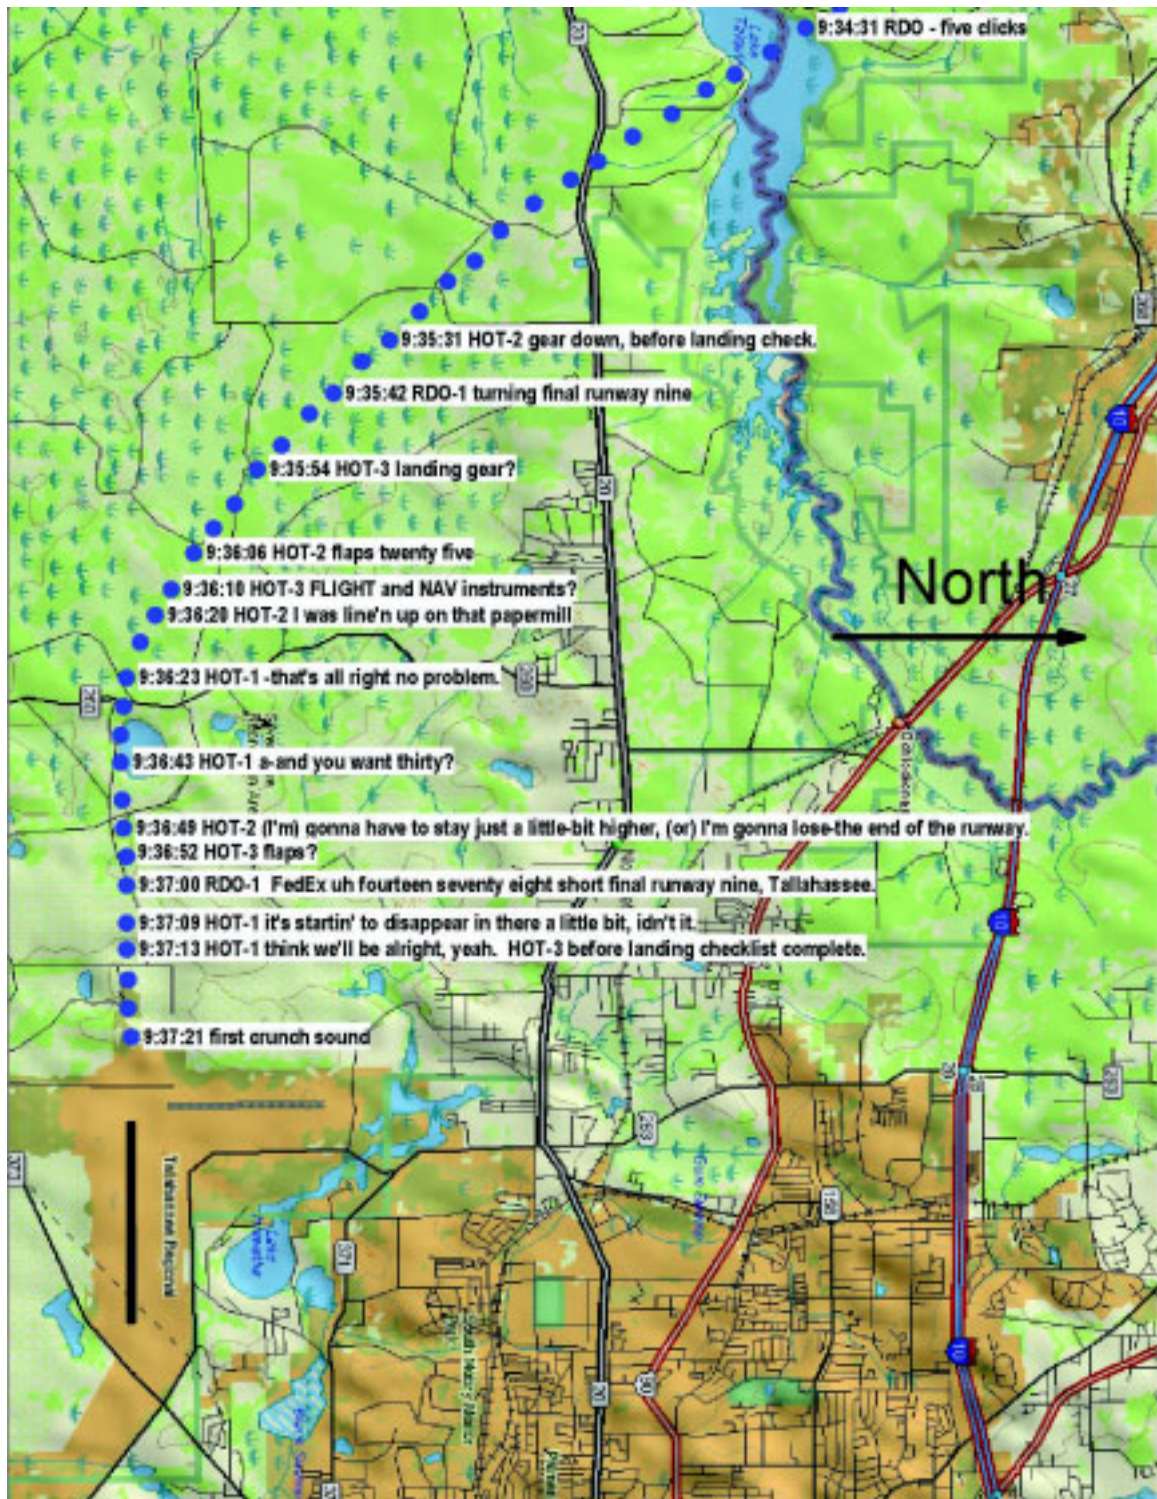
**Figure 3.** A map overlay of FedEx flight 1478's radar track into runway 9 at TLH, with excerpted CVR comments.

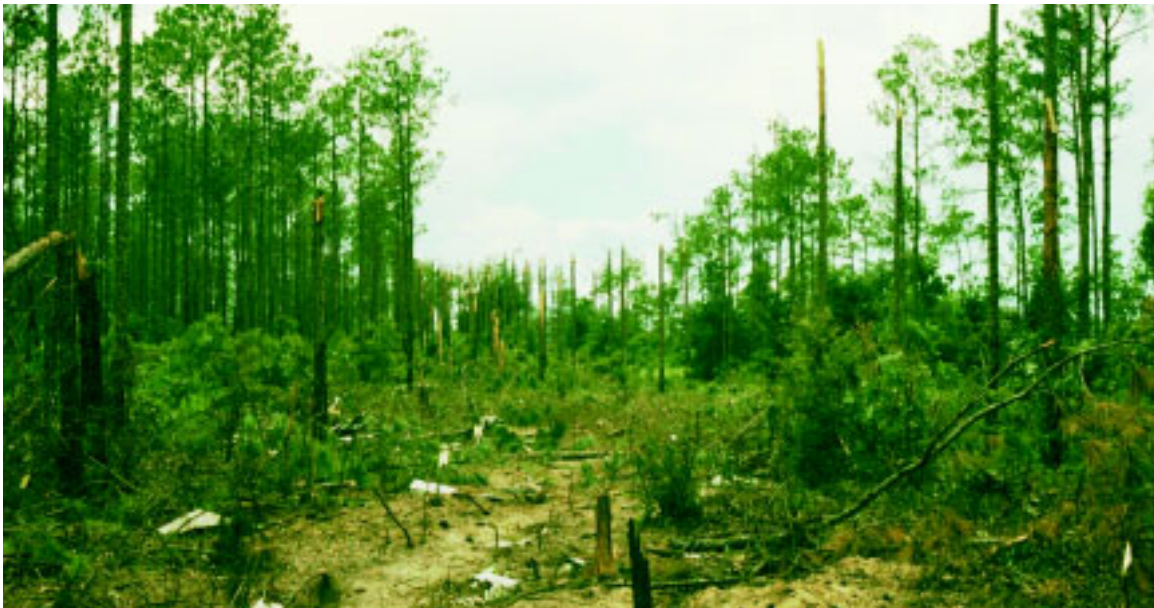
broken trees continued to the edge of the wooded area (about 1,130 feet from the initial impact), where the trees on the right and left sides of the swath were broken at 7.9 feet and 31.7 feet, respectively. (Figure 7 shows the swath of damaged trees, looking from east to west, with the first ground scars and airplane wreckage in the foreground.) Pieces of the right wing (including the right wing leading-edge flap, trailing-edge flap, wing tip, strobe light, flap jack screws, and slat tracks) were located in the wooded area.

**Figure 7.** A swath of trees damaged by impact with FedEx flight 1478.
