Glenpool South Tank Farm Glenpool, Oklahoma April 7, 2003

Storage Tank Explosion and Fire ConocoPhillips

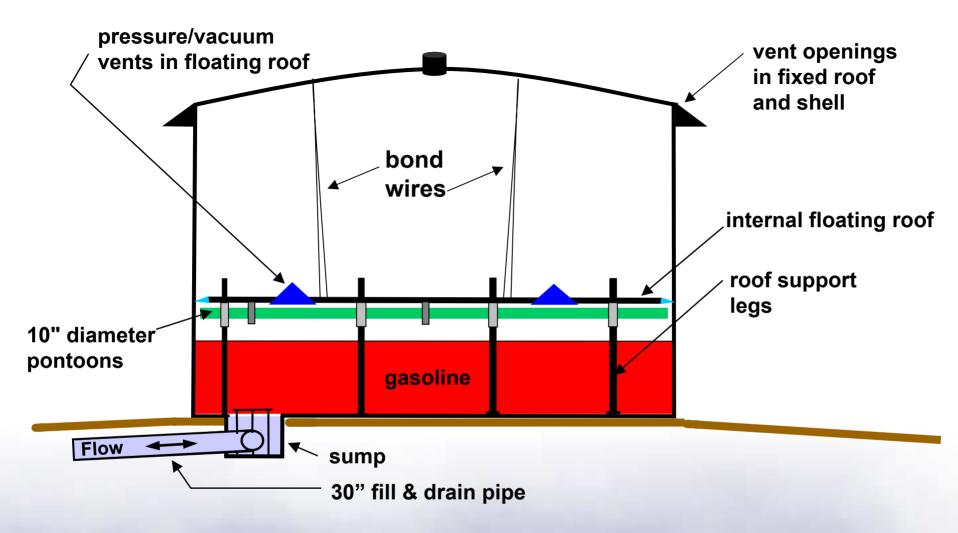
Tank 11 with the floating roof landed

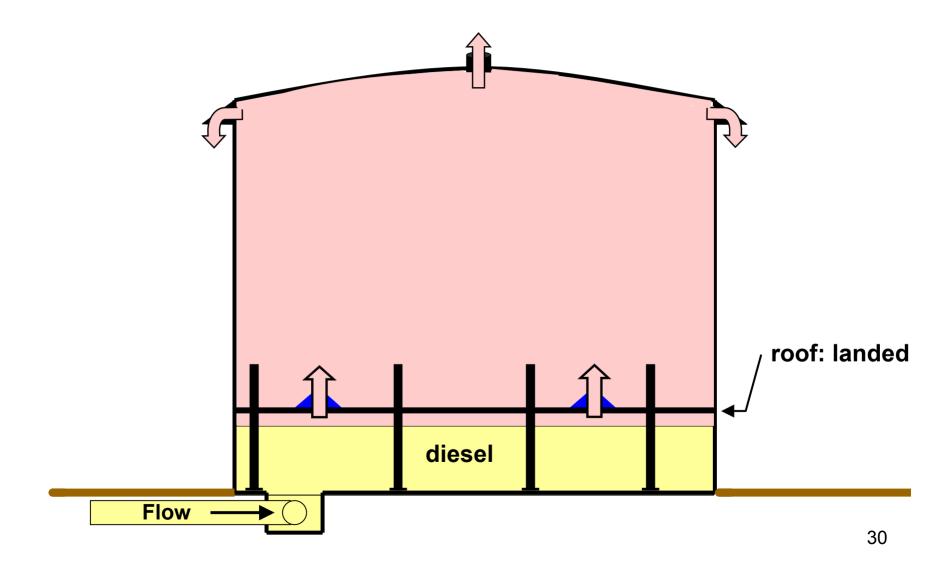
Diesel added (switch load)

All the conditions necessary for fuel vapor ignition were present in the storage tank at the time of the accident, and the explosion most likely occurred when a static discharge ignited a flammable fuelair mixture in the space between the surface of the diesel and the floating roof. The extensive damage to the tank is consistent with the flammable fuelair mixture above the floating roof contributing to the force of the explosion.
