# OPERATING EXPERIENCE SUMMARY

OE Summary 2004-17

September 7, 2004

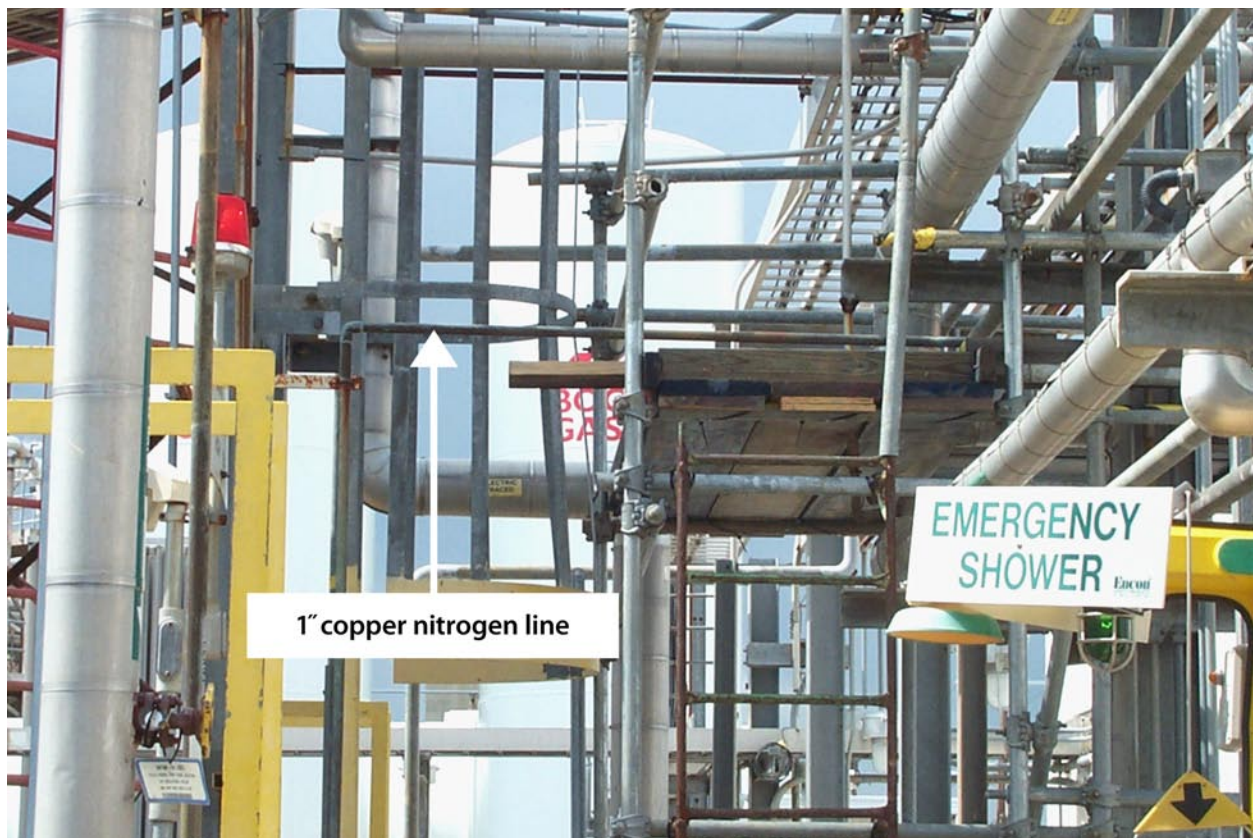
Carpenters were erecting scaffolding in the Cold Feeds area. The carpenter was about 12 feet up on the scaffold and was wearing a safety harness. The 1-inch copper nitrogen line was a branch line off a larger header of the normal nitrogen system. The nitrogen lines were clearly marked and the existence of the 1-inch line was discussed during the pre-job brief. Figure 1-1 shows the location

of the line, which ran approximately 6 inches above the wood flooring of the scaffolding.

Investigators determined that the carpenter should have been able to see the nitrogen line because it was in plain sight and that he knew the line was there because it had been discussed during the pre-job brief. Investigators also learned that the instructions for erecting the scaffold required all saw cuts to be performed on the ground, not up on the scaffold.

*Figure 1-1. Scaffold and nitrogen line*

*This event underscores the importance of adhering to work instructions and following the information provided during pre-job briefings. Workers need to maintain awareness of their surroundings at all times and remain focused on the task at hand, particularly when using powered hand tools. This event was a near miss because of the sudden high-velocity release of nitrogen near the carpenter, and it could have been even more dangerous if the nitrogen line had been a conduit containing energized electrical conductors.*

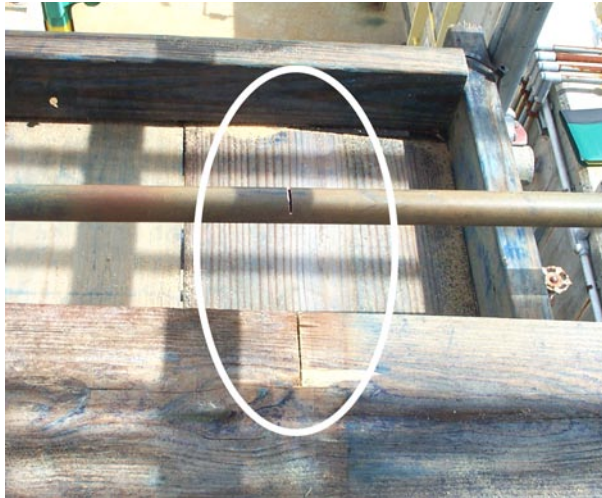
Although the carpenter knew about the line, he rested the board on top of it while cutting the wooden plank for the scaffolding installation. When the carpenter cut the board, the saw blade also cut almost all the way through the 1-inch line (Figure 1-2).

**Figure 1-2. Saw cut in line and plank**

Operators in the control room were notified of the breached nitrogen line and dispatched an operator to identify and close an isolation valve in the nitrogen system. After he isolated the nitrogen line, the operator locked and tagged the isolation valve closed.

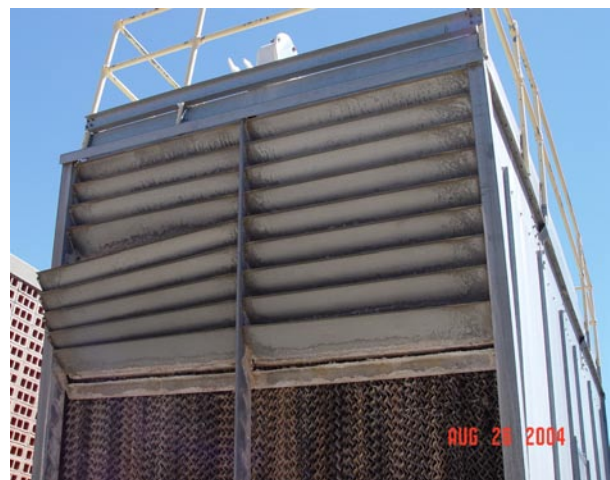
Such was the case on August 23, 2004, at Sandia National Laboratories, when workers were exposed to material containing 35 percent asbestos while removing cooling tower fill from three towers. (Figure 2-1 shows one of the towers and fill material.) The towers, manufactured in 1979 to fire-resistant specifications, were out of service for 15 years but are now being brought back into service to reduce energy costs. Facilities Management and Operations Center staff believed that the fill material was constructed of polyvinyl chloride (PVC), not transite or asbestos-containing materials (ACM). Because PVC and fire-resistant cooling tower fill are outwardly identical, and based on general material knowledge, no one ordered additional testing, nor was work planned or performed with controls associated with an asbestos abatement activity. (ORPS Report ALO-KO-SNL-NMFAC-2004-0005)

**Figure 2-1. Cooling tower and fill material**

Test results (received in less than 4 hours) showed that the fill material was 35 percent asbestos. All parties, including Kirtland AFB, the National Nuclear Security Administration (NNSA), contractors, and craftspeople associated with the project were notified; and workers associated with the retrofit project were directed to go to the site medical facility for evaluation.

Workers had removed about 30 cubic feet of asbestos from the tower at the time the ACM was discovered. Landfill personnel determined that the material had not been attached to any framework and had been covered with dirt and debris, so it was not recoverable. Kirtland management reported the event to the New Mexico Environmental Department. Although non-asbestos PVC insulation and the tower fill insulation looked identical, a more conservative approach of sampling it “just to make sure” might have prevented the subsequent work shutdowns and notifications.

*These events demonstrate the importance of anticipating the potential for discovering ACM during D&D activities and renovation work (i.e. any work that disturbs existing construction or infrastructure). Not only should D&D work planners consider the potential for ACM, but workers must understand that asbestos is neither rare nor a thing of the past — it can be encountered in a variety of places. Because of the subtle dangers of asbestos, workers should take all necessary precautions, never letting process knowledge or assumptions (e.g., building date or tile size) drive the work. In addition, an up-to-date analysis should be performed on materials sampled in the past.*

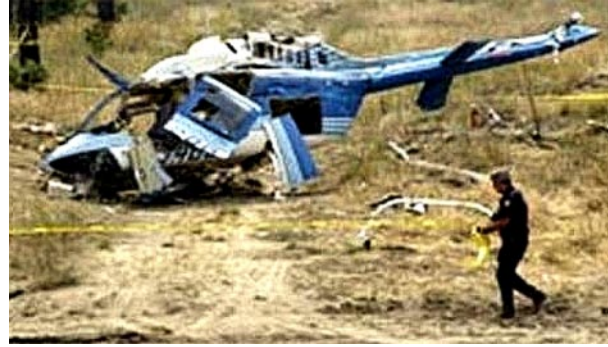
The pilot, with 29 years of service at BPA, was flying a 1994 Bell Jet Ranger (Figure 3-1) when it crashed in a field. FAA inspectors' preliminary findings indicate that the helicopter was pulling rope for installing a static wire at the top of 220-foot-high towers supporting a 500-kV power line. A reel machine operator played out rope from a truck-mounted machine on the ground,

**Figure 3-1. Accident scene**

and the rope was attached to the helicopter's cargo hook. The reel machine operator stated that he saw the adjacent turn of line cross over the outfeed line, which caused the line to begin rewinding on the reel.

The reel machine operator immediately disengaged the machine's spooling mechanism, but the rope between the reel and the helicopter had already pulled taut. About 20 members of the work crew installing the wires witnessed the accident and reported that when the rope went taut, the helicopter pitched up and rolled right. The helicopter fell approximately 200 feet to the ground and landed on its right side.

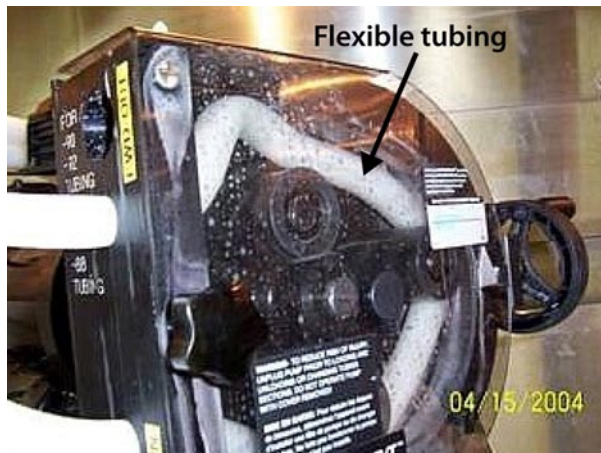
On April 15, 2004, waste operations personnel were using a peristaltic pump to move caustic liquid from waste containers into a 55-gallon drum when the flexible tubing used inside the pump burst, spraying approximately 500 ml of

*Figure 4-1. The pump shortly after the accident*

liquid into the room (Figure 4-1). A support staff member tried to turn off the pump and was sprayed with a small quantity of the liquid. He suffered first-degree chemical burns on his face and arms. One of the technicians working in a fume hood was sprayed in the face with a few drops of the liquid. He quickly wiped his face with a damp towel and was not burned or injured. (ORPS Report RL--PNNL-PNNLNUCL-2004-0004; final report filed August 6, 2004)

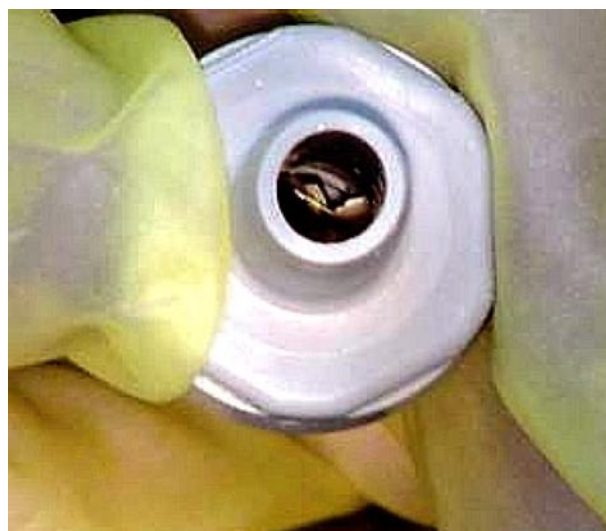
Investigators determined that the most likely cause for the tube rupture was a combination of an obstructed quick-disconnect fitting (Figure 4-2) on the outlet side of the pump and increased

backpressure caused by a higher than normal occlusion setting on the pump. Paper debris had clogged the quick-disconnect fittings (most likely pH paper or pieces of container labeling) when it was drawn in from the bottom of the waste containers. The paper accumulated during the transfer process and eventually blocked the fitting completely.

*Figure 4-2. Clogged quick-disconnect fitting*

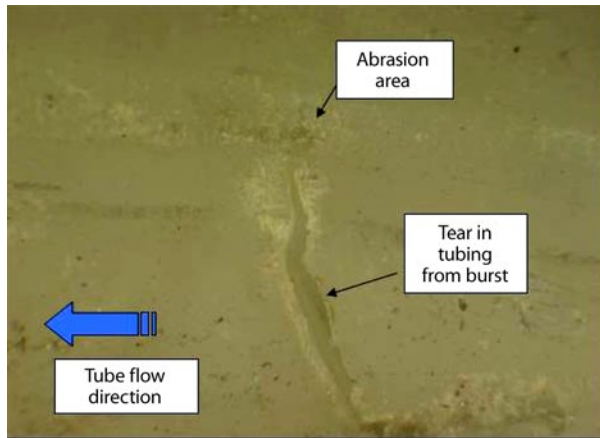
Figure 4-3 shows a microscopic image of the ruptured tube. The investigation revealed that the following work planning deficiencies contributed to this accident.

- The staff did not hold a pre-job meeting to discuss personal protective equipment (PPE) requirements or each member's roles and responsibilities. This prevented them from identifying and applying work controls for working with caustic material.
- The staff members did not read the manufacturer's operating manual before using the peristaltic pump.
- The safety subject matter expert reviewed the transfer procedure, but did not review the operation.
- The pump was not in an enclosure, which would have contained the spray from the ruptured tube.

*Figure 4-3. Microscope image of the ruptured tube*

- The remote shutoff switch was in a position that forced support staff to reach toward the pump to shut it down. When the staff member heard the pump vibrating, he had to get close to the pump to turn it off, placing himself in the spray path. Changing the location of the remote switch would have reduced the probability of being sprayed.
- The staff members wore PPE that was inadequate to protect them from the splashing liquid.
- The site procedure for radioactive liquid waste transfers did not address staff roles or PPE and did not specifically describe transfers by pumping, siphoning, or pouring.

- Developing a comprehensive safety and health improvement plan;
- Implementing a program to improve worker safety and health awareness;
- Developing a line management training program that focuses on safety and health;
- Developing hazard awareness training;
- Making line management more accountable for safety initiatives;
- Developing an experimental authorization form to inform cognizant space managers of the processes and potential hazards that will be in their assigned spaces;
- Targeting corrective actions to enhance trending of events; and
- Developing a new safety tool in which staff asks safety-specific questions such as "What's the worst thing that can happen?" and "How can I prevent that from happening?" before starting work.
