OPERATING EXPERIENCE SUMMARY

U.S. Department of Energy
Office of Environment, Safety and Health
OE Summary 2004-18
September 20, 2004

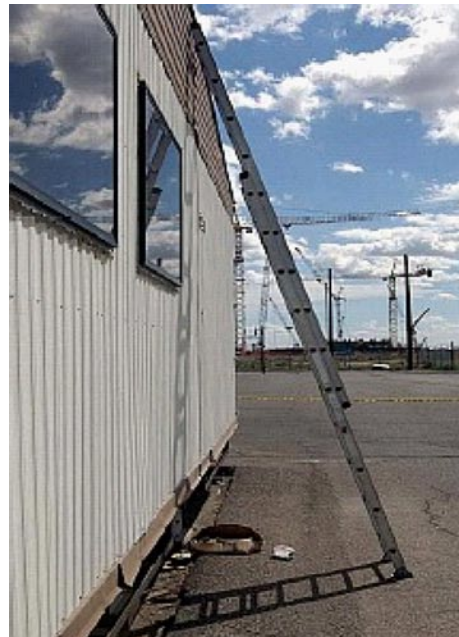
- The worker apparently was standing on the ladder approximately 5 to 6 feet off the ground removing screws from the aluminum trim of an office trailer to prepare it for transport to its new owner. Figure 1-1 shows the ladder propped against the trailer.

Figure 1-1. Ladder and trailer involved in the accident

- Identify the policy for, define, and establish authorities, accountability, and roles and responsibilities for non-government work activities at DOE sites.

- Establish policies for safe work performance and for applying ISM principles to site activities not governed by contract.
- Review formal and informal processes for applying ISM principles to non-government contract activity.

- Develop the personal property disposition process by formalizing and implementing procedures, training staff, and assessing program performance. Detailed procedures should address ISM, set expectations for CRO contractors, describe interfaces between involved site organizations and the CRO, and establish roles and responsibilities.

- Ensure that the site access process provides the appropriate badging, interfaces, and level of safety awareness for visitors doing work on site.
- Review the expectation for employees to stop work when they observe fitness for duty concerns as well as unsafe actions.

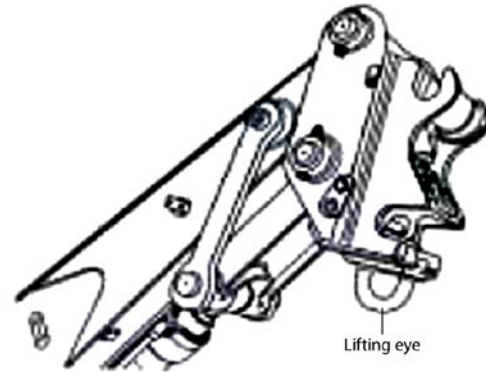
Quick couplers are after-market devices that enable contractors to quickly make attachment changes on hydraulic excavators. Most quick couplers have a lifting eye that is used for lifting materials (Figure 3-1). When the bucket is removed, the lifting capacity of the excavator is increased by the weight of the bucket, and the operator's line of vision is improved during lifting. Many contractors like to use a large bucket for the bulk of the digging, changing to a smaller bucket for fine tuning and work in tight areas. Quick couplers also allow the operator to replace a bucket attachment with various other attachments.

Figure 3-1. Lifting eye

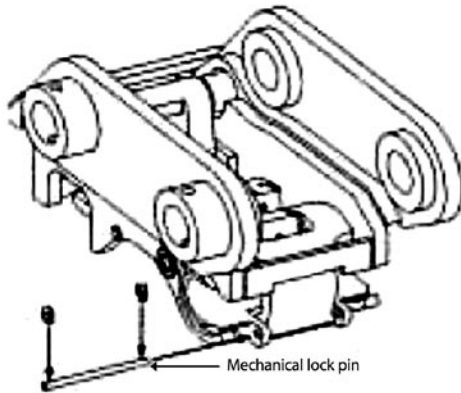
In many cases, unexpected bucket releases appear to be the result of users failing to properly engage and lock the quick couplers. Manufacturers of quick couplers recognize the hazards of unexpected releases of the bucket or attachments from these couplers, and most of them provide users with a retrofit locking pin (Figure 3-2). The pin is inserted manually behind the front or rear lever of the couplers to prevent unintended releases.

Figure 3-2. Retrofit lock pin

- Inspect all quick couplers to determine if they are subject to unexpected release hazards and whether the manufacturer has provided a locking pin and procedures for manual installation.
- Obtain and install manufacturer-recommended retrofits, including positive locking pins and other devices.
- Consider using newer-model quick couplers specifically designed to prevent unintended releases.
- Follow manufacturer's recommendations for maintenance, inspection, and installation of quick couplers.
- Test coupler and attachment connections every time an attachment is made.
- Train workers on using quick couplers correctly, making visual inspections, and following procedures for engaging attachments and testing connections.

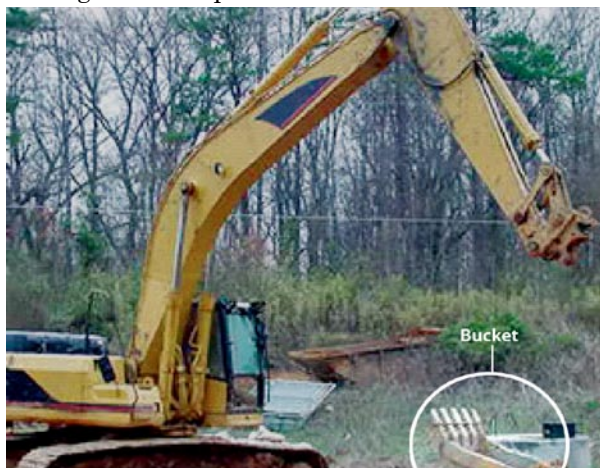
sections onto a truck. The victim was on the ground connecting the sections to the excavator while his co-worker was on the truck waiting to disconnect the sections after loading. The operator positioned the excavator bucket near a manhole section while the victim attached a three-legged bridle to the manhole section to lift it. The bucket unexpectedly disconnected from the excavator stick, struck the victim, and killed him. Figure 3-3 shows the bucket on the ground after it detached from the excavator stick.

Figure 3-3. Excavator and dropped bucket

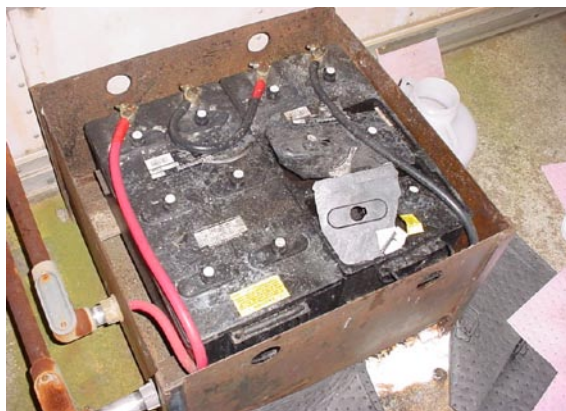
On July 15, 2004, at the Savannah River Site, a battery for a standby diesel generator failed during a diesel start test, resulting in the spill of approximately 24 ounces of battery electrolyte (sulfuric acid). The battery had been in service beyond its warranty period when an internal failure occurred. There were no injuries as a result of this event. (ORPS Report SR--WSRC-FBLINE-2004-0004; final report filed September 30, 2004)

Maintenance workers were in the process of conducting a no-load test of the diesel generator following preventive maintenance on the battery and battery charger. When the diesel start signal was initiated, they heard a loud “bang” at the battery box and saw liquid leaking from the box. Figure 4-1 shows the battery box. A sizzling, electrical noise could be heard coming from the batteries, so they opened the battery disconnect switch to isolate the batteries from the diesel start circuit, and the electrical noise ceased. The workers initiated a spill response, and responders positioned spill control pillows and applied soda ash to the spilled liquid to neutralize the electrolyte.

Figure 4-1. Battery box containing failed battery

Corrective actions included evaluating the adequacy of the preventive maintenance frequency for battery replacement based on the published warranty life. The service life of similar batteries in other systems/plant areas where catastrophic failure is possible will also be evaluated. Consideration will be given to replacing NAPA batteries within 30 months from initial installation. Some systems use Caterpillar batteries, and they will be replaced within 36 months of installation.

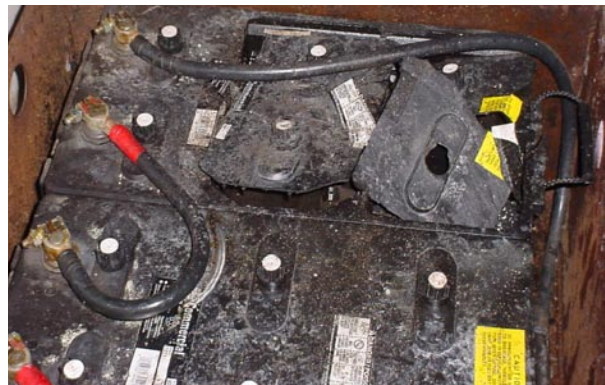
As part of the investigation, the failed battery was shipped to NAPA Batteries/Exide Technologies (manufacturer) for examination. The manufacturer found advanced grid corrosion, positive grid growth, cracked positive grid frames, and open welds; all of which are consistent with batteries that have served their expected life. The 30-month battery had been in service for 38 months. Investigators believe that constant charging current could have contributed to internal component degradation that ignited hydrogen gas inside the battery. Figure 4-2 shows a close-up of the failed battery.

Figure 4-2. Damaged top of failed battery cell

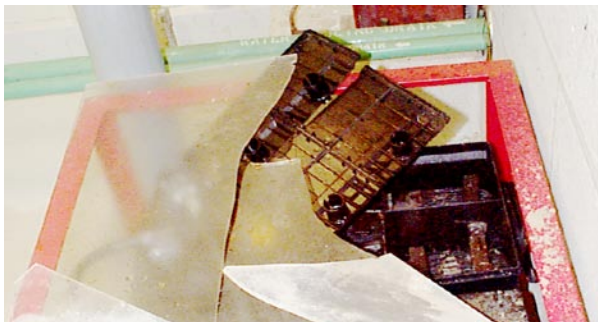
On March 8, 1999, a battery exploded while workers were starting a diesel-driven fire pump for a weekly test run at INEEL. An operator was 20 feet away when the battery ruptured, spilling a quart of acid on the floor. The battery had not been inspected for 18 months and had been in service for 5 years. Figure 4-3 shows the damaged battery bank.

Figure 4-3. Damaged plastic cover over battery bank

An inspection of the battery indicated that the electrolyte levels were low and corrosion had formed around a fractured bus bar inside the battery. The battery manufacturer believes that low electrolyte contributed to lead corrosion and expansion inside the battery case that fractured the bus bar. The fractured bus bar produced an arc that ignited battery gases when the operator attempted to start the diesel fire water pump. (ORPS Report ID--LITC-CFA-1999-0003)
