**Hazardous Materials Accident
Failure of an Anhydrous Ammonia
Nurse Tank**

Calamus, Iowa, April 15, 2003

DCA-03-MZ-001

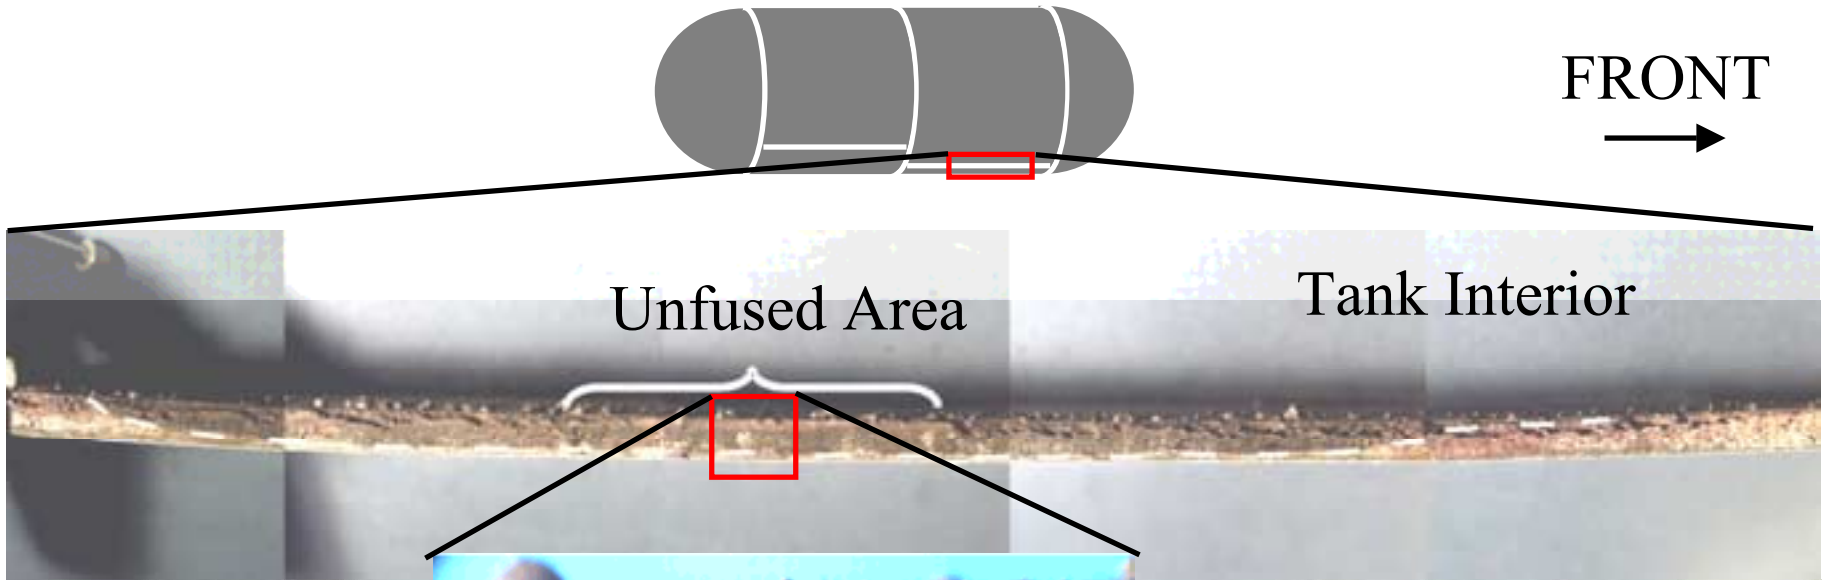
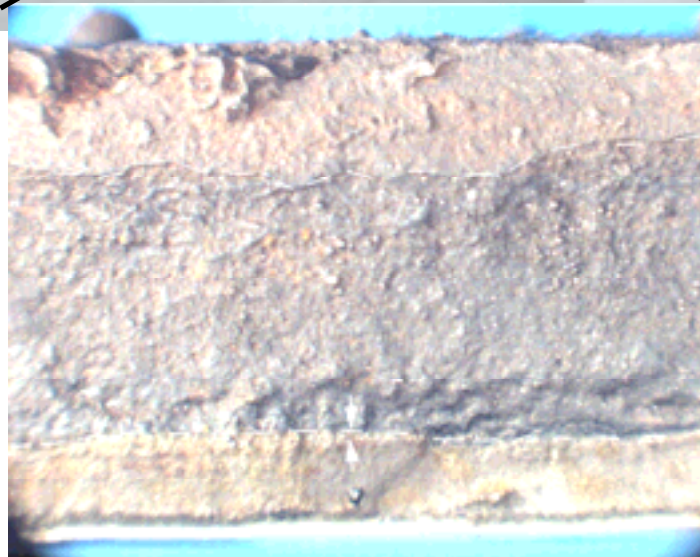
Fracture Surface

Fracture Interpretation

- Black region indicates long-term existence of crack.
- Rough features of majority of black region indicative of relatively high stress – most likely the 1976 proof pressure test.
- Fatigue region indicative of growth under lower cyclic (operational) loads over time.

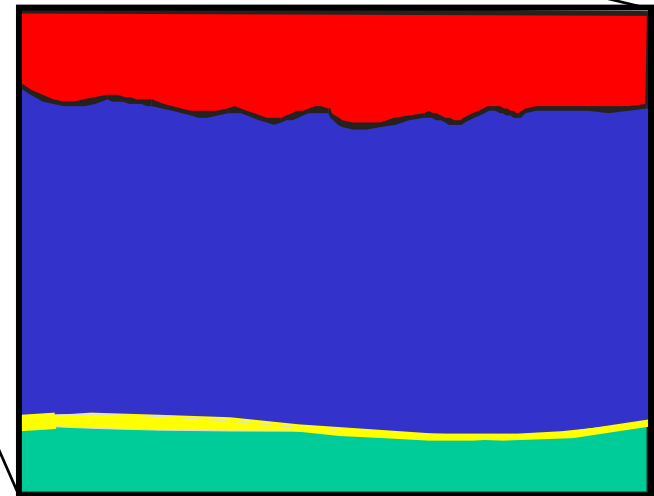
Fracture Surface Schematic Drawing

Unfused area

Unfused region

Black region (rough)

Black region (fatigue)

Overstress region

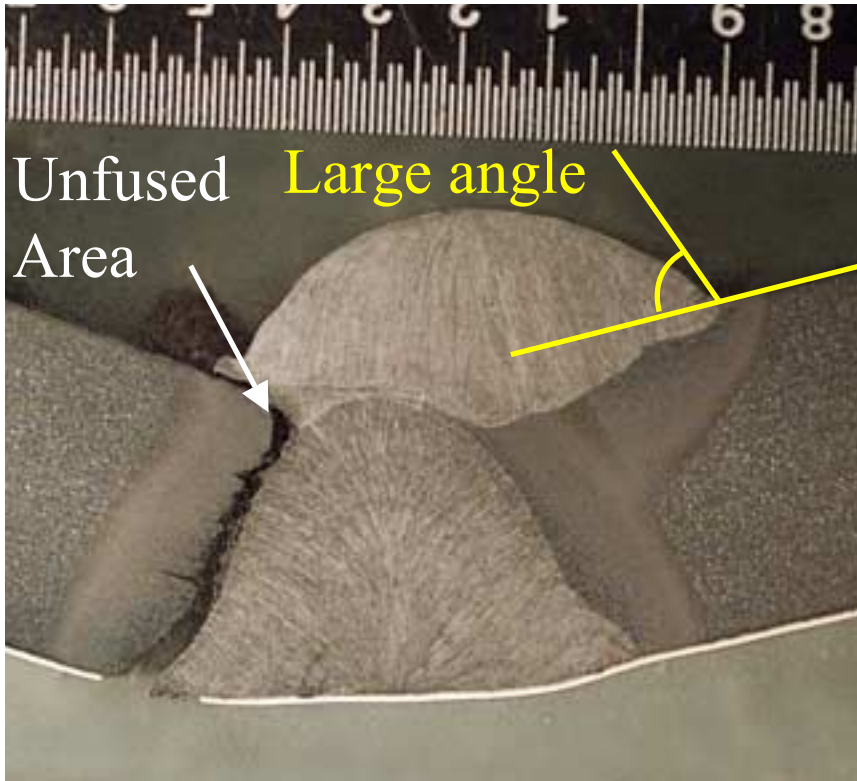
Fractured region

- The unfused area and offset weld bead weakened the tank wall.
- Misalignment of the shell surfaces and the large angle weld bead increased the stresses in this area.

- A crack extended from the unfused area of the weld, probably during the manufacturing proof pressure test.
- The crack grew by fatigue under normal operating loads until the tank failed.
