Lessons Learned From the Construction of Upgrades to the NASA Glenn Icing Research Tunnel and Re-Activation Testing

David W. Sheldon, Charles R. Andracchio, and Thomas M. Krivanek
Glenn Research Center, Cleveland, Ohio

Major upgrades were made in 1999 to the 6-ft by 9-ft (1.8 m by 2.7 m) Icing Research Tunnel (IRT) at the NASA Glenn Research Center. These included replacement of the electronic controls for the variable-speed drive motor, replacement of the heat exchanger, complete replacement and enlargement of the leg of the tunnel containing the new heat-exchanger, the addition of flow-expanding and flow-contracting turning vanes upstream and downstream of the heat exchanger, respectively, and the addition of fan outlet guide vanes (OGV's).

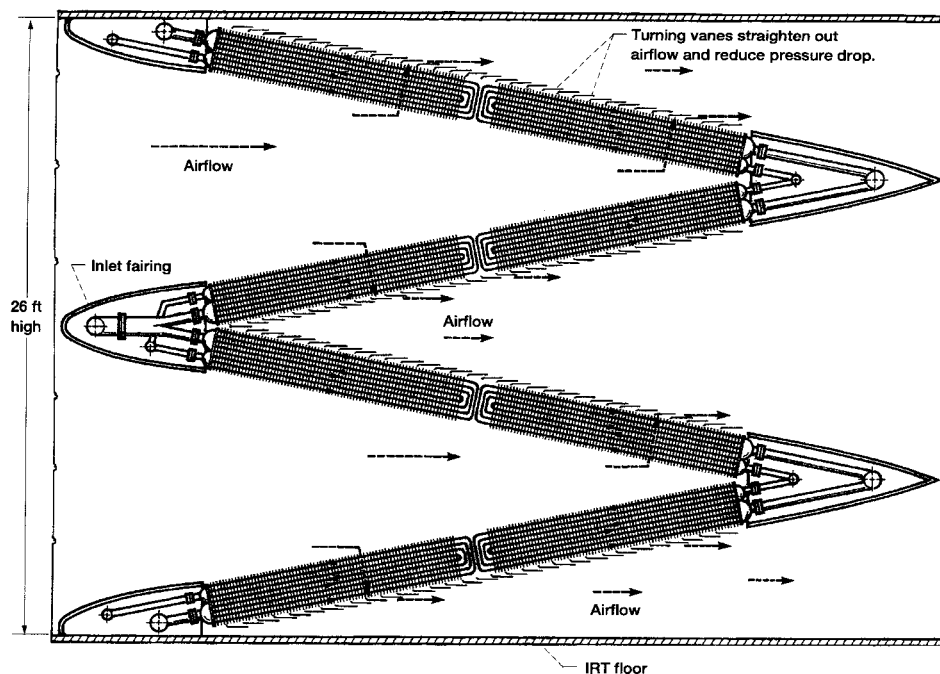
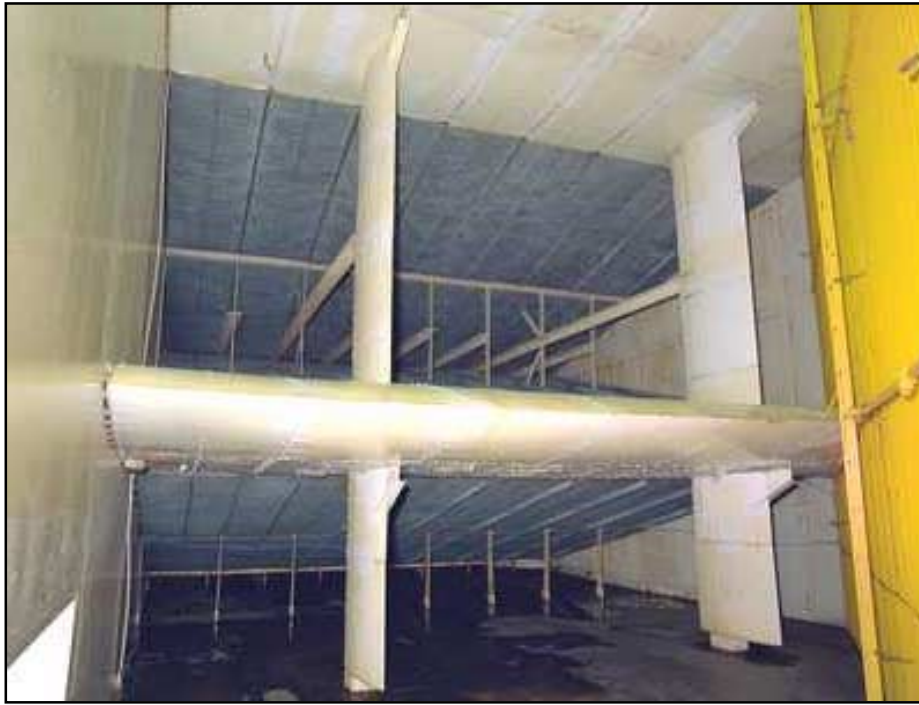
The airflow in the supply legs, from the vent tower section downstream of the fan through the refrigeration heat exchanger and into the stilling chamber has been shown to be unevenly distributed across duct flow areas.^{3, 4} The two main causes of these flow distortions were the “W” shape of the heat exchanger and the presence of two large fairings around the legs of the fan motor support stand below the fan motor nacelle. These leg fairings are shown in **Figure 3**. The non-uniform distribution of airspeed across the heat exchanger produced non-uniform cooling rates, and this required a complicated balancing of the coolant flow through the various HX panels in order to achieve a uniform air temperature in the Test Section.

Figure 2.—Original W-shaped heat exchanger in the IRT.

(b) **View upstream of the original IRT heat exchanger.** The upper layer of fin-tube panels is out of view.
(C-99-1334)

Figure 2.—(Concluded) Original W-shaped heat exchanger in the IRT.

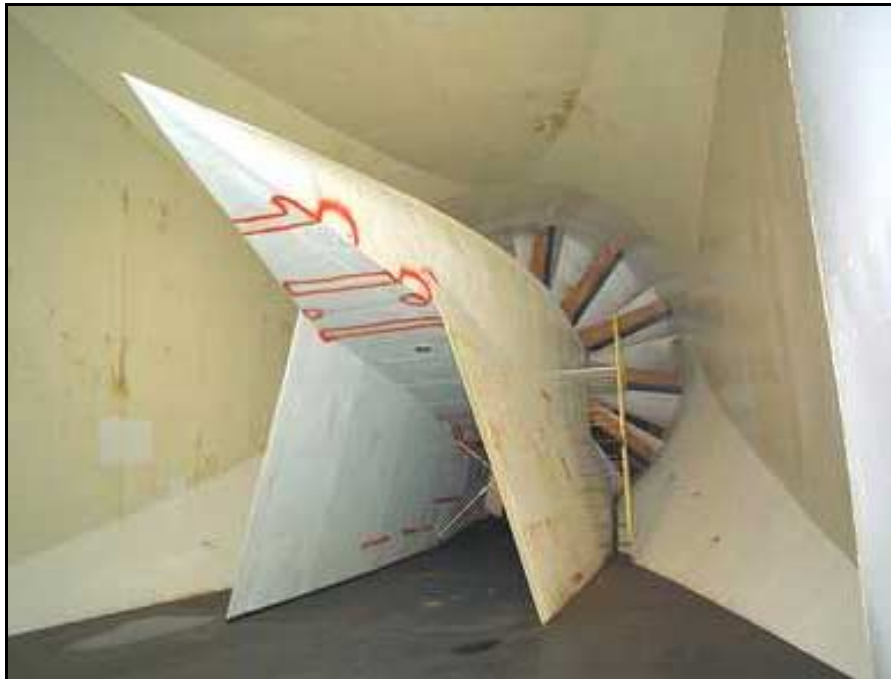
Figure 3.—View upstream of the IRT fan and motor housing. The two long fairings over the legs of the motor support platform are theorized to cause large variations in downstream air velocities.

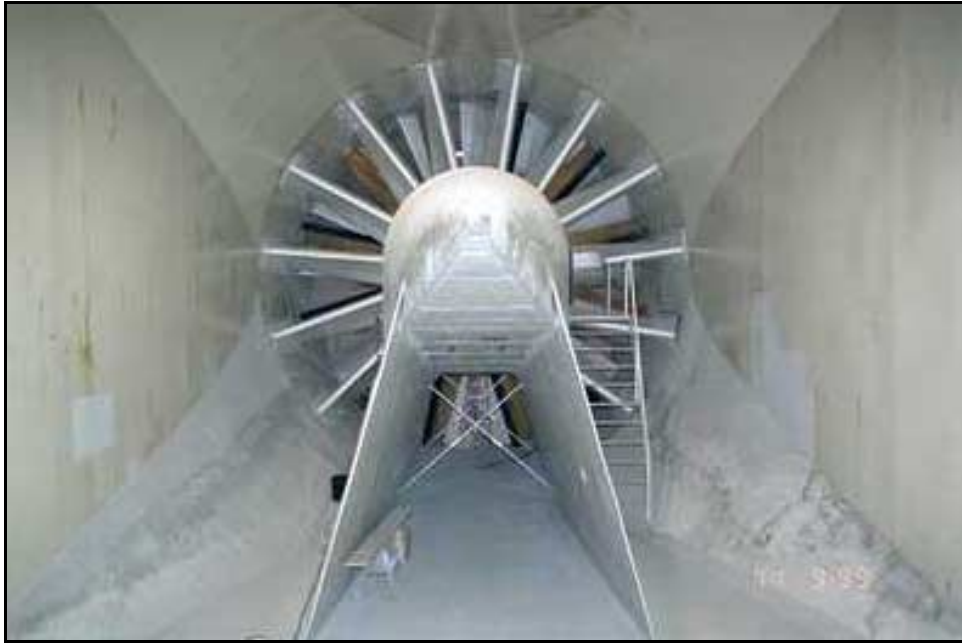
A design requirement for the new outlet guide vanes was a minimum natural frequency of 100 Hz. This relatively high frequency, which is just above the maximum blade passing frequency, was specified in order to avoid any possible resonance between the OGV's and the fan blades. An initial OGV design met all strength requirements but failed to meet the frequency requirement, even when the airfoil walls were stiffened by two internal spars and the laminate was reinforced with carbon fibers. The entire airfoil was then thickened, particularly in the trailing edge

Figure 6.—Installation of the 12 fan OGV's around the motor housing. Views is upstream. Fan blades can be seen in the background. The leg fairings take the place of two additional OGV's. The OGV at the six o'clock position has been eliminated because it would block the primary access path to the fan blades. (C-99-2410)

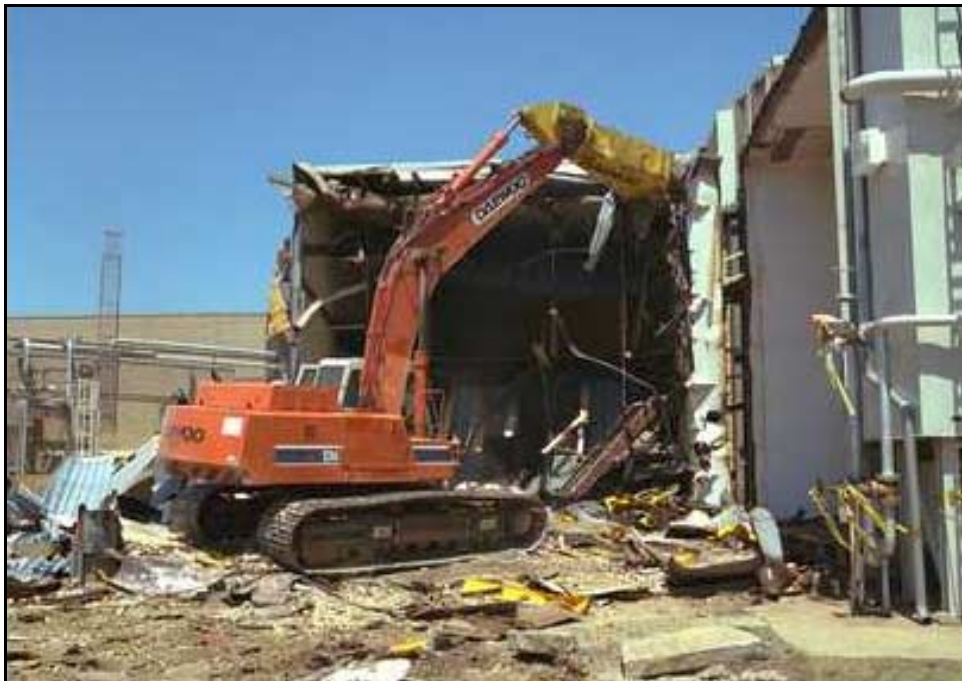
The entire C-D leg of the tunnel, which extends from just downstream of the Vent Tower to just upstream of the Stilling Chamber, was demolished and replaced with a new C-D leg significantly different in size and construction. The demolition work included abatement of lead paint and removal of contaminated soil. The width of the leg was increased 69 percent, from 29.2 feet (8.89 m) to 49.2 feet (15.0 m), to accommodate a new flat heat exchanger. A basement was added that contains the main coolant supply and return pipes and instrumentation cables. The basement also allowed the application of spray-on insulation to the underside of the tunnel floor. **Figures 7 and 8** show views of the demolition of the original C-D leg and the beginning of the construction of the new C-D leg.

Figure 7.—Demolition of Corner D and the original heat exchanger. Corner C is in the background. (C-99-1452)

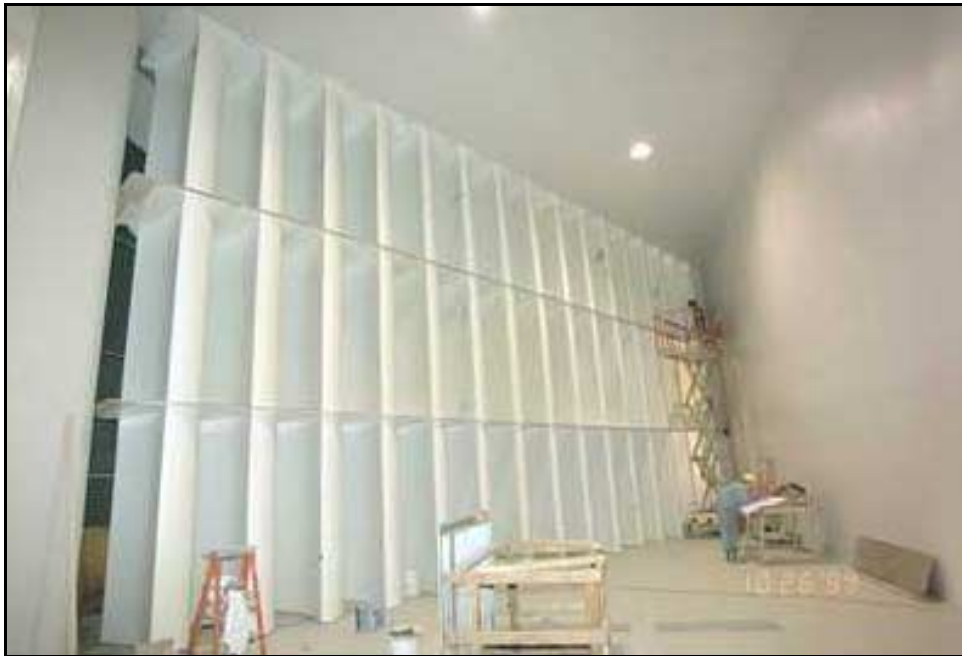
During flow quality testing in the stilling chamber downstream of the Corner D turning vanes, it was determined that the flow distortions of the bolted flanges and the tie plates had been underestimated. The wakes of these extraneous structures cause small local decreases in the downstream flow, and the extra pressure drops cause a small decrease in the maximum test airspeed in the tunnel. Leading- and trailing-edge fairings have now been added to the tie plates in Corner D. Improvements in flow quality are expected, but these have not yet been verified by test.

Figure 9.—Installation of the new fiberglass-composite turning vanes in Corner C. The horizontal tie plates between the vane segments help carry airloads directed outward along the corner diagonal. Socket connections at the ceiling provide for differential thermal expansion and contraction. (C-99-2287)

Recommendation: During the design phase, exercise more care in predicting the aerodynamic effects of alterations to an airfoil design, even when the alterations appear to be minor. Do not permit deviations from a clean aerodynamic profile unless absolutely necessary. For example, a smooth socket joint between segments of the turning vanes should have been considered before a flanged and bolted joint.

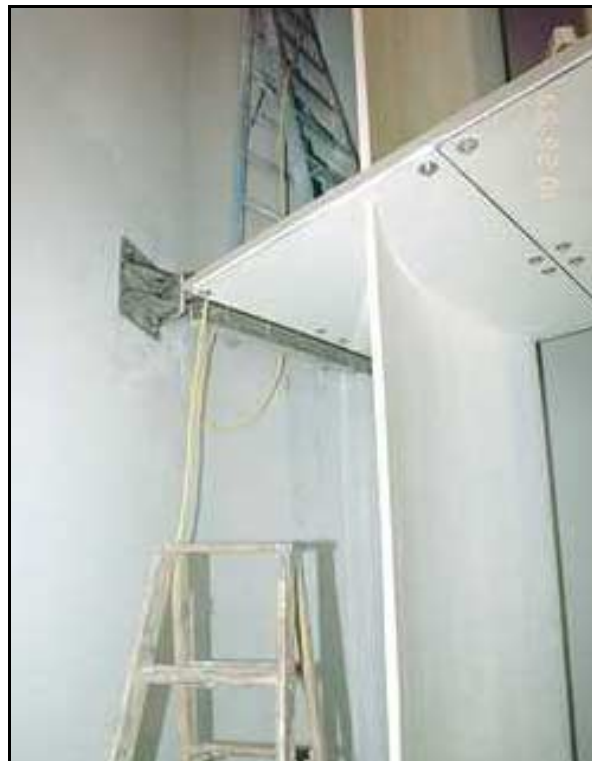
Figure 11.—View in Corner C of the trailing edge of vane C-1, showing the outer end of a tie plate sandwiched between bolted flanges. The reinforced end of the tie plate bears against brackets on the outer wall of the tunnel. (C-99-2432)

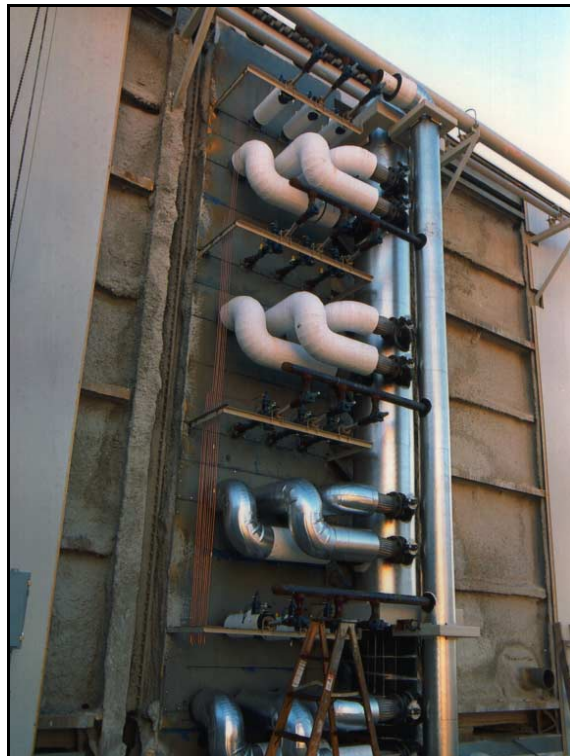
7. The design of the coolant supply pipes called for only a single pressure gage at the top of each of the two main supply headers from which the two units of the HX received coolant. As a result, pressures throughout the system of headers and secondary headers were unknown during the checkout and balancing of the HX modules. Additional gages were required that had to be installed during the re-activation test phase, which caused project delays.

Figure 15.—View of the HX coolant supply (smaller diameter) and return (larger diameter) pipes on the West wall of the new C-D leg. Separate pairs of pipes are connected to each of the three streamwise zones in each of the four HX modules that are stacked vertically to form the West HX unit. (C-99-2655)

Recommendation: For a complex multi-path flow system, like the coolant supply piping to the HX modules, locate sufficient pressure gages for checkout and balancing, and not just the few needed for routine operation.

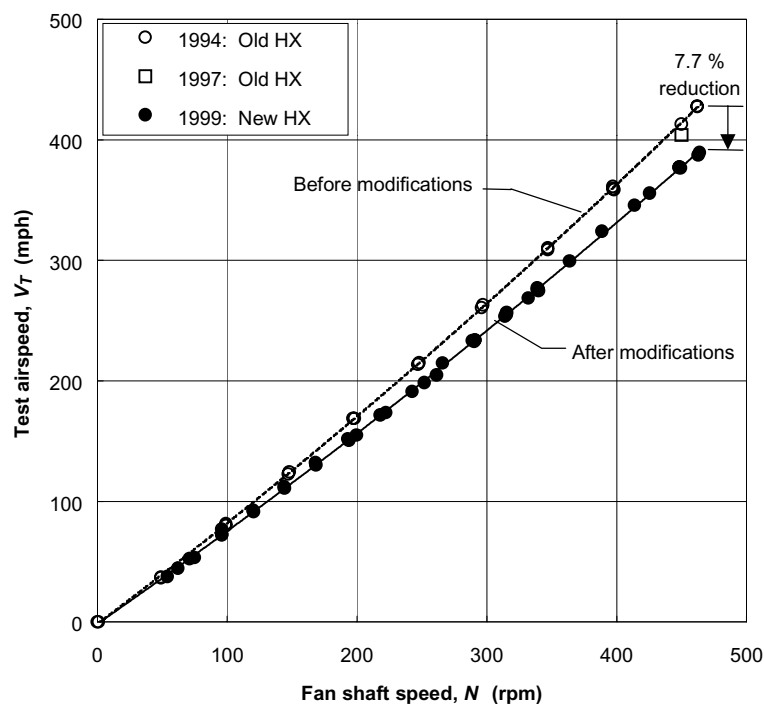
conditions. It can be seen from this chart that the maximum airspeed attainable in the IRT has decreased from its historic high of 420 mph (188 meter/s) measured during the 1994 qualification of new fan blades to approximately 390 mph (174 meter/s) today. This decrease is attributed to an approximately 50 percent increase in the drag losses across the flat HX compared with the original W-shaped HX, and to more drag loss than expected at the OGV's.

Figure 17.—Comparison of test airspeeds achievable in the IRT before and after tunnel modifications. Maximum airspeed was reduced approximately 8 percent.

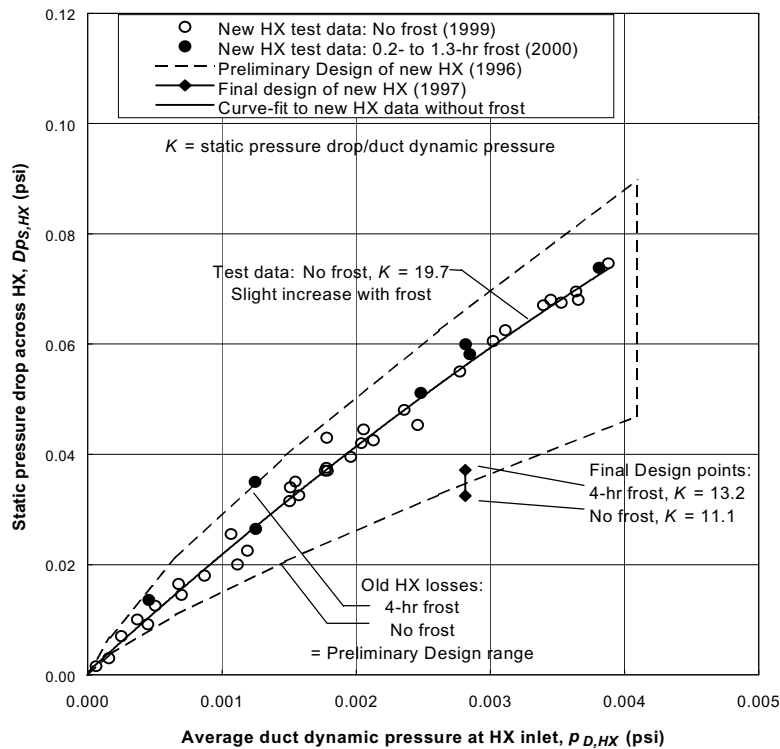
In **Figure 18**, pressure drops measured across the new HX are compared with design pressure drops. The range labeled "preliminary design" is a direct application of pressure drops measured across the original W-shaped heat exchanger, where heavy frost doubled the pressure drop.¹⁶ In the final design of the replacement HX, however, frost was expected to cause only a small increase in the pressure drop. The two final design points at the bottom of the range show this, which represent operation at a test airspeed of 300 mph (134 meter/s). Pressure losses across the new HX with or without frost were expected to be about the same as those with the original HX in a dry condition. Examination of the actual pressure drops measured across the new HX with and without frost shows that the minor effect of frost was correctly predicted. While the pressure losses without frost at the design point are about 70 percent higher than predicted, losses for the frosted condition are still lower than those for the original HX. Therefore, these additional drag losses at the HX are not expected to significantly affect tunnel operations during icing tests at moderate airspeeds and with test section blockage.

10. When static pressures were measured upstream and downstream of the new HX, it was determined that the pressure drop had been underestimated by about 70 percent during the final design phase. It is clear from this large error in predicting pressure losses that the procedures used for calculating the aerodynamic drag of this type of HX are not acceptable. However, the minor effect of frost on pressure loss was predicted correctly.

Figure 18.—Comparison of measured and design pressure drops across the replacement heat exchanger. Measured pressure drop is approximately 70 percent higher than the final design.

Recommendation: Use the measured loss coefficients from these IRT tests to calibrate improved methods for predicting the aerodynamic drag losses in HXs of this general configuration.
