OPERATING EXPERIENCE SUMMARY

U.S. Department of Energy
Office of Environment, Safety and Health
OE Summary 2004-19
October 4, 2004

1. INADEQUATE EQUIPMENT ISOLATION RESULTS IN ELECTRICAL SHOCK

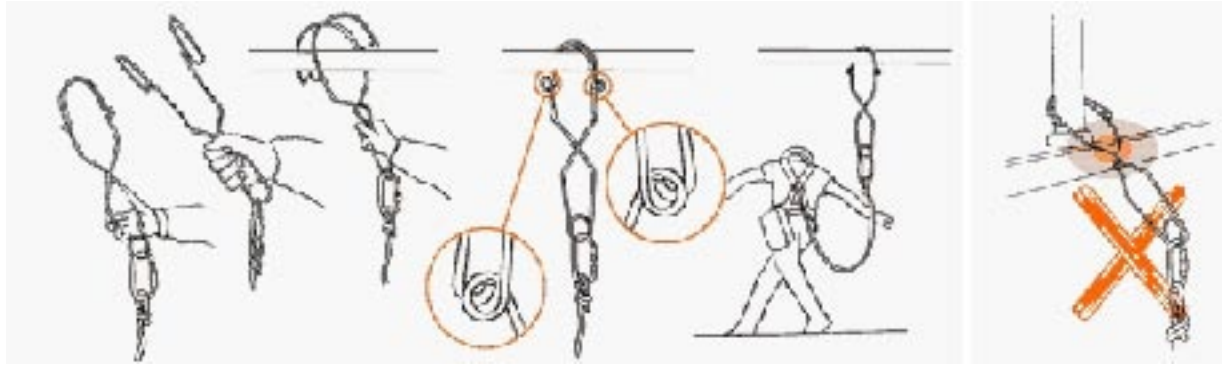
Figure 3-2. Correct (left) and incorrect (right) way to connect to an anchorage

OSHA issued the bulletin following a fatal accident in North Dakota that occurred when a worker used a spring-loaded wire form anchorage connector as part of a fall-protection device while upgrading the structural members of a tower. The worker fell approximately 75 feet when the device failed.

The worker apparently attached the wire form anchorage connector to a diagonal tower member instead of connecting his fall arrest system directly to an anchorage, as the manufacturer recommends. Figure 3-2 illustrates the difference. This positioned the anchorage connector so that the worker's weight exerted a significant side load on the connector. These connectors are designed to be used vertically by being hooked to an anchorage directly above the worker — they are not designed to hold side loads.

- Employers must only use personal fall-arrest system connectors and positioning device system connectors that meet applicable OSHA regulations.
- Employers must train employees on the appropriate use of personal fall-arrest systems and positioning device systems and ensure that such systems are connected only to compatible components.

- Contractors and other employers should review manufacturer instructions and markings and must ensure that the wire form anchorage connector is the appropriate anchorage connector for the situation and work environment in which it will be used.
