FACE 88-06: Plumber Falls to His Death Through a Roof opening

On October 30, 1987, a 24-year-old plumber died when he fell 22 feet through a skylight opening to a concrete floor.

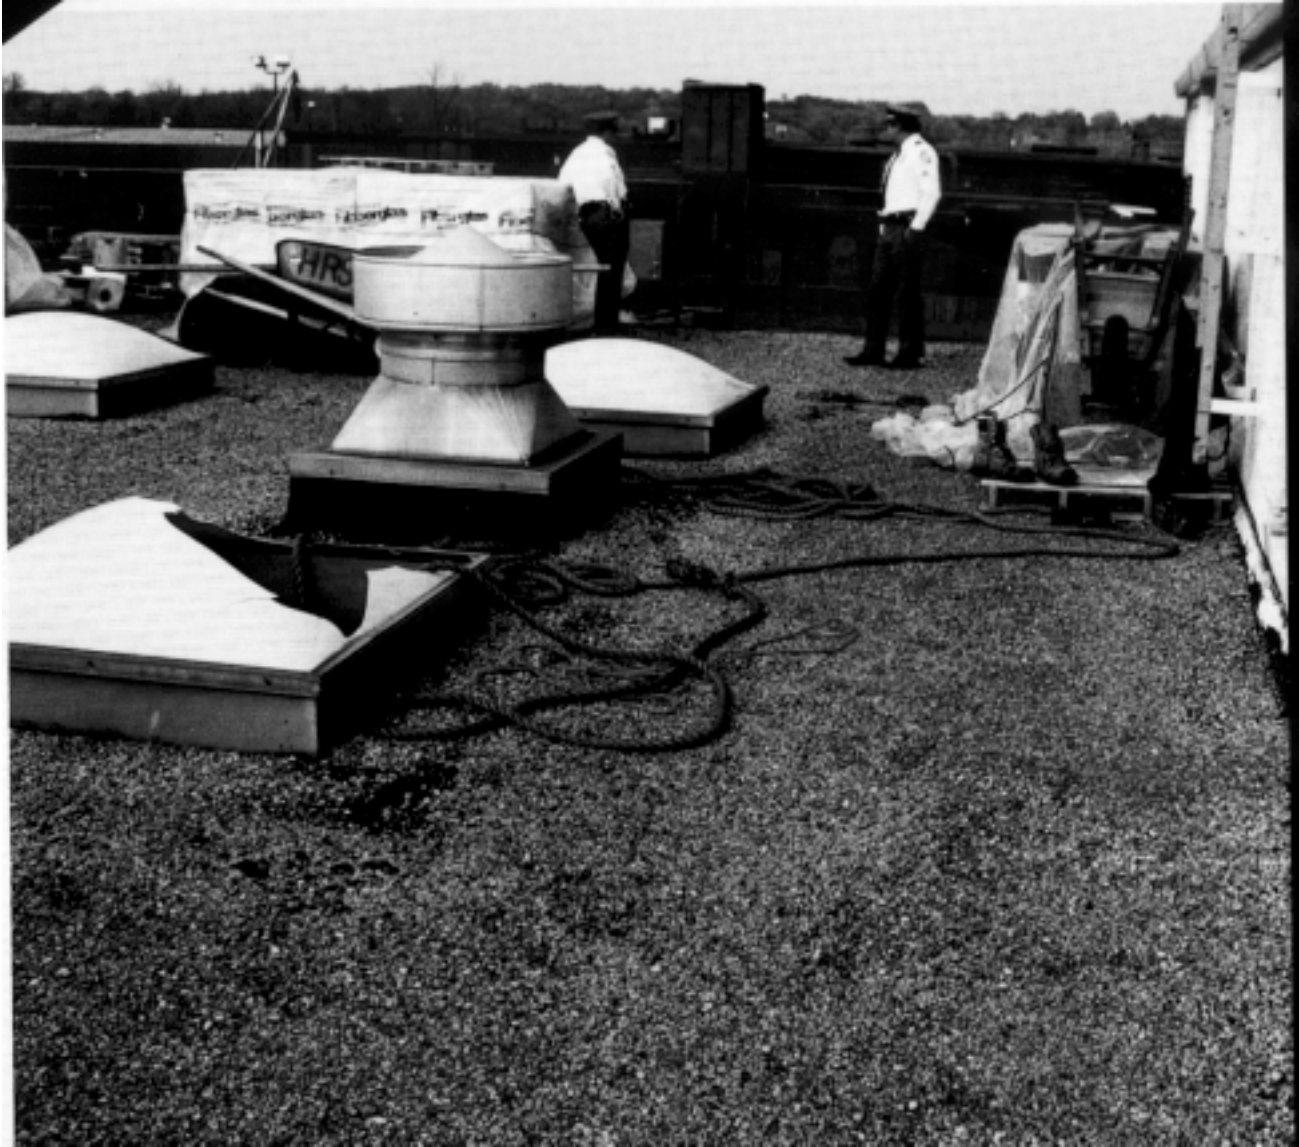
Figure 2. This Figure Shows an Intact Smoke Dome Type Skylight Just Opposite the Broken Skylight. The Fixed Ladder Providing Access to Roof of the Higher Section of the Building is Shown at Left.

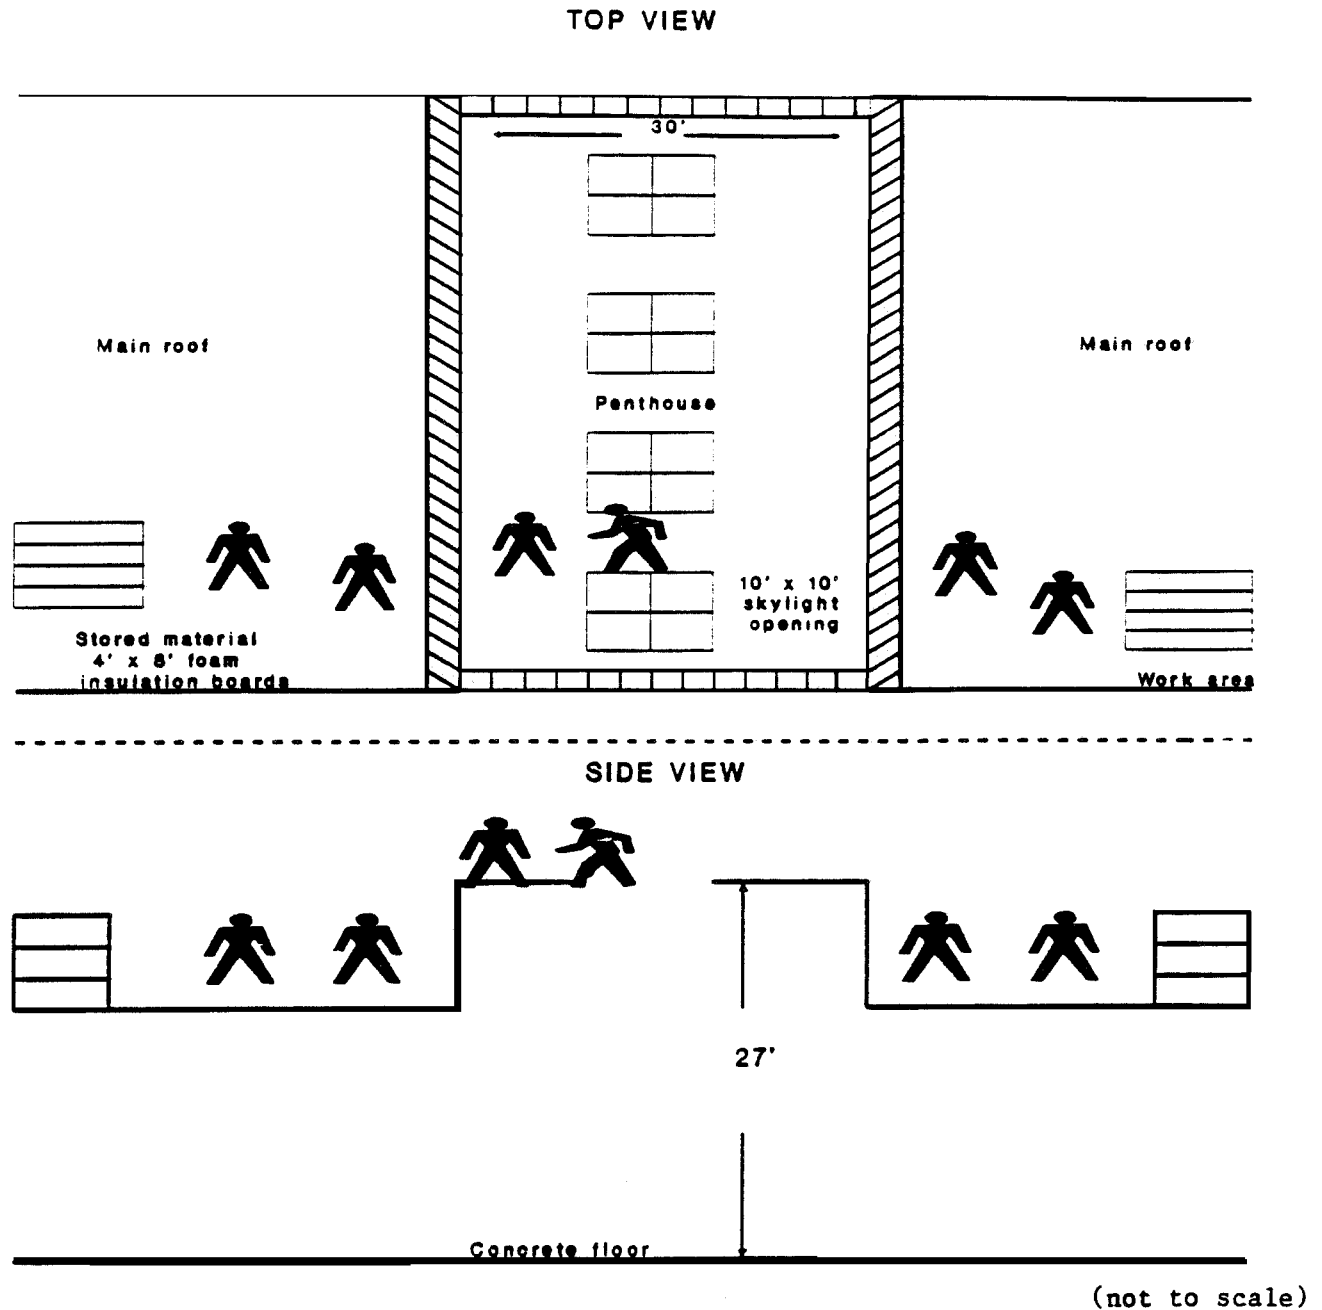
Discussion: This company accepted the risk of a potentially serious or fatal fall by failing to provide fall protection for workers exposed to unguarded skylight openings. Employers should emphasize safety of their employees by designing, developing, implementing, and enforcing a comprehensive safety program to prevent incidents such as this. The safety program should include, but not be limited to, the recognition and avoidance of fall hazards.

Figure 1. Top and Side Views of the Roof Area Where the Fatal Fall Occurred.

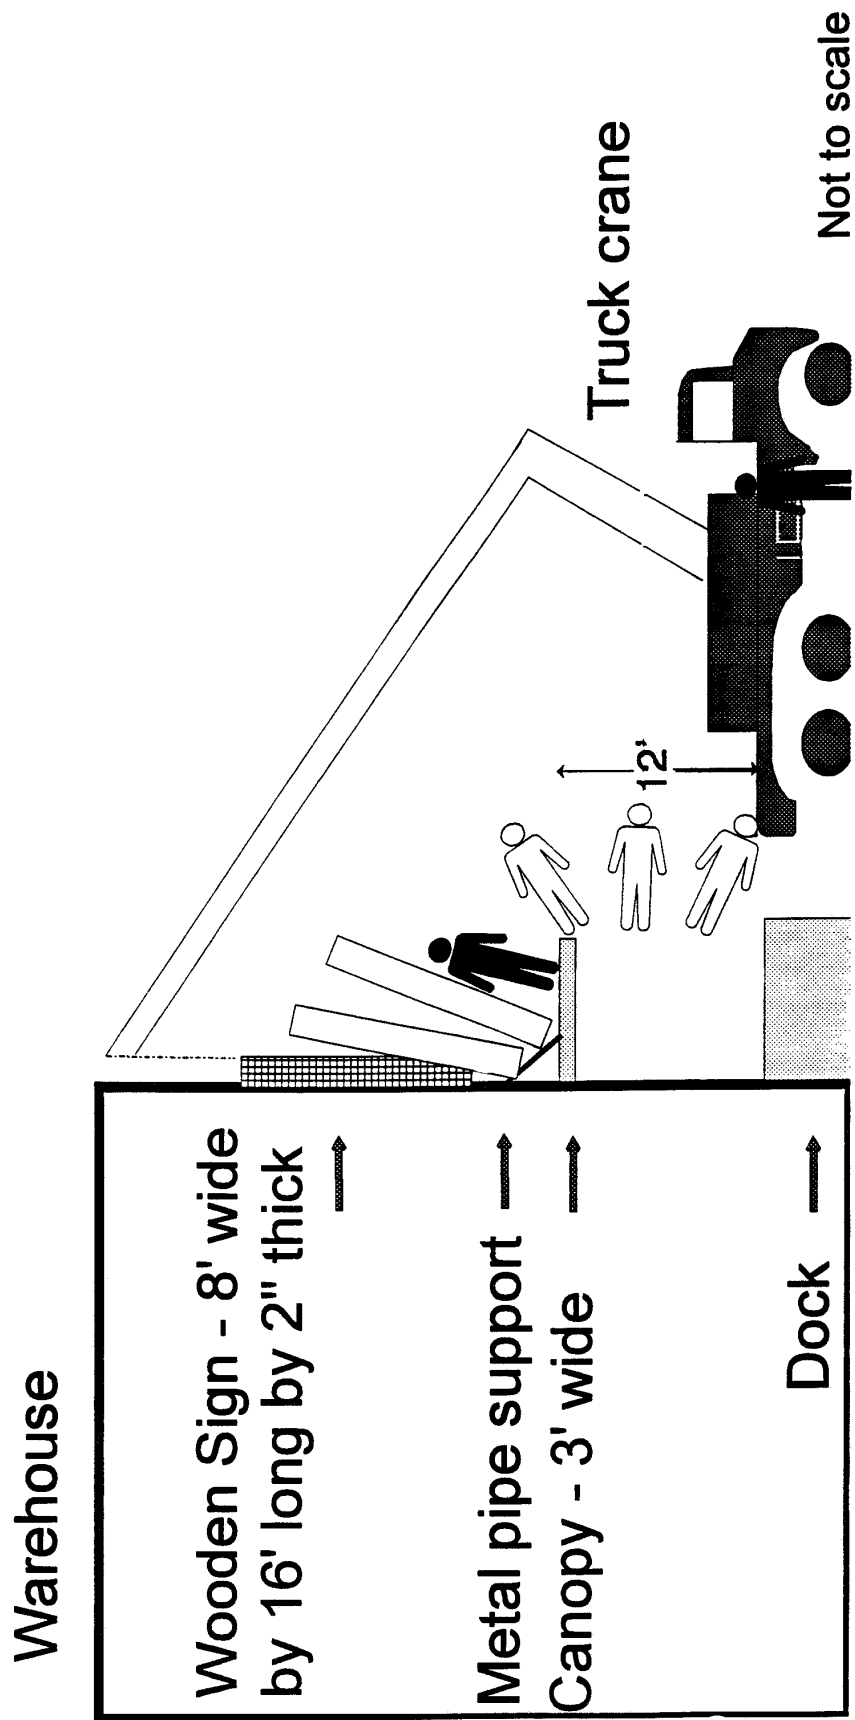
Figure. Victim's Position on Canopy
