NIST Response to the World Trade Center Disaster

World Trade Center Investigation Status

June 18, 2004

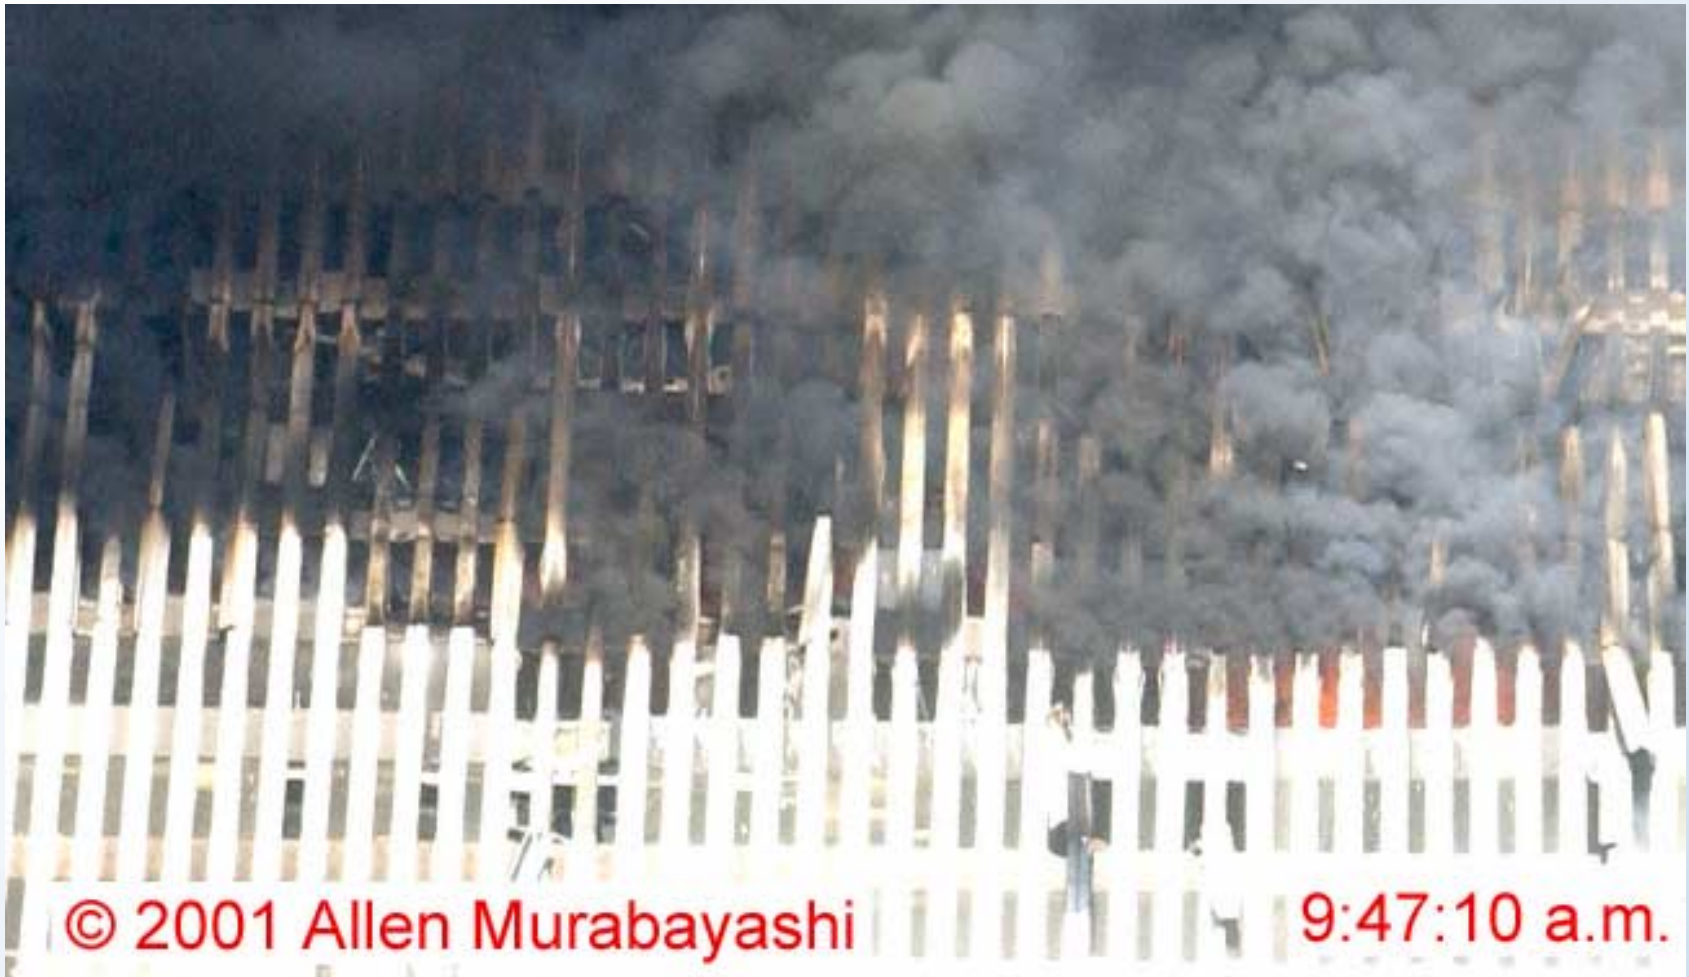
Photographic Evidence of Hanging Floor Slab

East Face of the South Tower. Image shows what appear to be a floor slab from the 83rd floor hanging across window opening over a large fraction of the 82nd floor.

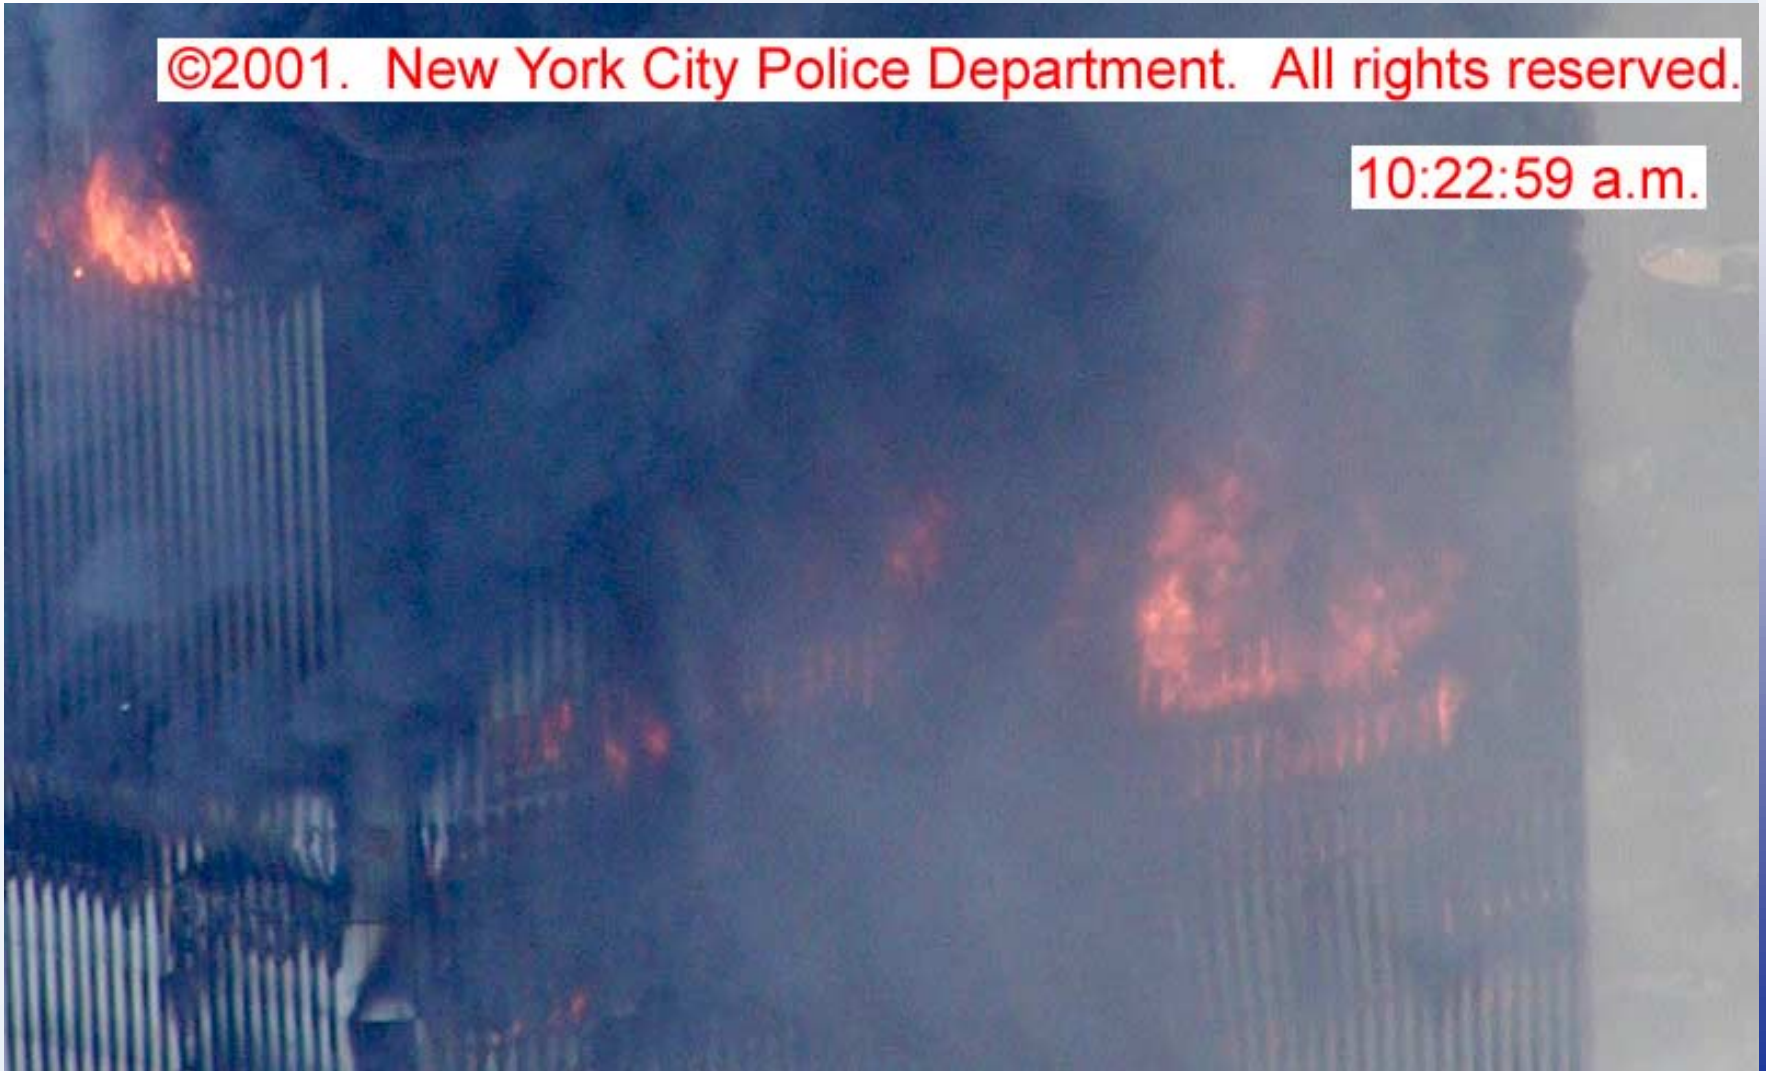
Inward Bowing of Perimeter Columns Some Minutes Prior to Collapse: WTC 1 South Face

10:22:59 a.m.

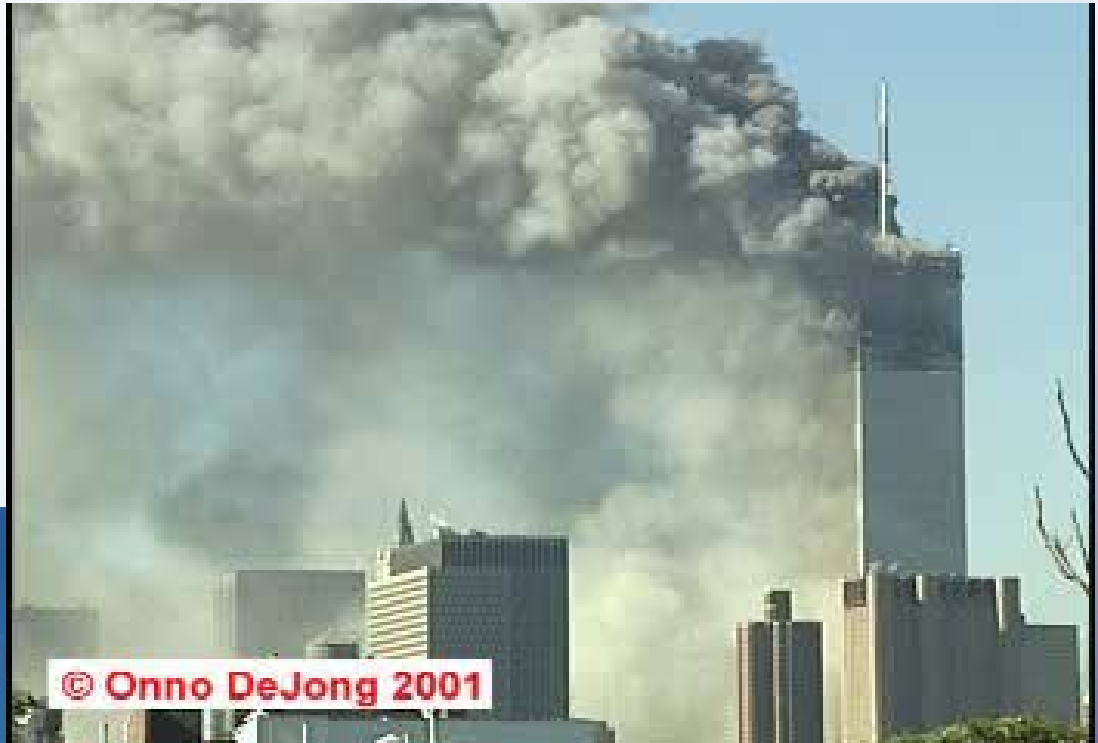
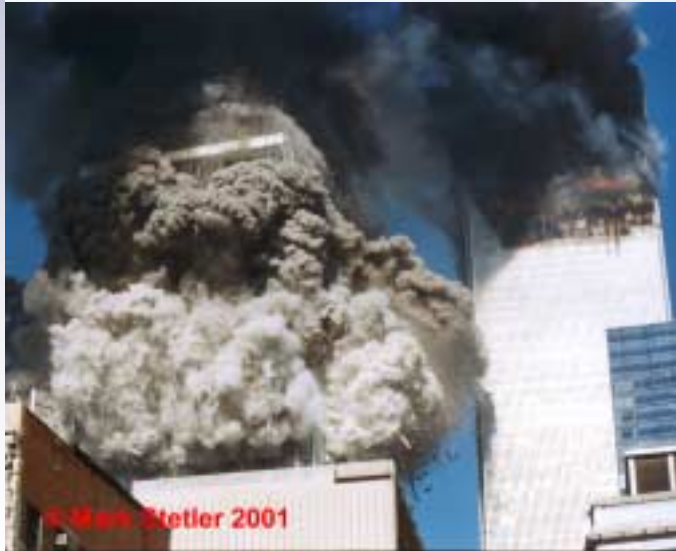
Tilting of Building Sections

Initiation of global collapse was first observed by the tilting of building sections above the impact regions of both WTC towers.

WTC 1 tilted to the south; WTC 2 tilted to the east and south and twisted in a counterclockwise motion

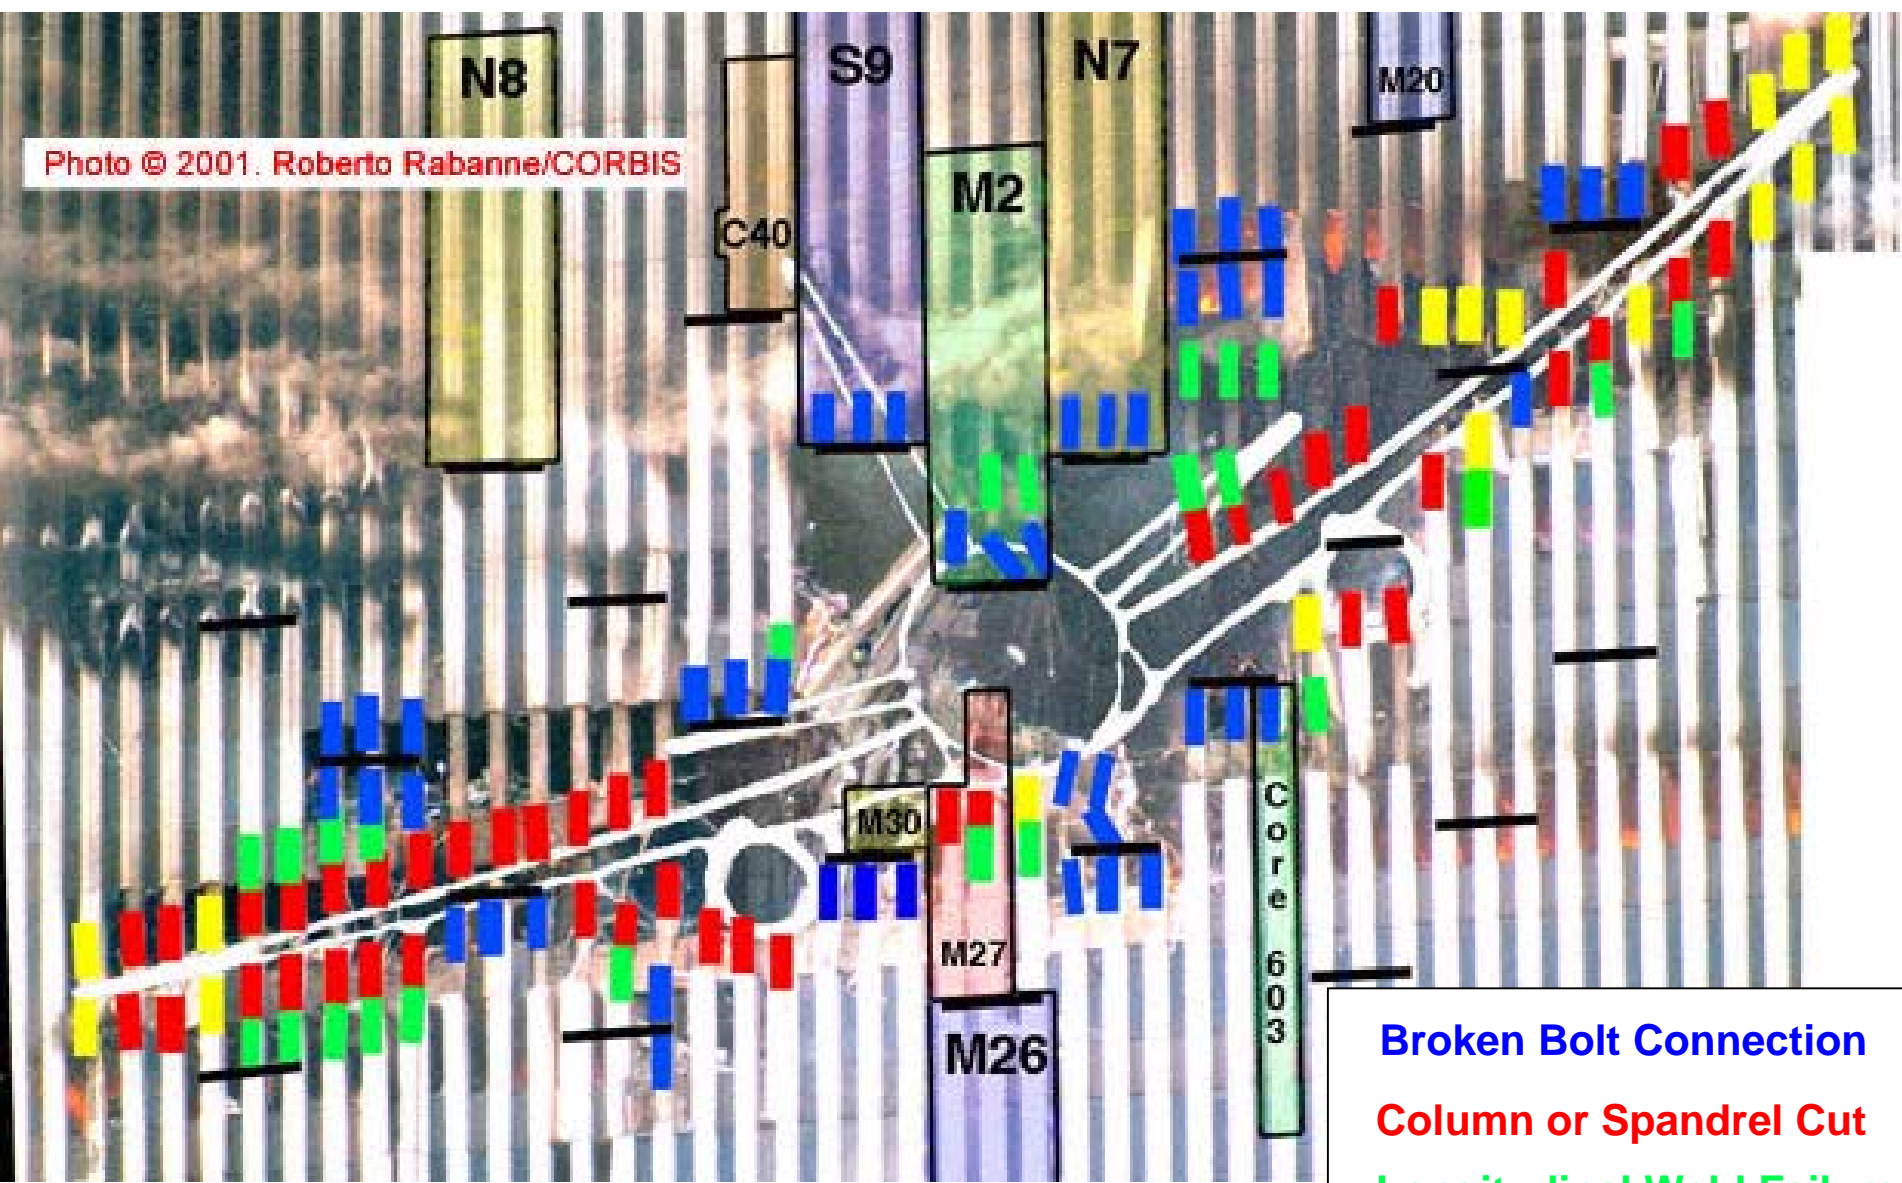
Broken Bolt Connection
Column or Spandrel Cut
Longitudinal Weld Failure
Unknown
Panel Junction

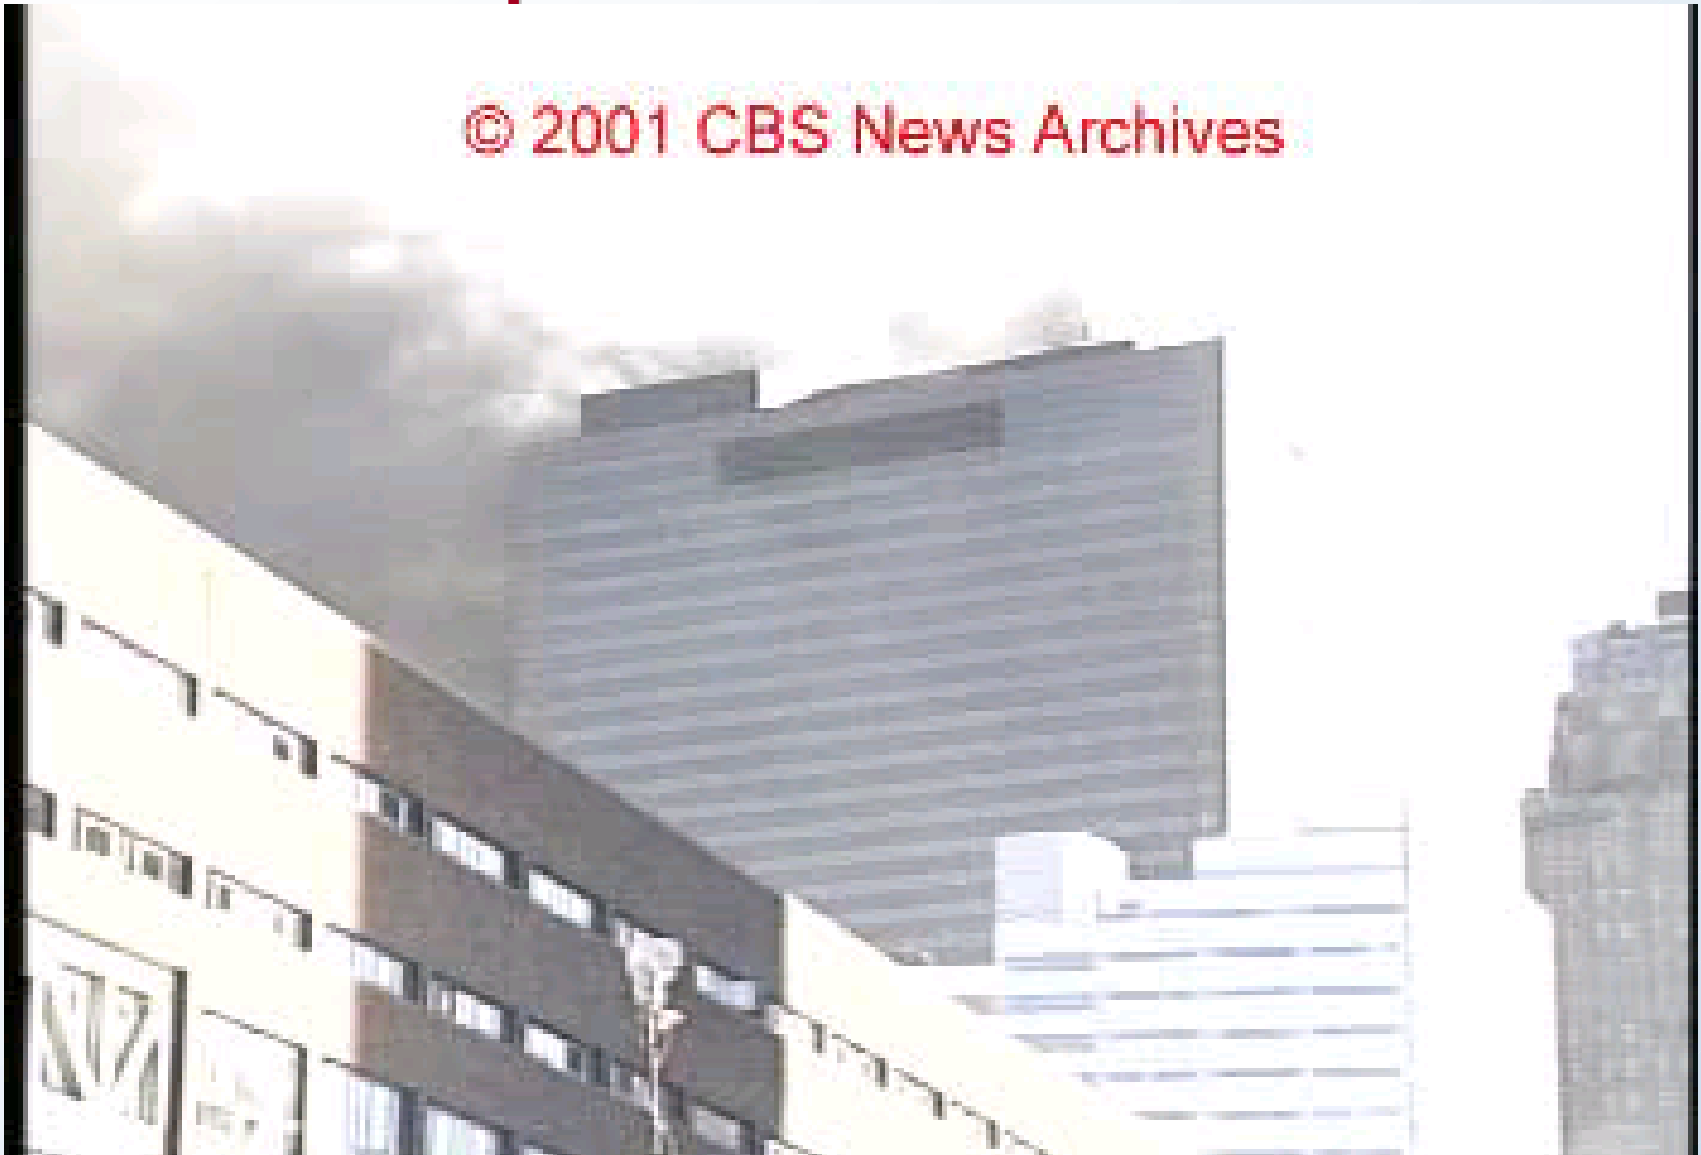
Observed Sequence of Failures in WTC 7

- An initial local failure at the lower floors (below Floor 13) of the building due to fire and/or debris induced structural damage of a **critical column (the initiating event)**, which supported a large span floor area of about 2,000 ft²;

- Vertical progression of the initial local failure up to the east penthouse, as large floor bays were unable to redistribute the loads, bringing down the interior structure below the east penthouse; and

- Horizontal progression of the failure across the lower floors (in the region of Floors 5 and 7, that were much thicker than the rest of the floors), triggered by damage due to the vertical failure, resulting in **disproportionate collapse** of the entire structure.

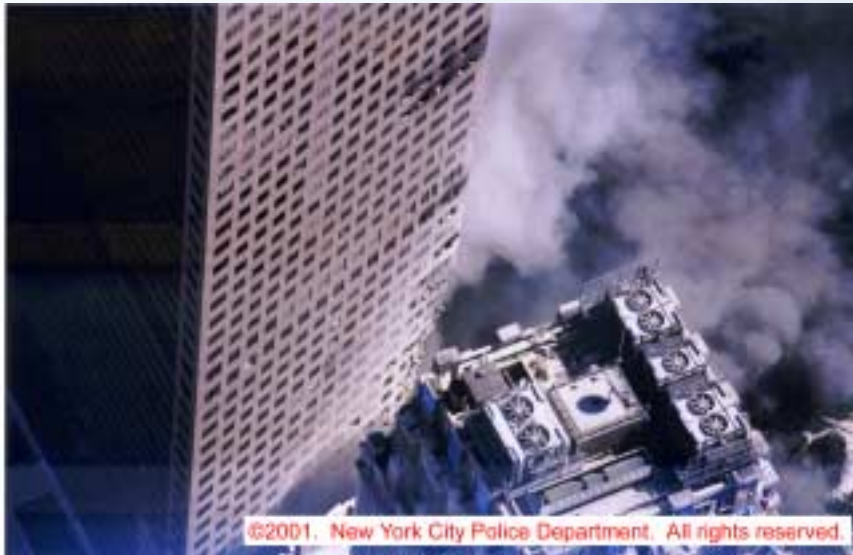
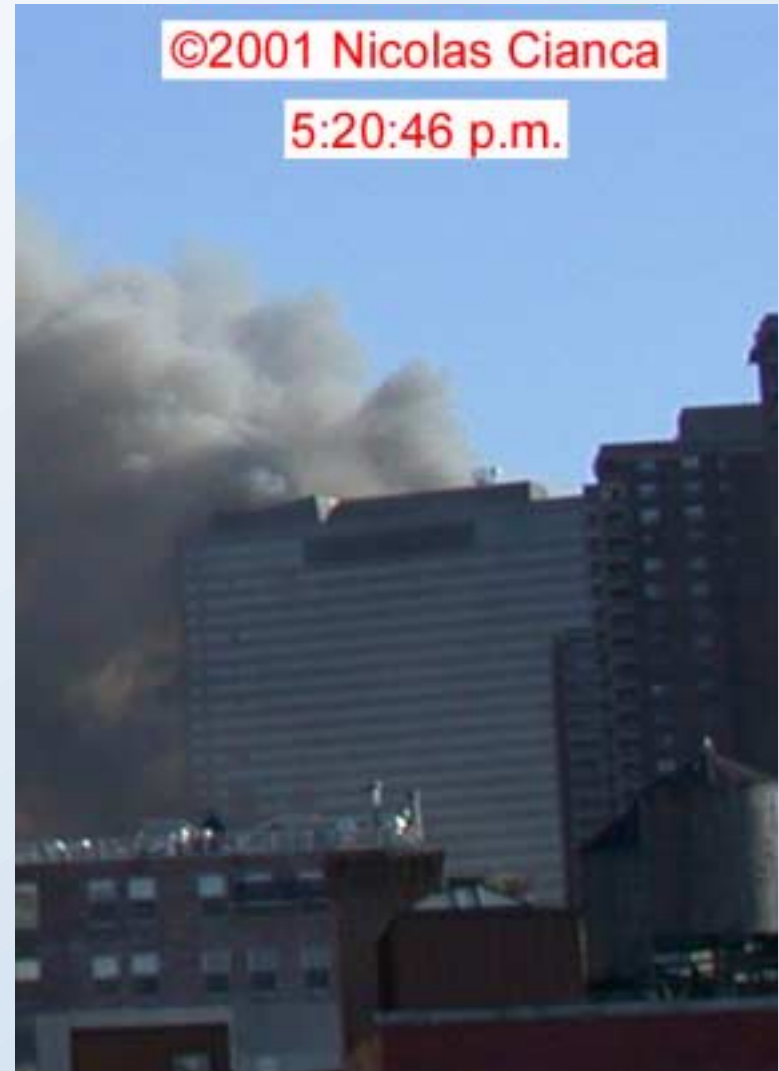
Visual Observations for WTC 7

- ❑ *The first exterior sign of structural failure in WTC 7 was the sinking of the east penthouse roof structure into the building.*
- ❑ *Witnesses reported structural damage to WTC 7 on its south face and southwest corner from WTC 1 debris.*

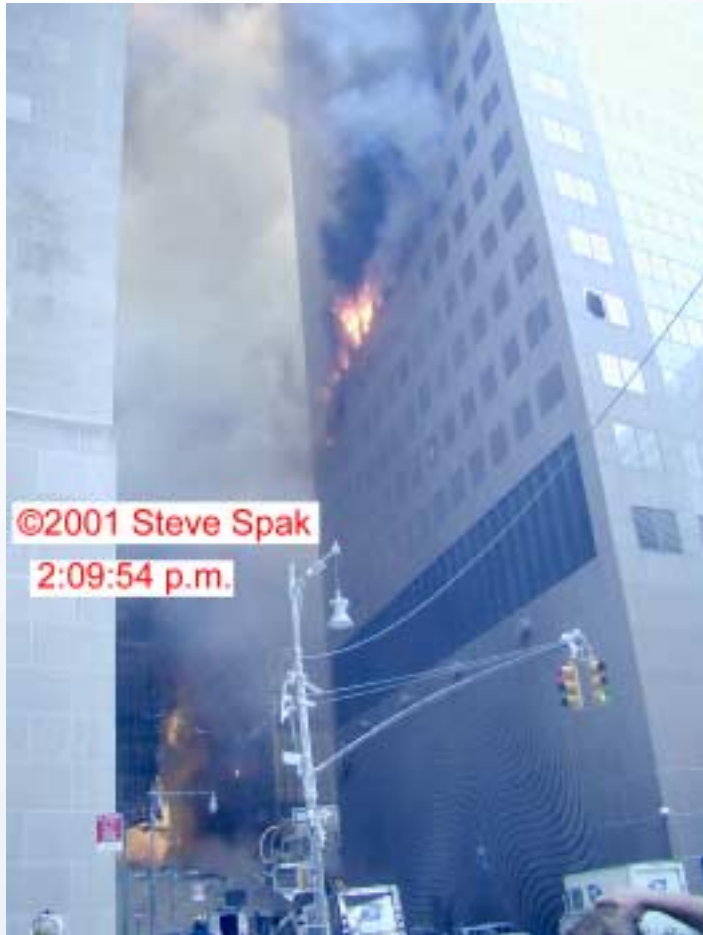
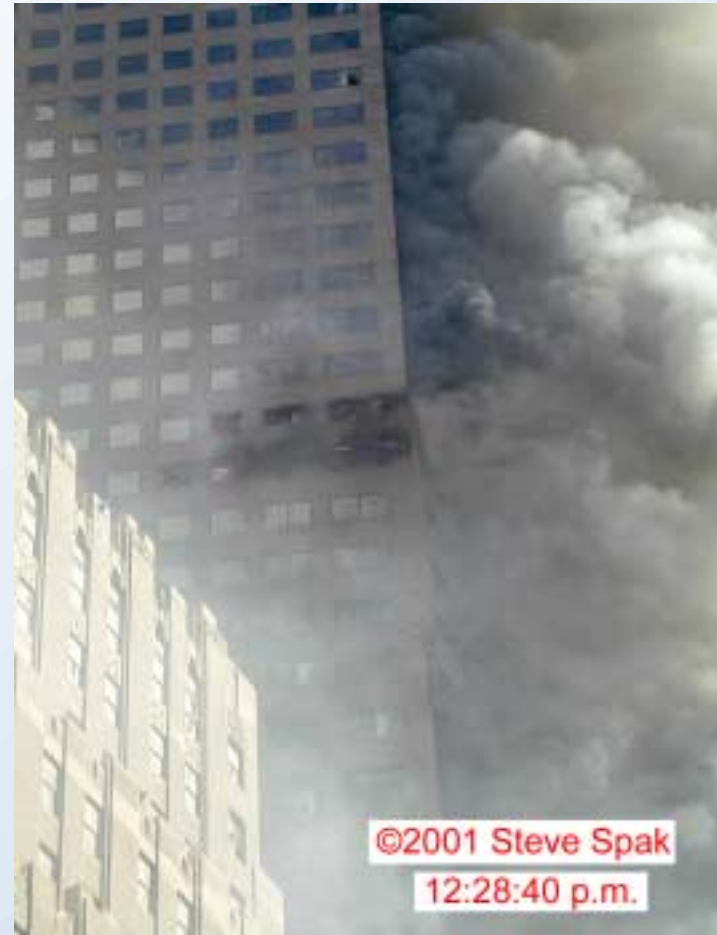
Visual Observations for WTC 7

Fires in WTC 7—which began soon after WTC 1 collapsed—were observed on Floors 7, 8, 9, and 11 near the middle about half an hour before collapse; Floor 12 was burned out by this time. Fires were also seen on Floors 12, 13, 22, 29, and 30 at various times during the day.

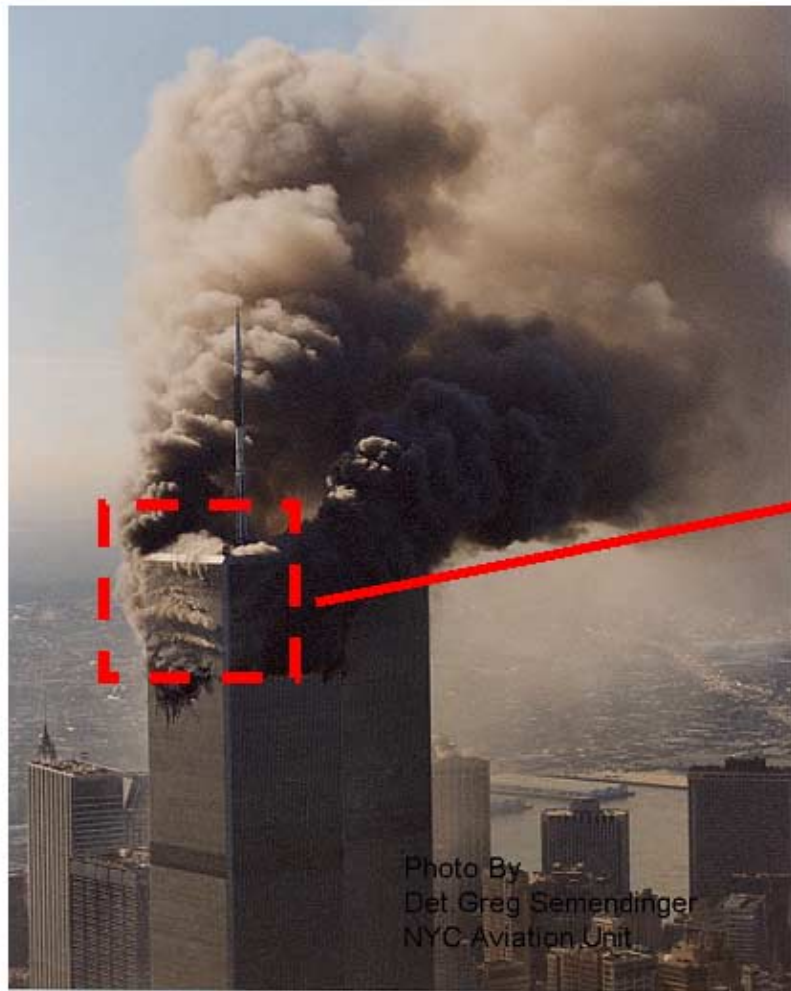
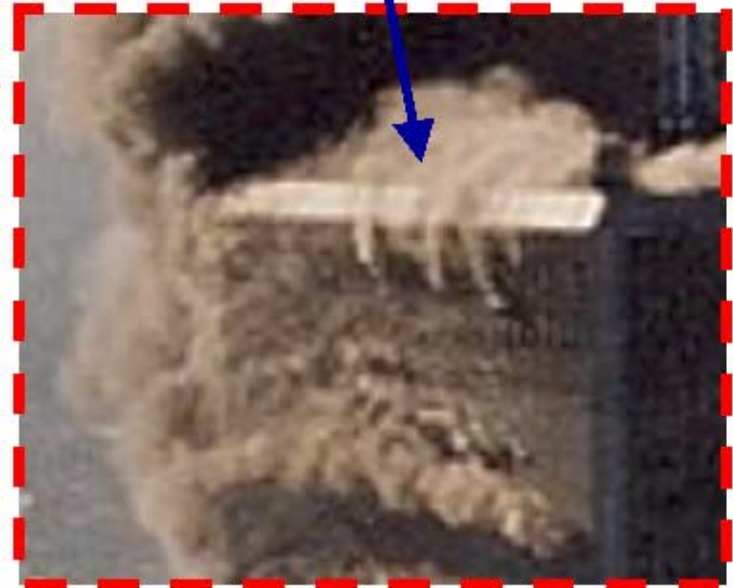
Example of Vertical Smoke Spread

- Analysis indicates that **HVAC (heating, ventilation, and air-conditioning) ductwork was a major path for vertical smoke spread in the buildings.**
- Analysis indicates that **stair pressurization systems would have provided minimal resistance to the passage of smoke in WTC 1 and WTC 2 had they been installed on September 11, 2001.**

North Face – WTC 1

Smoke Exits NW Interior
Ventilation Zone Supply Inlet
