Attachment of Rooftop Equipment in High-Wind Regions

HURRICANES IRMA AND MARIA IN THE U.S. VIRGIN ISLANDS *Recovery Advisory 2, March 2018*

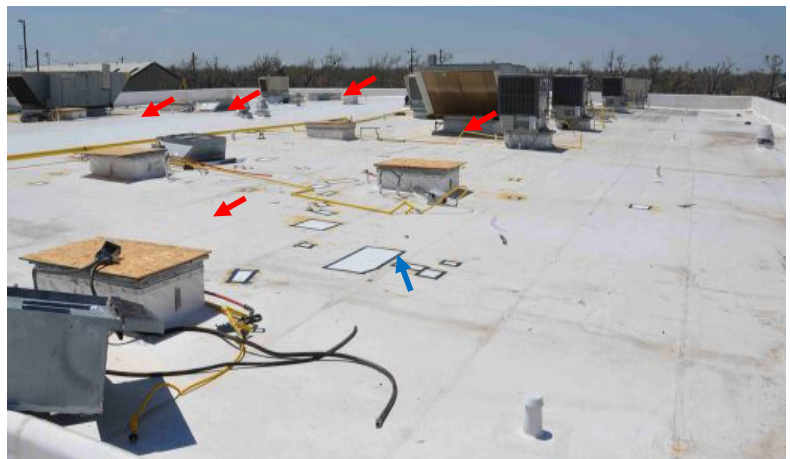
Figure 1. HVAC units blown off their curbs (red arrows). Curb openings were temporarily covered with plywood. Patches had been installed at membrane punctures (blue arrow). Hurricane Harvey, Texas.

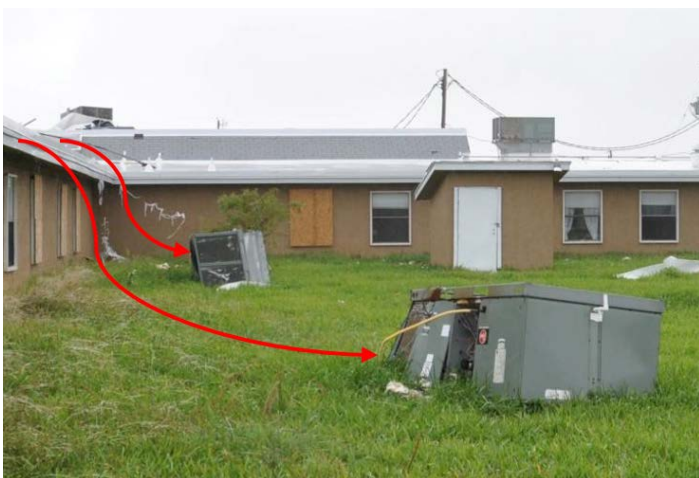
Figure 2. HVAC units at this nursing home were blown completely off the roof. Hurricane Harvey, Texas.

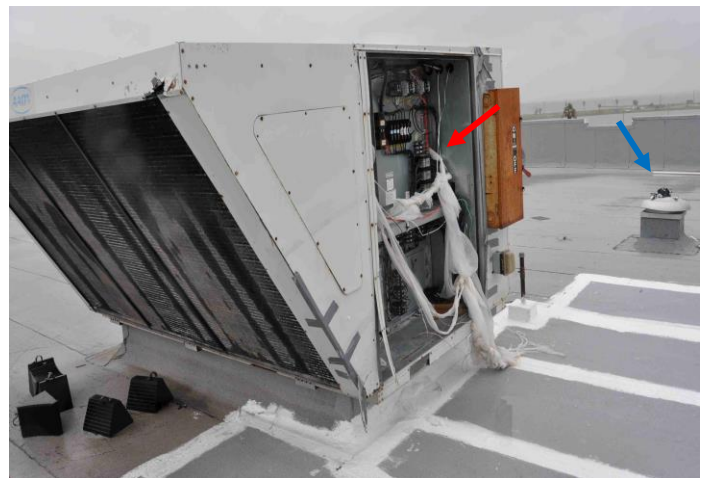
Figure 3. Blown-off access panel at a hotel (red arrow) and blown-off fan cowling (blue arrow). Hurricane Harvey, Texas.

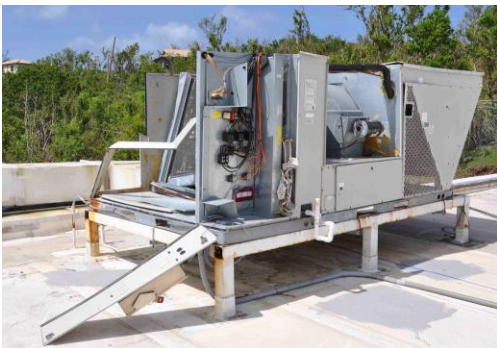
Figure 4. Blown-off unit enclosures at a medical clinic.

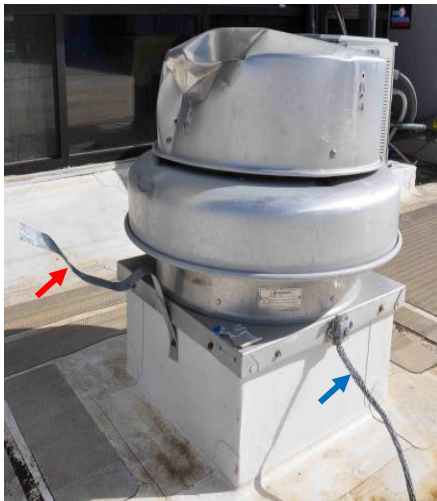
Figure 7. Damaged fan cowling with damaged strap (red arrow). Note the lightning protection system conductor (blue arrow).

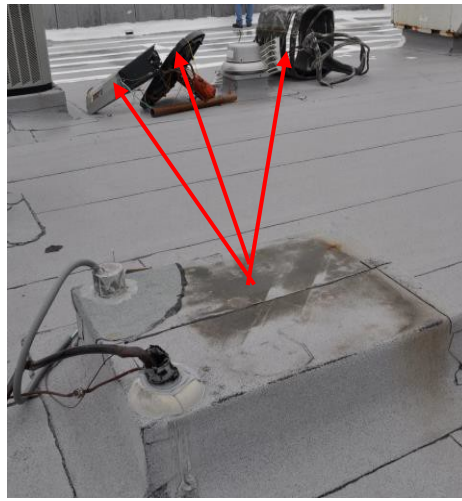
Figure 8. The condenser at this hotel was placed on the curb and was not anchored. Hurricane Harvey, Texas.

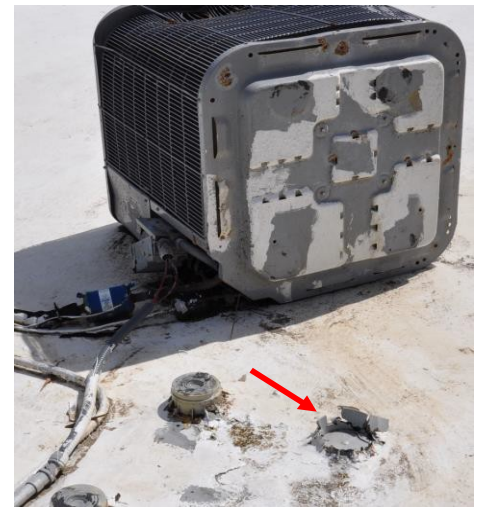
Figure 9. This condenser was blown off the plastic pedestals to which it was attached. One of the pedestals was broken (red arrow).

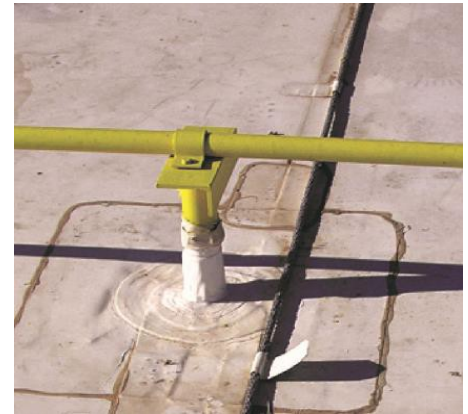
Figure 12. Enhanced gas line support detail using a strap. From FEMA P-424 (Figure 6-100).

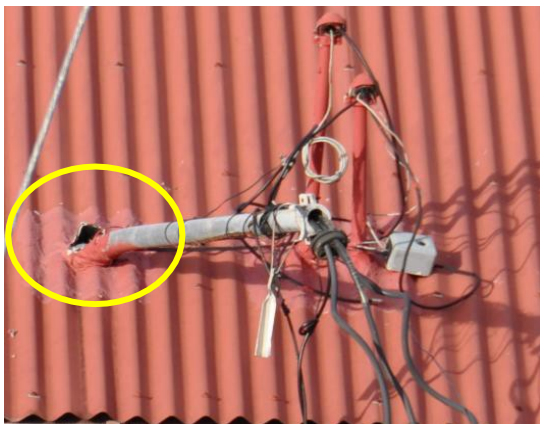
Figure 14. A collapsed overhead power line pulled over this service mast which caused flashing rupture (yellow oval).

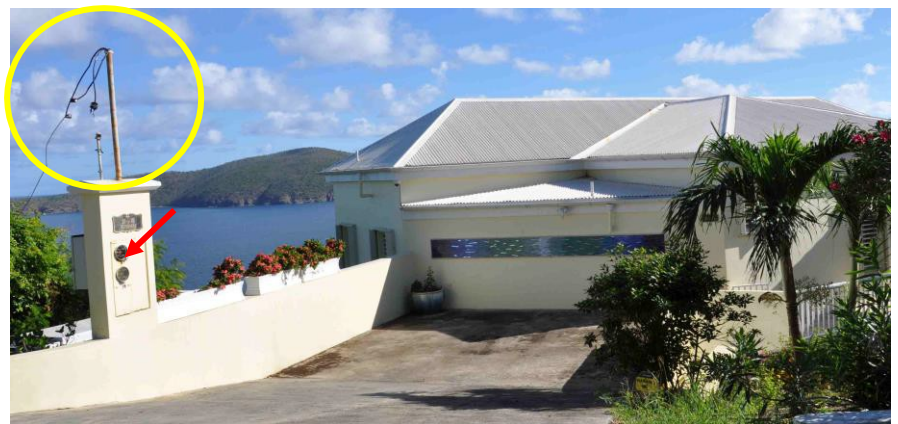
Figure 15. Overhead power line terminated at a service mast (yellow circle) anchored to a concrete pylon (red arrow). Service ran underground from the pylon to the house.

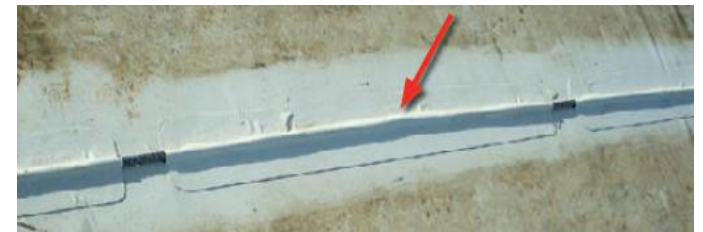
Figure 18. Enhanced LPS attachment, using intermittent roof membrane flashing strips. From FEMA P-424 (Figure 6-114).
