Potential Errors Associated with Stage-Discharge Relations for Selected Streamflow-Gaging Stations, Maricopa County, Arizona

Water-Resources
Investigations Report 00–4224

By Anne C. Tillery, Jeff V. Phillips, *and* Joseph P. Capesius

Tucson, Arizona
October 2001

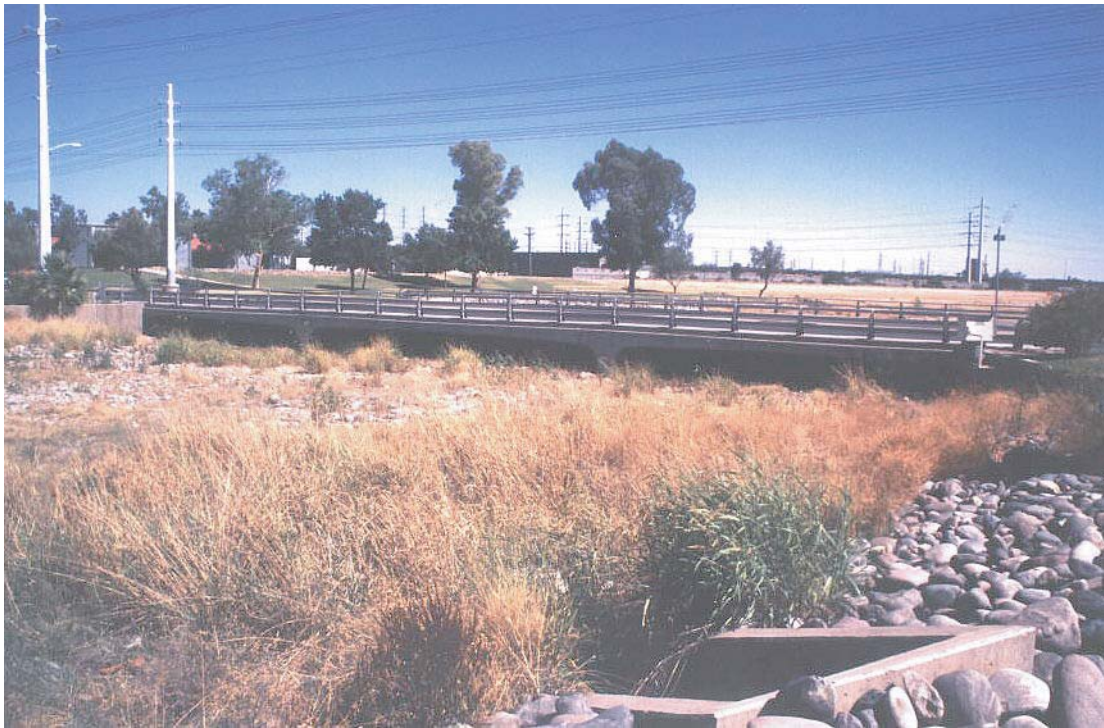
Description of channel conditions.—The low-flow control at the Curry Road site is the upstream invert of the series of culverts. Two additional cemented boulder weirs are about 400 ft and 800 ft upstream, and a golf-cart path is 100 ft upstream from the gaging station. The channel is nearly straight for 0.75 mi upstream from the gaging station. The channel has boulders and cobbles for 100 ft upstream and 300 ft downstream from the gaging station. The grass-lined channel, which is upstream from the boulders and cobbles, is mowed periodically (public golf course). The amount and height of grass and weeds present in the cobble channel near the gaging station, however, varies and probably influences the stage-discharge relation for low to moderate flows.

Figure 3. View looking downstream at gaging station from right bank, Indian Bend Wash at Curry Road, Tempe, Arizona.

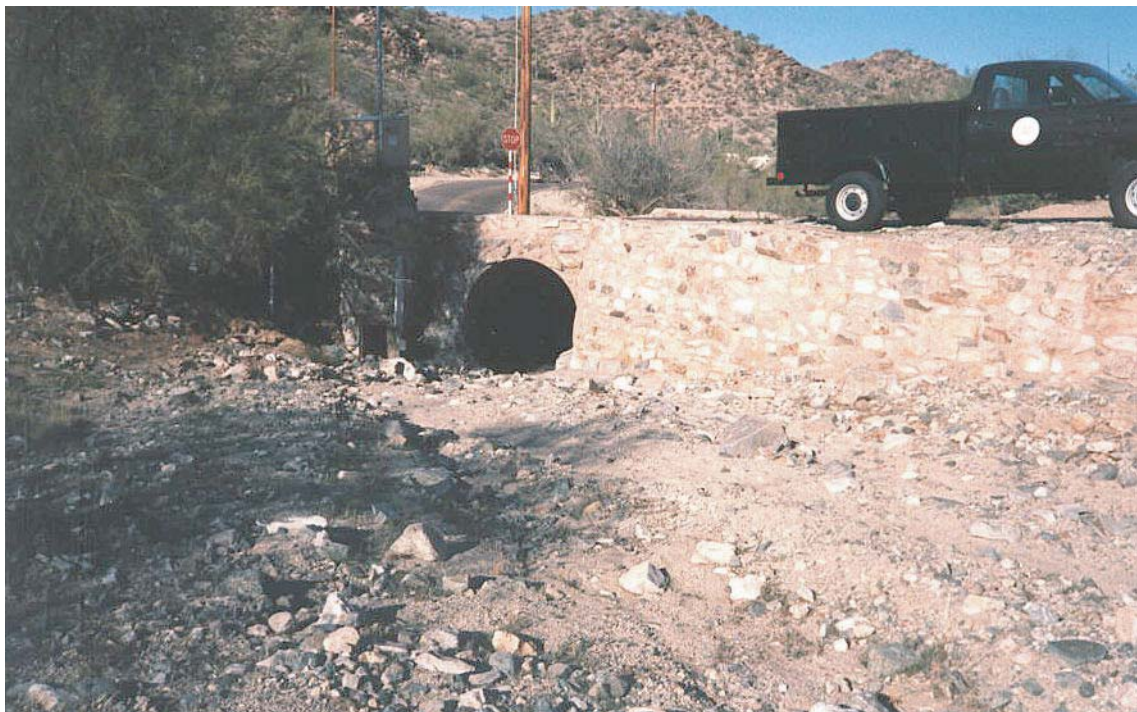
Description of channel conditions.—The low-flow control is the upstream invert of the culvert, which is susceptible to fill of sand- and gravel-sized material including angular cobbles. At this location, however, the channel alluvium is shallow and is not subject to considerable shifting. The medium-flow control is the culvert. The sensitivity of the rating decreases greatly when water overflows the left bank. This decrease in sensitivity has caused the rating to be changed several times during the period of record. Upstream from the gaging station, the channel is straight for about 500 ft and is between 15 to 40 ft wide. The channel banks generally are covered with vegetation and mesquite trees. Downstream from the culvert, the channel is straight for about 150 ft and is between 10 and 25 ft wide. The vegetation becomes thicker in the downstream reach of the channel.

Figure 5. View looking downstream at gaging station, Salt River Tributary in South Mountain Park at Phoenix, Arizona.

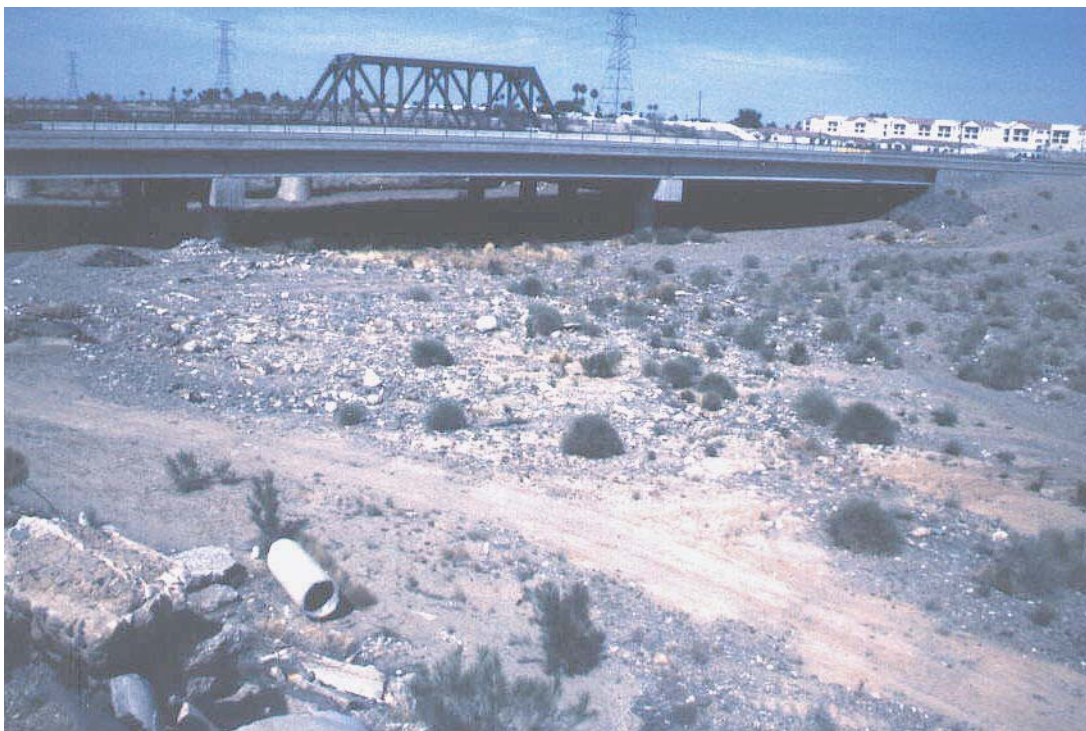
Description of channel conditions.—The low-water control is a cobble riffle about 100 ft downstream from the gaging station. The channel is fairly straight for about 800 ft upstream and 1,200 ft downstream from the gaging station. The channel is rectangular in shape and is composed primarily of coarse gravel. The main channel is about 600 ft wide at the gaging station, but widens slightly above and below the gaging station. Channel banks are shaped and lined with rocks to minimize erosion at high flow. The high-flow control is the channel.

Figure 7. View looking upstream toward gaging station from right bank, Agua Fria River at El Mirage, Arizona.

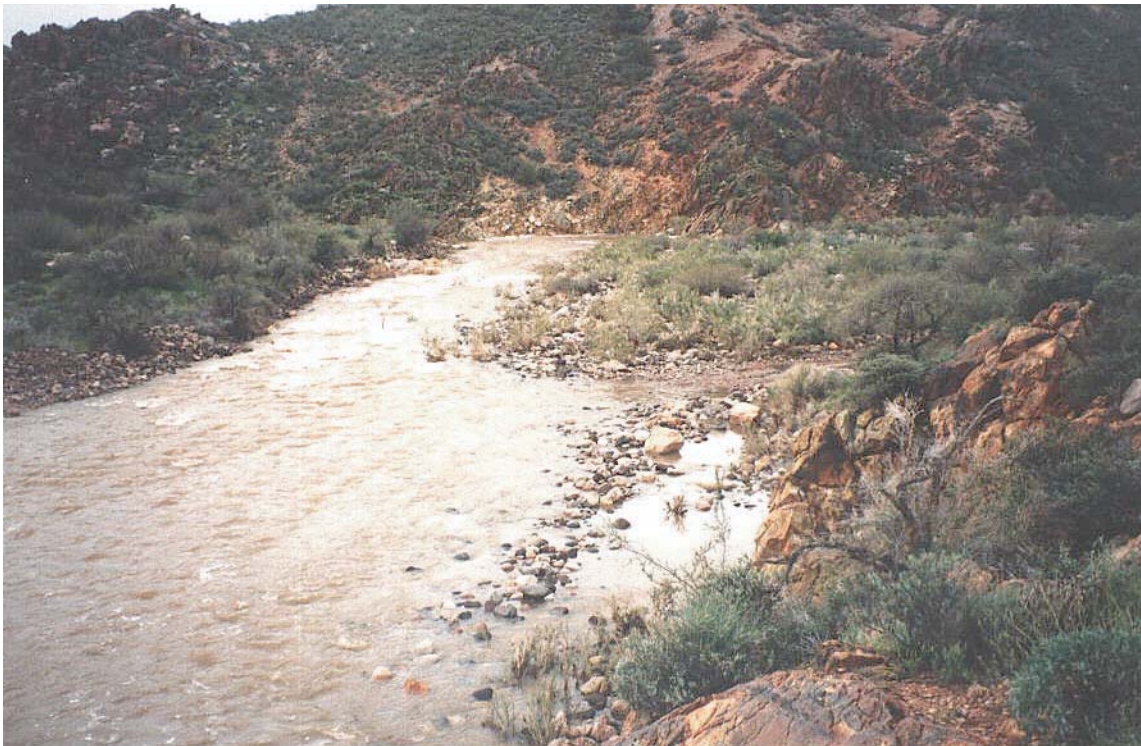
Description of channel conditions.—The low- and medium-flow control is the sand-and-gravel riffle that begins about 25 ft below the gaging station and extends to a graded road crossing about 200 ft downstream from the gaging station. The road crossing is susceptible to scour and fill because of automobile traffic, flooding, and road-grading activities. The high-flow control is the channel. The site has an overflow channel to the left of the main channel at a gage height of about 9 ft. The left bank has sparse vegetation, and the right bank consists of steep bedrock near the gaging station with sparse vegetation downstream.

Figure 9. View looking downstream from control on right bank, New River near Rock Springs, Arizona.

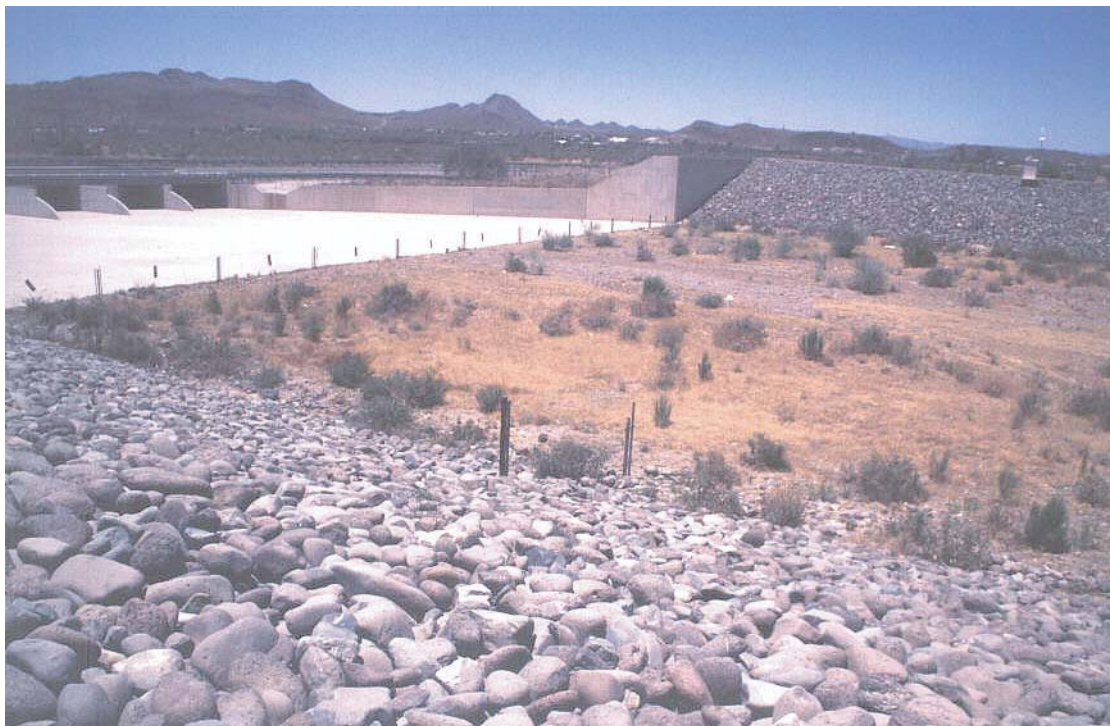
Description of channel conditions.—The watercourse is channelized above and below the present streamflow-gaging station by sloped earthen-dike walls covered with large angular boulders. The channel bottom has coarse sand and gravel and a cover of sparse vegetation. A concrete apron that is the control at all stages extends the entire width of the channel. The apron begins about 85 ft below the station and extends 240 ft to eight box culverts that run beneath Interstate 17 and Frontage Road. Vegetation in the channel is razed periodically by the Flood Control District of Maricopa County.

Figure 11. View looking downstream at gaging station from left bank, Skunk Creek near Phoenix, Arizona.

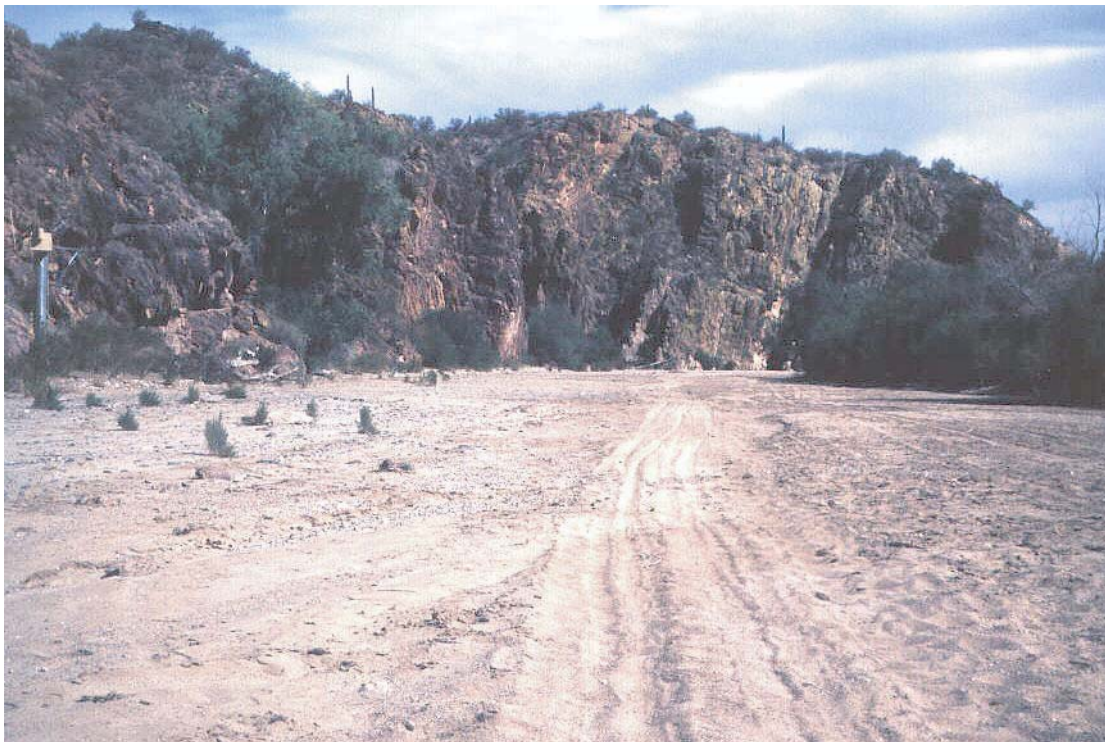
Description of channel conditions.—The low- and medium-flow control is a 200-foot wide sand channel that is straight for 1,000 ft above and below the streamflow-gaging station. The channel-bed material is a coarse sand-and-gravel mix that is subject to considerable shifting at all stages. The left bank is a near-vertical bedrock cliff. The right bank is a bedrock outcrop that slopes away from the channel floor. A railroad track right-of-way is adjacent to the right bank of the channel. Mesquite trees line the right bank below the terrace. A sharp right bend in the channel and a railroad-bridge abutment 1,000 ft downstream acts as the control during high flows.

Figure 13. View looking downstream at gaging station from midchannel, Hassayampa River near Morrystown, Arizona.

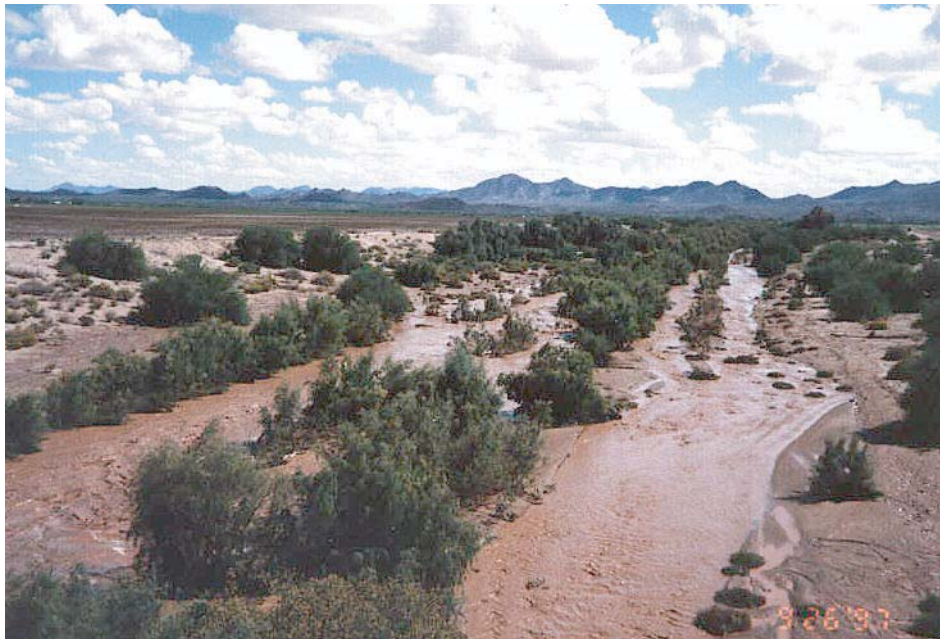
Description of channel conditions.—The low-flow channel is the control most of the time; a gravel riffle downstream from the gage becomes effective at extremely low flows (less than 5 ft³/s). The channel is subject to scour and fill at all stages. The channel is fairly straight for 750 ft above and about 1,000 ft below the gaging station but does slightly turn toward the right bank 75 ft upstream from the bridge. The channel is trapezoidal in shape and is unstable at high flows. Substantial amounts of vegetation (saltcedar, willow, mesquite, and palo verde) may grow along the edge of the low-flow channel during sustained periods of low flow. Vegetation is more sparsely distributed throughout the main channel. Higher flows have a tendency to scour and uproot the vegetation downstream from the station. Scour of as much as 8 ft has been measured by depth-sounding methods from the bridge during floods. The average low-flow channel width is about 30 ft, and the high-flow channel width is about 250–300 ft. Flow is primarily irrigation return flow most of the year.

Figure 15. View looking downstream from bridge, Hassayampa River near Arlington, Arizona.

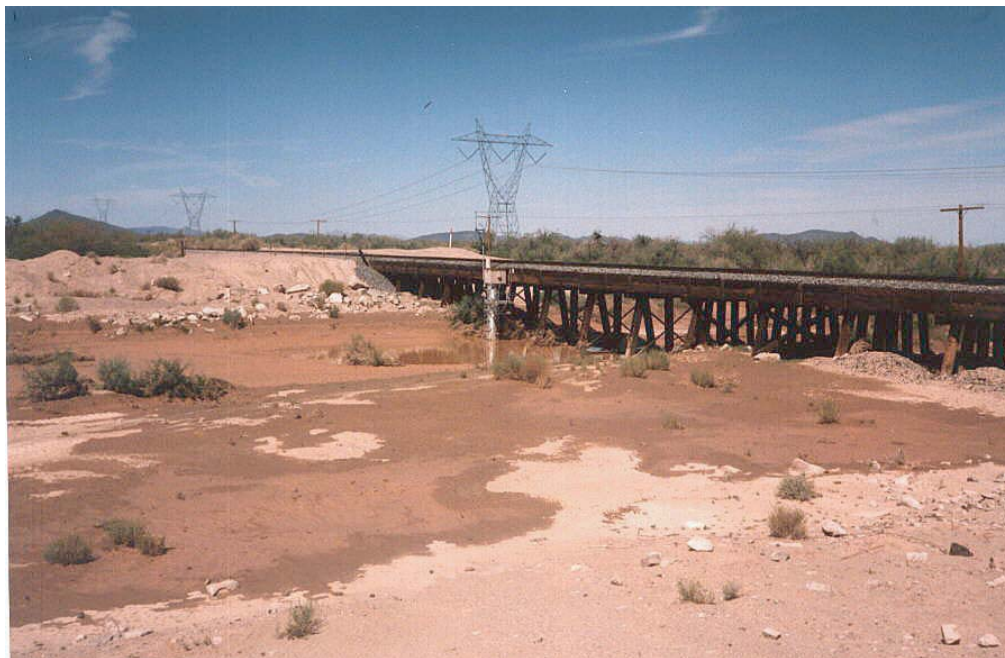
Description of channel conditions.—The location of the low-flow control, a gravel riffle downstream from the gaging station, varies for each flow. The machine-graded channel banks become the control during medium and high flows. The wash upstream from the railroad bridge approaches the bridge from a northwestern direction. At the bridge, the wash abruptly turns to the south. Winters Wash joins Centennial Wash from the northeast just north of the bridge. The channel is fairly straight for about 2,000 ft downstream from the railroad bridge and gradually expands and then bends to the southeast. The channel shape is fairly trapezoidal, about 300 ft wide, and composed of sand and clay with gravel deposits in places. Brush and small trees grow in the channel above the gaging station, but the channel is clear below the gaging station. The banks and channel are maintained by frequent bulldozing. The low-flow channel, which is about 10 ft wide, meanders downstream from the bridge adjacent to the right bank. The stream is ephemeral and is dry most of the year.

Figure 17. View looking upstream at gaging station from left bank, Centennial Wash at Southern Pacific Railroad Bridge near Arlington, Arizona.

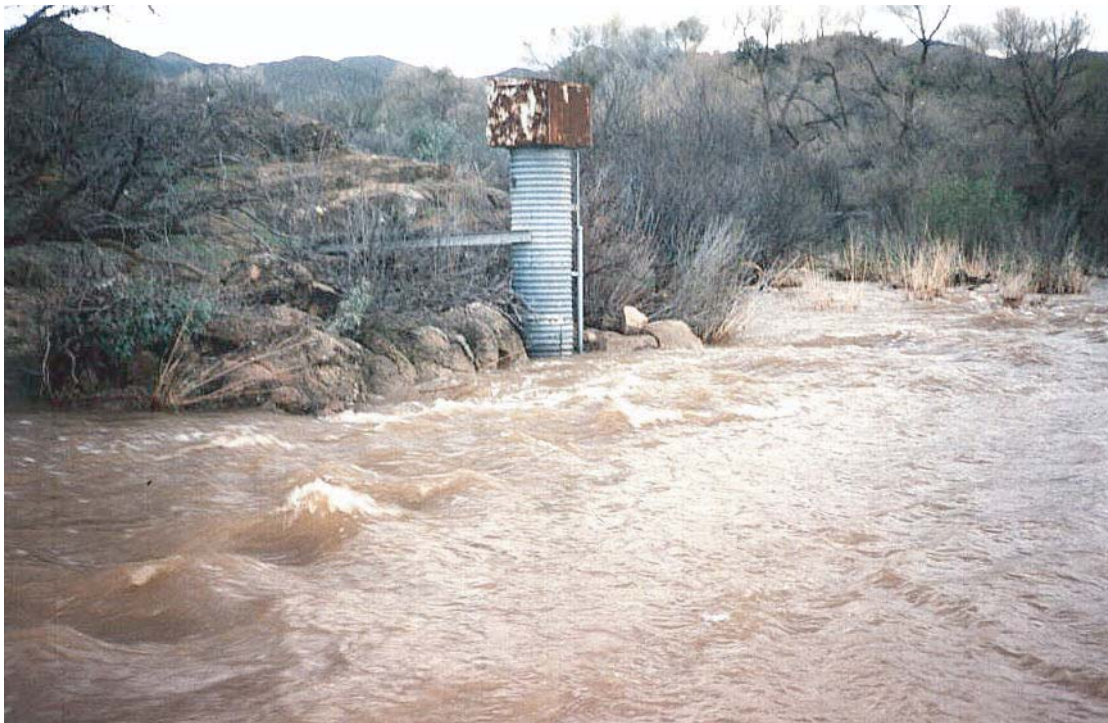
Description of channel conditions.—The low-water control is a concrete weir 50 ft long with a small v-notch that controls stage for extremely low flows. The medium control is the concrete weir. At higher stages, the channel may control flow. The weir is often covered with sand, and its effectiveness during moderate to large flows is unknown. The channel is straight 75 ft upstream and 300 ft downstream from the gaging station. The left bank is a 10-foot high rocky bank with scattered trees and brush. The slope varies from vertical to 1 to 1, and the right bank is a fairly flat flood plain with many trees, scattered rocks, and brush. The streambed is composed of loose sand with scattered grass and brush below the control.

Figure 19. View looking upstream at gaging station, Rock Creek near Sunflower, Arizona.

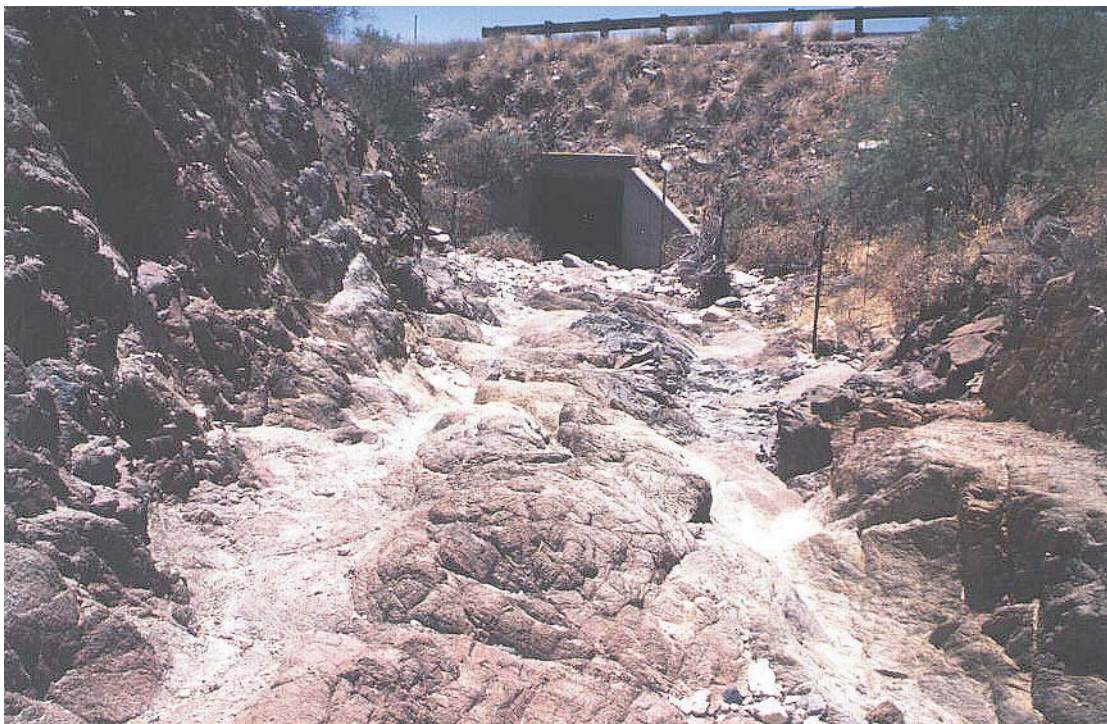
Description of channel conditions.—The control of flows less than about 30 ft³/s is a riffle formed by fill on the apron between the crest-stage gaging station and the culvert entrance. This sediment is subject to shifting during flow. The box culvert forms the control for higher flows with Type I flow below about a 7.2-foot gage height and Type 5 at higher stages (Bodhaine, 1968). The highway embankment and pavement also form the control for road overflow at extremely high stages.

Figure 21. View looking downstream at gaging station, Agua Fria River Tributary No. 2 near Rock Springs, Arizona.

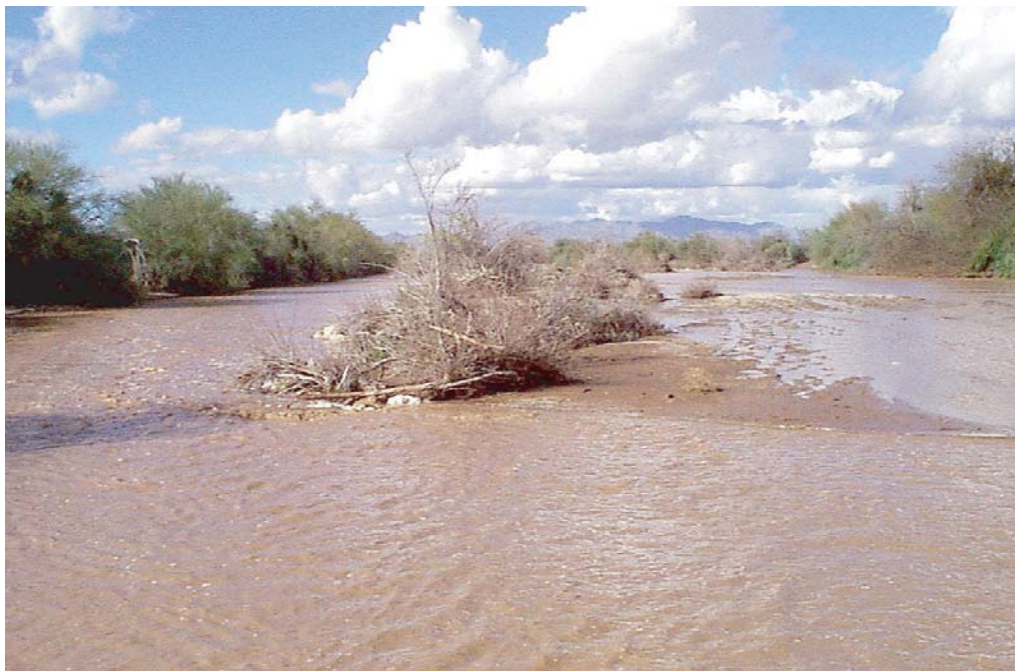
Description of channel conditions.—The channel is composed primarily of sand-sized material and is about 120 ft wide. The channel is straight for several hundred feet both upstream and downstream from the crest-stage gaging station. A bar composed of sand and gravel is midchannel just upstream from the station. Vegetation often is found growing on this mound, in other small areas throughout the channel, and on the channel banks. The stage-discharge relation is controlled by the channel for all but low stages. The channel is susceptible to scour and fill during flows, which directly affect the stage-discharge relation.

Figure 23. View looking upstream, Waterman Wash near Buckeye, Arizona.

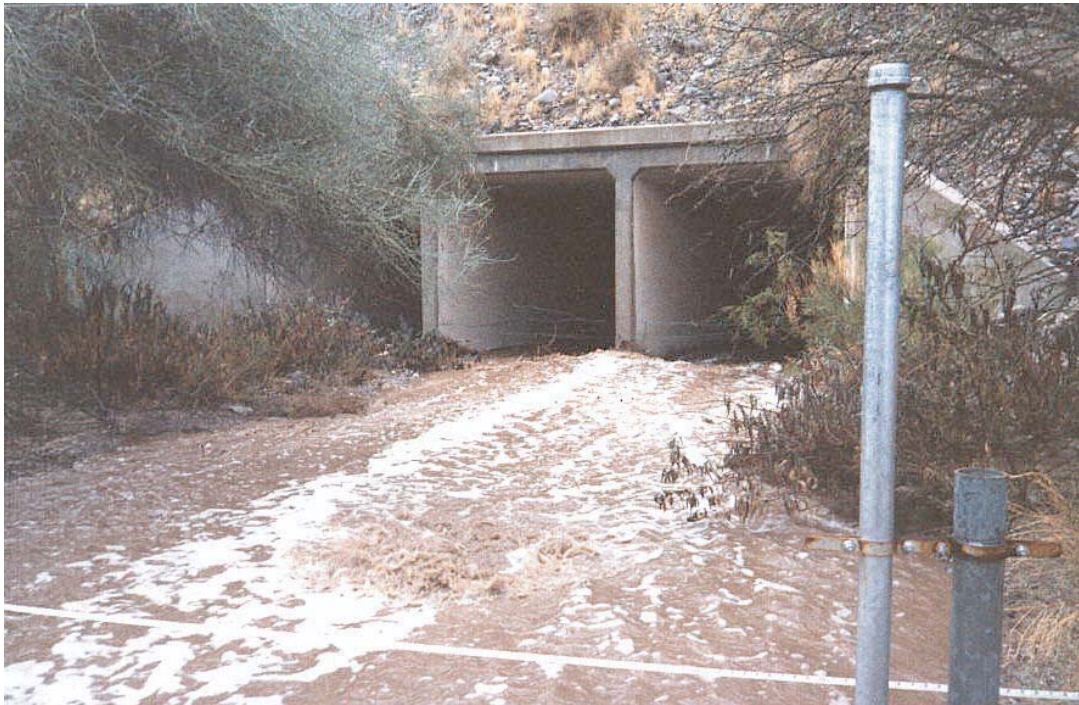
Description of channel conditions.—The low-flow control is the alluvial channel between the gaging station and the box culvert. The high-flow control is a 3-barrel box culvert, which is just downstream from the gaging station. Sediment can fill the culvert bottom decreasing its effective area during flow. Additionally, vegetation growing in the channel and along the channel margins may affect the theoretical culvert hydraulic measurements and thus, the accuracy of the rating curve. Vegetation dislodged from upstream sources also may catch on the vertical walls of the culvert and further decrease the effective area.

Figure 25. View looking downstream at culvert from gaging station, Ox Wash near Morrystown, Arizona.

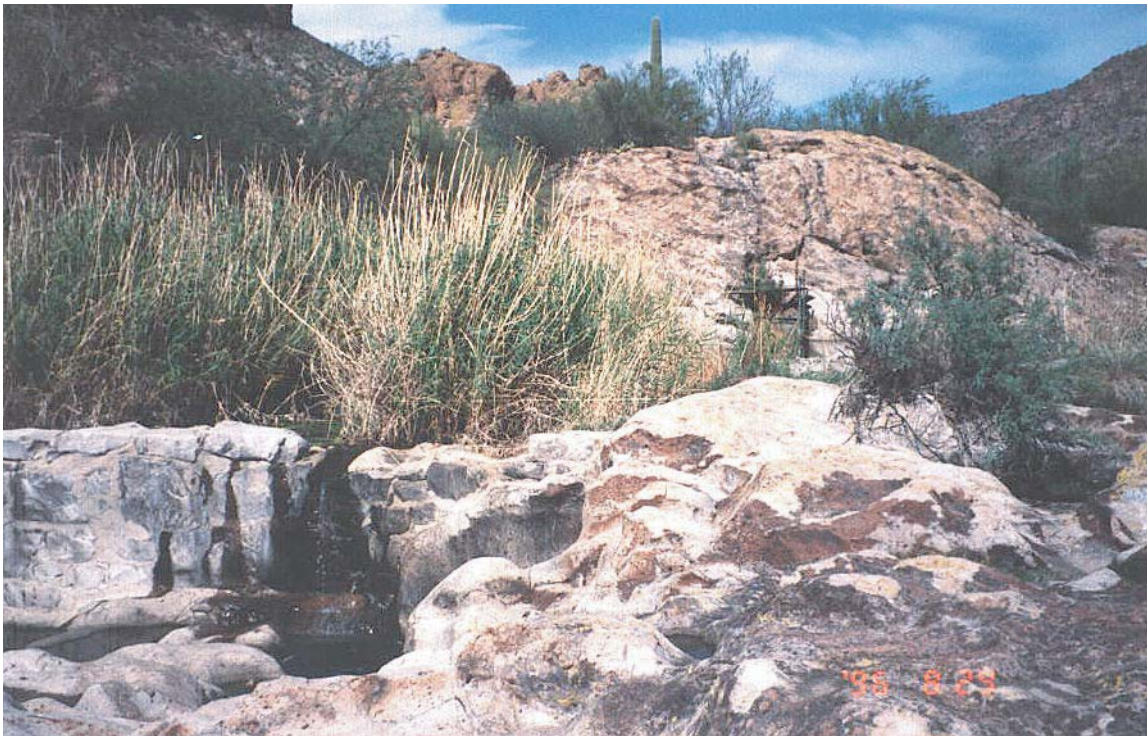
Description of channel conditions.—The control is an 80-foot-long concrete weir, about 1 ft above the ground surface that extends across the channel 90 ft downstream from the gaging station. A stand of thick vegetation (cattails) grows between the gaging station and the weir. The channel bends left just upstream from the gaging station and is straight for several hundred feet downstream. A small notch that controls low flows is near the left end of the weir. The left side of the weir is bedrock that is inundated at higher stages. The right bank is steep and is mostly gravel. The banks are covered with vegetation that may alter the stage-discharge relation. The approach section is composed of unconsolidated material and may shift during flows that also may affect the stage-discharge relation.

Figure 27. View looking upstream at gaging station from left bank, Tortilla Creek at Tortilla Flat, Arizona.

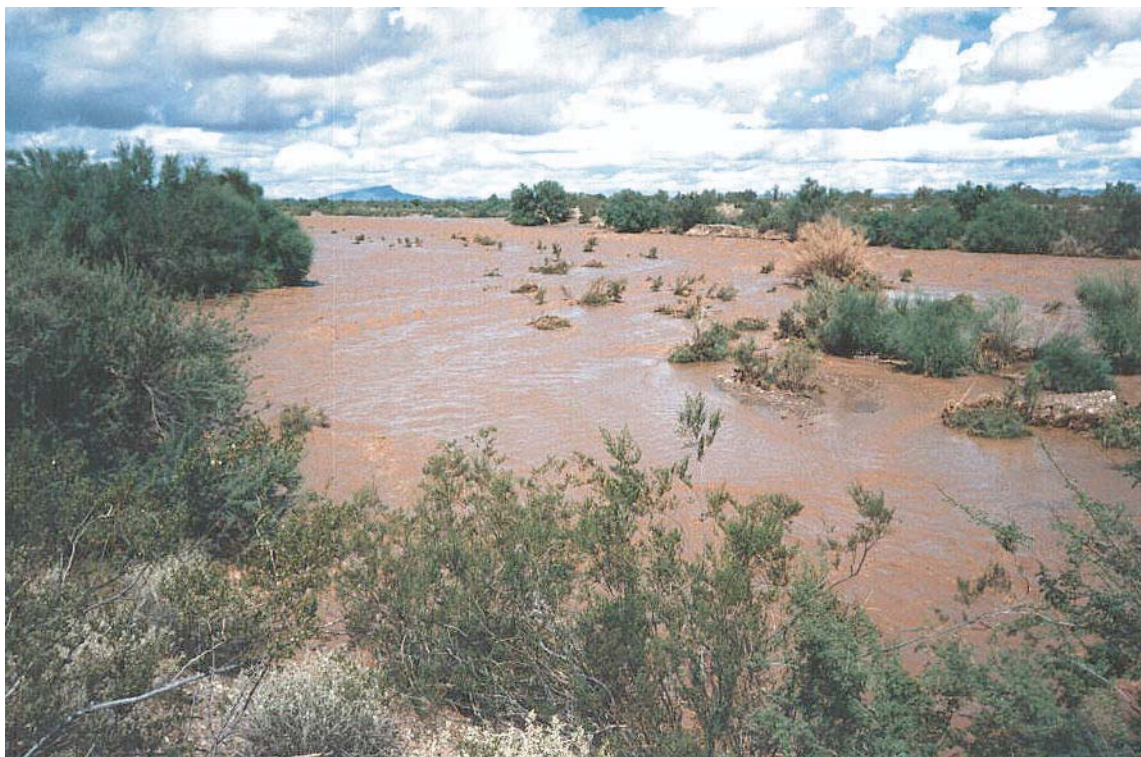
Description of channel conditions.—The control is a wide sandy channel that has some gravel and small cobbles. The rectangular channel is unstable and contains vegetation along both banks. Shifting of the control is possible at all stages but is particularly significant at low stages because the control is affected by a man-made berm that is about 160 ft below the gaging station. The berm tends to wash out at high stages.

Figure 29. View looking upstream at gaging station from right bank, Jack Rabbit Wash near Tonopah, Arizona.

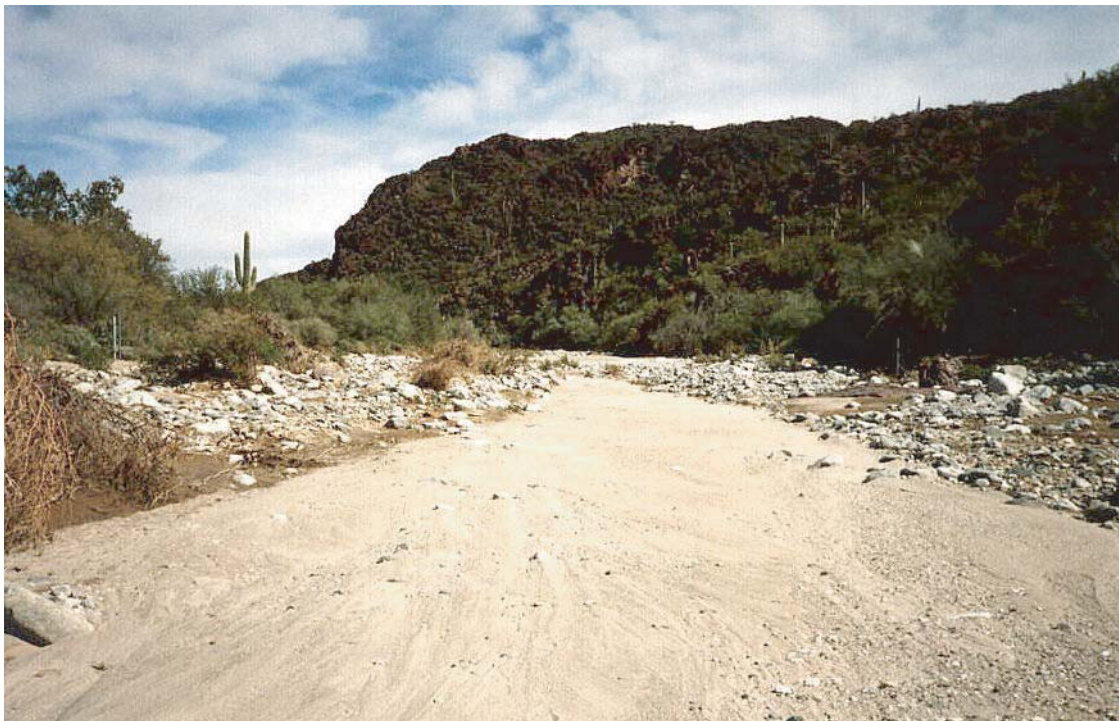
Description of channel conditions.—The control is a sand-and-gravel channel that is straight for several hundred feet upstream and several hundred feet downstream from the gage. An overflow channel is on the right bank and has a dense growth of vegetation that may affect the stage-discharge relation at high flows.

Figure 31. View looking upstream at gaging station, Tiger Wash near Aguila, Arizona.

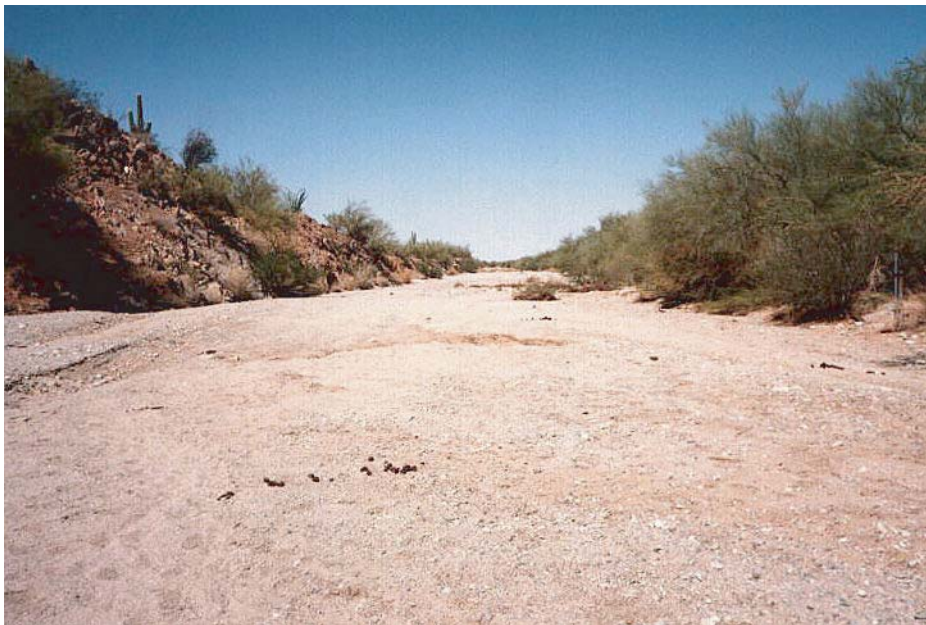
Description of channel conditions.—The sand-bed channel at the gaging station is straight and constricted by a steep bedrock outcrop on left bank and the freeway embankment on right bank. The control is a rock outcrop crossing the channel diagonally from the left bank downstream to the right bank. The control is considered stable except for low flows when shifts may result because of movement of sediment.

Figure 33. View looking upstream at gaging station, Bender Wash near Gila Bend, Arizona.

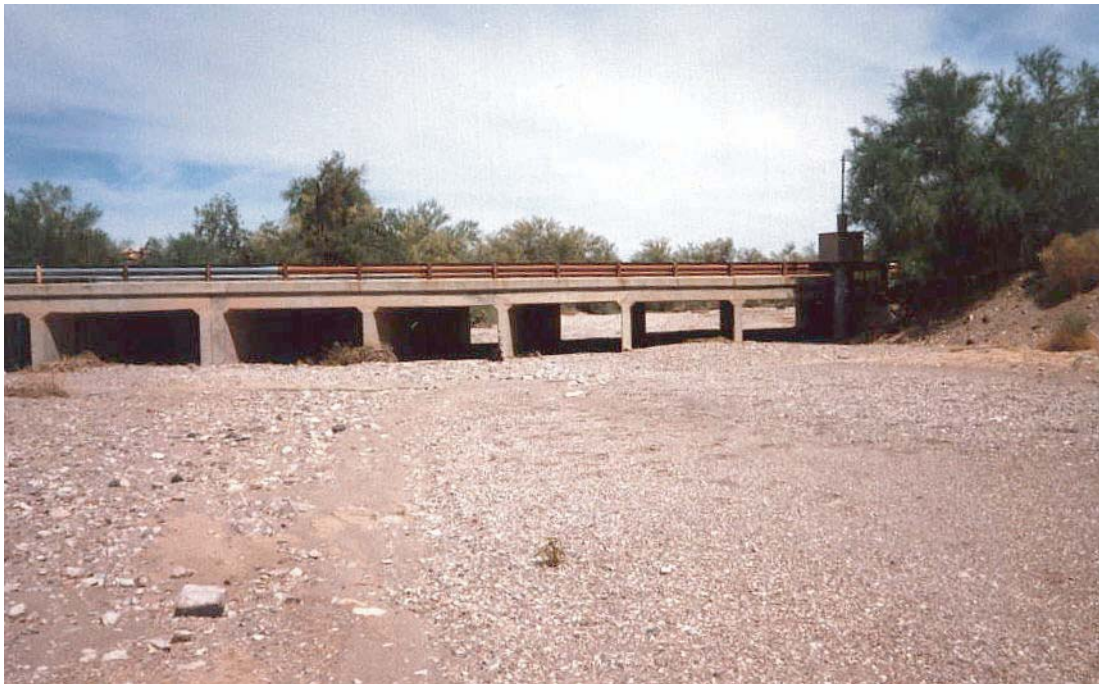
Figure 35. View looking downstream at gaging station, Saucedo Wash near Gila Bend, Arizona.
