Federal Building and Fire Safety Investigation of the World Trade Center Disaster

Project #3: Analysis of Structural Steel Update

October 20, 2004

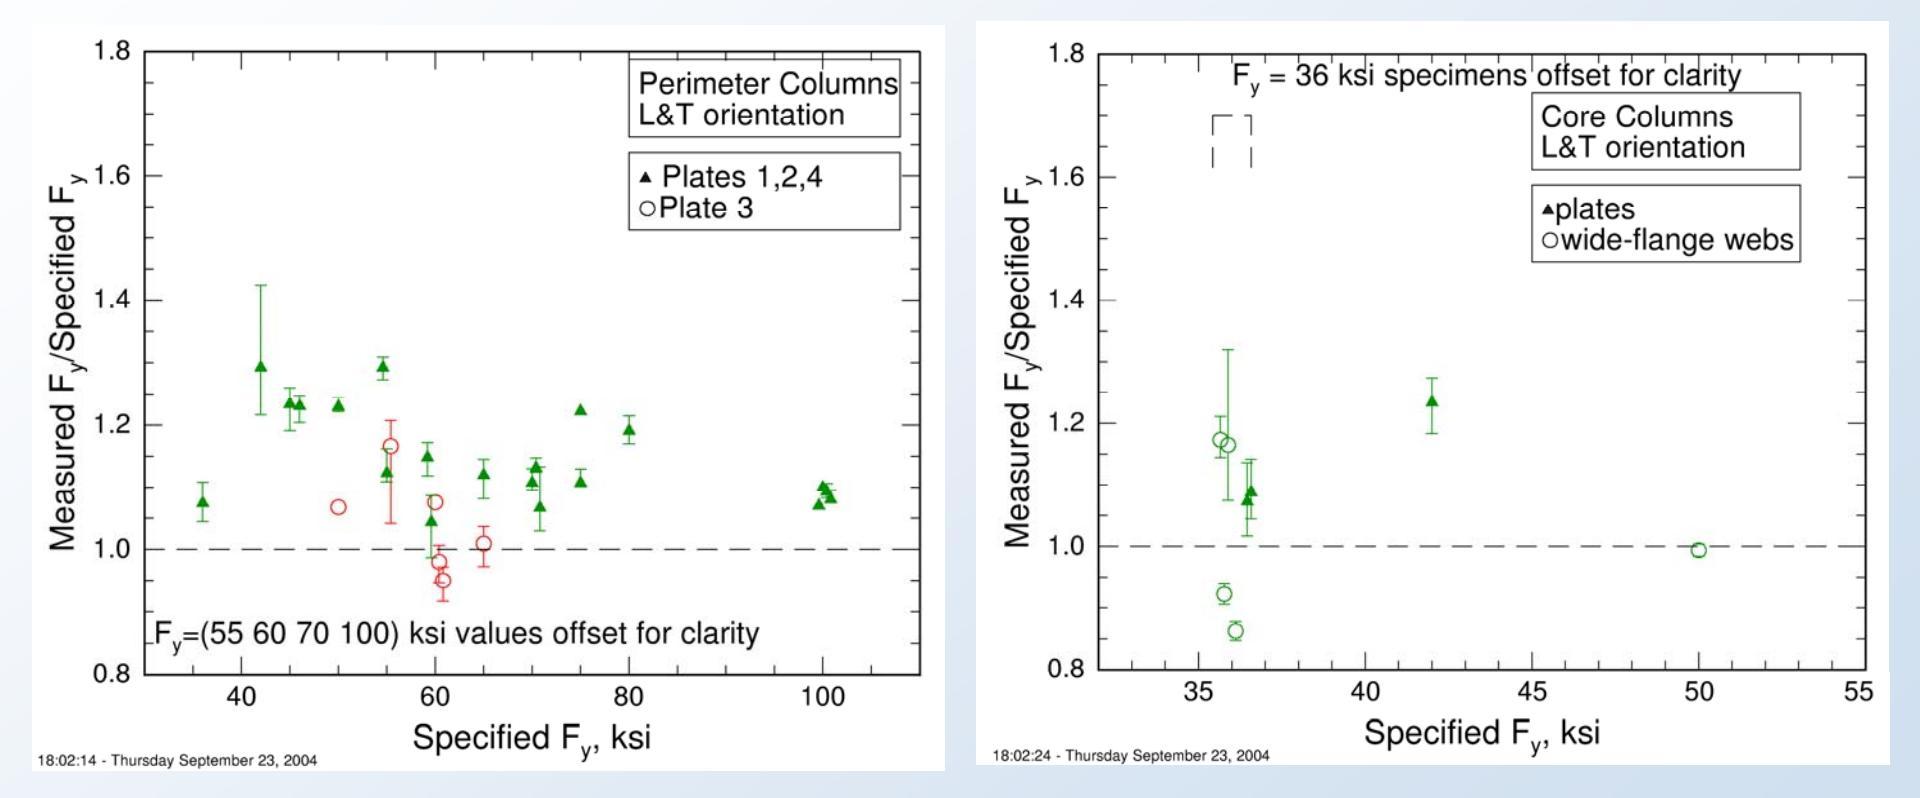
Perimeter Columns

Core Columns

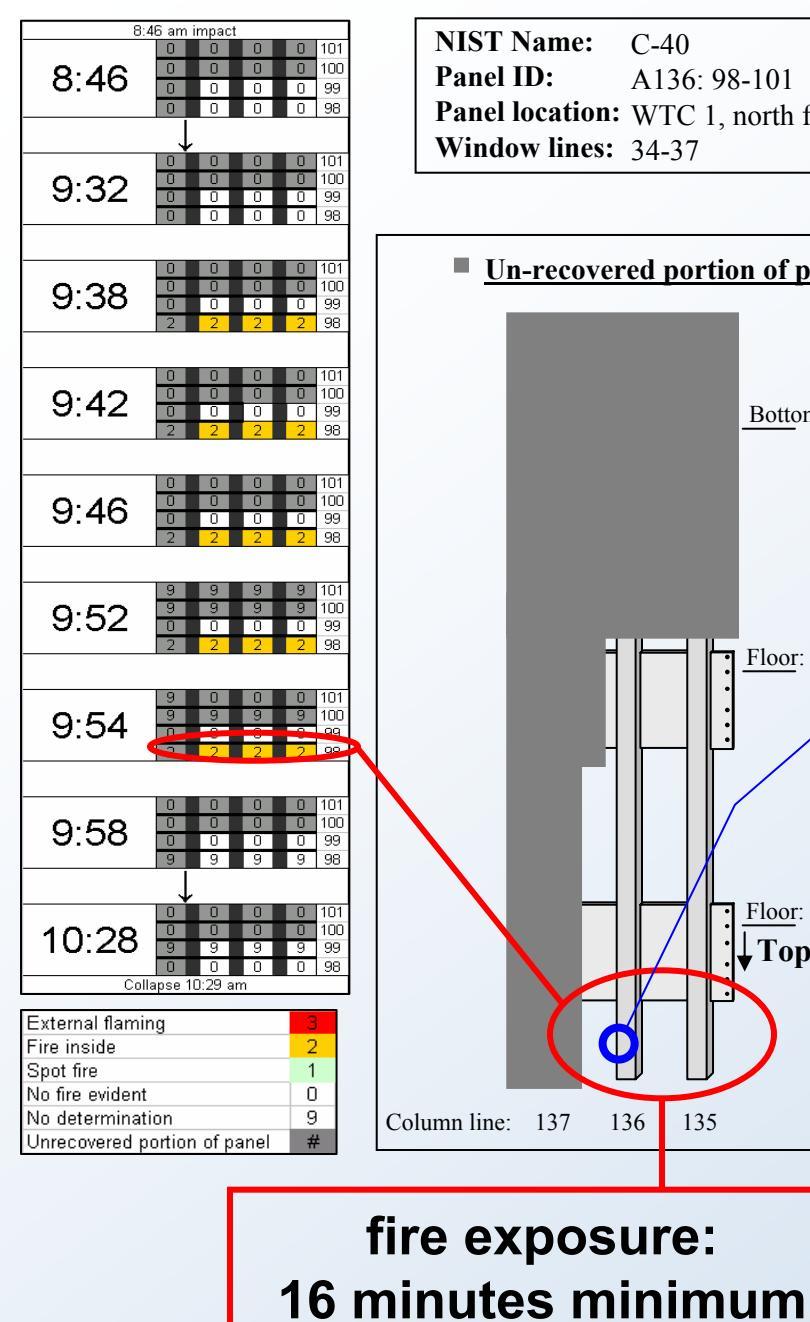
C-40 A136: 98-101 Panel location: WTC 1, north face Un-recovered portion of panel Bottom 101st floor Floor: 100th Floor: 99th Top of 98th floor 135

Sample location: WTC1, column 136, 98th floor -Column with Fy = 60 ksi -No mud cracking of paint

Cementite as <u>plates</u> ¬

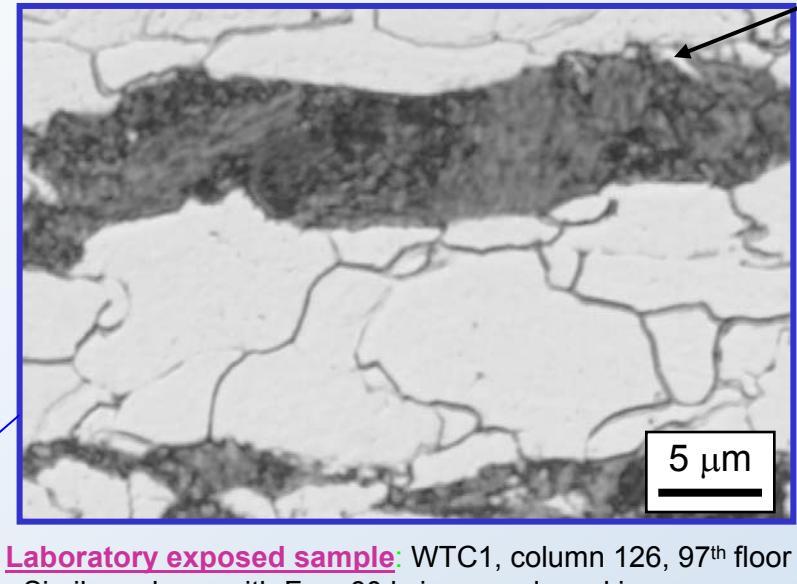
- Similar column with Fy = 60 ksi, no mud cracking - Furnace exposure at 625 °C

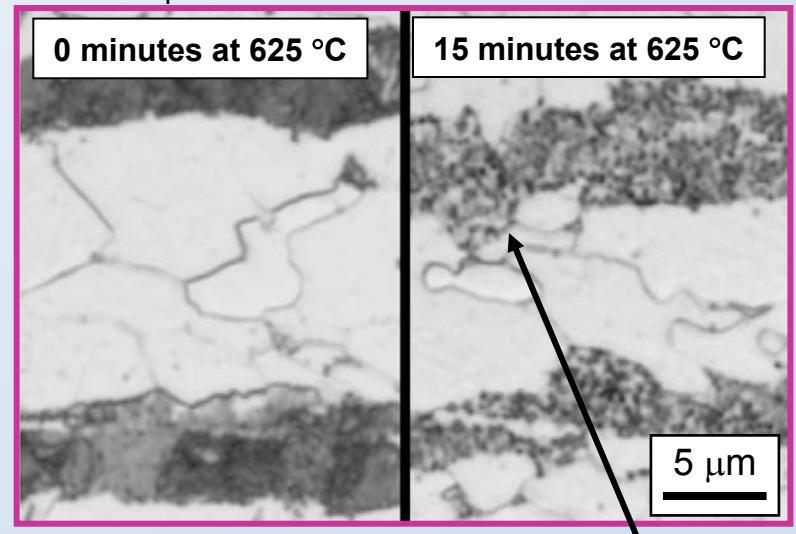
Cementite has begun to <u>spheroidize</u> after 15 min exposure
