# *Continuing Conservation of Brumidi's Murals in the U.S. Capitol*

*Barbara A. Wolanin*

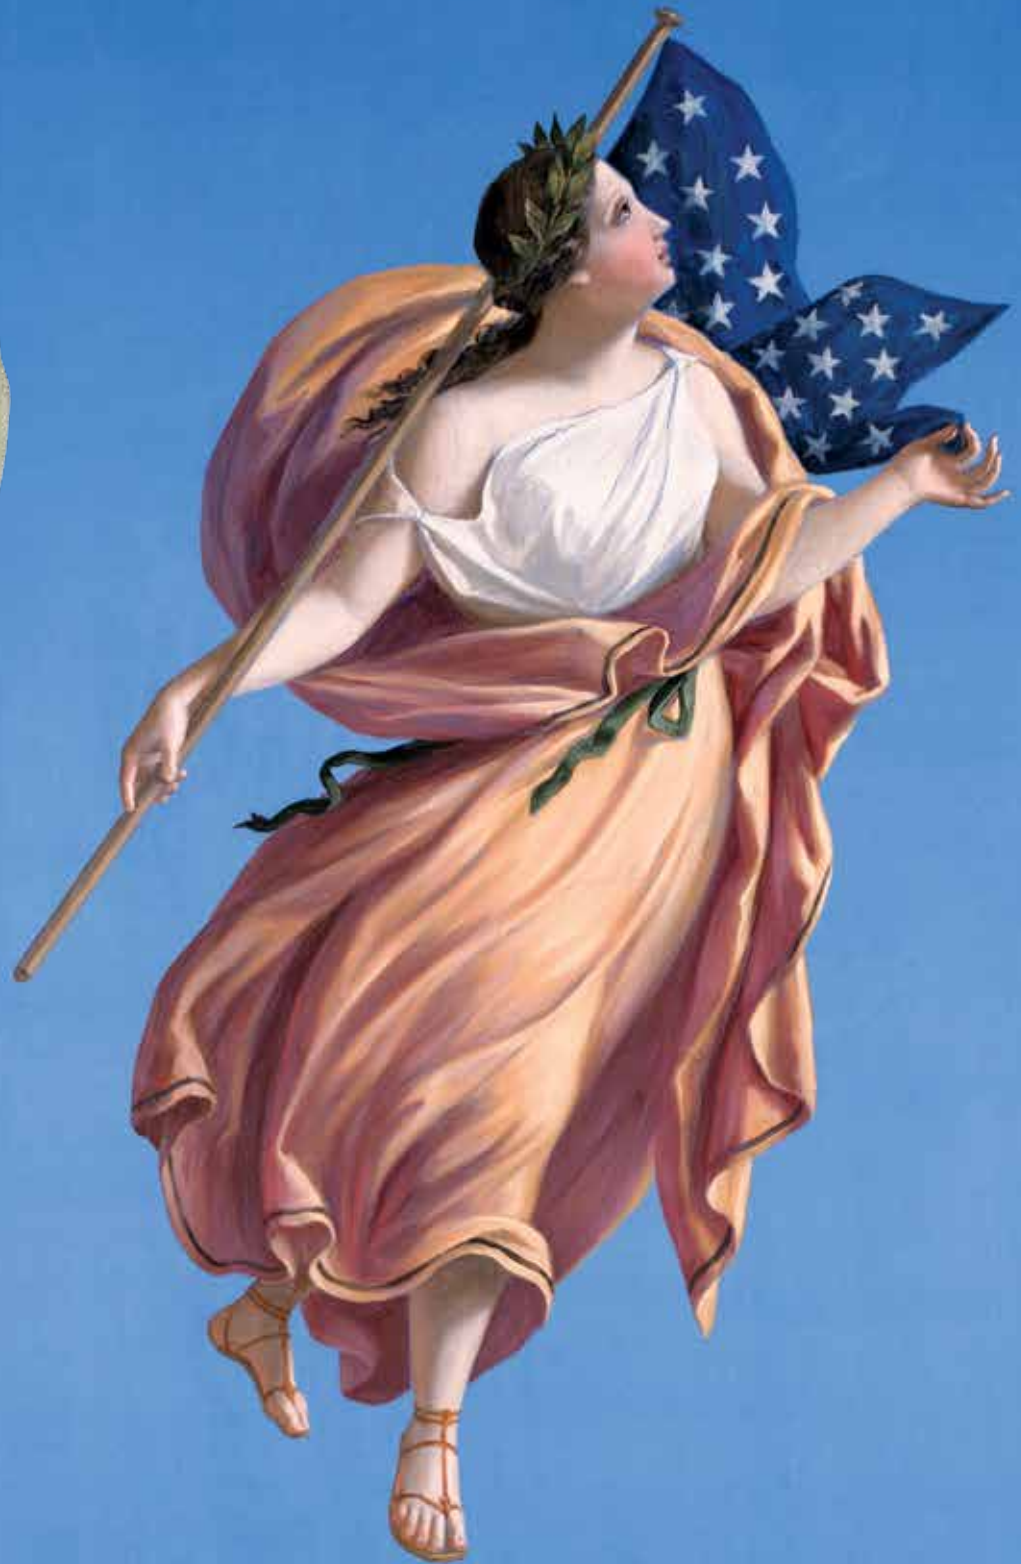
Conserved maiden panel (detail), Senate Appropriations Committee Room.

Conservation restored the graceful, floating quality of the nine maidens featured on the room's wall panels.

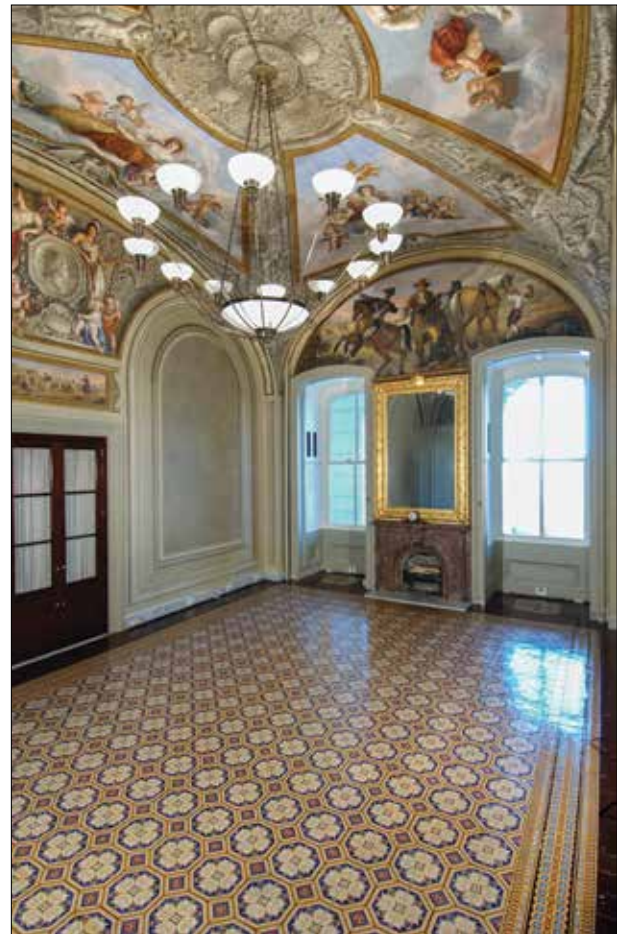
House Agriculture Committee Room after conservation of the murals on the ceiling, lunettes, and walls.

The walls, the only ones in the Capitol that Brumidi painted in true fresco, show his skill in executing trompe l'oeil moldings that resemble carved stone arches.

been originally painted in true fresco to look like stone with arched moldings. This illusionistic effect was obscured by the overpaint, and in 2005, the walls were fully restored. After removing multiple layers of oil paint, conservators reduced the unsightly appearance of soot-filled cracks on the original fresco and skillfully inpainted damaged areas to match the original color and surface appearance.<sup>4</sup> Now, 150 years after Brumidi painted his first room in the Capitol, one can appreciate his sophisticated murals, which create a Renaissance-inspired illusion of a room constructed

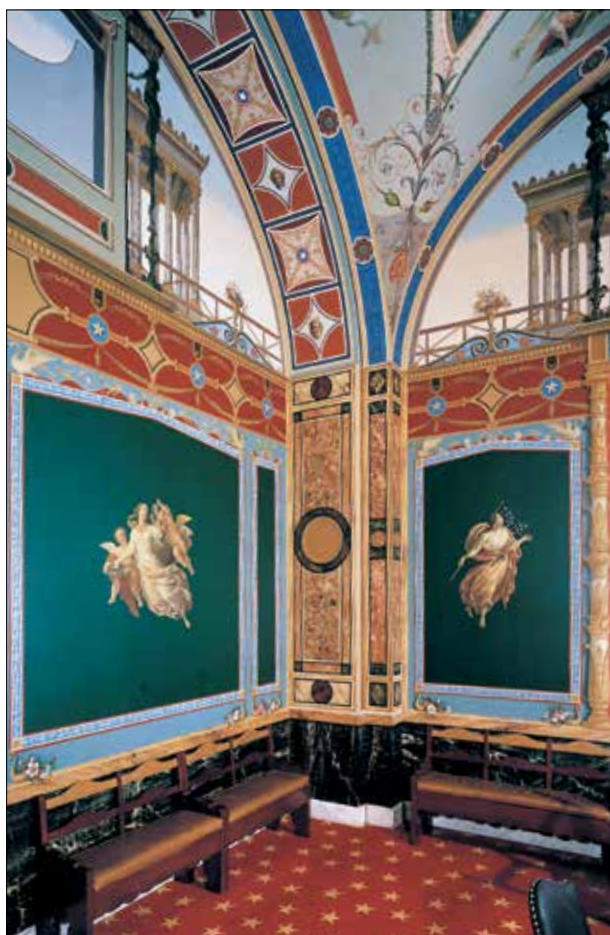
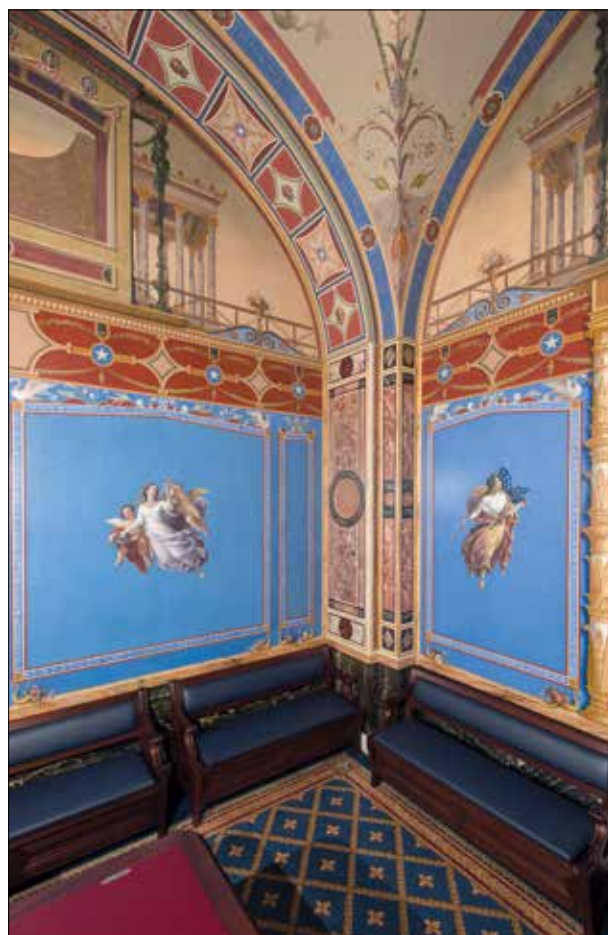
Senate Appropriations Committee Room before and after conservation.

Before conservation, *left*, overpaint and yellowed varnish obscured details in the wall and lunette murals. The restored murals, *right*, can now be appreciated with their original brilliant colors and three-dimensional forms.

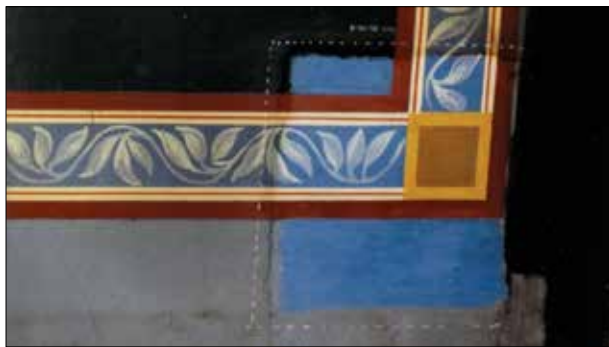
**Testing of area behind mirror, Senate Appropriations Committee Room.**  
Conservators first revealed the original blue field in this area located behind the room's large gilded mirror.

was a priority. Brumidi's 1856 watercolor sketch, early photographs, small exposure windows made by conservators, and a cleaned area on the panel behind the room's gilded mirror all verified the original color. In 2005, the panels were fully conserved, and layers of green overpaint were removed to reveal Brumidi's vibrant blue. Cleaned of yellowed varnish and overpaint, the trompe l'oeil frames surrounding the panels could once again be appreciated.

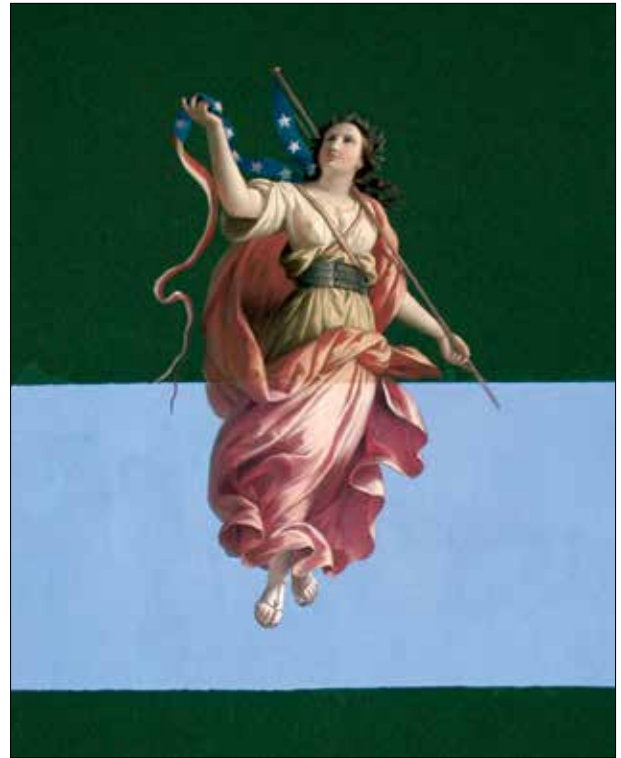
**Maiden panel (detail), Senate Appropriations Committee Room.**  
This photograph shows the striking contrast between the original brilliant blue of the backgrounds and the dark green overpaint.

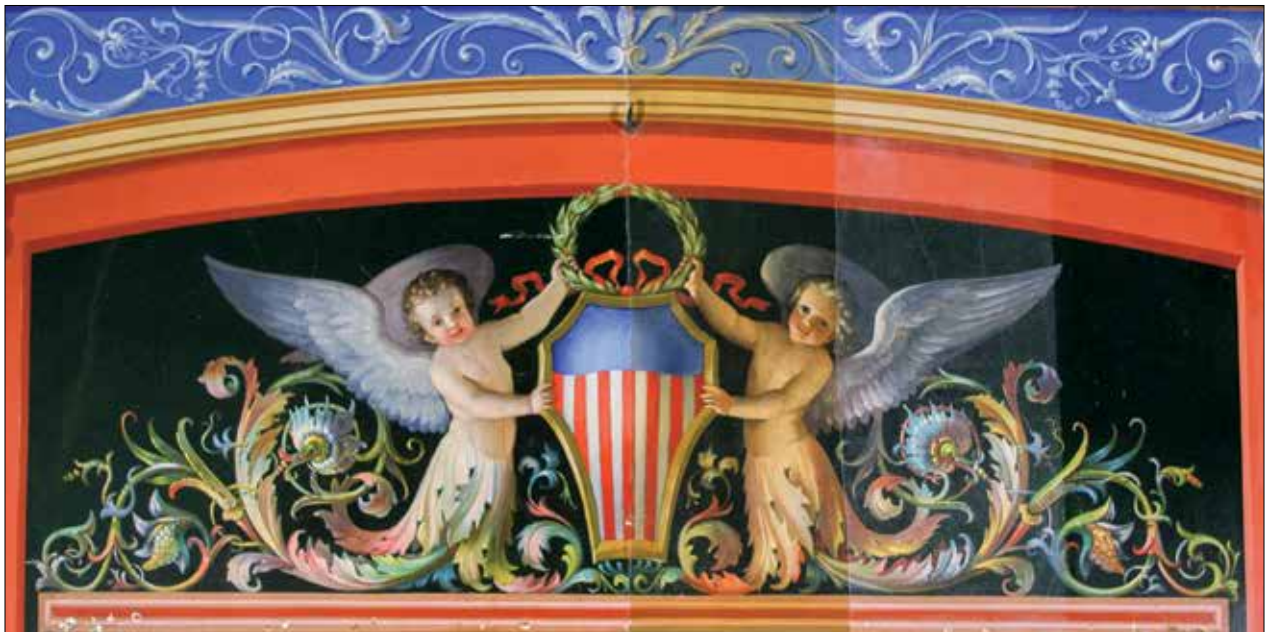
**Partially restored panel of genii with American shield, Senate Appropriations Committee Room.**  
The delicate, rich colors and three-dimensional quality of the genius on the left were revealed after the removal of yellowed varnish.

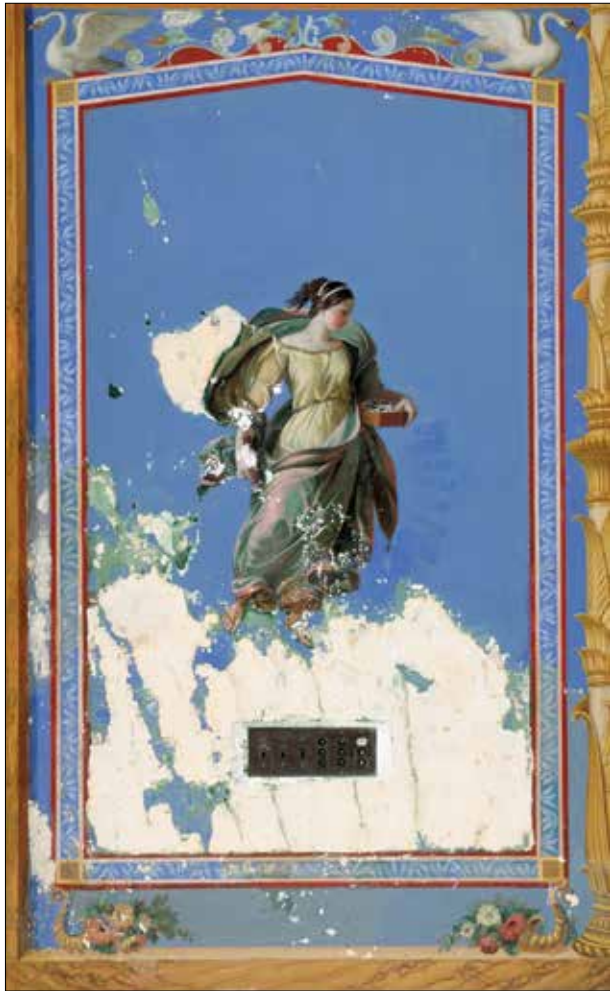
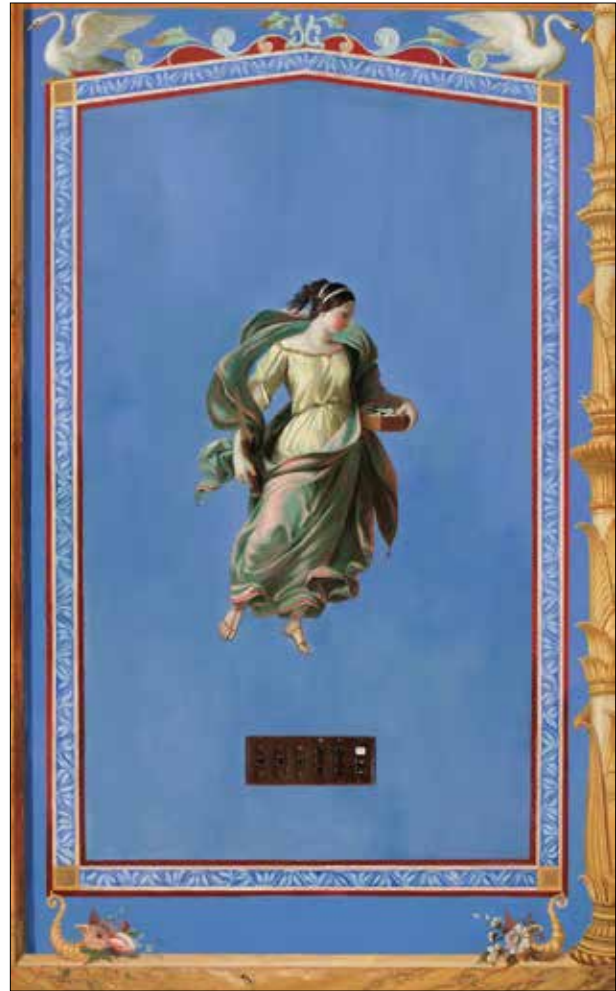
Damaged maiden panel during and after conservation, Senate Appropriations Committee Room.

The most severely damaged of the maiden panels is shown with paint losses after the removal of heavy overpaint, *left*, and after the missing areas of the blue field were carefully recreated, *right*.

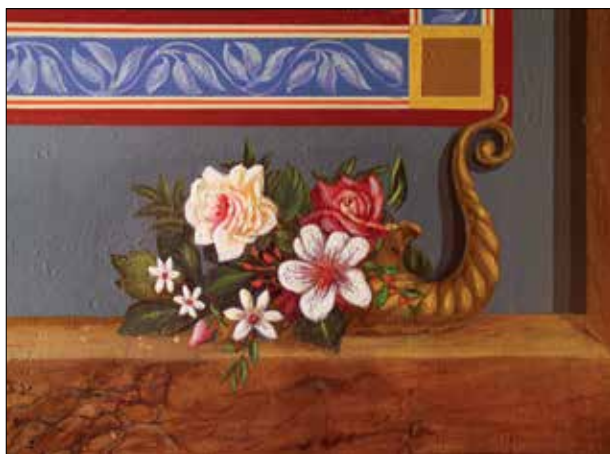
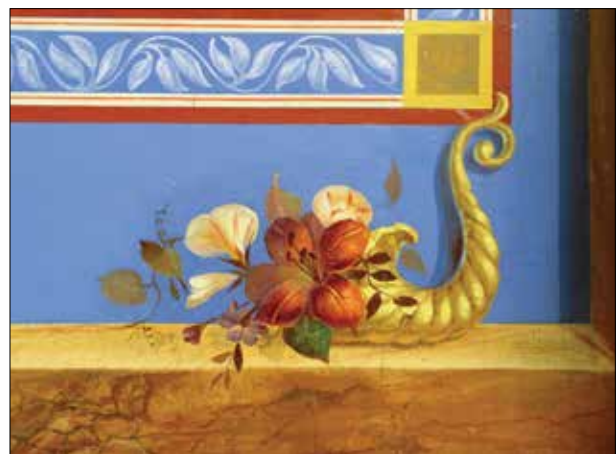
Cornucopia with flowers before and after conservation, Senate Appropriations Committee Room.

The overpainted cornucopia, *left*, had been given a heavier arrangement of roses and leaves. The restored original mural, *right*, features morning glories and delicate tendrils.

The panels' graceful maidens in their iridescent dresses were brought back to life, and incredibly delicate details were recovered, such as the line on one maiden's fishing pole. Some of the cornucopias of dainty flowers on the illusionistic ledge had been significantly altered, changing the colors and the types of flowers. Other cornucopias were found to be badly damaged under the overpaint and had to be sensitively recreated based on those on other walls that had remained intact under the overpaint.

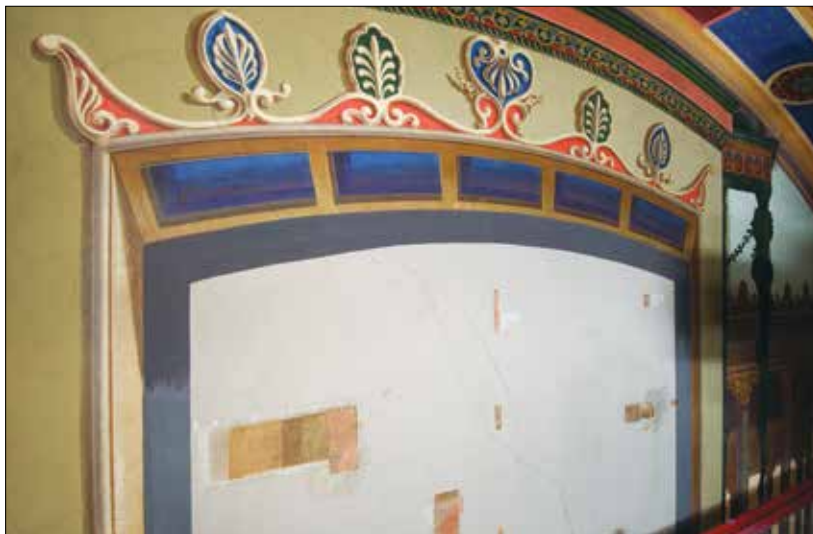
**Left: Exposure windows in the northwest lunette, Senate Appropriations Committee Room.**

The overpainted lunette was tested to explore underlying layers of paint.

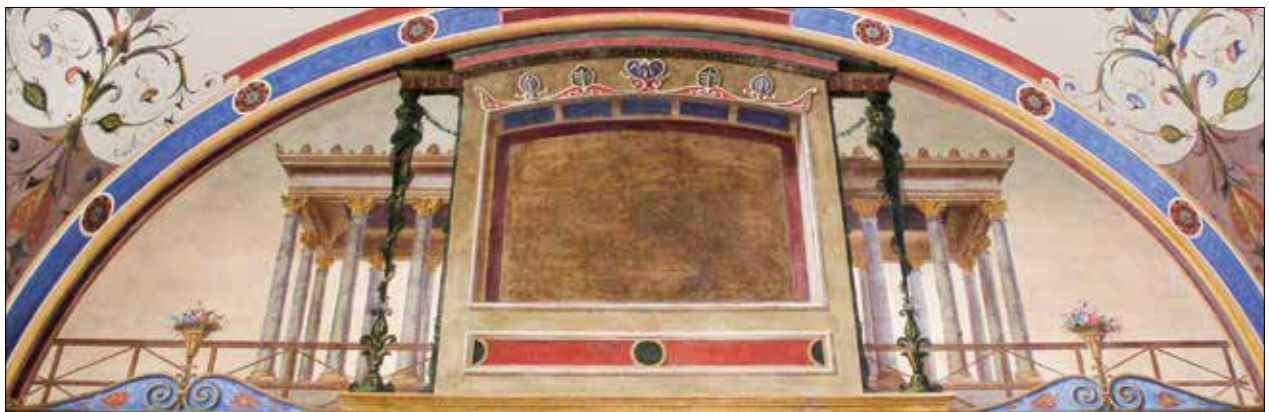
**Below: Conserved northwest lunette, Senate Appropriations Committee Room.**

Beneath overpaint in the northwest lunette, conservators found the central area's shadowy neutral color. This effect was replicated in the remaining lunettes.

Conservators consolidated detached paint in the lunettes so that they could safely clean the murals of grime and overpaint. They found that water leaks had destroyed much of Bisco's painting in his one completed lunette, leaving the design compromised and eliminating the option of replicating Bisco's scene in the other lunettes' central areas. Instead, the solution for the blank areas was to remove overpaint and recreate the shadowy neutral tone, leaving them as they looked in Brumidi's lifetime.

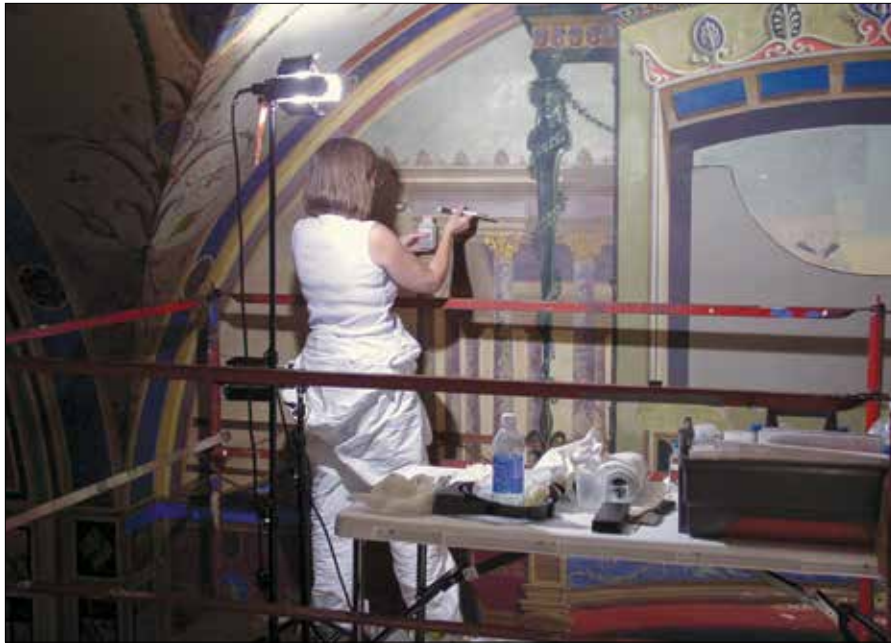
**Treating lifting tempera paint in the lunettes, Senate Appropriations Committee Room.**

Before cleaning and overpaint removal could begin, conservators consolidated lifting paint.

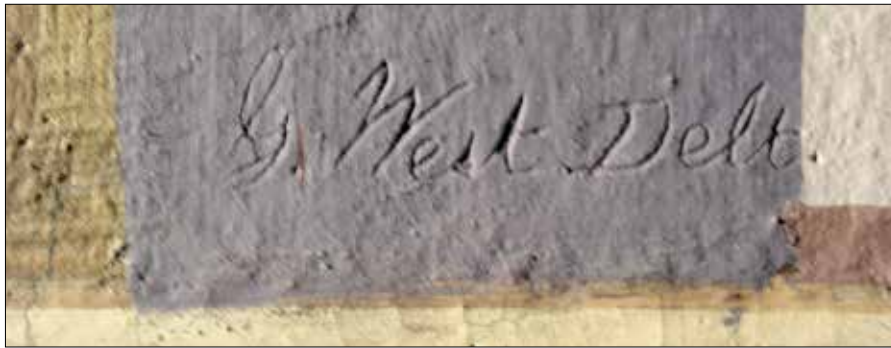
**Evidence of mural painted by one of Brumidi's assistants, Senate Appropriations Committee Room.**

The artist's signature, "G. West," was found inscribed in the plaster with "Delt.," an abbreviation for "Delineator."

scraped off and are now lost to history. Conservators did discover that West had pressed so hard in signing his name that it remains inscribed in the plaster, tangible confirmation that he had worked in the room.

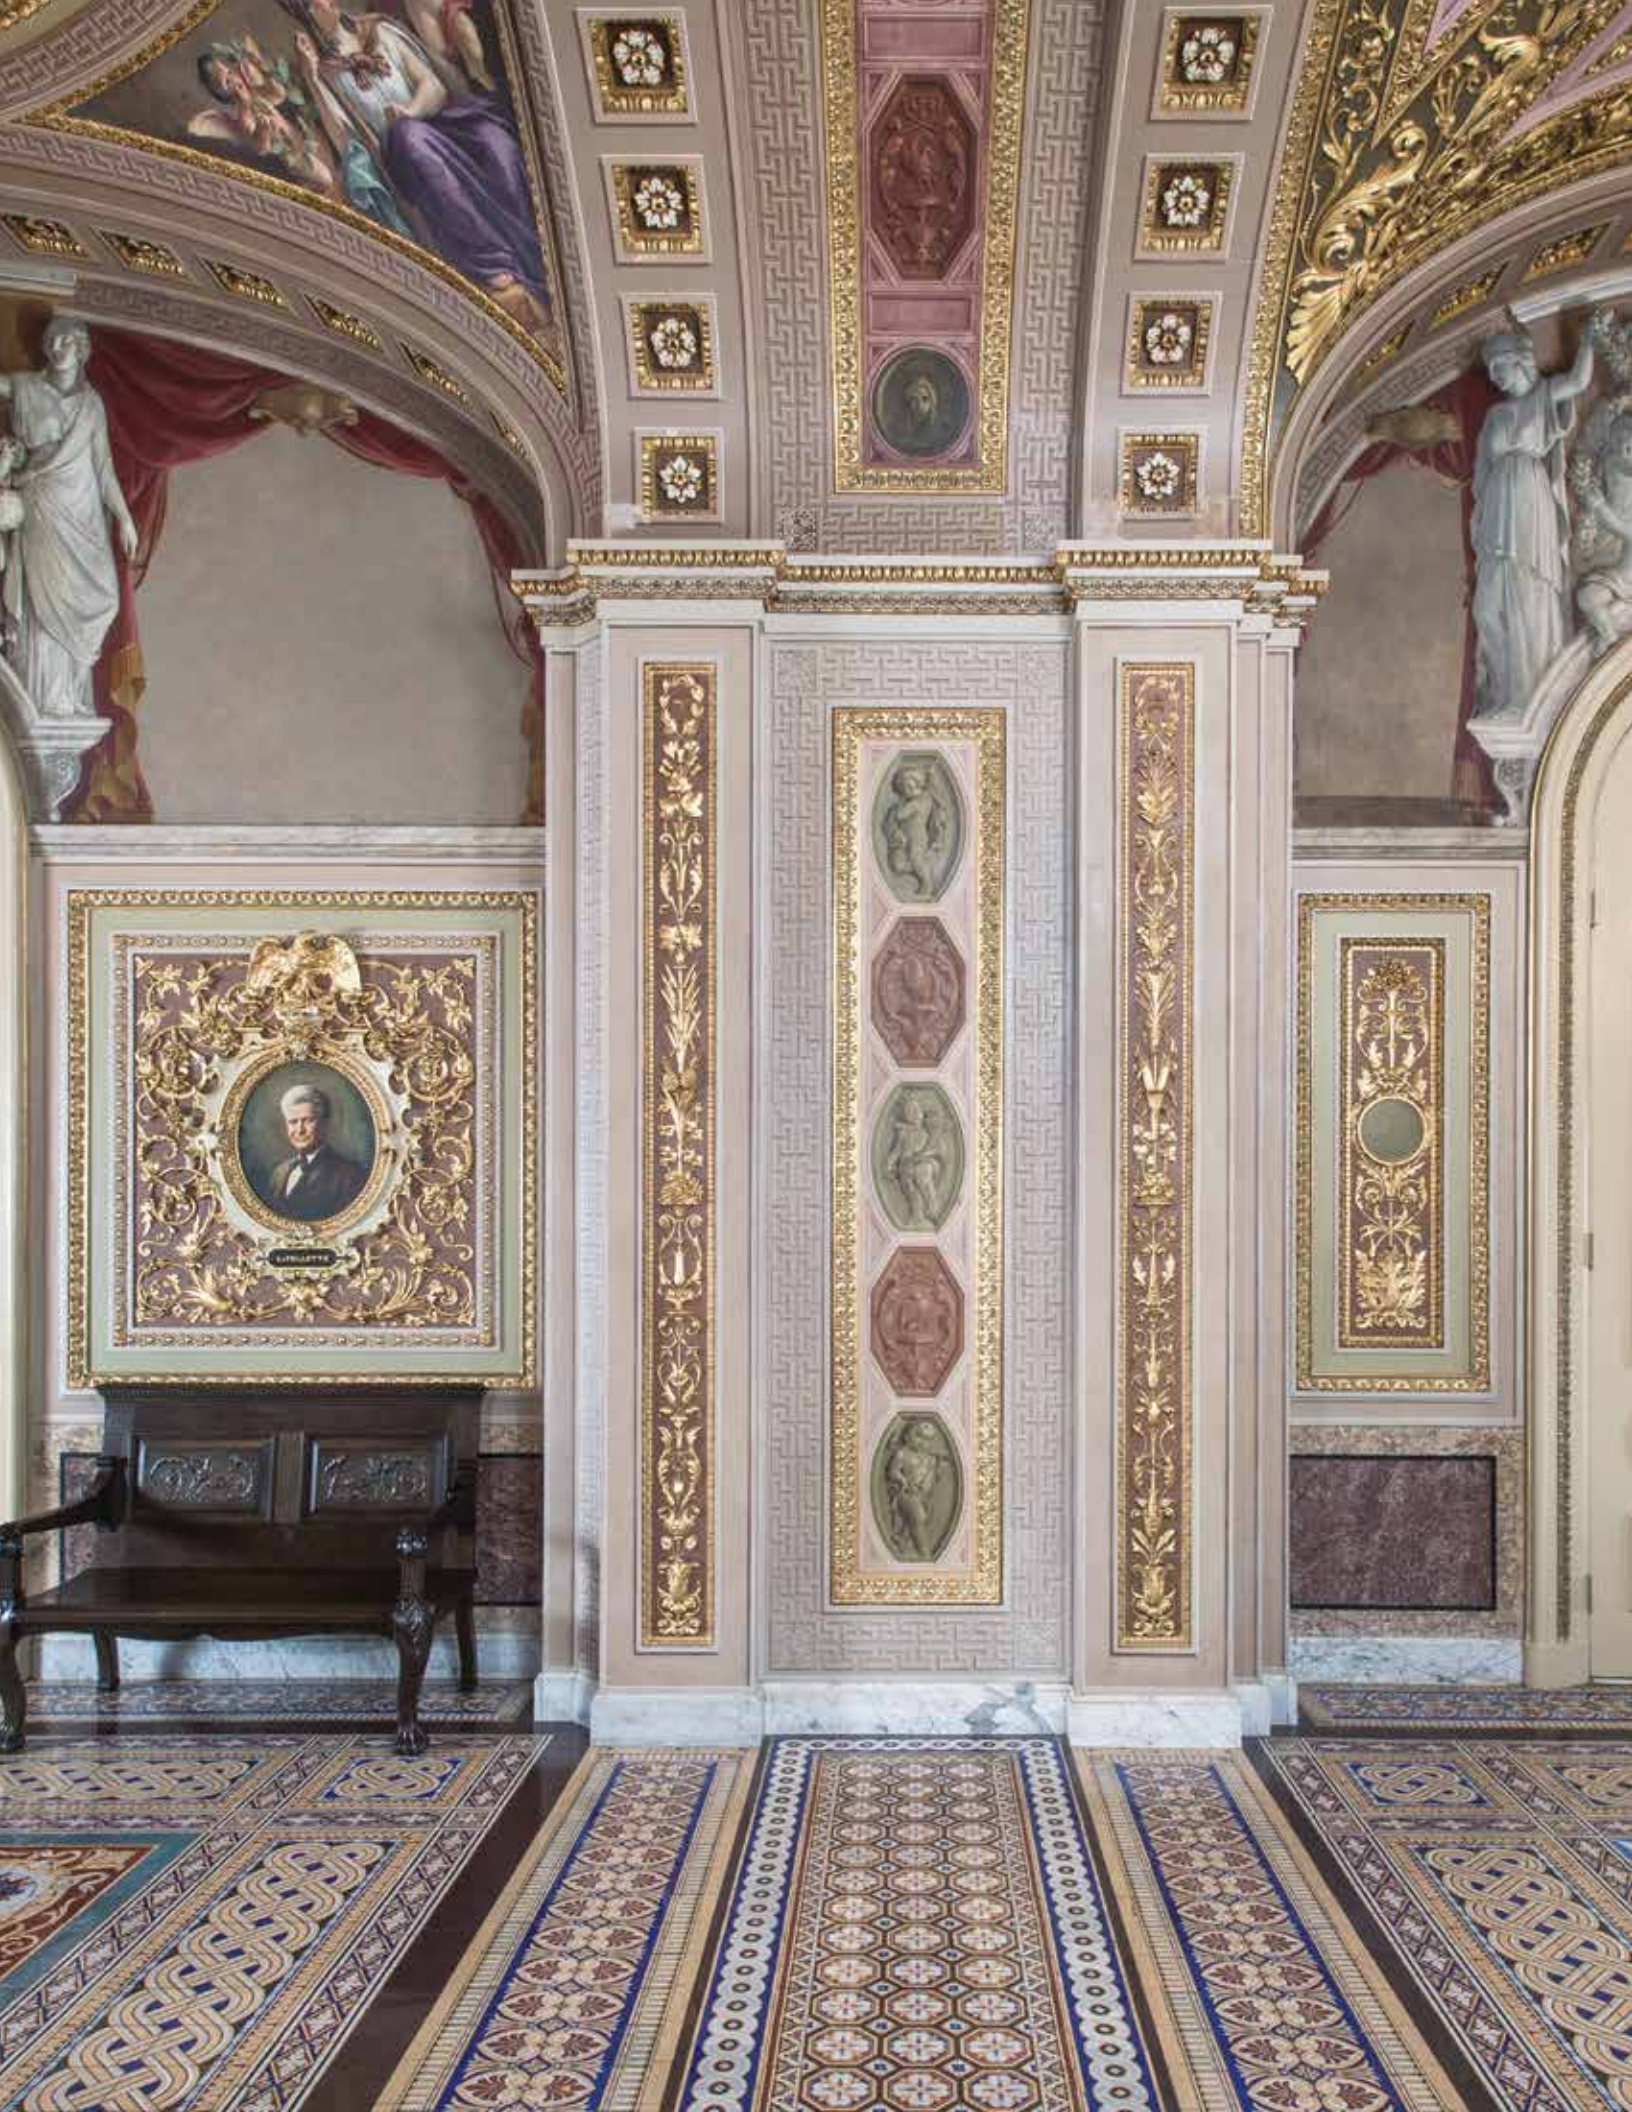
*Opposite: Pilot treatment on the west wall, Senate Reception Room.* The pilot area included one of every kind of panel: the portrait panel on the left; the central pilaster's putti panel, Greek key border, and flanking candelabra panels; and the disc panel on the right.

A pilot treatment of the Senate Reception Room's west wall included testing on the three types of wall panels that repeat throughout the room. Because of the complexity of the decoration, restoration was carried out by professional gilding and painting conservators working alongside skilled decorative painters, all interacting with the curators during the analysis and decision-making process. Dark brown overpaint was painstakingly removed from the borders of one of the pilot panels. Conservators identified the borders' original pinkish-tan color resembling sandstone, and these original surfaces exposed by conservators served as the model for the replication of other borders.<sup>11</sup> Exposures on the painted areas surrounding the shimmering gold botanical forms and classical moldings revealed delicate tones of warm light stone, coppery brown, and soft green. These colors were carefully replicated on other

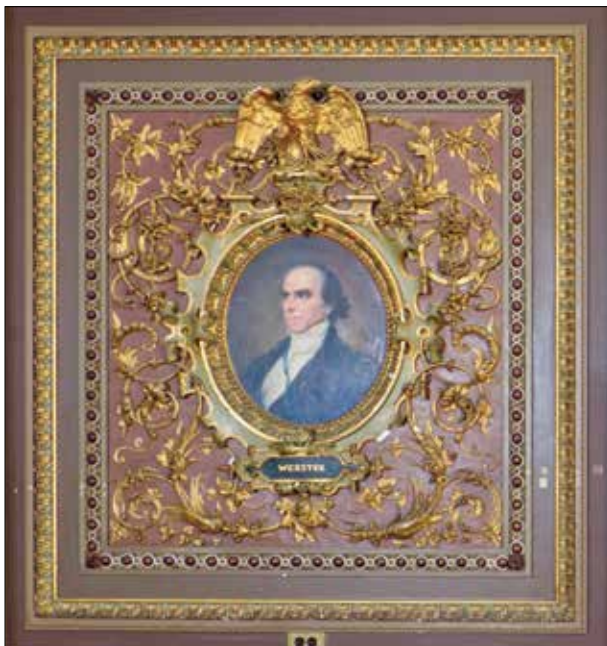
Webster portrait panel before and after conservation, Senate Reception Room.

Before restoration, layers of dark overpaint and inappropriate gilding gave the panel a drab appearance, *left*. Restoration of the original paint colors and brilliant gilding brought out the sophisticated, dynamic quality of the plaster ornamentation, *right*.

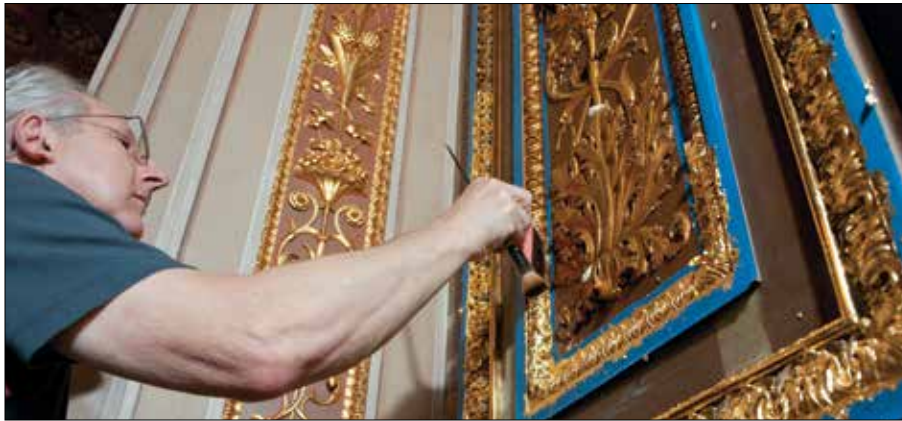
**Conservator regilding cast plaster ornaments, Senate Reception Room.**

This intricate work requires skill and patience, as well as a thorough understanding of the historic gilding patterns.

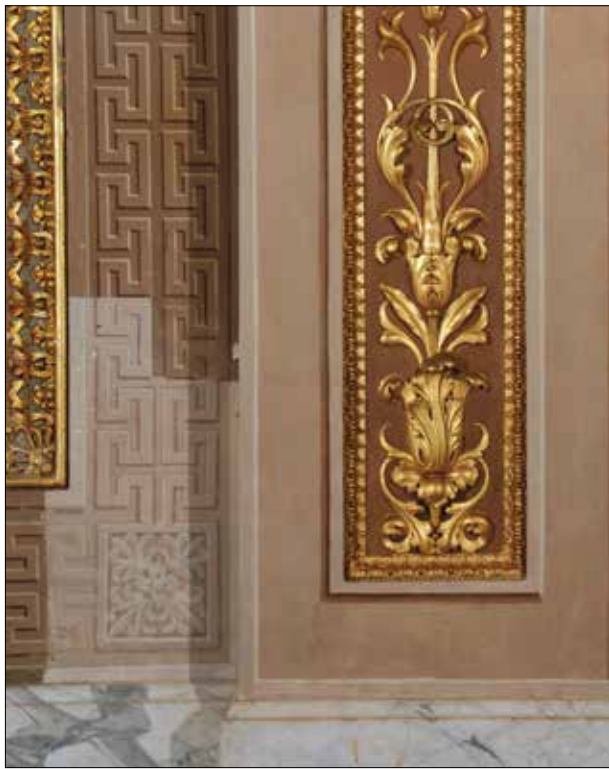
**Pilot treatment of stone-colored borders, Senate Reception Room.**

The original Greek key pattern in light colors resembling stone was completely covered by dark brown overpaint. (The candelabra panel’s borders and cast-plaster gilded moldings are shown already restored.)

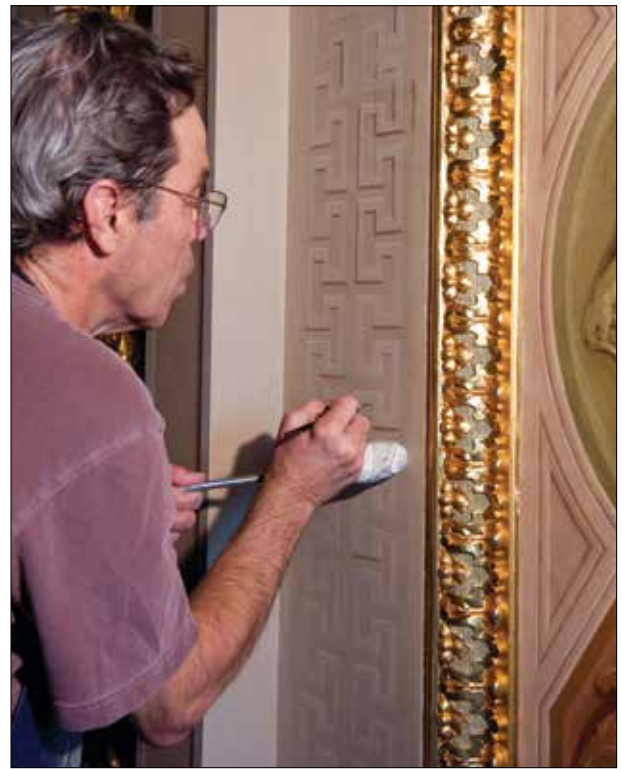
**Replicating the Greek key design, Senate Reception Room.**

Conservation of the pilot panels helped determine the best methods for restoring the walls in the room. Here, the decorative painter replicates the trompe l’oeil Greek key design.

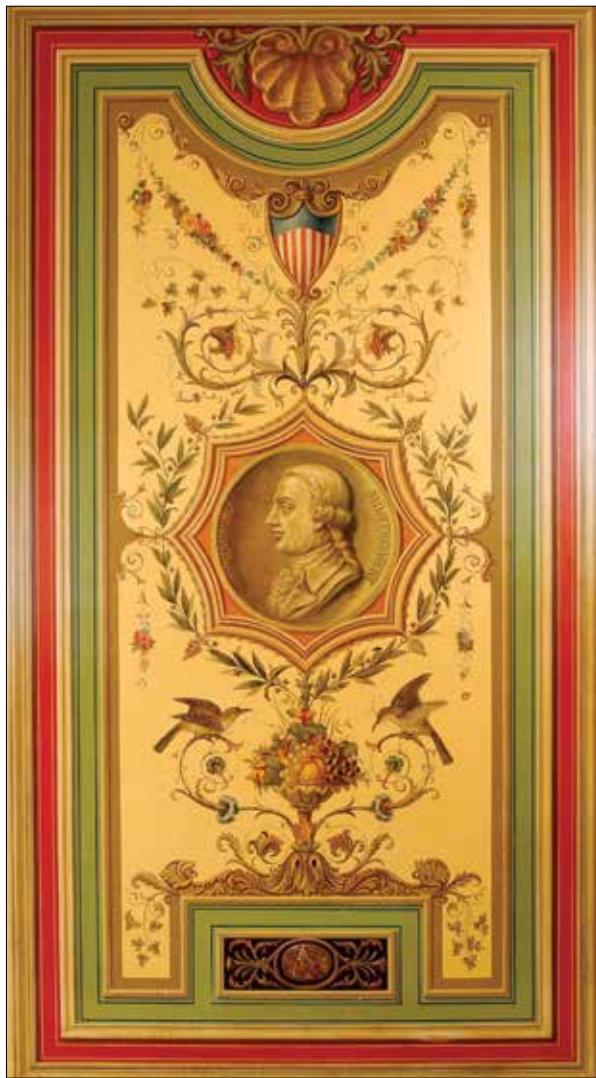
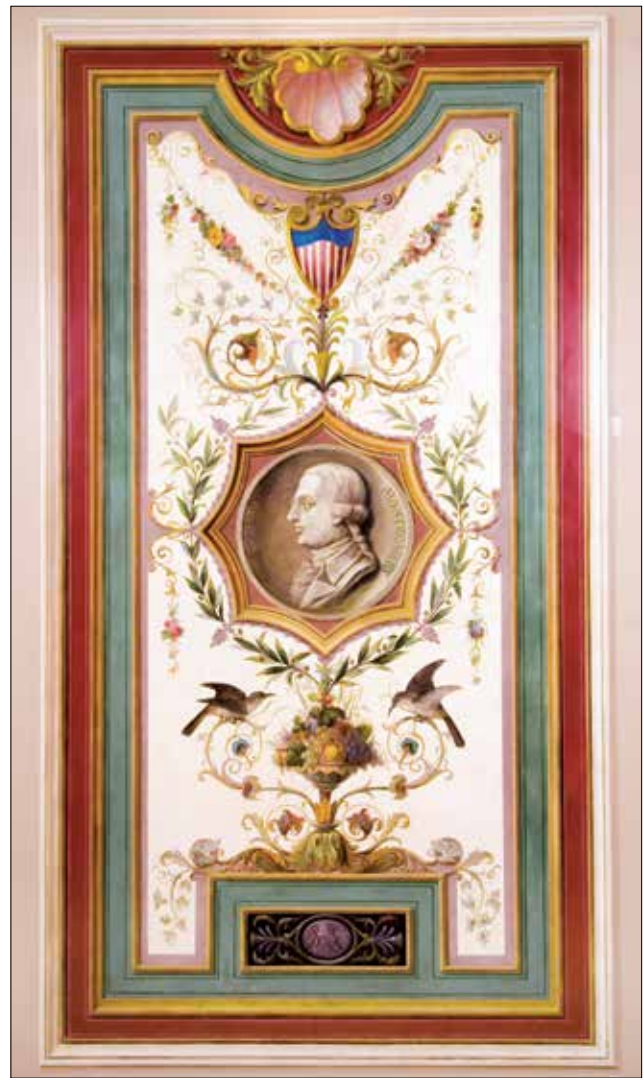
Panel with illusionistic relief portrait of Revolutionary War General Richard Montgomery, Brumidi Corridors (North Corridor).

A comparison of the panels before conservation, *left*, and after conservation, *right*, shows how the subtle colors, details, and three-dimensional effects were lost during repainting over the years.

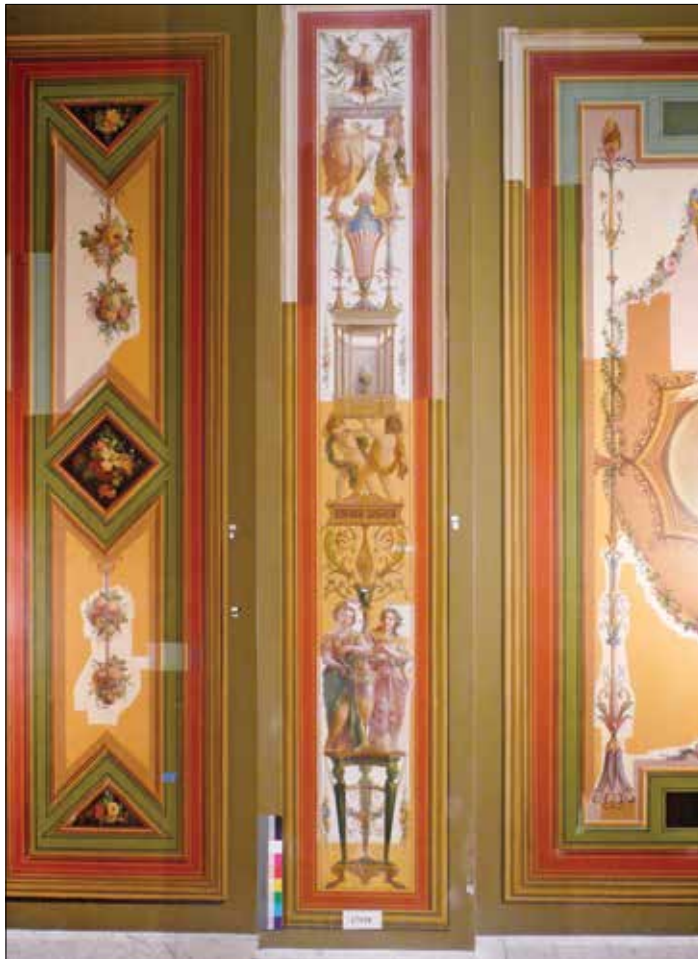
**Left: Wall panel during conservation testing, Brumidi Corridors (West Corridor).**

The soft white fields and fresh colors of the original 1850s designs slowly came back into view as conservators removed overpaint and yellowed varnish.

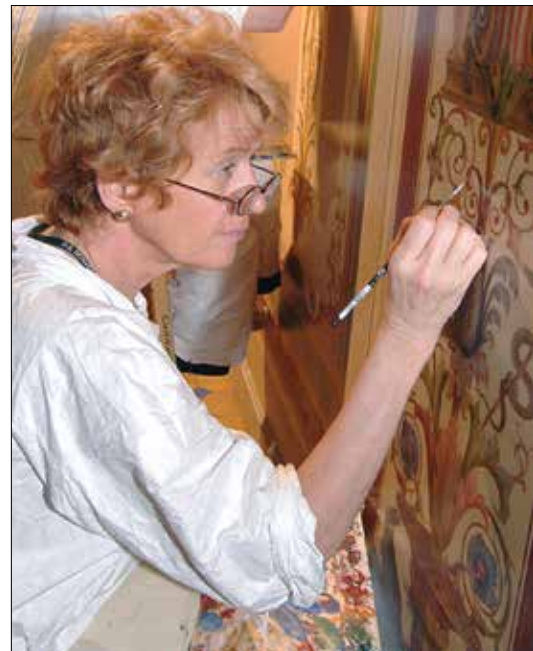
**Below: Conservator at work, Brumidi Corridors.**

After removing layers of overpaint, the conservator carefully applies reversible materials to areas where the original paint is missing.

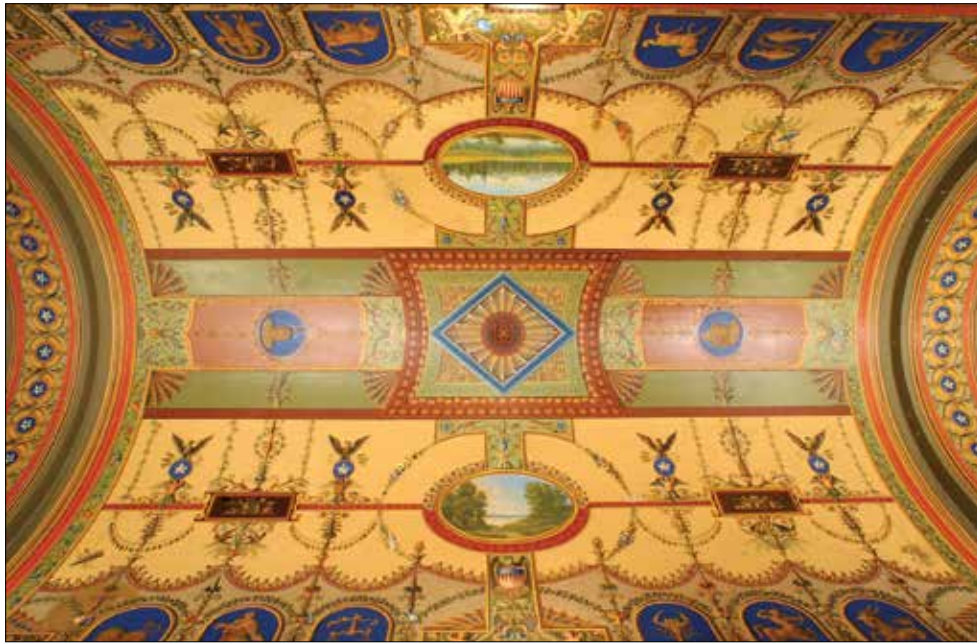
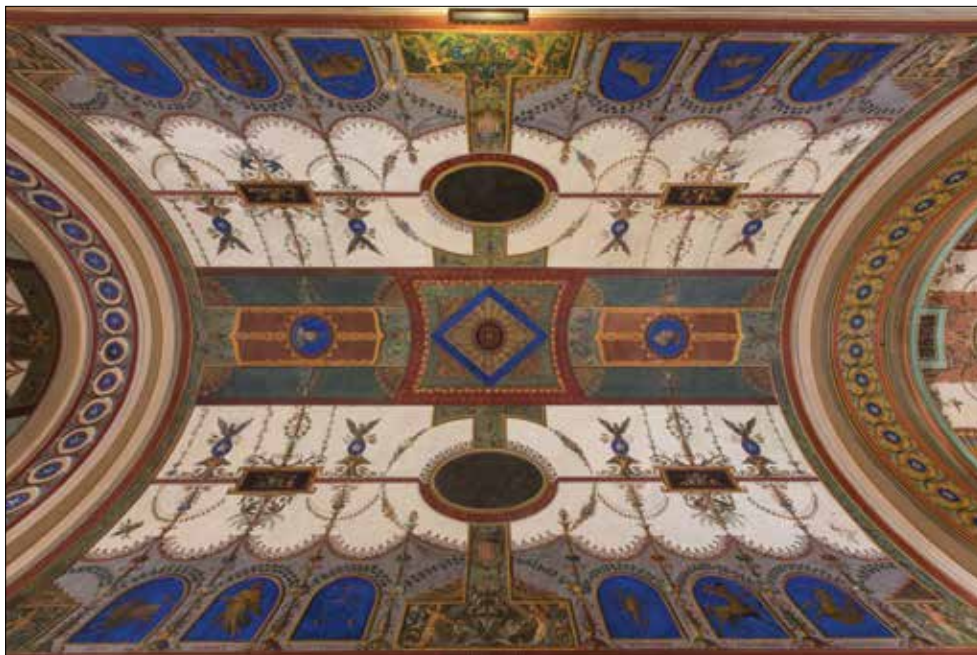
Ceiling before and after restoration, Brumidi Corridors (Zodiac Corridor).

Overpaint compromised the sophisticated design and dramatically altered the colors, *above left*. After conservation, *left*, the ceiling's murals once again resembled gathered fabric panels.

Conservation of the area began in 2012. Unstable plaster and paint were consolidated, and to the extent possible, overpaint was removed from the ceiling. This work revealed the colors and designs of the tempera ceiling, transforming the fields from dirty yellow to creamy white and bringing back the jewel-like tones of the original. Where Brumidi's designs had been washed away by water leaks, they were reconstructed from similar images on the opposite side of the ceiling vault. Where heavy applications of oil overpaint could not be removed, the correct colors were replicated based on the original colors identified by the conservators.

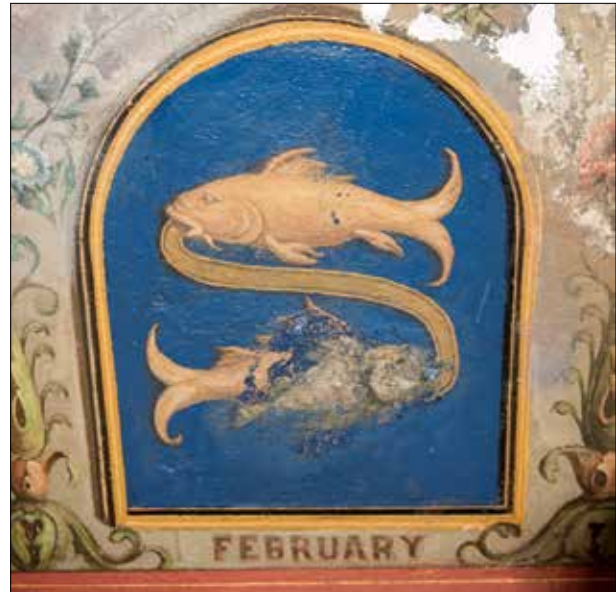
**Conservation of Pisces, Brumidi Corridors (Zodiac Corridor).**

The large overpainted zodiac sign concealed Brumidi's original, smaller sign. The bottom fish, partially conserved, shows the size difference between the original and the overpainted fish.

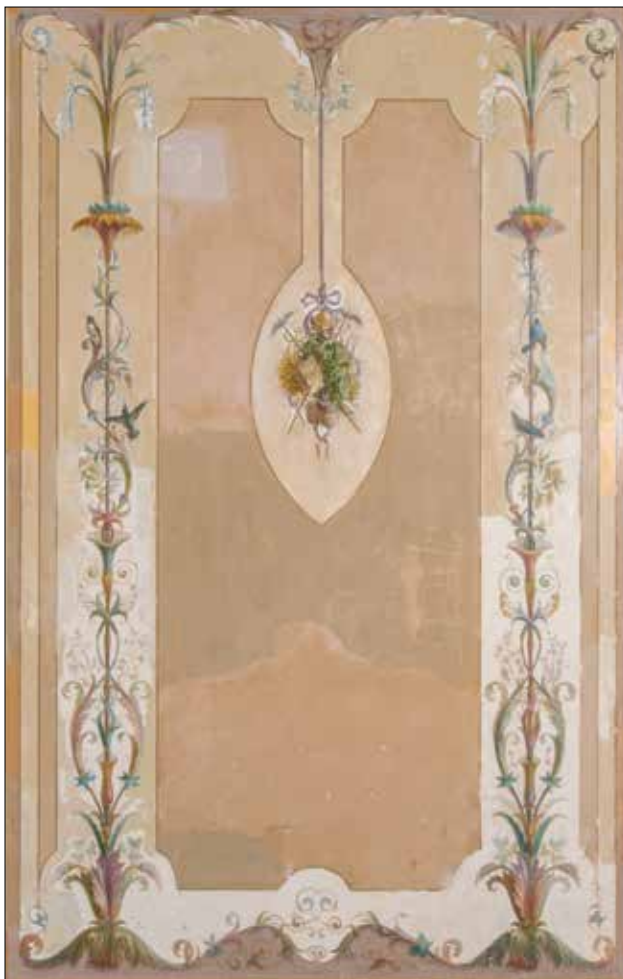
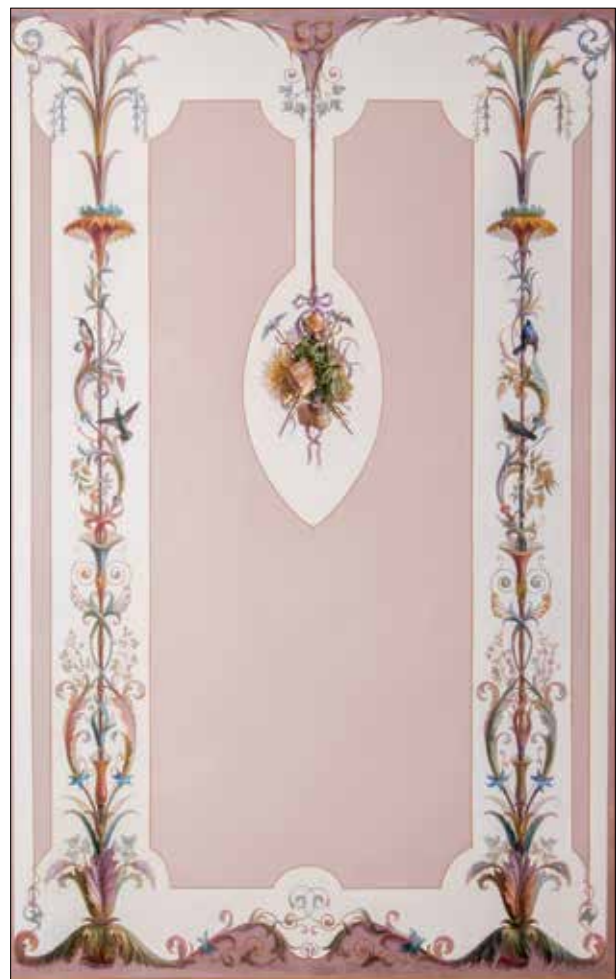
Panel with trophies and flowers during and after the conservation process, Brumidi Corridors (Zodiac Corridor).

As conservation progressed, *left*, the refinement of the original wall murals became apparent, *right*.

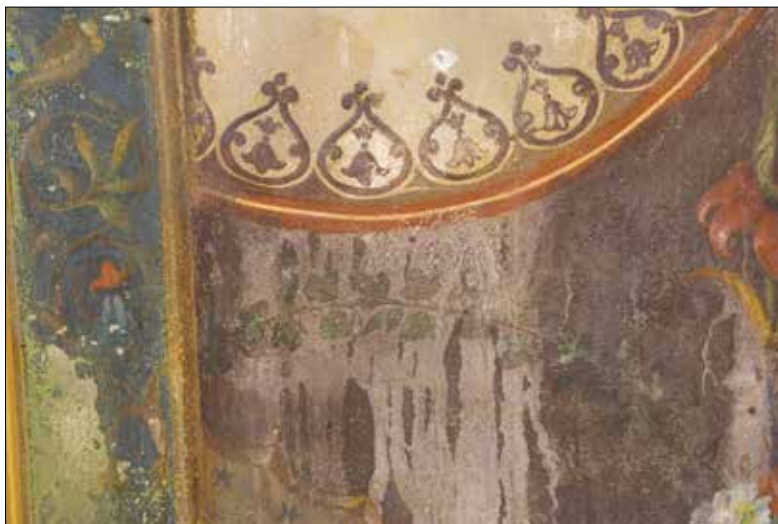
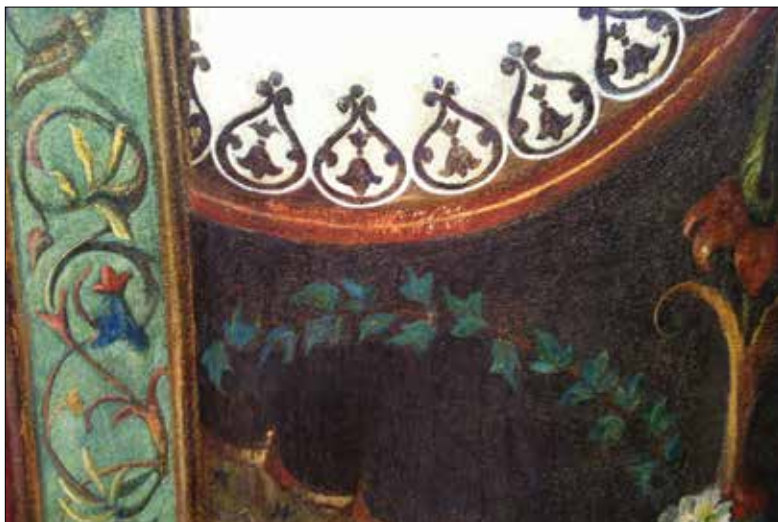
Ceiling mural before and during conservation, Brumidi Corridors (Zodiac Corridor).

The fragile nature of tempera paint made the ceiling susceptible to water leaks that started to wash away the paint layer, *above left*. The same detail is shown during conservation, *left*.
