# *Continuing Conservation of Brumidi's Murals in the U.S. Capitol*

*Barbara A. Wolanin*

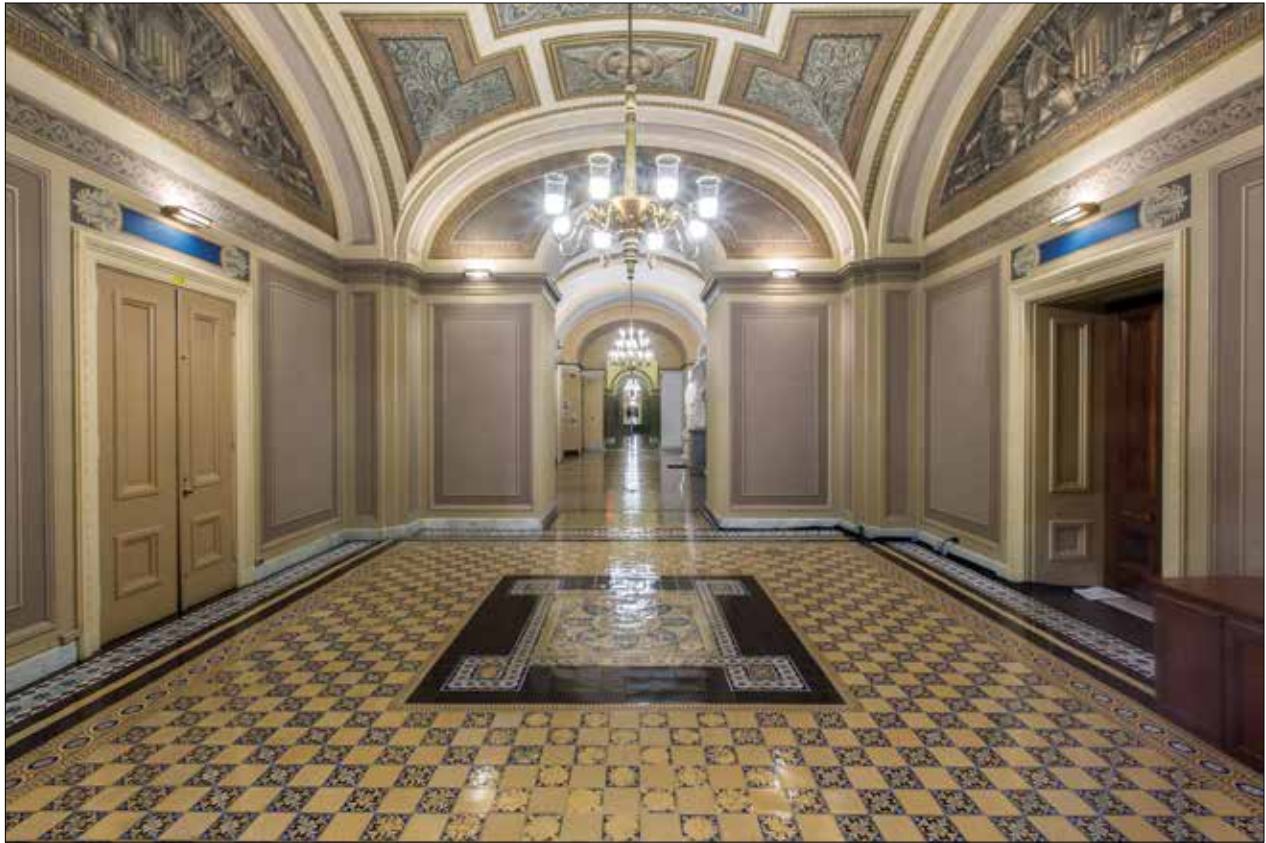
**Top: Restored Trophy Room, Brumidi Corridors.**

Guided by evidence of the original mural, conservators restored the ceiling primarily by replication in this section of the Brumidi Corridors.

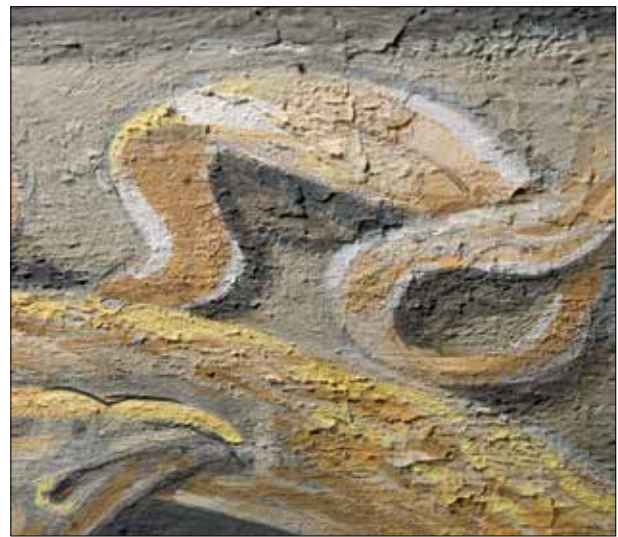
**Bottom: Flaking paint in the ceiling mural of the Trophy Room, Brumidi Corridors.**

Extreme flaking of multiple layers of delicate and porous tempera presented a challenge to the conservators.

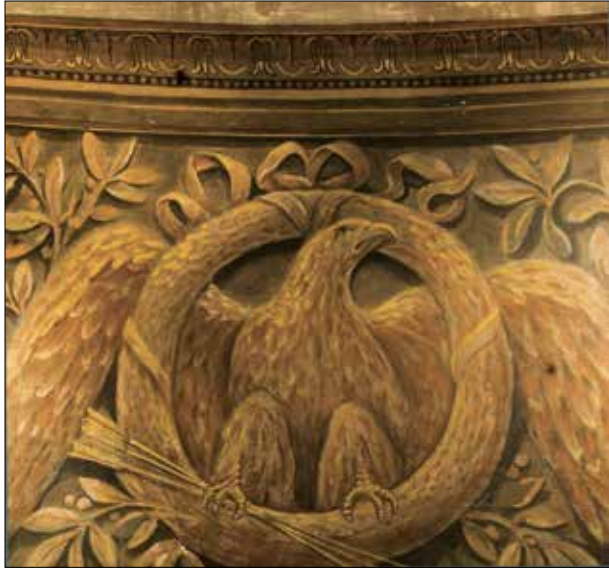
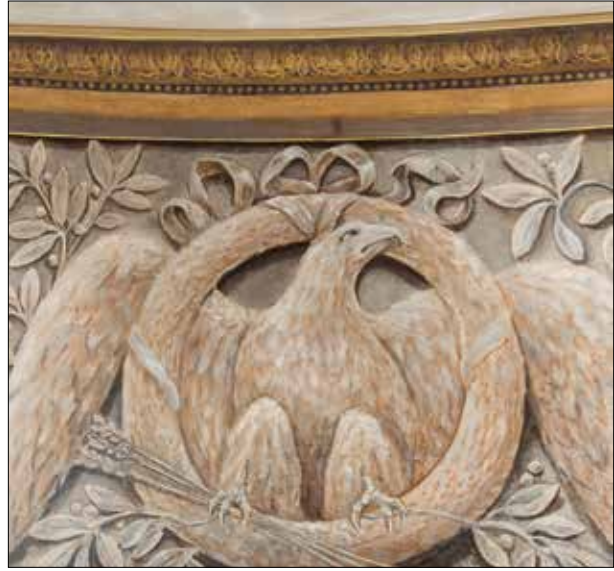
Eagle and wreath before and after restoration, Trophy Room, Brumidi Corridors.

During the restoration process, the overpainted mural of an eagle and wreath, *left*, was carefully retouched, *right*, using evidence of the original colors to restore the mural's illusion of carved stone.

original colors were still visible and then retouched the overpainted designs to match, restoring the subtle effect of carved stone and moldings.<sup>20</sup> Due to extensive damage, the walls in the Trophy Room and the adjacent refectory area had to be replicated. While the condition of the Trophy Room did not allow for full recovery of the original decoration, the combination of restoration and replication has reestablished the quiet beauty of this room with illusionistic stone carvings.
