Repair and Replacement of Wood Residential Roof Covering Systems

HURRICANES IRMA AND MARIA IN PUERTO RICO

Recovery Advisory 6, April 2018

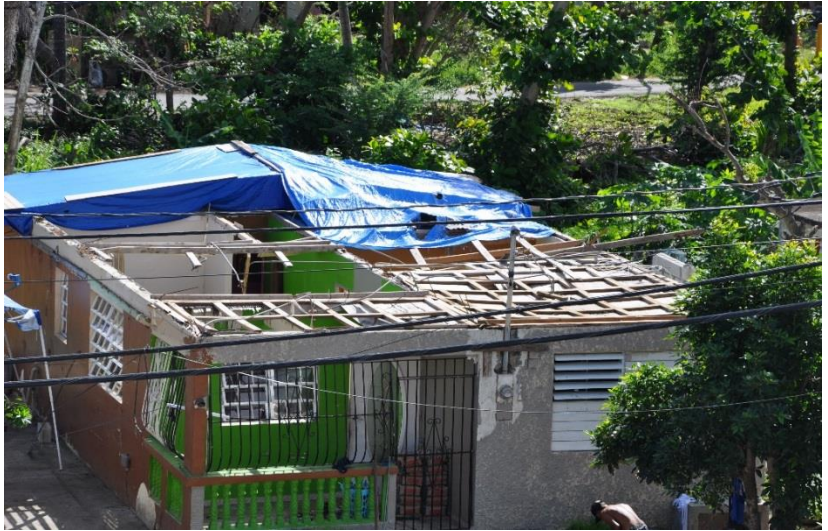
Figure 2. A damaged corrugated metal roof. The roof did not have plywood sheathing or adequate roof support framing or connections.

Metal roof panels can be a robust and durable roof covering system when designed and constructed correctly. It is important to select a roof panel that is thick enough to resist uplift forces. In Puerto Rico, thin corrugated metal roof panels frequently sustained wind and water leak damage under normal weather conditions. In Figure 2, note a portion of the roof structure missing due to high wind forces after hurricane Maria in 2017. The corrugated metal roof panels were screwed to 2 inch x 4 inch nailers, which were placed over plywood sheathing. The nailers and plywood were attached with nails, which provided insufficient uplift resistance.

Proper fastener size and spacing is critical to ensure that metal panels remain connected to the roof framing. Three-quarter inch T-1-11 structural sheathing or equivalent plywood deck under the roof panel is strongly recommended to provide load transfer to the roof framing, prevent water intrusion into the structure, and create a proper diaphragm. A robust underlayment system, such as #30 saturated roof felt, is strongly recommended to provide a secondary water barrier to further protect against water intrusion. If the new roof covering system were to be placed over such a roof support structure without strengthening it, the new roof covering system would be susceptible to future damage.

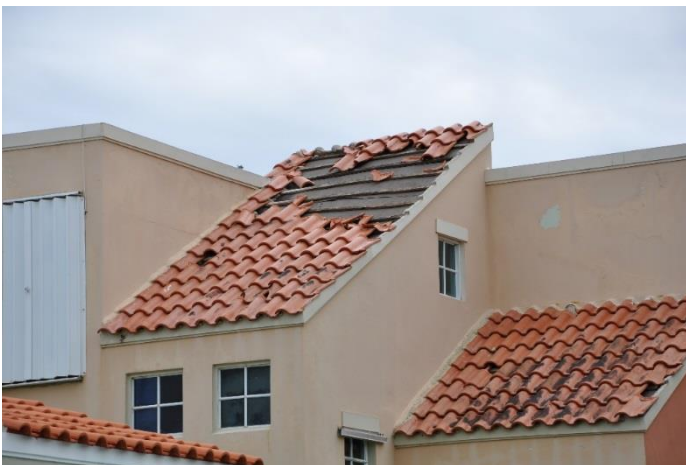
Figure 3. A damaged clay tile roof.

An ideal installation includes roof tile installed atop a solid concrete roof deck. A waterproof membrane is then installed, followed by battens. Tile roofs in hurricane regions must be anchored to the roof with fasteners, typically at battens. Fasteners used must be adequate to resist uplift from wind loads in accordance with the IBC. If fasteners are inadequate to hold roof tiles down on the roof, tiles can break away from the structure and become wind-borne debris. Roof tile missiles can be blown a considerable distance and can penetrate shutters and glazing, potentially causing injury. Roof tiles tend to be vulnerable to breakage from wind-borne debris, even when well attached, unless they are rated as impact resistant. Once roof tiles have been compromised and have broken away from the roof, the roof deck is susceptible to water intrusion. Many of the clay tiles blew off the house shown in Figure 3.
