January – March 1999

The Naval Safety Center's Aviation Maintenance Magazine

Vol. 2, No. 5, Jan – Mar '99

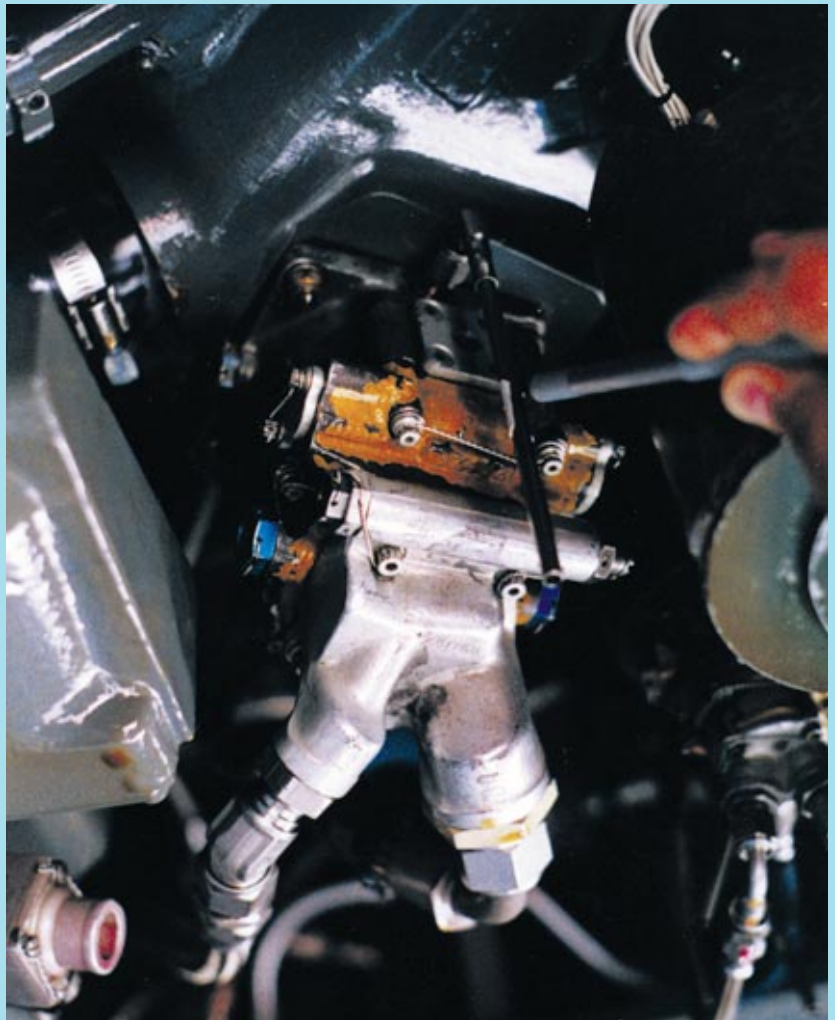
A leaking hydraulic pump may not have to be changed if it leaks less than 15 drops per minute. Will you VERTREP if your utility-systems pump leaks only 13 or 14 drops per minute?

Publication A1-H46AE-450-000 wp 01400 contains the leak rates for the utility system's hydraulic pump and says that 15 drops per minute with the system operating is too much. I relayed this information to the HAC, who asked everyone if they were comfortable flying with a leaking pump. Everyone was OK about the within-limits leak, so we continued the mission. We conducted in-flight, aft-station checks every 15 to 20 minutes (as briefed before every mission) and updated the status of our leaking drain line. We finished the flight with no problems.

After the flight, the det's maintenance LCPO and the MO decided to remove and replace the pump because of the high failure rate of H-46 hydraulic pumps. An indication of an impending failure can often be a leak that is still within limits. I'd hate to think that someone "sorta" knew about a problem with an aircraft but did nothing to solve it and didn't tell anyone about it.

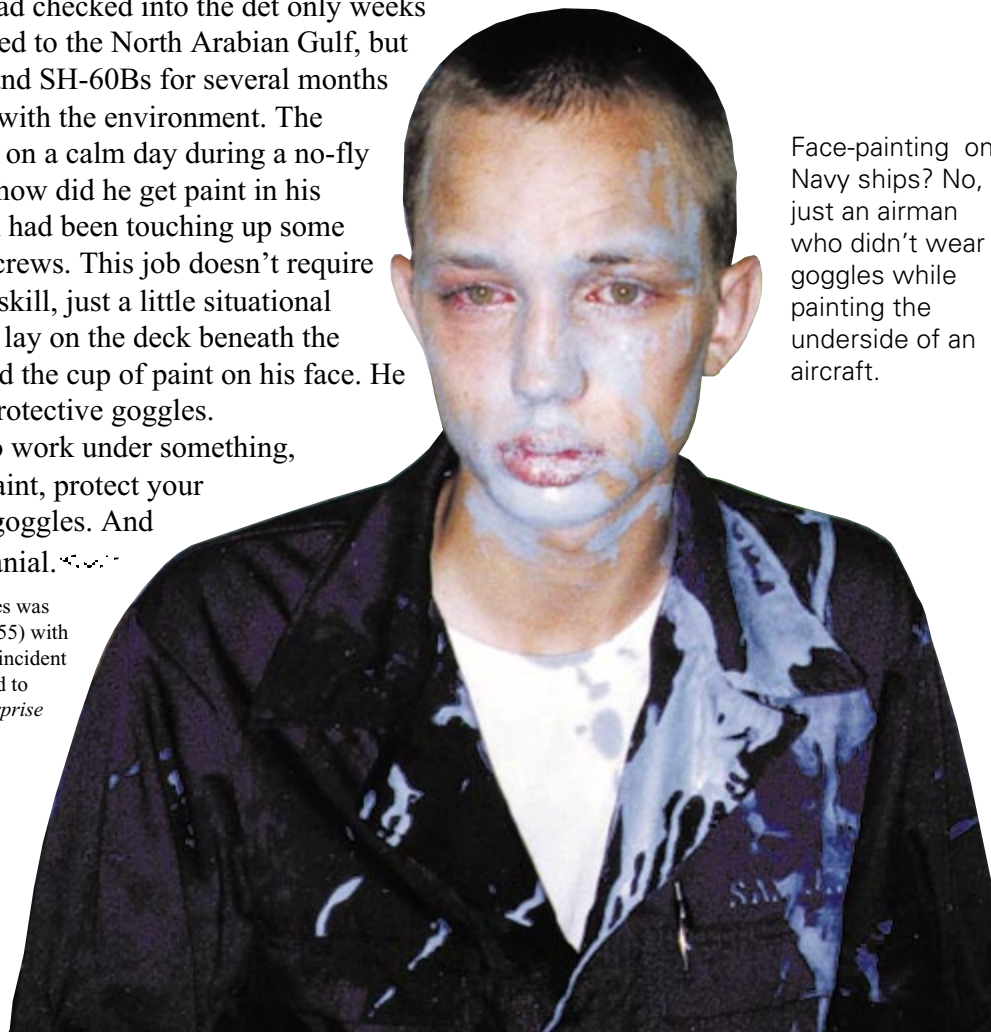
Face-painting on Navy ships? No, just an airman who didn’t wear goggles while painting the underside of an aircraft.

If you have to work under something, especially with paint, protect your eyes with safety goggles. And always wear a cranial.

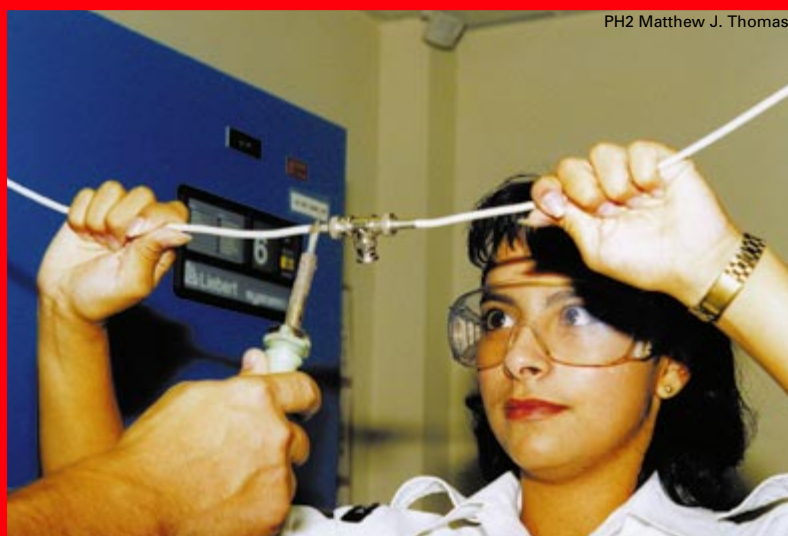
YNSR Mary McLoyd of the Naval Safety Center illustrates a technique that will launch molten solder in your face.

A few minutes later, I was pulling on the wire while my partner applied the hot soldering iron. The wire whipped loose and hurled a piece of molten metal through the air. Before I could holler, "Watch out," my partner jumped back; I could see, quite plainly, a glob of molten solder stuck to his goggles.

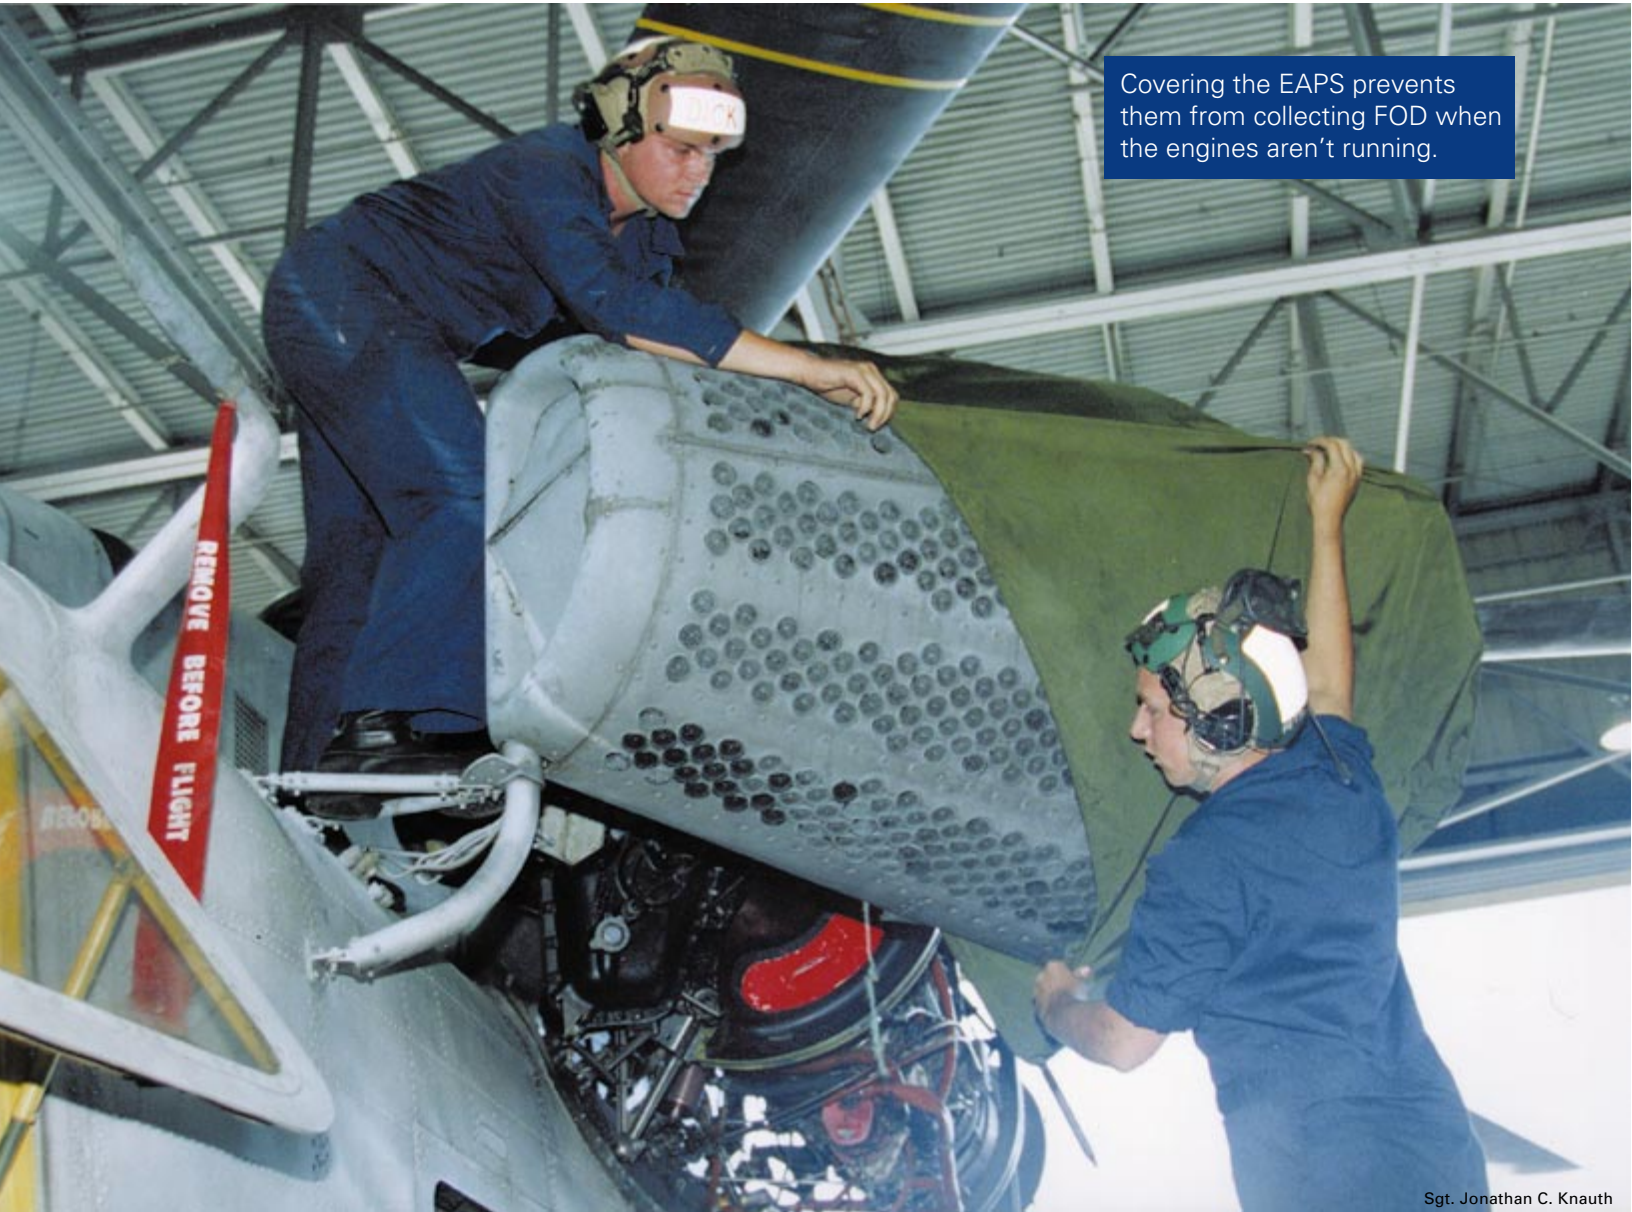
Covering the EAPS prevents them from collecting FOD when the engines aren't running.

When a technician inspects an EAPS barrel for FOD, it is virtually impossible to check every strato-tube. Therefore, he usually inspects engine intakes more closely. For years, I've suspected that engine FOD in the H-53 is caused by the EAPS. The sealing system allows debris to enter the engine intake without passing through the EAPS. With 20 years' experience, I can remember only one bolt that migrated through the engine cowlings, past the EAPS seal and into the engine.

Our QA department noted that we paid attention to engine intakes and exhaust, but not the EAPS. You can look at any H-53 parked on a line and see that if the EAPS are opened for extended periods or removed, engine intake plugs are installed. This is an excellent precaution for the engine but not for an EAPS barrel left unprotected. A technician working on another part of the aircraft could easily allow a piece of rivet, cotter pin, safety wire, or even a piece of tool, to enter an unprotected EAPS barrel.

QA also made people stop using safety wire to secure EAPS latches and made them start using barrel-latch clips listed in the MIMs. Over time, substituting safety wire for the clips had become acceptable, but there have been times when a technician went out to the aircraft and there was no safety wire on the latch. We can only hope it found its way into a FOD can.

The correct procedure is to secure a clip with a section of nylon string, tying one end to the clip and the other to the EAPS barrel. If a clip is missing, you file a missing-fastener report, and the aircraft is not released for flight until the clip is found or the MO certifies the aircraft FOD-free and safe for flight.

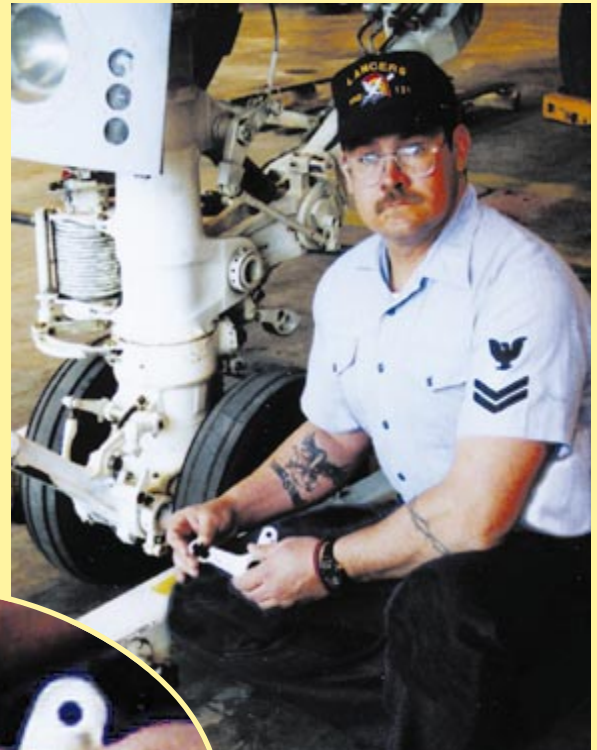
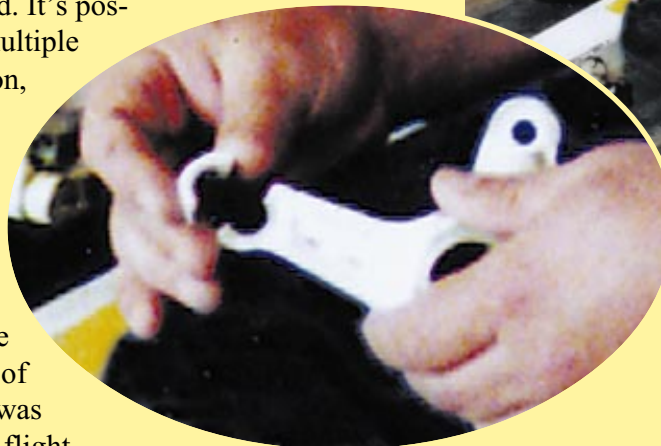
After the prowler trapped, purple-shirts refueled Skybolt 622, then the flight-deck crew respotted it to the finger. Our FDC told an AMS troubleshooter to do a 10-10 cat-trap lube. This inspection revealed that the adapter-crank mechanism on 622's NLG holdback for the tow-link had broken at one of its lobes. The mysterious chunk of metal belonged to our EA-6B.

The aircraft probably could have taken another cat shot, but the broken crank could have kept the tow link from stowing and would have damaged the airframe and the nosegear when it retracted. It's possible the aircraft had taken multiple cats and traps in that condition, but because the landing gear was not raised during pattern work around the ship, no problems were reported.

AMS2 Willis shows the broken adaptor that could have damaged Skybolt 622's airframe and nose gear when it retracted.

Note: If an FDC cannot identify a piece of FOD while launching and recovering aircraft, and can't dispatch a troubleshooter, he should request maintenance control to send a squadron representative, preferably a full-systems QAR, up to flight-deck control immediately. – Maintenance analyst.

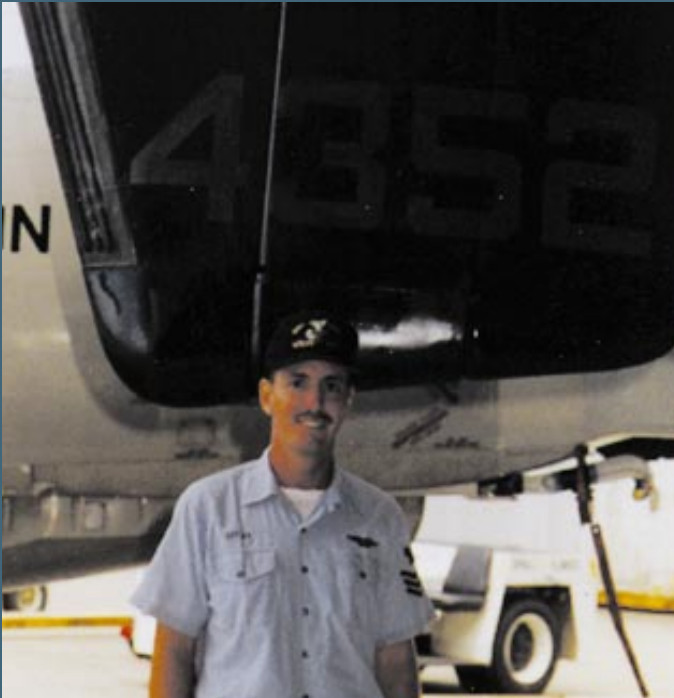
AMH1(AW) Steven Lefler
VAW-117

After a plane wash, AMH1(AW) Lefler, a line-division CDI, was inspecting an E-2C's vertical stabilizer when he noticed part of a bolt sticking out under the upper outboard rudder on the starboard side. He figured the bolt had vibrated loose and told the MMCPO, who downed the aircraft and ordered an integrity check.

Inspectors found a six-inch bolt wedged between the rudder and the horizontal stabilizer. Troubleshooters believe the bolt had been left inside the rudder during maintenance at another command.

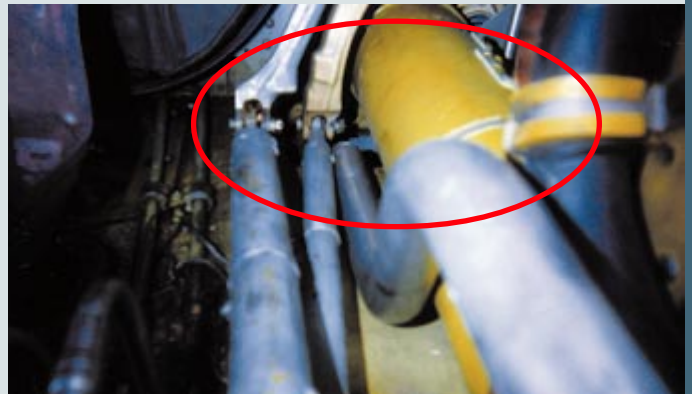
the open access panel by the No. 4 synchronization shaft and found a utility-hydraulic-pump handle wedged beside the shaft.

Further checking revealed that the pump handle had been left below No. 2 intake the previous night when the engine had been removed and replaced during other maintenance. Qualified personnel had inspected the engine; however, they missed the pump handle.

A utility-hydraulic-pump handle jammed against the shaft could throw the rotors out of sync and cause an in-flight emergency.
