# Mech

The Naval Safety Center's Aviation Maintenance Magazine

Vol. 2, No. 7, Jul – Sep '99

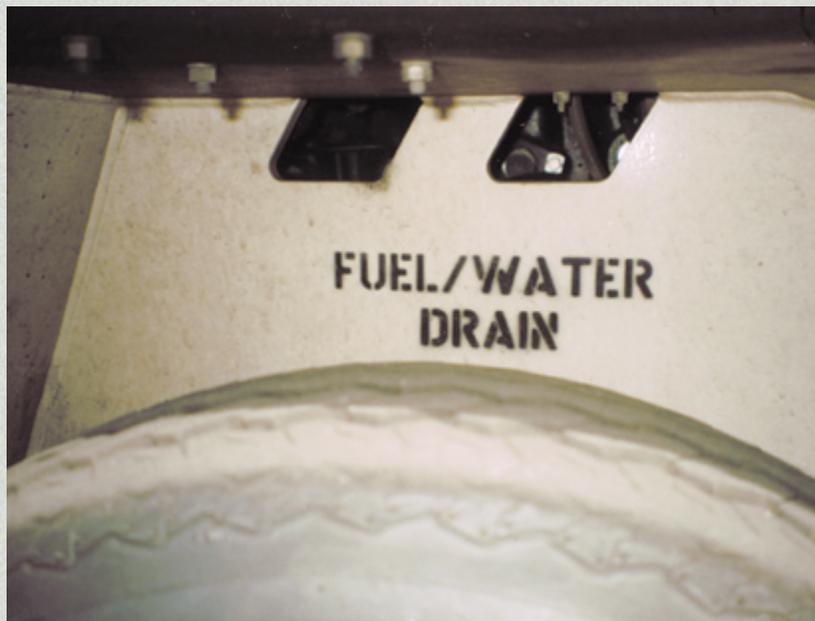
Even though location of the fuel-water separator is painted on the tractor and identified on the pre-op card, most operators don't know where the item is. (It's located on the engine side of the right-front wheelwell.)

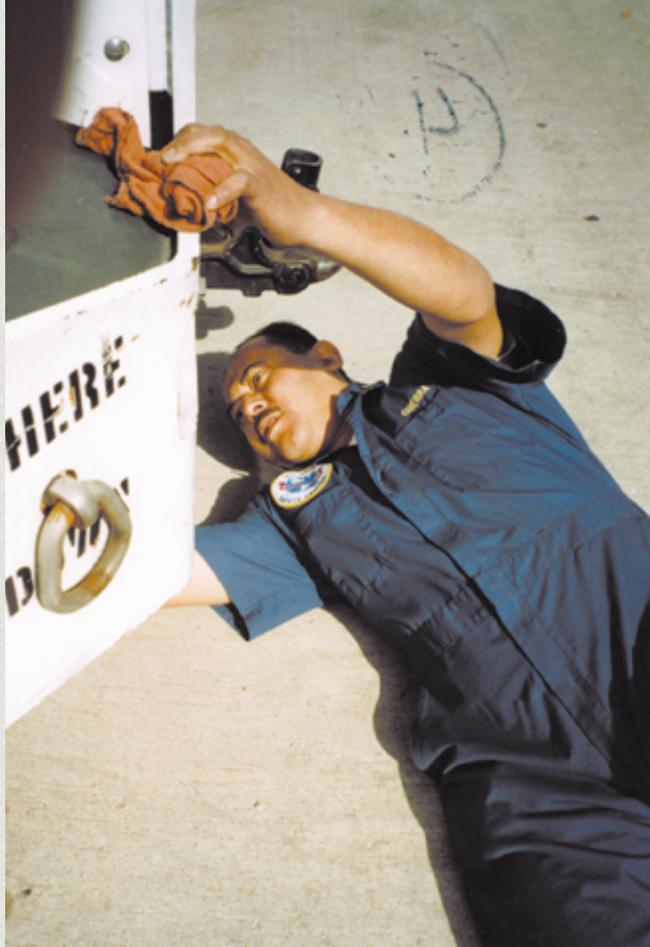
The author drains fluid from the fuel-water separator that most people can't find.

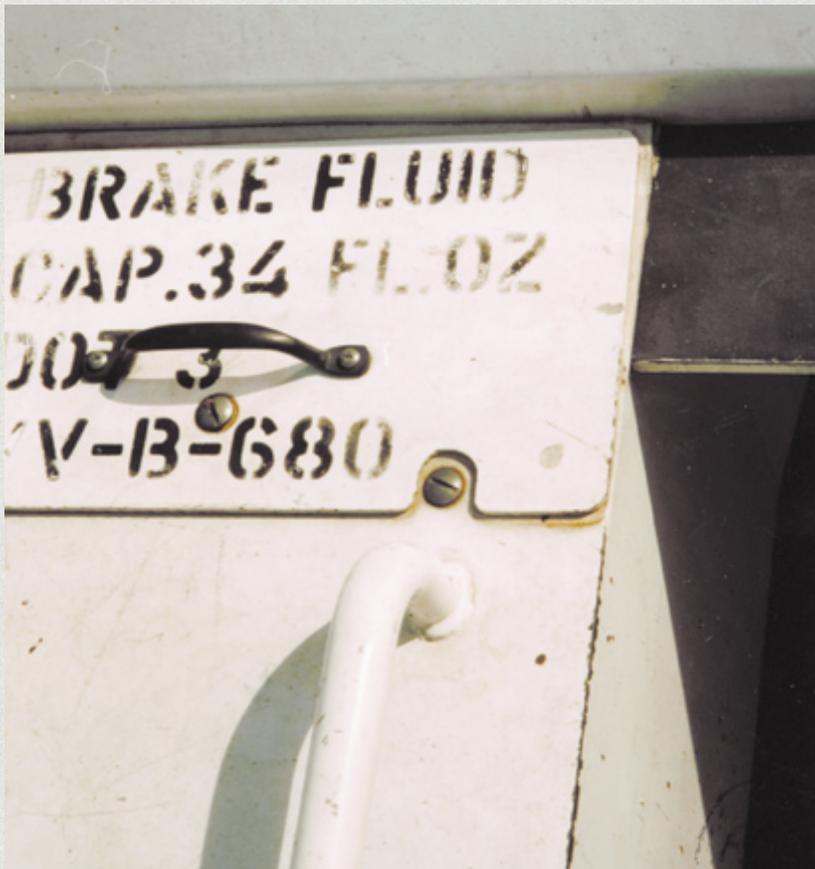
The brake master-cylinder reservoir is the second item most operators can't locate. It's to the right and forward of the driver's seat, under the brake fluid sign.

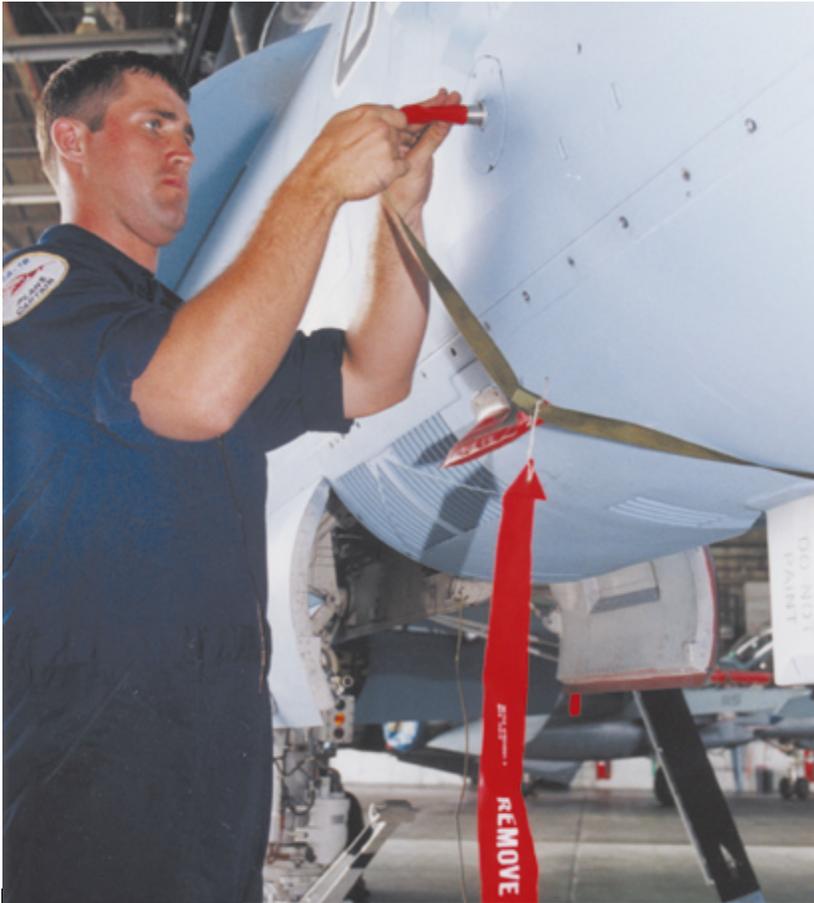
Covers, such as the ones being installed by this Hornet plane captain, keep bugs and dirt out of pitot tubes when the aircraft isn't flying. Pitot tubes get very hot when energized.

I approached the Hornet from the port side, curiosity gnawing at me. As I moved to the starboard side of the nose, I was shocked to see the aircraft's starboard pitot-tube cover burning. "Fire! Fire! Fire!" OK, that is a bit melodramatic, but there was a fire! I grasped an unburned part of the cover, pulled it free from the pitot tube, and threw it to the deck. I stamped out the fire, and got the attention of the maintenance technician atop the aircraft. He came down and quickly extinguished the fire, which was still smoldering on the pitot tube.

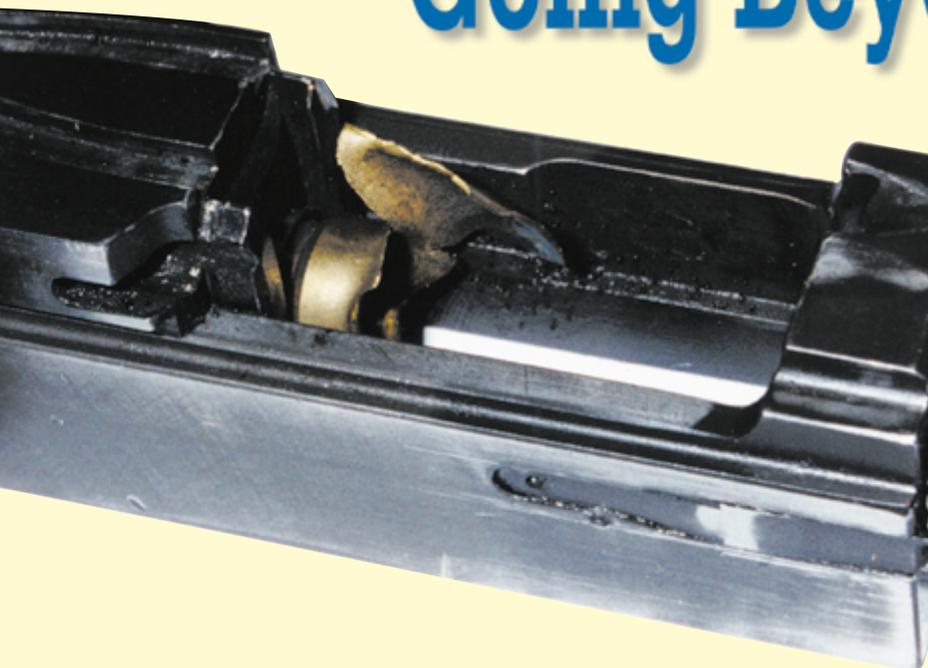
The firing pin struck the primer, and the jammed round exploded in the crew chief's face.

As he lifted the bolt-carrier group and barrel from the weapon, he inadvertently pressed the cocking lever. This caused the firing pin to strike the primer, which exploded the round in the crew chief's face. The blast embedded black powder in his right side and neck. Although the projectile moved only 3 inches down the barrel, pieces of metal-casing fragments struck the crew chief's right arm. Another fragment missed his head and tore a 1-inch hole in the Huey's cabin door.

In order to keep someone else from going beyond the immediate-action procedures and getting hurt, our maintenance department submitted a technical publication deficiency report (TPDR) recommending the following warning be added to the checklist:

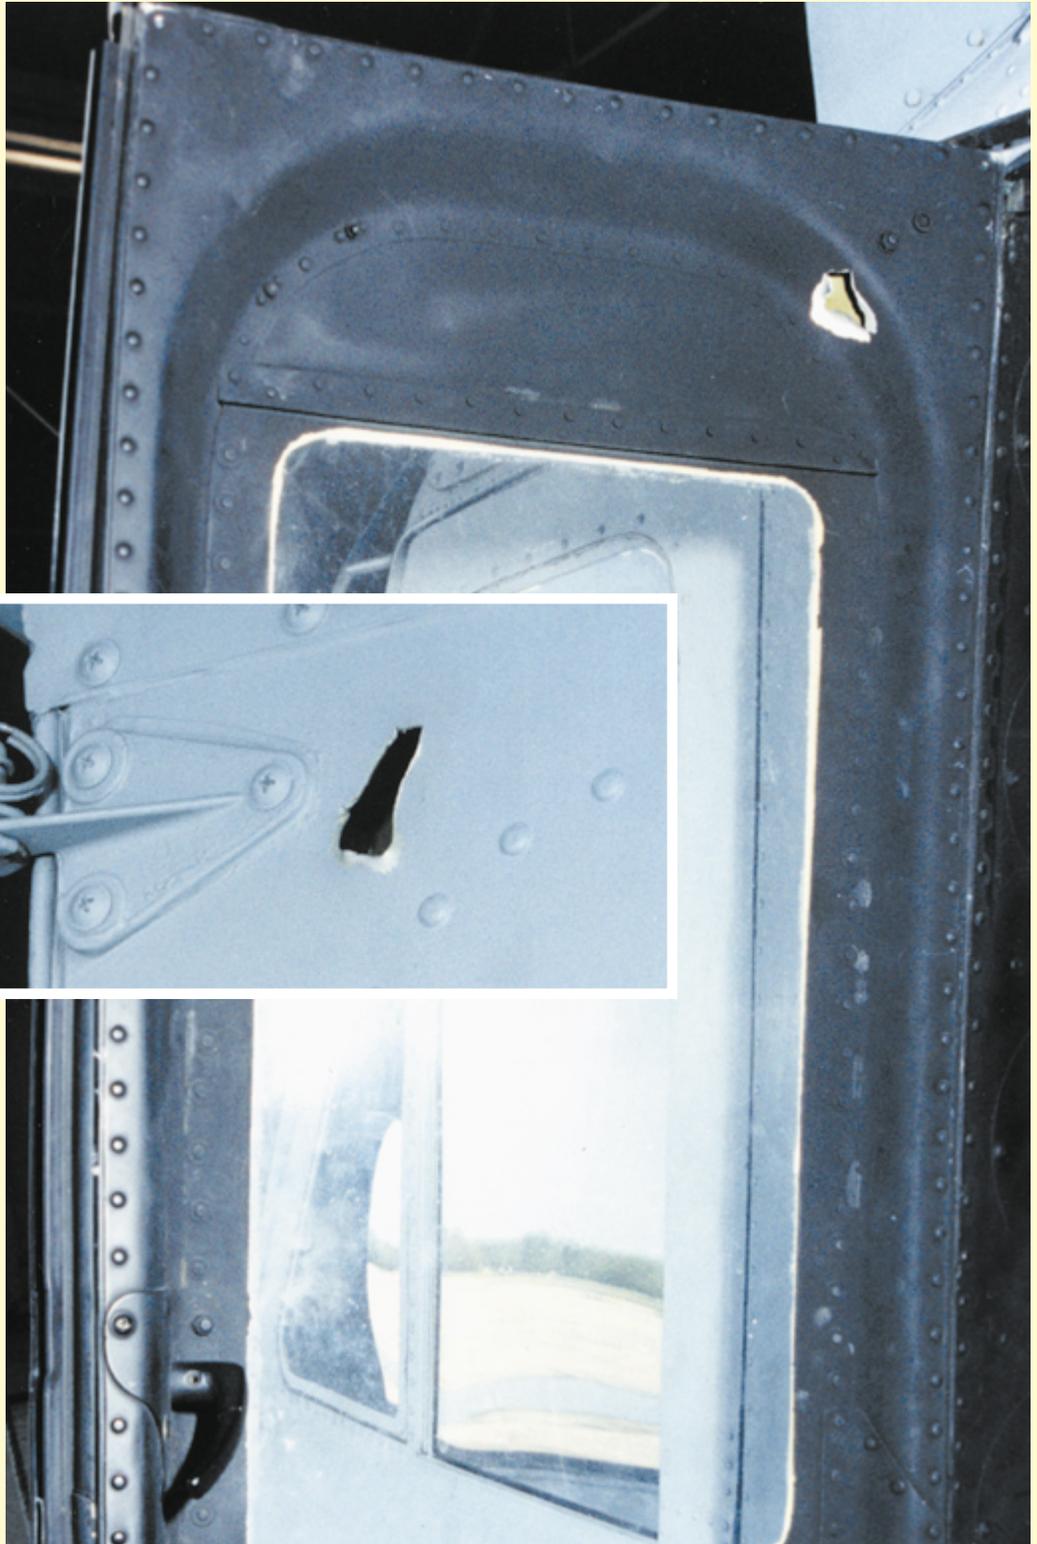
A fragment missed the crew chief's head and tore holes in the cabin door.

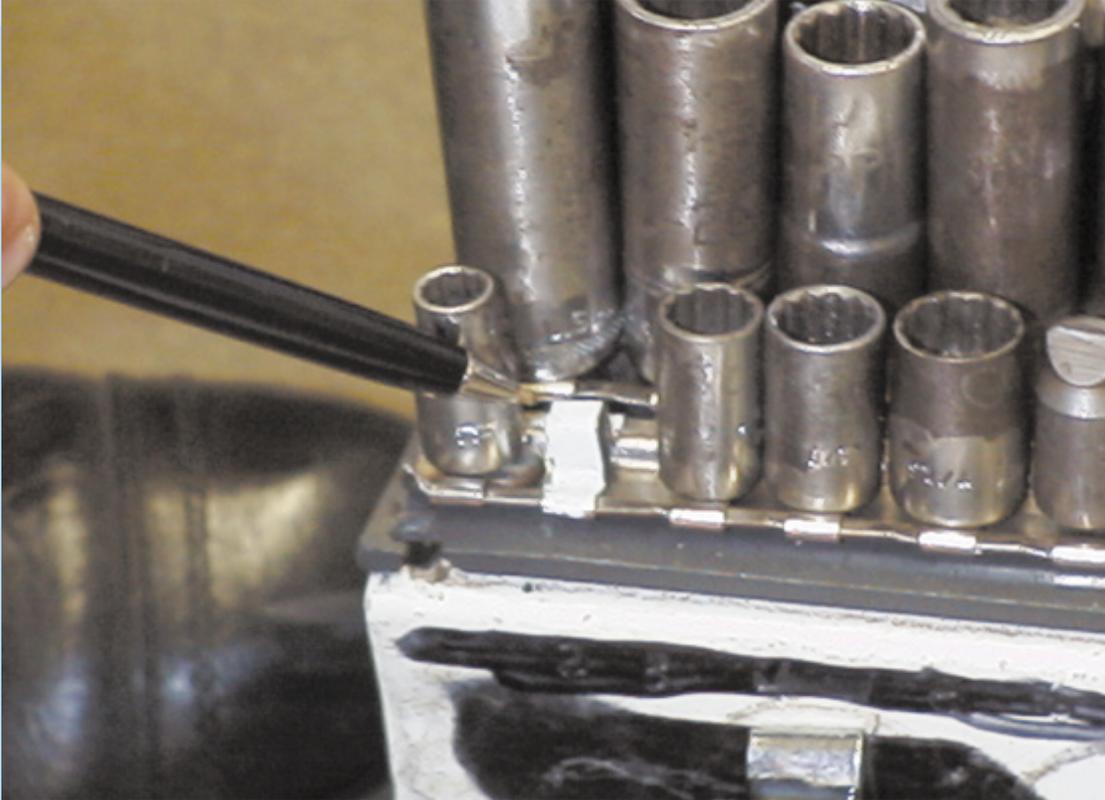
The white paint means the corresponding tool has been surveyed. The document number must be entered on the toolbox's shortage list and filed with QA.

The team reviewed our tool-control program and identified some serious discrepancies. For example, airframes division was using a file with a missing tip. A missing-tool investigation should have been done the instant shop personnel knew about the broken tool, and they should have surveyed it. Neither occurred. When our power-line division surveyed a tool, they indicated it in the toolbox with a white outline of the tool, but they didn't place a document number on the toolbox's shortage list. They didn't file it with QA, either.

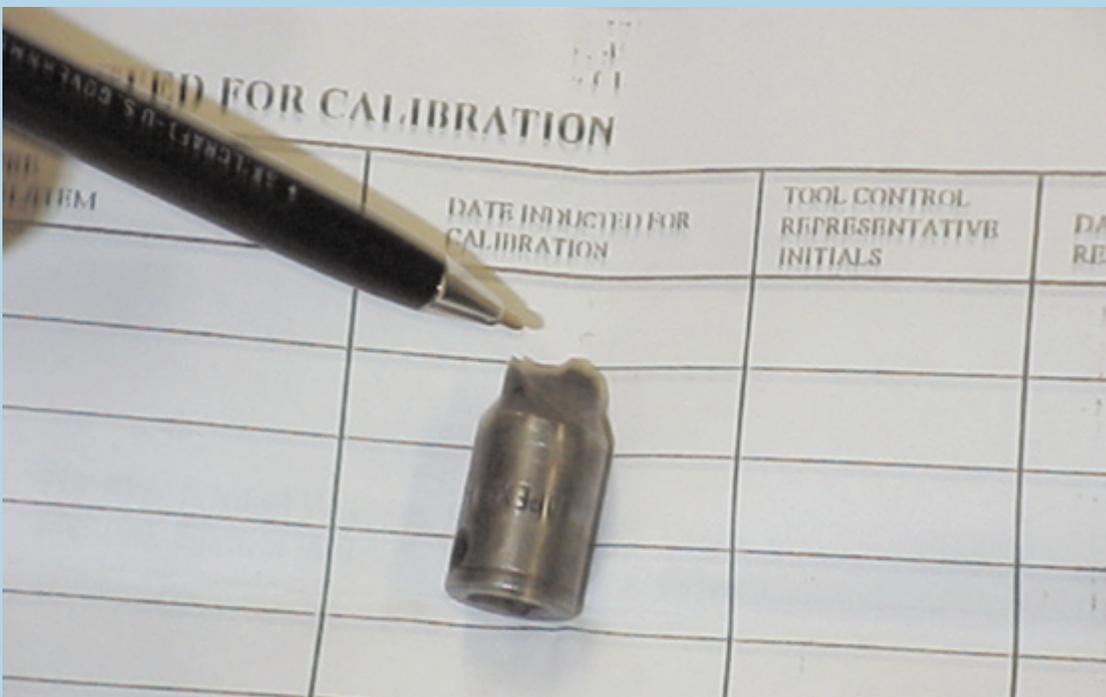
This broken socket is the tool that came from the white area in the first photo. Notice the tool control document under it.

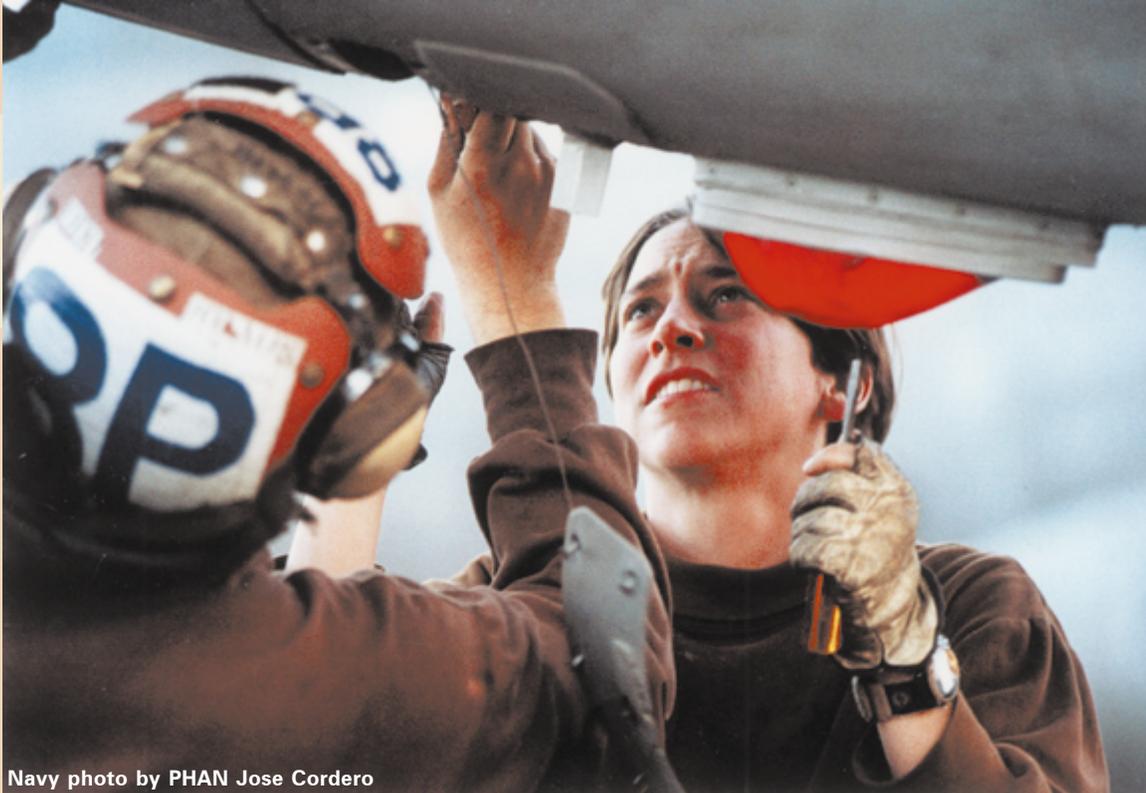
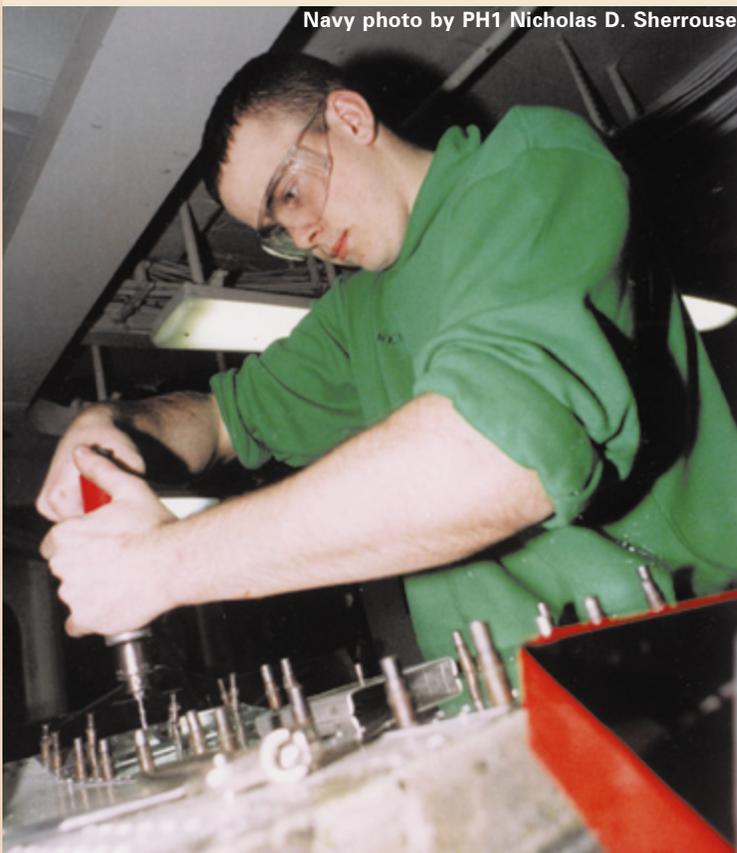
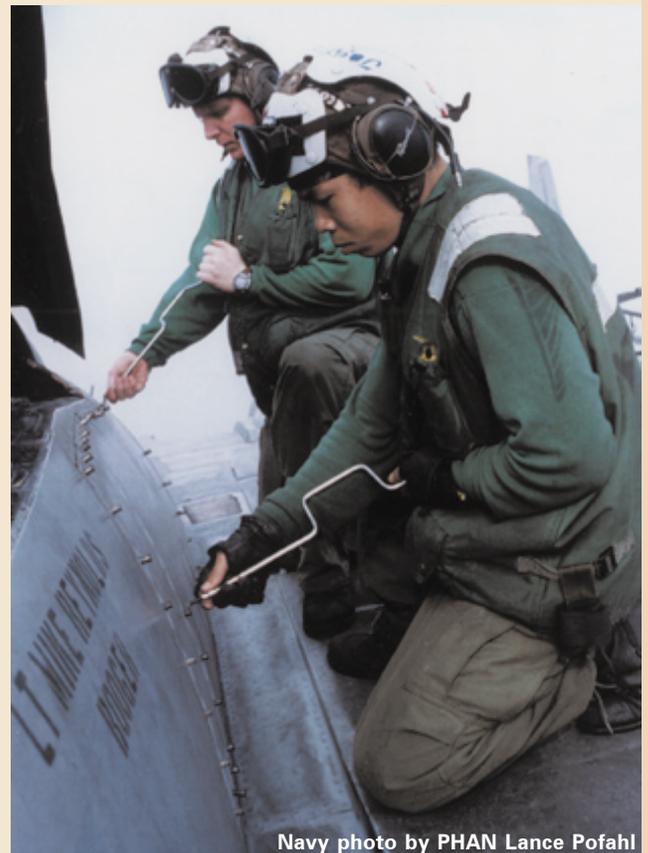
Too many aircraft go into depot-level maintenance with missing, unidentifiable or wrong bolts, and broken anchor strips. When people such as AN Tracy Pipes (top photo), doing a daily inspection on a VAQ-135 Prowler aboard USS *Carl Vinson* (CVN 70) in the Arabian Gulf; AMSAN Gregory Wendel (bottom left) repairing an aircraft panel in AIMD aboard USS *Enterprise* (CVN 65) en route to the Persian Gulf, and AE3 Joey Jose (front) and AE2 Rick Edwards reinstalling panels on a Tomcat aboard USS *Nimitz* (CV 65), find these problems, their difficult jobs become even harder.

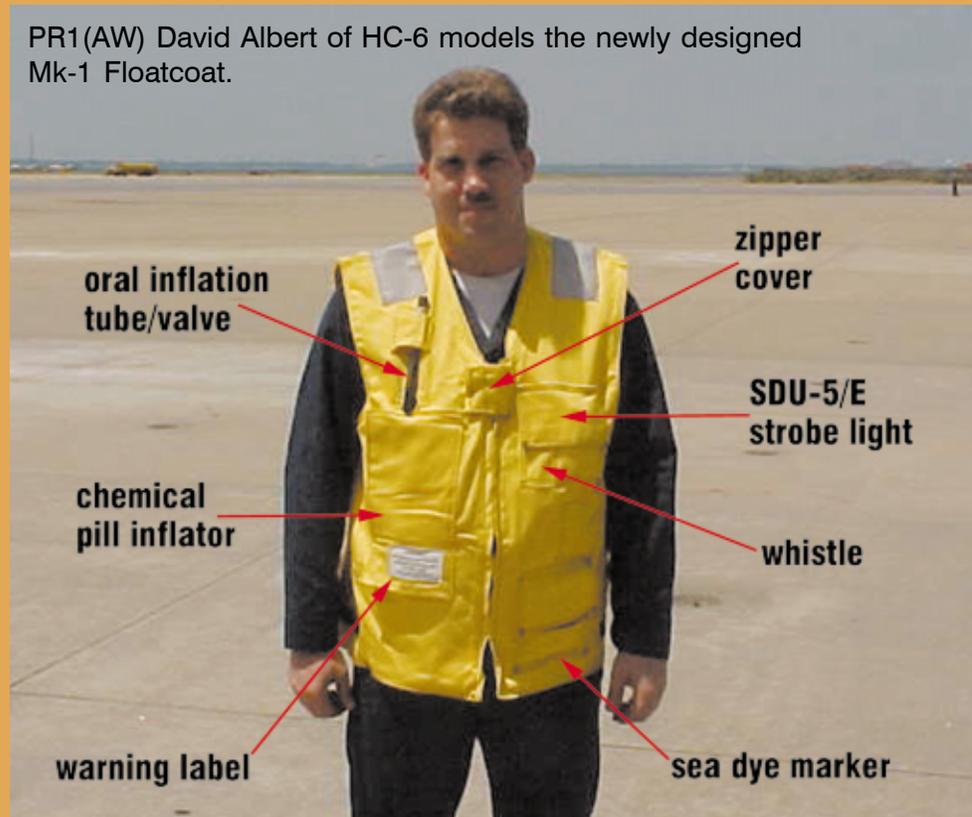
PR1(AW) David Albert of HC-6 models the newly designed Mk-1 Floatcoat.

COMNAVSEASYS COM has a newly designed Mk-1 life preserver in the supply system. The new Mk-1 has a nylon zipper instead of snaps, expanded pockets for the dye marker and strobe light, and a redesigned opening to fit both existing and proposed inflators. You order the new Mk-1 with the same stock number you used to order the old life preserver. You even use the same PMS for the new design.

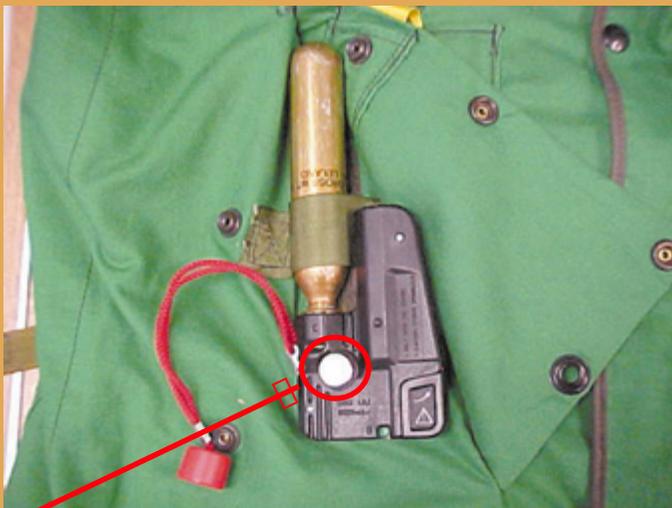
Note the pill used in the new auto-inflator. Order chemical pills in packages of 10: 1701SP1-00-NAV, chemical-pill inflators and gaskets: 1701KIT-00-NAV.
