Research  
Paper  
FPL-RP-543

# Roof Temperatures in Simulated Attics

Jerrold E. Winandy  
Rhett Beaumont

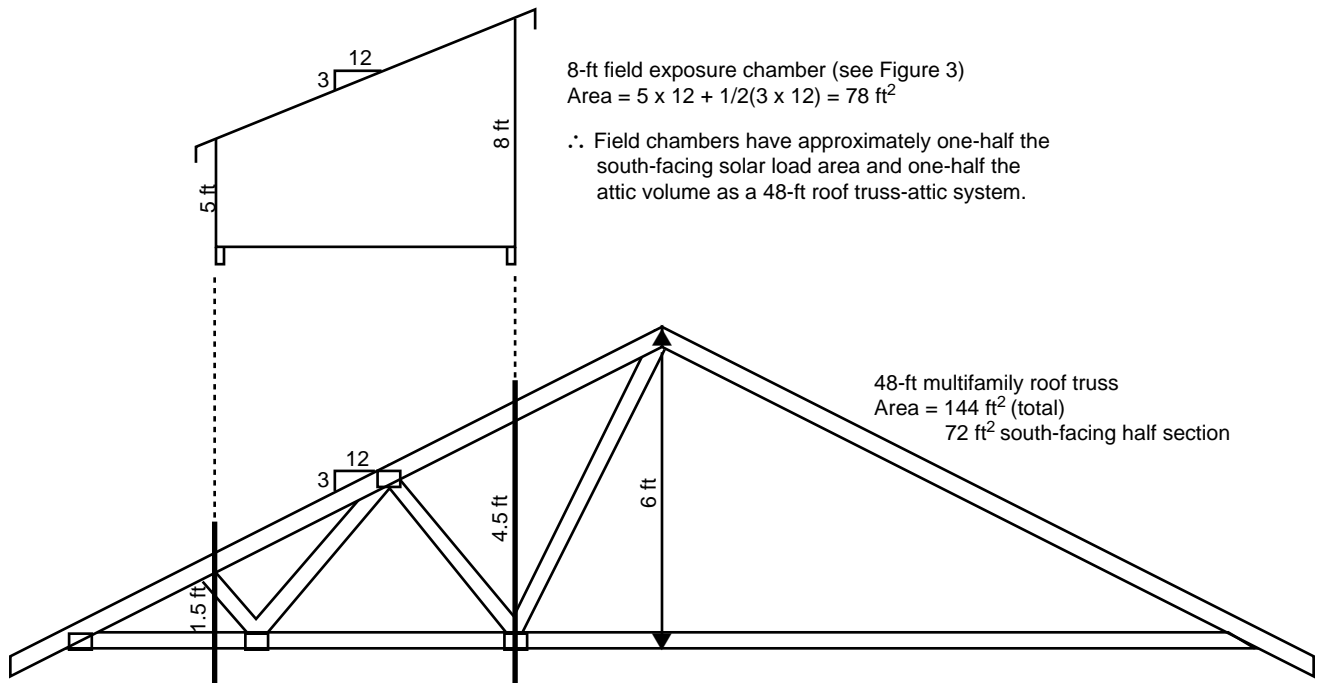
Figure 2—View of field exposure chamber in relation to roof truss of multifamily structure. Field chamber has approximately half the south-facing solar load area and half the attic volume as that of a 48-ft (14.6-m) roof truss-attic system.  $1 \text{ ft}^2 = 0.09 \text{ m}^2$ .

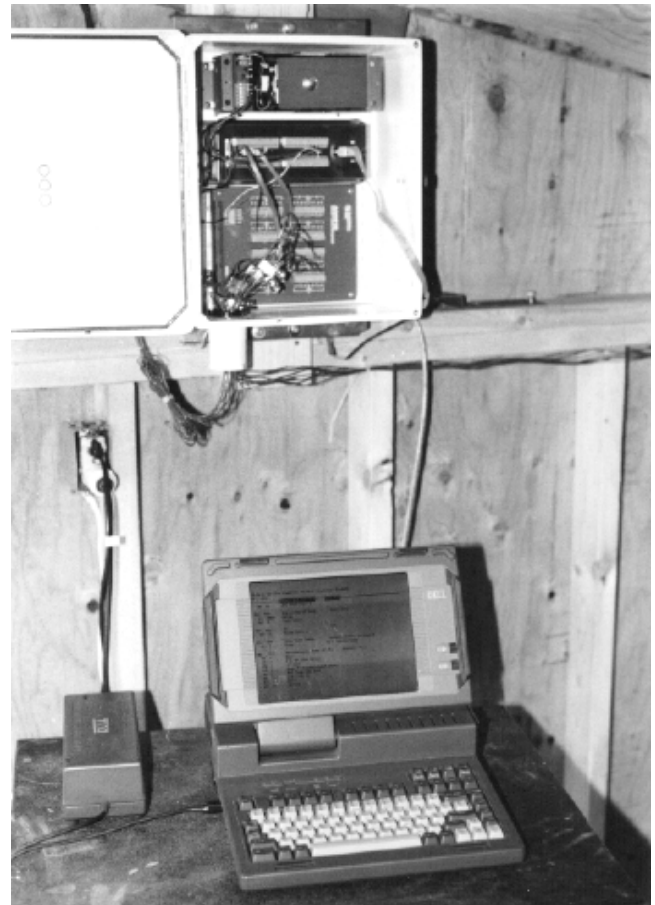
**Figure 5—Set-up of datalogger–multiplexer, temporarily attached to downloadable, portable computer system. (M95 0057–21A)**

$185^{\circ}\text{F}$  ( $85^{\circ}\text{C}$ ). The datalogger and multiplexer were placed in a weather-sealed box inside the white-shingled chamber, on the east wall approximately 6-ft (1.83-m) above the floor. The datalogger–multiplexer system collected temperature data every 5 min for each exposure chamber; the datalogger was programmed to calculate and record hourly average temperatures. Each week, the hourly data were downloaded to disk with a laptop computer. The set-up of the datalogger–multiplexer system and a temporarily attached laptop computer is shown in Figure 5.

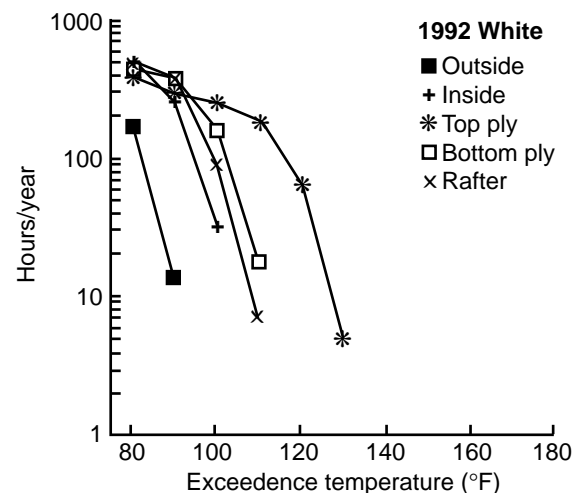
**Figure 7—Number of hours that recorded temperatures at specified locations went beyond the exceedence temperature in white-shingled exposure chamber in 1992.**

A comparison of outdoor temperature histories from 1991 through 1994 is informative (Figs. 6–11, Tables 1–6). When studying the winter weather/exposure patterns, note that based on a comparison of the colder periods of outside ambient temperature, the winters of 1991–92 and 1992–93 were quite similar in cumulative and minimum cold temperatures (Tables 1–6). Both of these winters were considered average to slightly colder than average. However, the winter of 1993–94 was considerably colder than normal, which became apparent when comparing the 3-year data. We also noted that the effect of snow cover could often be evaluated by simply monitoring the top-of-plywood temperatures. When snow cover was present, especially a new snow cover on a previously snow-free roof with either black- or white-shingled chambers, we repeatedly observed that the top-of-plywood temperature data would hover very near 32°F (0°C). We assume that as snow melts and re-freezes, it acts as a phase-changing medium that stabilizes the sheathing temperatures. Most importantly, we noted that trends and/or fluctuations in this top-of-plywood temperature were controlled during snow-covered periods by the air temperature in the interior attic space, which, in turn, dictated the temperature at the bottom of the plywood sheathing. In other words, the snow cover acted like an insulative blanket in which thermal loads on the roof sheathing were dictated from inside-to-outside heat flux rather than the normal outside-to-inside flux.

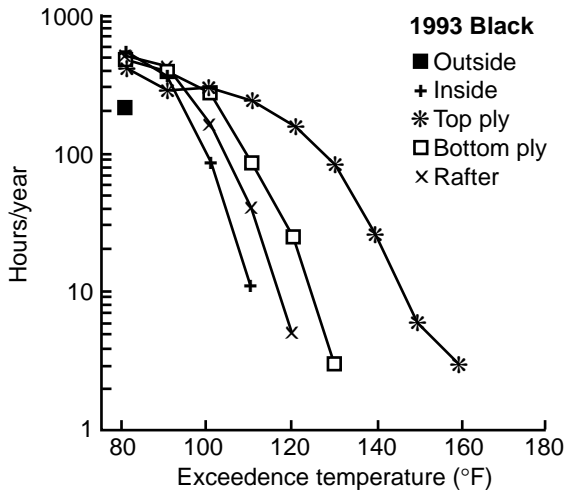
**Figure 8—Number of hours that recorded temperatures at specified locations went beyond the exceedence temperature in black-shingled exposure chamber in 1993.**
